Arboricultural Impact Assessment

For Trees At

Trinity,

South Shields,

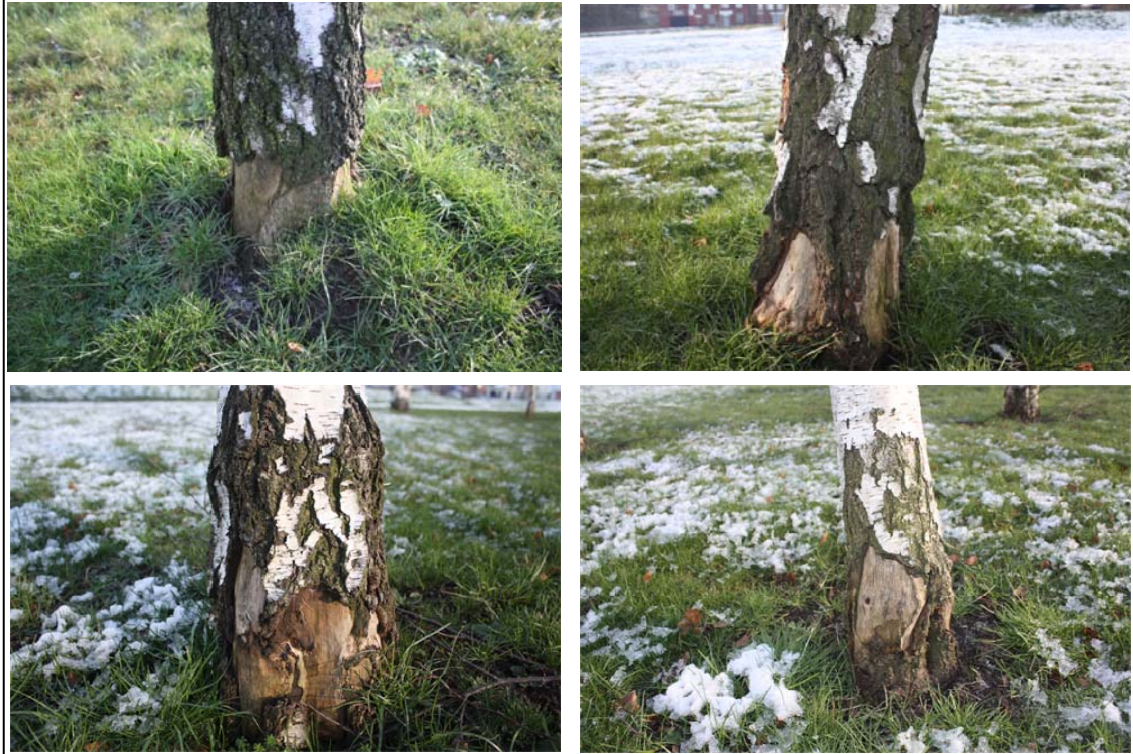
Figure 2 – Mechanical damage to birch trees

3.4 A large number of trees have been damaged by mechanical means, most likely arising from careless grass strimming operations. Notably every birch tree toward the north (trees 11 to 31) have been damaged to some extent. This will have a detrimental effect on their safe useful life expectancy.
