Arboricultural Impact Assessment

For Trees On

Land At Church Lane,

Whitburn - Revision E

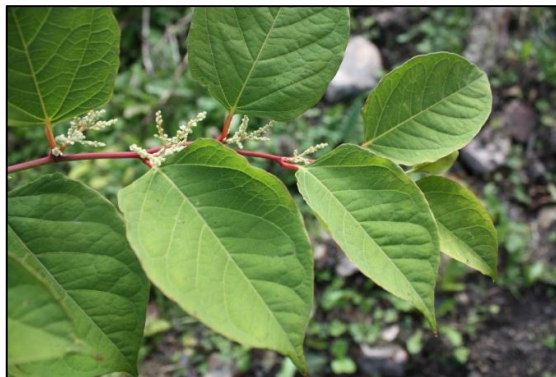
4.10.1 Japanese knotweed (*Fallopia japonica*) is established at various locations around the site.

Figure 2 - Japanese Knotweed (*Fallopia japonica*)

4.10.3 Japanese knotweed can spread prolifically through rhizomes, generating from fragments as small as 0.4g. This makes a thorough control strategy extremely important, given Japanese knotweeds ability to damage manmade structures. Japanese knotweed's invasive manner and strong growth is capable of damaging foundations, buildings, roads, paths etc.

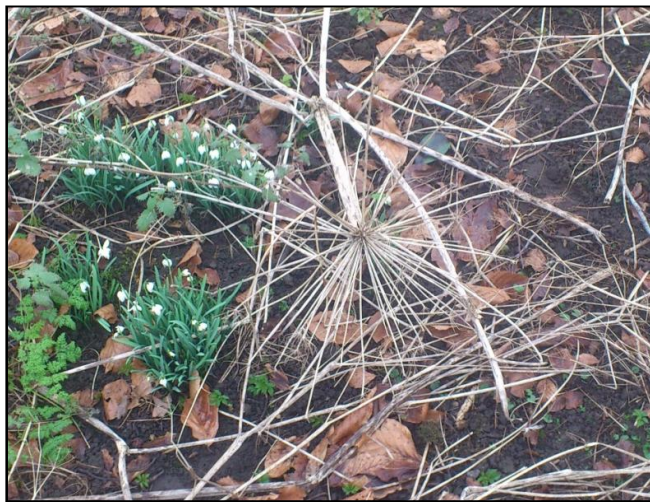
4.10.7 The desiccated remains of a number of Giant hogweed plants were found around the study area. It is unclear whether these plants are established or have been dumped here.

4.10.9 Giant hogweed flowers in its final year producing between 1,500 and 100,000 seeds. A number of desiccated flower heads were found.

Figure 3 – Desiccated flower head of Giant Hogweed found in study area.

4.10.11 It is suggested an additional walkover survey is carried out in the active growing season to confirm the presence or absence of Giant Hogweed with appropriate management practices implemented following this.

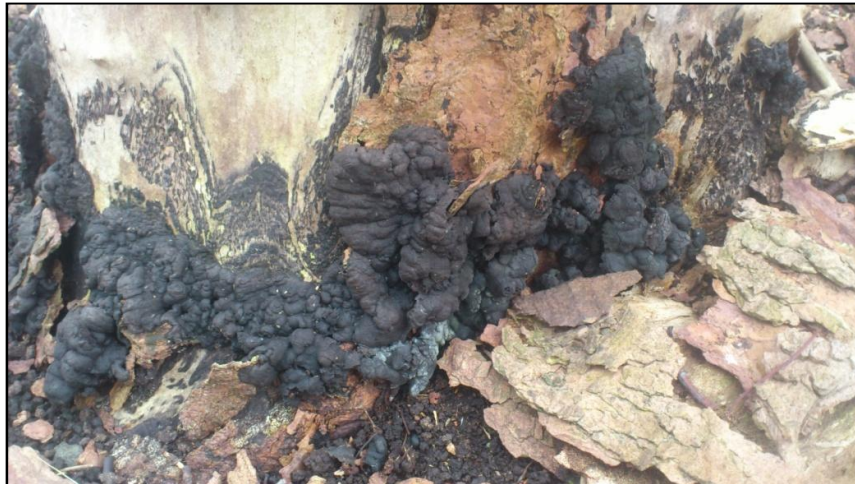
4.11.4 Tree 31 was found to be host to the fungal pathogen *Kretzschmaria deusta*. Charcoal fungus is renowned for causing sudden and catastrophic failure of trees. Tree 31 is already dead and as such lacks the ability to put on any adaptive growth. The tree also leans towards a small building within the grounds of the adjacent cricket pitch. This tree should be removed as part of site management and in the interests of safety.

4.11.6 This fungus induces a brittle ceramic fracture of the trunk and/or root system with fracturing tending to occur before an advanced white rot has established. The fracture surface can be quite hard.

4.11.7 The fungus is particularly dangerous as it is often difficult to locate and the brittle fracture associated with the decay tends to occur without warning of incipient failure.

Figure 4 – *Kretzschmaria deusta* fruiting bodies around base of T31
