TREE SURVEY

AT
SANDFIELD HOUSE
DOWNHILL LANE
WEST BOLDON

Document Title: TREE SURVEY

Date: 20th January 2015

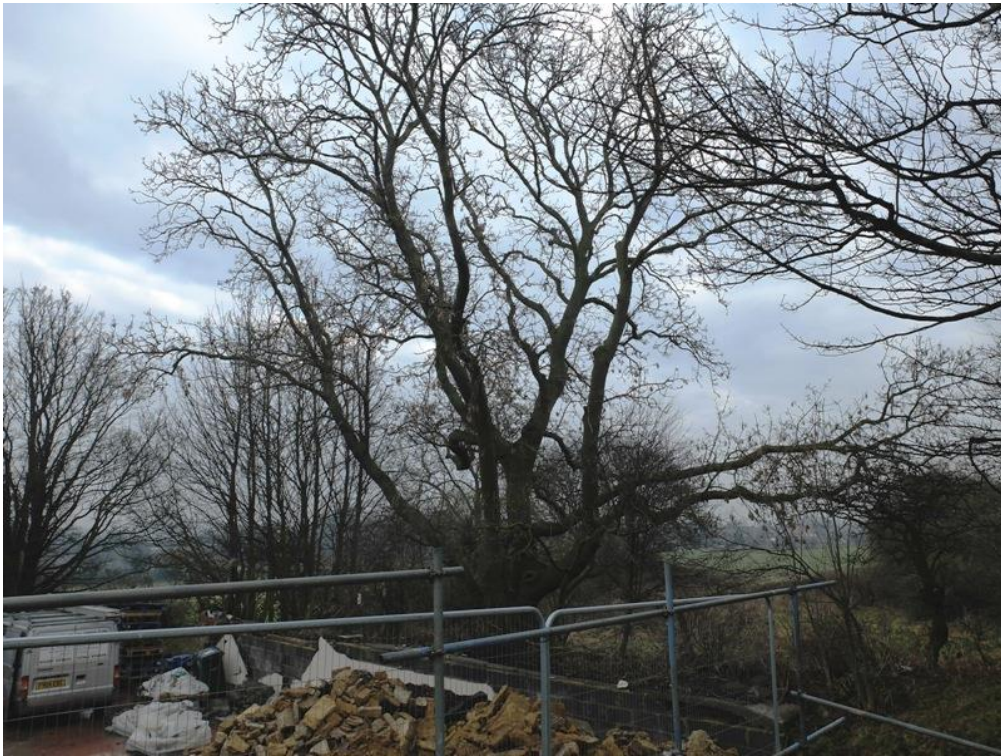
Plate 1

2.3.5 View looking northeast towards T1 growing on raised southeastern boundary with recently demolished adjacent garage as shown in Plate 1.

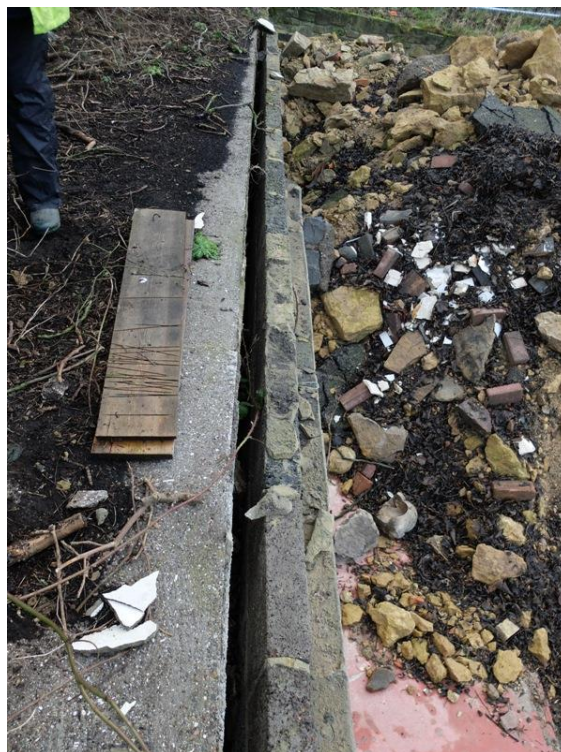
Plate 2

2.3.6 View looking southeast along top of 2m high retaining wall located 1.3m from western edge of base to T1, which forms a root barrier modifying the root plate, as shown in Plate 2.

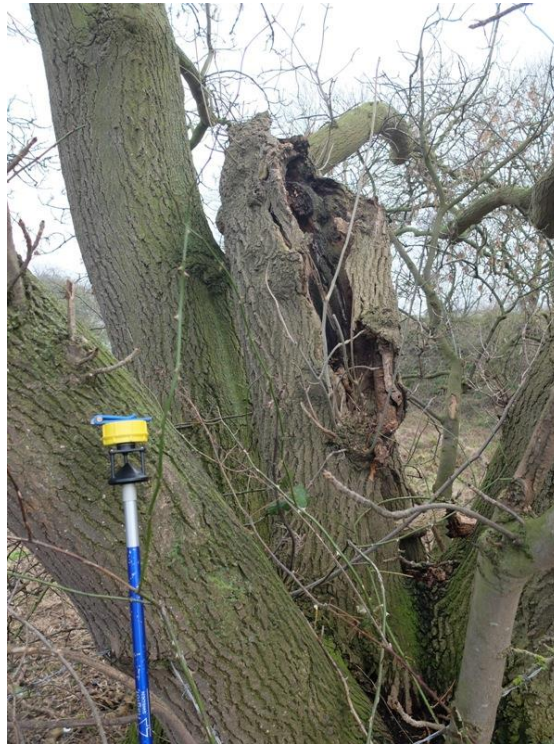
2.3.7 View looking northeast towards rotten central stem of T1 showing signs of structural collapse as shown in Plate 3A and southern-most bole with large cavity and extensive decay with soft wood to 80% of circumference as shown in Plate 3B.

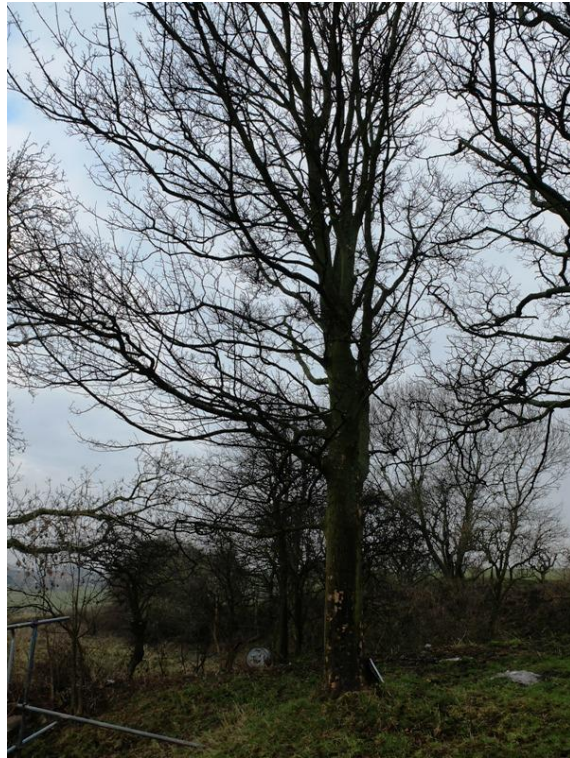
Plate 4

2.3.8 View looking east towards T2 on the south eastern boundary as shown in Plate 4.

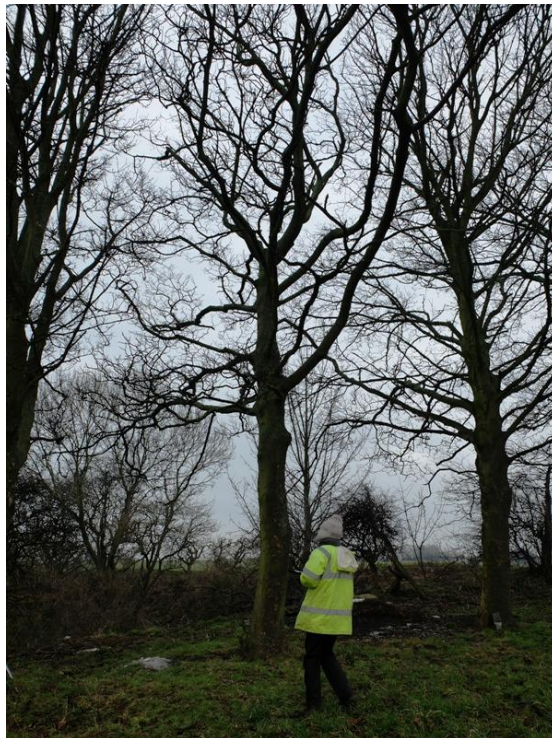
Plate 5

2.3.9 View looking east towards T3 and T4 on the south eastern boundary as shown in Plate 5.

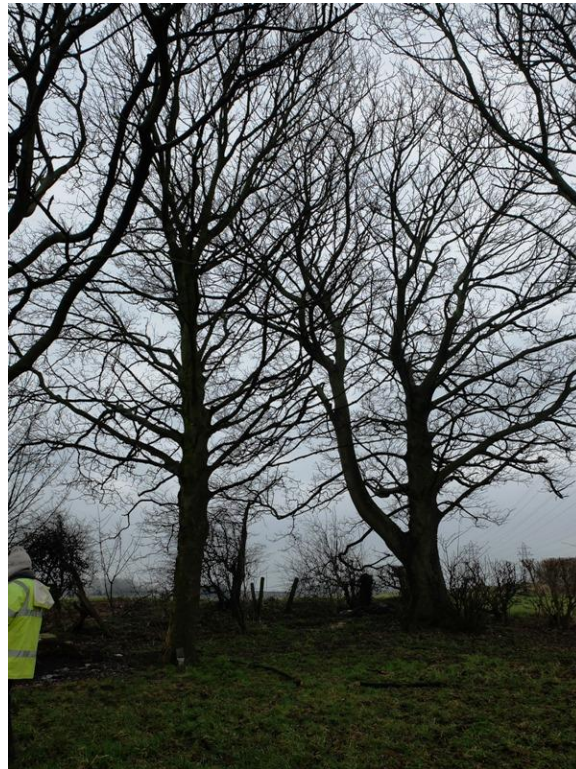
Plate 6

2.3.10 View looking east towards T5 (with T4 left of photo) on the south eastern boundary with massive decay and lesion to northeast on major branch, suspected fire damage as in T4, and suspected fungal decay, as shown in Plate 6.

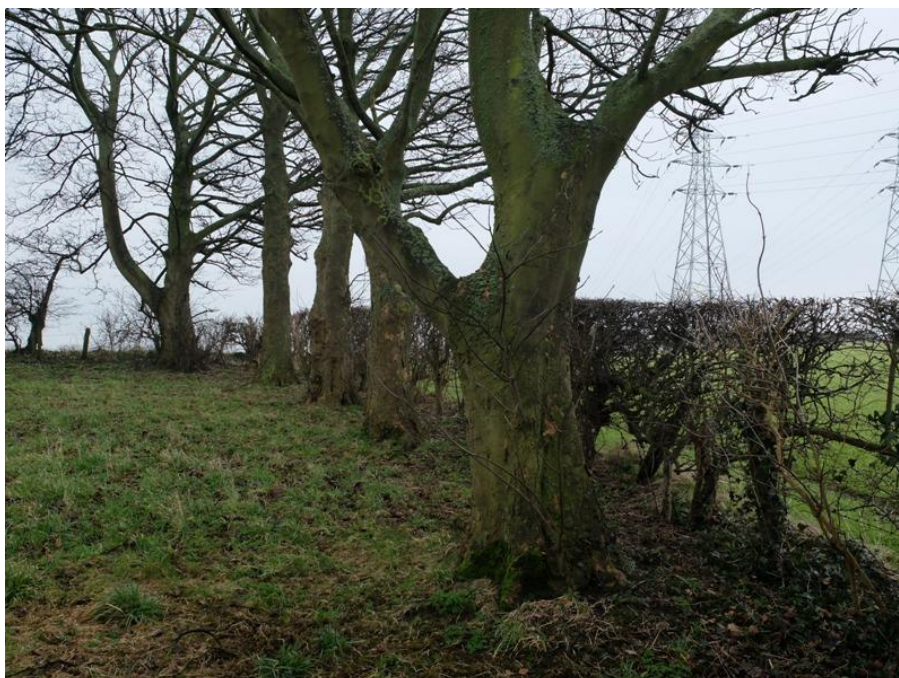
Plate 7

2.3.11 View looking east towards T6, T7, T8 and T9 growing as a row along the southern boundary, (with T5 beyond on eastern boundary) with a boundary hedge, as shown in Plate 7.

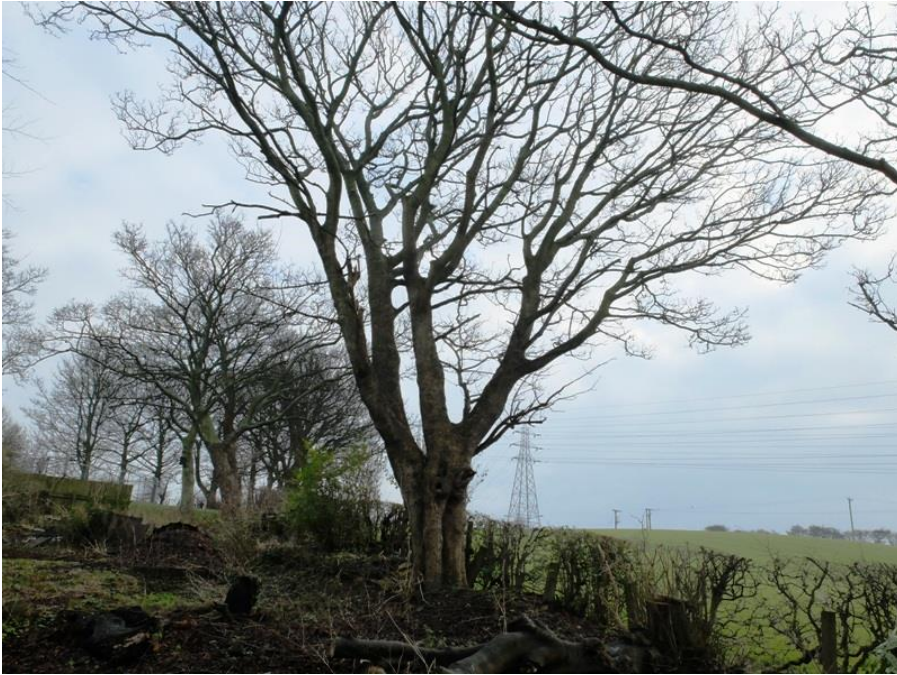
Plate 8

2.3.12 View looking east towards T12, T13, T14 and T16 growing as a row along the southern boundary, with a boundary hedge, as shown in Plate 8.

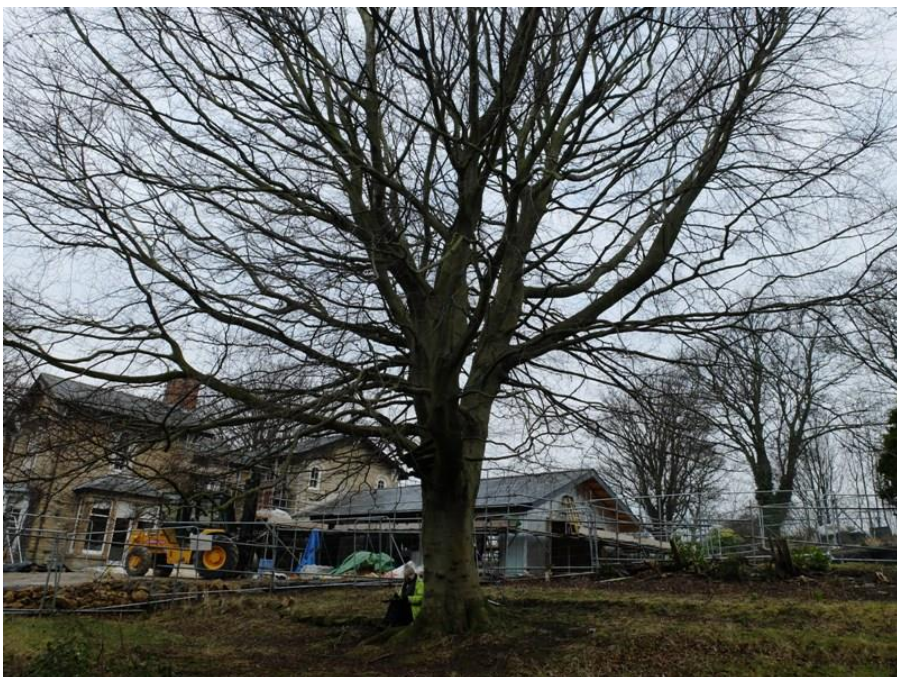
Plate 9

2.3.13 View looking north east towards the specimen tree T17 growing on a former terraced lawn, as shown in Plate 9.

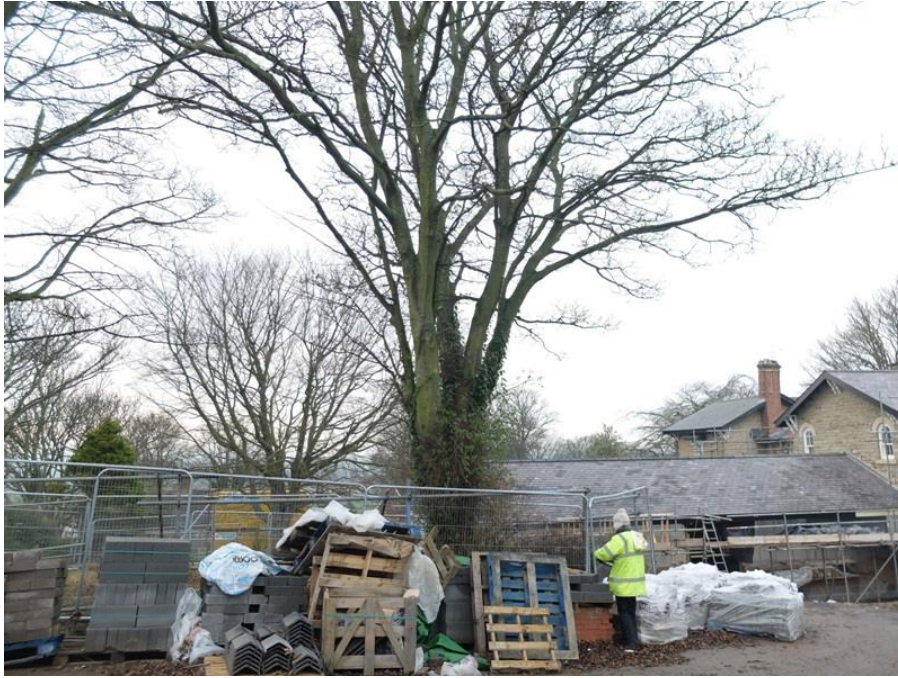
Plate 10

2.3.14 View looking west towards T21 (with T20 Lawson cypress beyond left of photo), as shown in Plate 10.

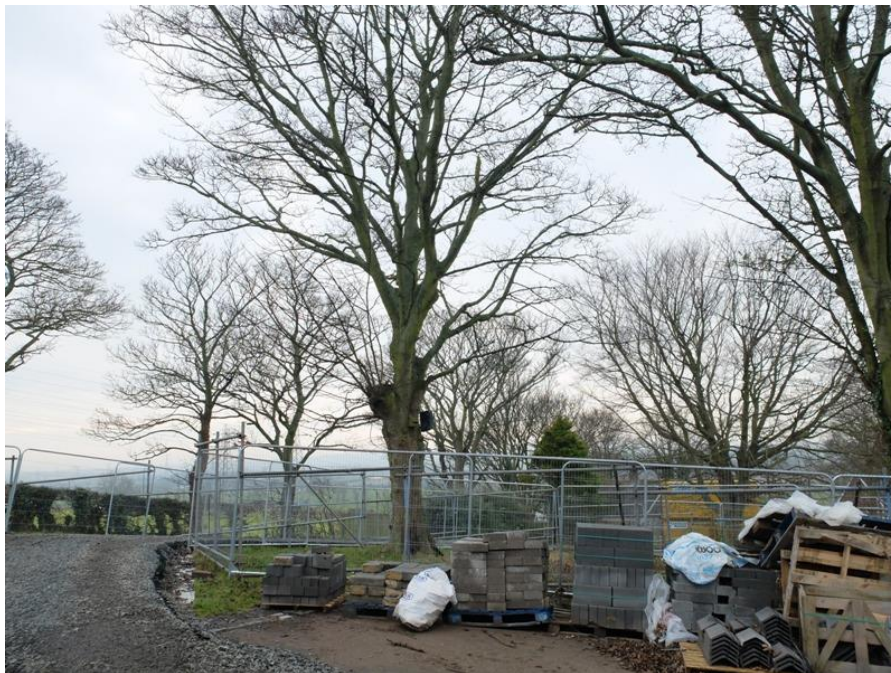
Plate 11

2.3.15 View looking southwest towards T22, as shown in Plate 11.

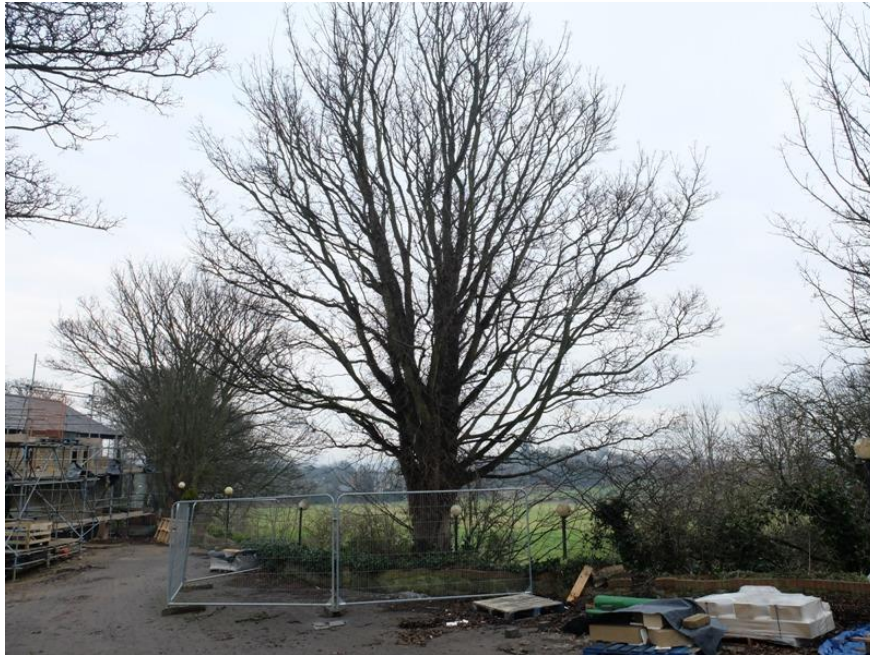
Plate 12

2.3.16 View looking north towards T23, with T24 and T25 beyond, growing on eastern boundary edge, with a former quarry to east and retaining wall and block paving to the west, as shown in Plate 12.

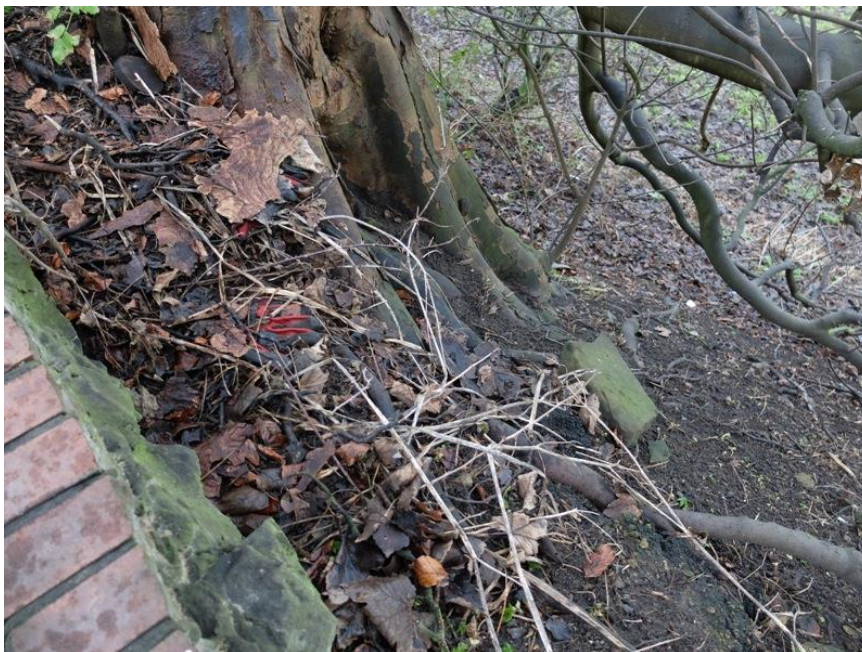
2.3.17 View east of T25 with former quarry ledge to base to east and retaining wall and tarmac drive to west with wall showing deflection and large crack as shown in Plate 13A and 13B respectively, and wet cavity to crown spring and structurally suspect requiring further investigation, as shown in Plate 13C.

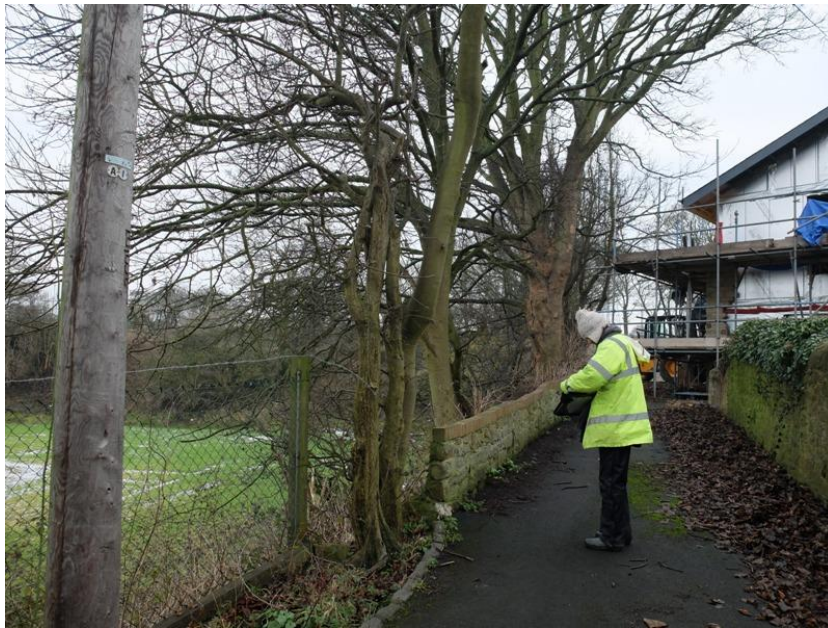
Plate 14

2.3.18 View south along eastern boundary with of T26, T27, T28, T29 and T30 with former quarry ledge to base to east and retaining wall and tarmac drive to west as shown in Plate 14.

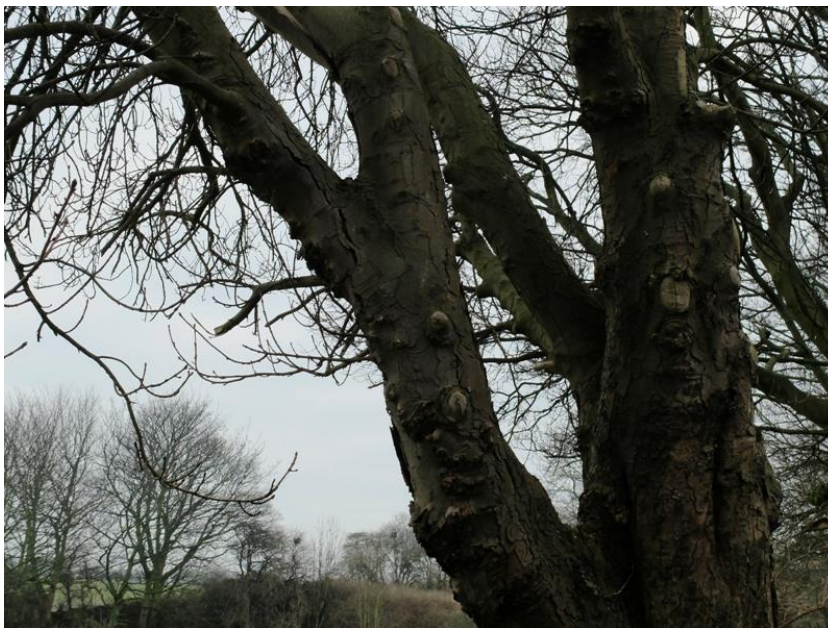
Plate 15

2.3.19 View of T31 with large split to east branch and past pruning cuts for telephone cable with cavities, as shown in Plate 15.

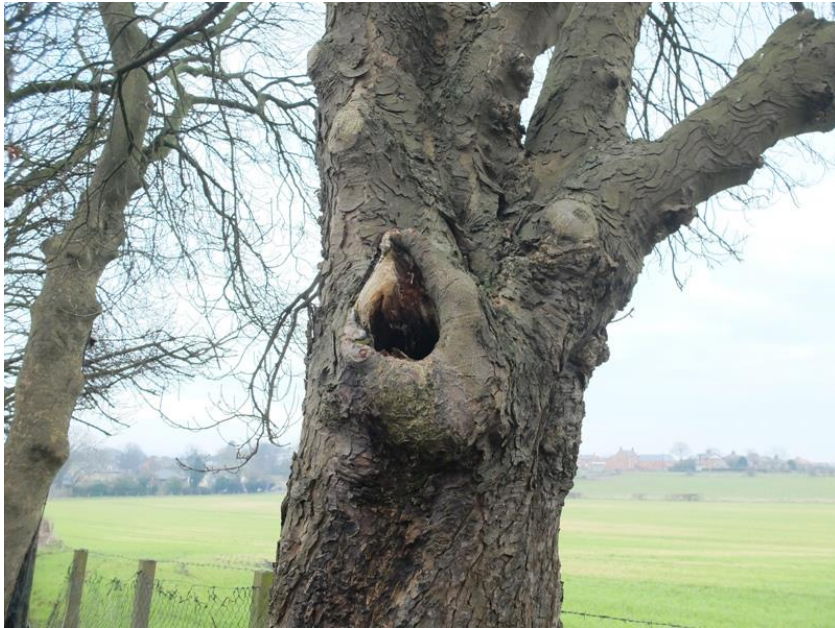
2.3.20 View of T33 (left of photo) and T32 with cavity to southwest bole with decay extending 400mm into heartwood and structurally suspect, as shown in Plate 16A with structural cracking and splitting to northeast bole from union up into crown as shown in Plate 16B, with decay to roots to base to west due to drive construction as shown in Plate 16C.

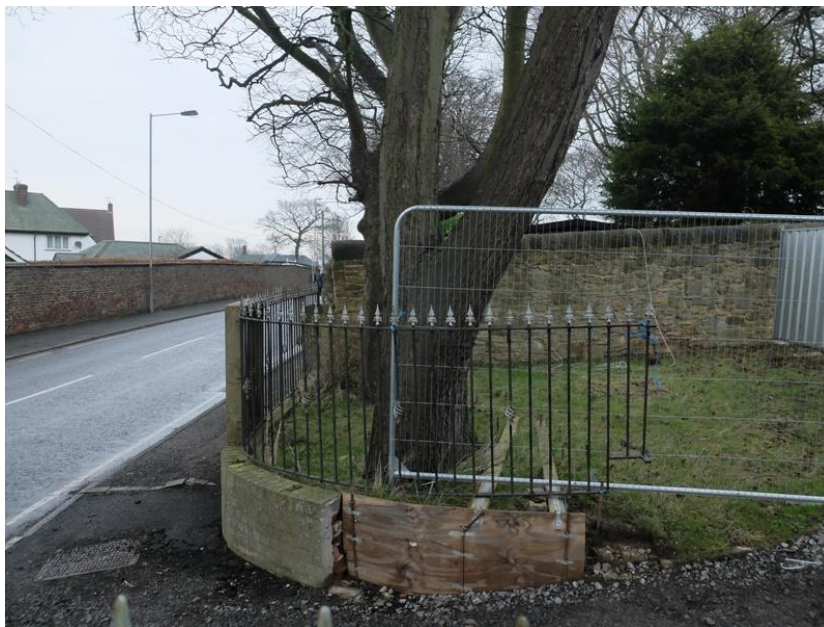
Plate 17

2.3.21 View looking north along Downhill Lane towards T60 and T61 with structural cracking to boundary retaining wall and deflection to hard surfaces as shown in Plate 17.

T12, T13, T14, T60 and T61			Careful consideration of foundation design may be required to avoid damage to tree roots if found to be present within the location of a proposed structure within the Root Protection Areas. Root damage can be minimised by using a combination of the following: a) Piles or radial strip footings, both of which should be located to avoid major roots; b) Beams, slabs, suspended floors, where all should be laid at or above ground level and cantilevered as necessary to avoid tree roots identified by site investigation.	Moderate value as part of a group along the southern and western boundary, with some importance in the landscape as viewed from a public vantage point, but in poor condition.
T64	Category B Moderate		<p>In order to arrive at a suitable solution, site specific and specialist advice would be sought regarding foundation design from the arboriculturist and engineer.</p> <p>On completion of main construction works, where it is necessary to incorporate part of the protected area around the tree within the hard surfacing for footpaths and roads or within adjacent excavations for any re-profiling works, any excavations close to the tree will be undertaken by hand and hard surfaces to be porous paving, leaving the underlying soil intact to prevent damage or disturbance to roots.</p> <p>Arboriculturist to advise on any tree roots exposed by such operations and should be treated in accordance with details in Clause 6, 7 and 8 BS5837: 2012, Trees in relation to design, demolition and construction - Recommendations and as set out within Section 3.4 of this report and under arboricultural supervision.</p> <p>Arboriculturist to advise and supervise all necessary works.</p>	Moderate value as part of a group along the western boundary, with some importance in the landscape as viewed from a public vantage point.

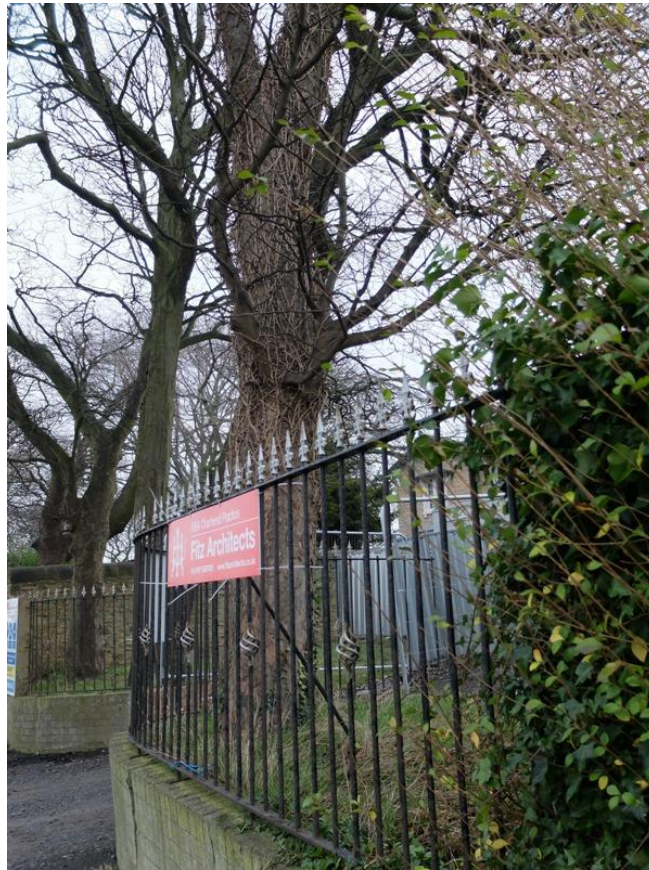
Plate 18

2.3.22 View looking north along Downhill Lane towards T62 which leans at 22° and structurally suspect with cracking and deflection to boundary retaining wall as shown in Plate 18.

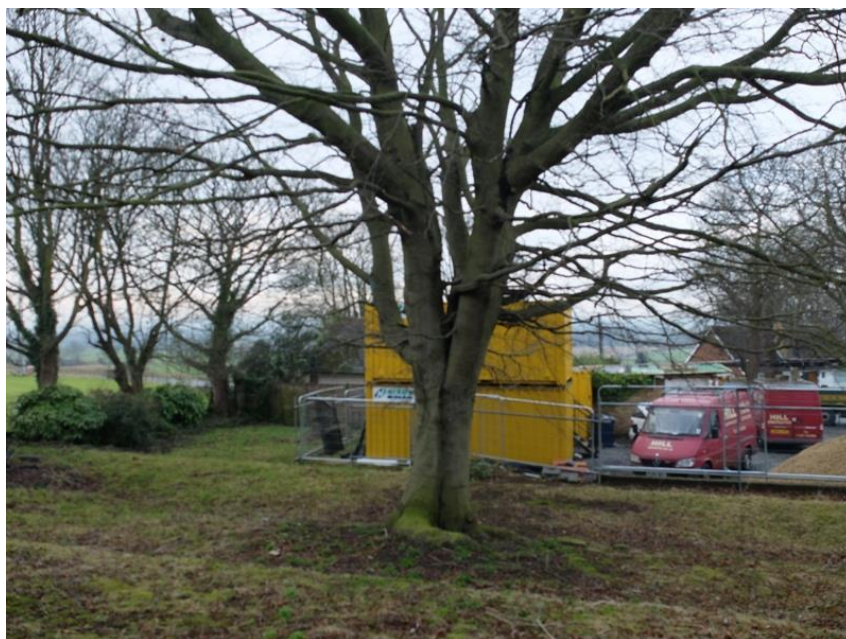
Plate 19

2.3.23 View looking west towards T17 in the foreground and T64, T65 and T66 beyond along the southern boundary, as shown in Plate 19.
