Ponteland Newcastle Upon Tyne NE20 9SD 01661 822017 info@captureia.co.uk info@hedleydesign.co.uk Job Title: St Andrew's Church & Centre Church Street, Hebburn Client: DMCN Drawing Name: Existing Ceiling Photographs

Drawing Number: C039(B)11

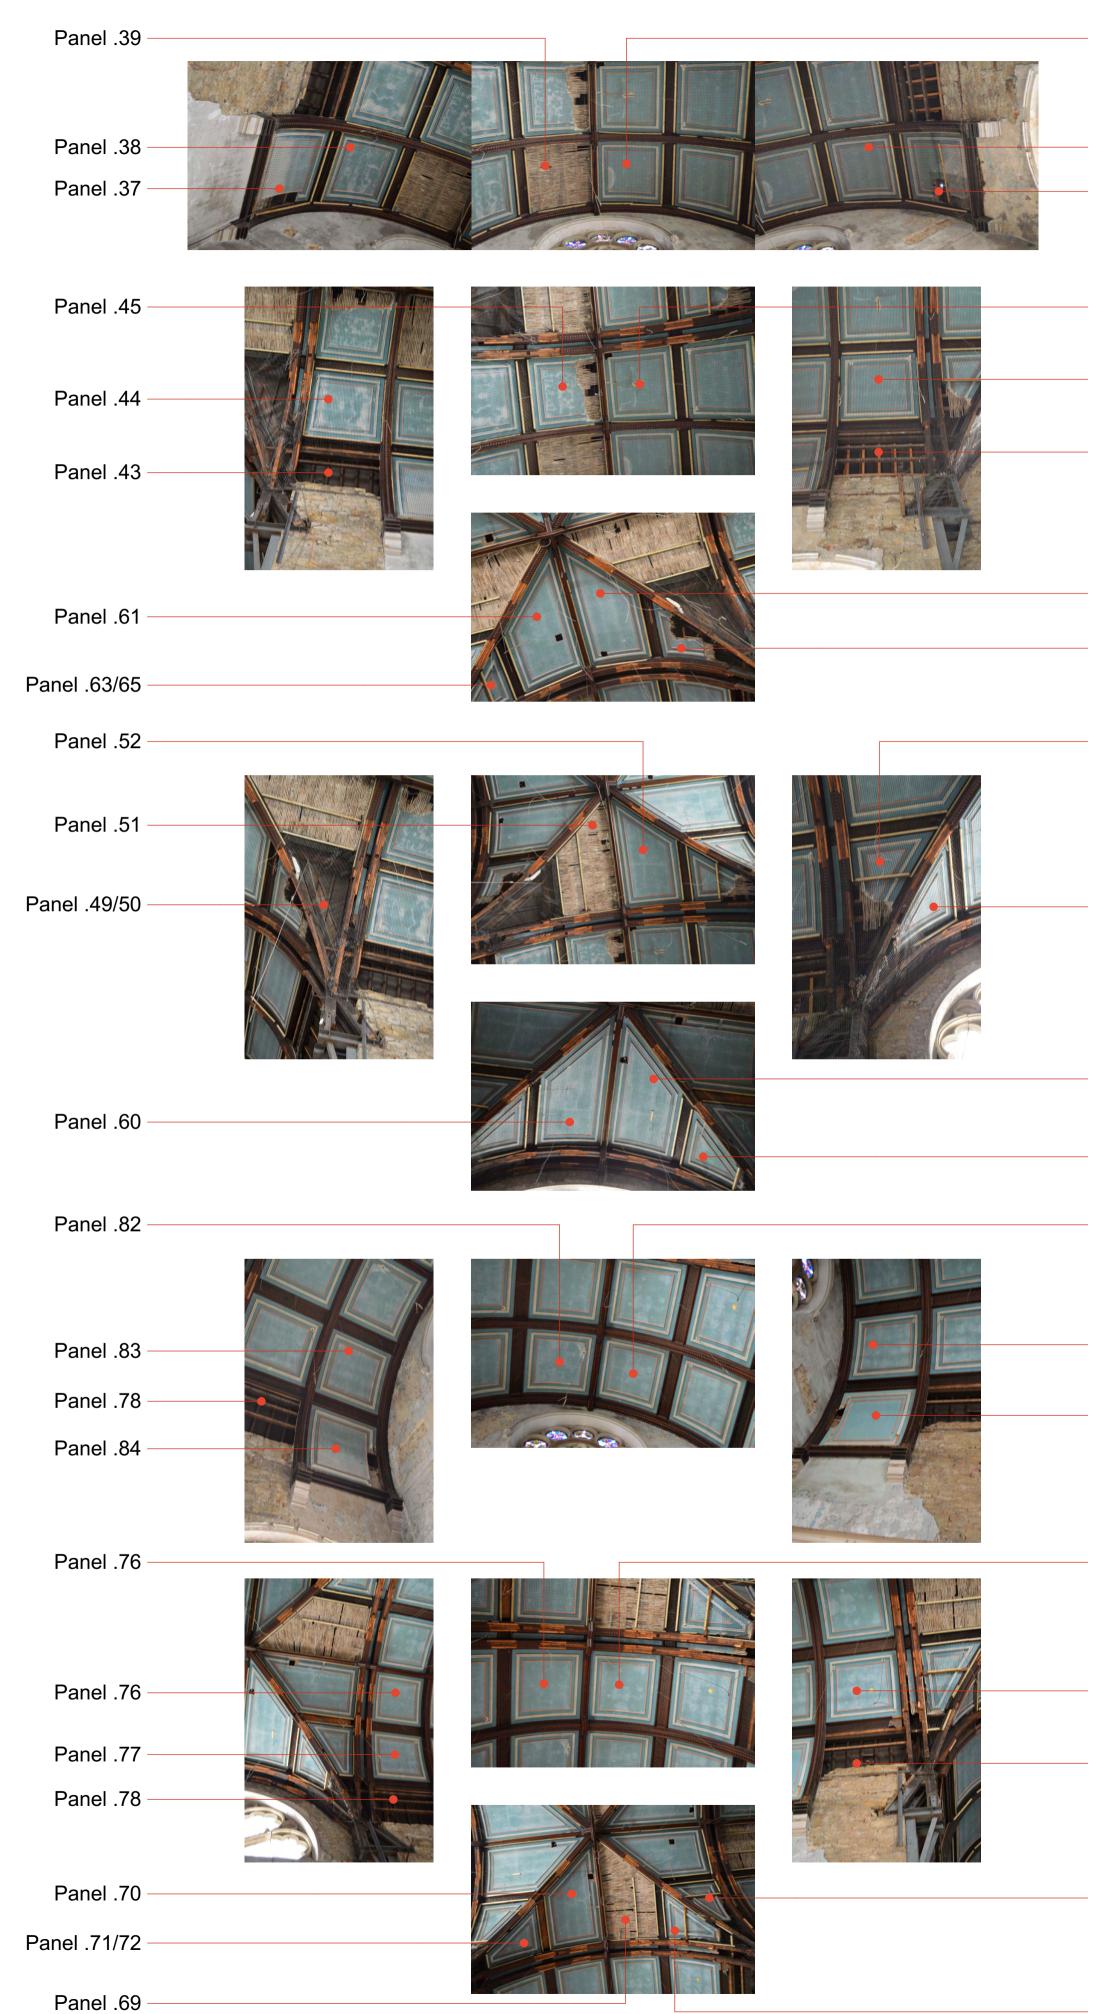
- Damage present to ribs of roof structure
