Gwyn Davies
12 West Park Road
Cleaton
SR6 7RR

Vegetation Report - Horticultural / Arboricultural

We refer to your request to undertake an inspection of the trees and vegetation in the grounds of 12 West Park Road, Cleaton.

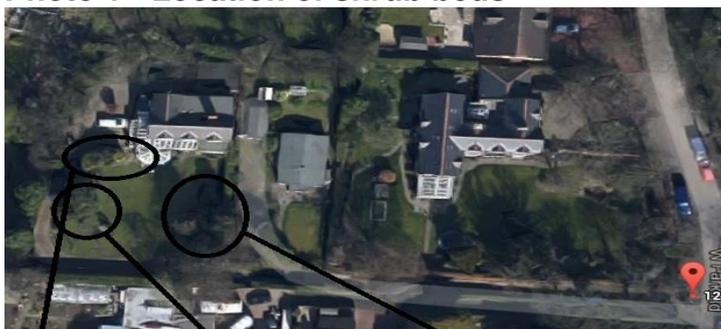
Photo 1 - Location of shrub beds

Shrub bed 1

Shrub bed 2

Shrub bed 3

Both beds 1 and 2 could be removed to allow for better replanting when the new extension to the property has been built.

A new selection of more appropriate species of both trees and shrubs could be selected which will allow for better plant association and with good maintenance will enhance the remodelled building.
