**Arboricultural Impact Assessment
Tree Survey
Barns Close, Monkton**

Client: David Leybourne

Date: 16th July 2015

Our Ref: 0007477

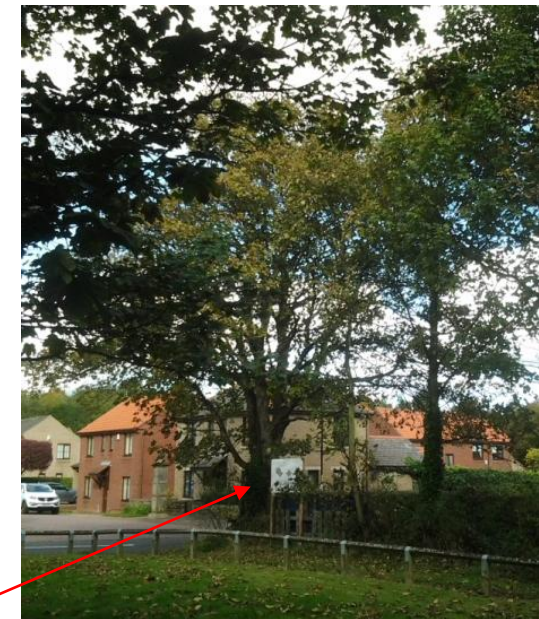
Tree T1

Tree Comment : Relatively healthy in appearance.
 Dense Ivy growth upon lower stem.
 Co-dominant stems form at 3m HGL.
 Relatively healthy branching system in appearance.
 Major deadwood within canopy.

Survey Comment : Tree growing outside of site boundary.
 Root containment by Public highway to northwest, and access road to southwest.
 Competition for ground moisture and nutrients with surrounding, dense vegetation.
 Inspection limited due to dense Ivy growth.

Work Category	Action
Remove	Major dead wood
Remove	Ivy
	<i>Sever at base</i>

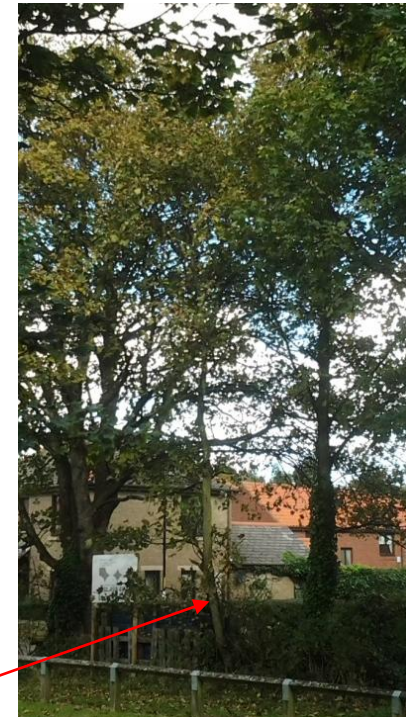
Tree T2

Tree Comment : Poor quality, spindly specimen.
Buttress roots covered by dense vegetation.
Main stem leans to south approx. 20 degrees.
Evidence of previous pruning on south side of stem, with pruning stubs left.
Sparse, poorly formed canopy.

Survey Comment : Tree growing outside of site boundary.
Root contained by access road to south.
Competition for ground moisture and nutrients with dense vegetation to north.
Inspection limited due to dense Ivy growth.

Work Category	Action
Fell and replacement plant	In agreement with the LPA

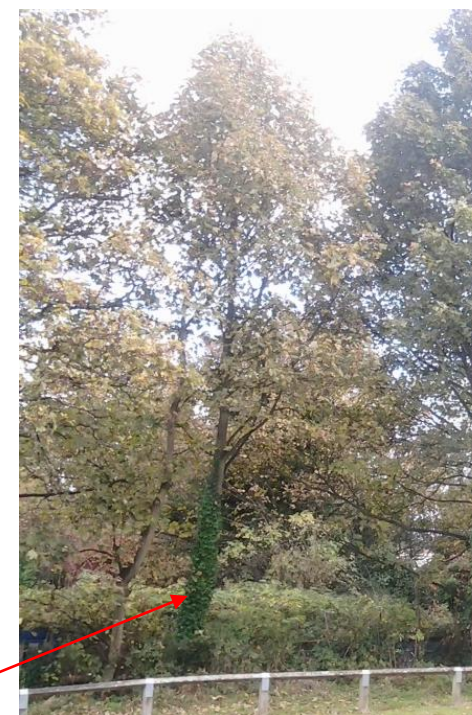
Tree T3

Tree Comment : Poor quality, spindery specimen.
 Dense Ivy growth surrounding buttress roots and main stem.
 Evidence of previous pruning on south side of stem, with pruning stubs left behind.
 Suppressed canopy and sparse branching system.

Survey Comment : Tree growing outside of site boundary.
 Root contained by access road to southwest.
 Competition for ground moisture and nutrients with dense vegetation to north and east.
 Inspection limited due to dense Ivy growth.

Work Category	Action
Remove	Ivy
	Sever at base
Remove	Stubs

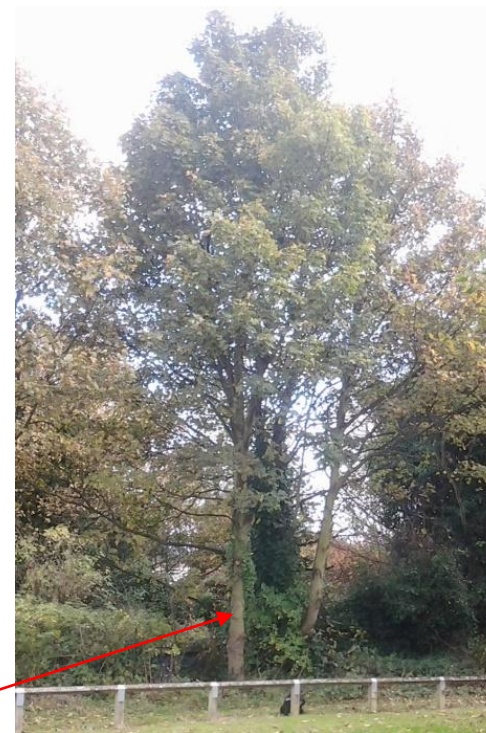
Tree T4

Tree Comment: Relatively healthy in appearance.
 Ivy growth surrounding buttress roots and lower stem.
 Evidence of previous pruning on south side of stem.
 Asymmetric canopy towards south and west.
 Minor deadwood within canopy.

Survey Comment: Tree growing outside of site boundary.
 Minor root containment by compacted access road to southwest.
 Competition for ground moisture and nutrients with surrounding vegetation.
 Inspection limited due to dense Ivy growth.

Work Category	Action
Remove	Minor dead wood
Remove	Ivy
	<i>Sever at base</i>

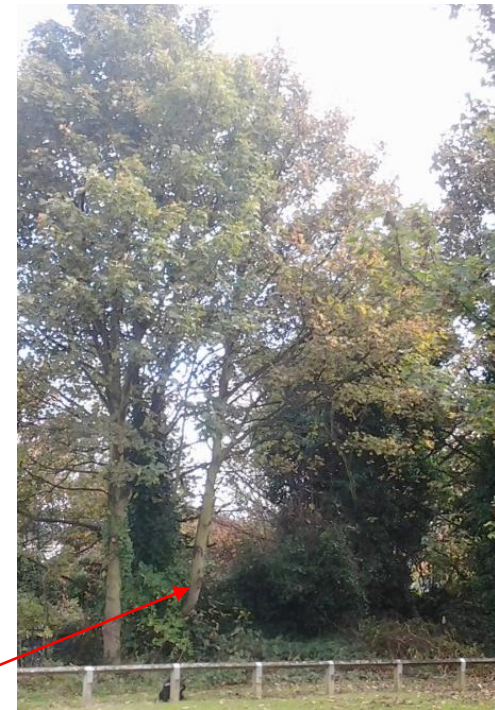
Tree T5

Tree Comment: Poor quality specimen, multi stemmed from base.
 Dense vegetation surrounding base of tree.
 Dense Ivy growth surrounding buttress roots and main stems.
 Evidence of previous pruning towards south.
 Major deadwood on stem to east.

Survey Comment: Tree growing outside of site boundary.
 Competition for nutrients and ground moisture with surrounding vegetation.
 Inspection limited due to dense Ivy growth.

Work Category	Action
Remove	Major dead wood
Remove	Ivy
	<i>Sever at base</i>

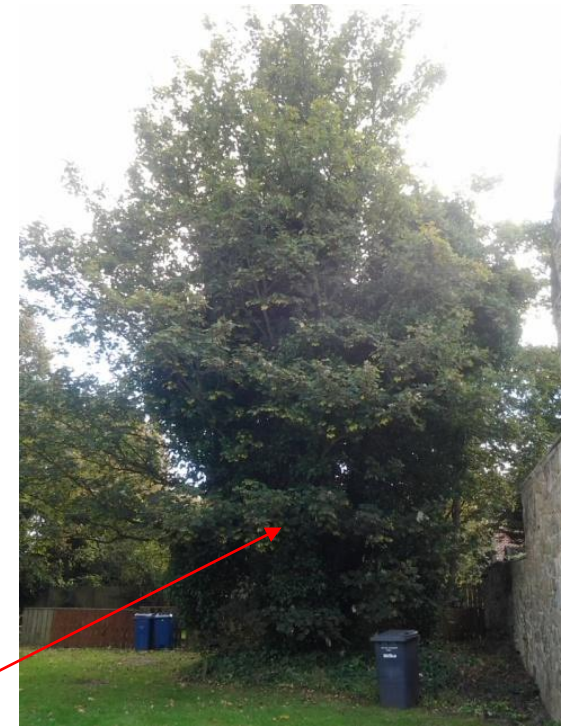
Tree T6

Tree Comment: Large, multi-stemmed from base specimen.
Dense Ivy growth surrounding base, stems and canopy.
Visual inspection limited.

Survey Comment: Tree growing outside of site boundary.
Root contained by adjacent property to west.
Competition for ground moisture and nutrients with surrounding Ivy growth.
Limited inspection due to dense Ivy growth.

Work Category **Action**
Remove Ivy
Sever Ivy at base

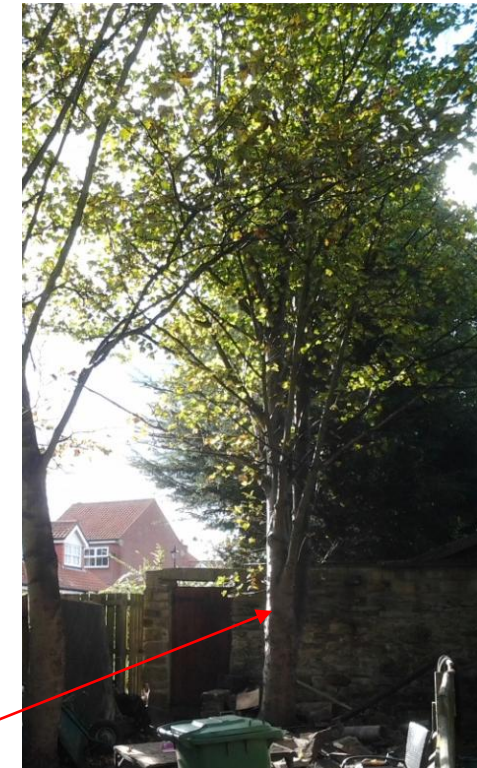
Tree T7

Survey Comment : Tree growing outside of site boundary.
Severe root containment by surrounding hard surfaces.
Rubble deposited around base of stem.

- 11.3** Trees **T7**, **T8** & **T9** are seen to be growing closely together within a group. This closeness has resulted in all three trees showing evidence of minimal ‘main stem taper’, suppressed branch growth and asymmetric canopies. It should also be noted, that the consolidated ground surface is semi-permeable.

Work Category	Action
Remove	Major dead wood

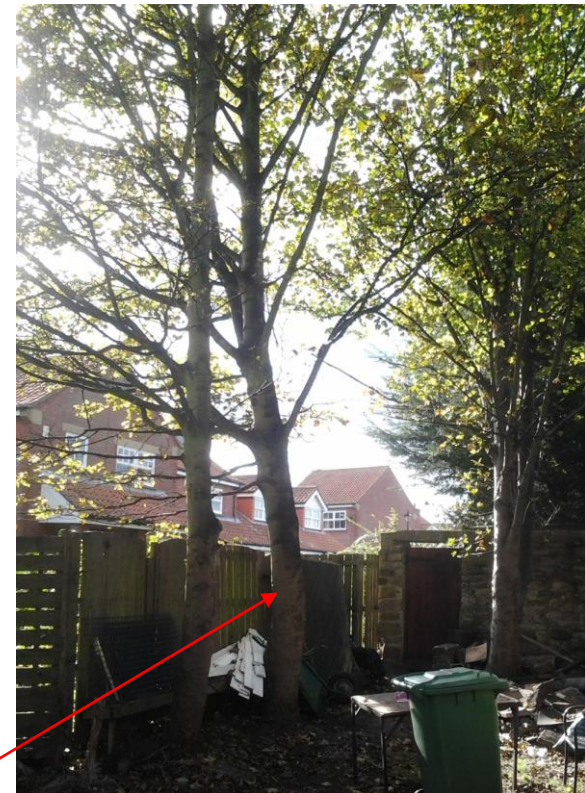
Tree T8

Survey Comment : Tree growing outside of site boundary.
Severe root containment by surrounding hard surfaces.
Competition for growth space, ground moisture and nutrients with adjacent trees.

Work Category	Action
Remove	Minor dead wood

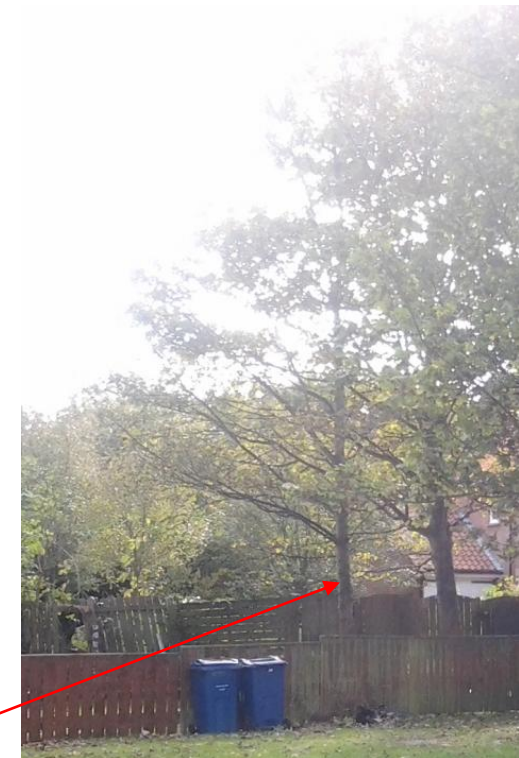
Tree T9

Survey Comment: Tree growing outside of site boundary.
 Root containment by surrounding hard surfaces.
 Competition with adjacent trees for growth space, ground moisture and nutrients.

Work Category	Action
Remove	Minor dead wood

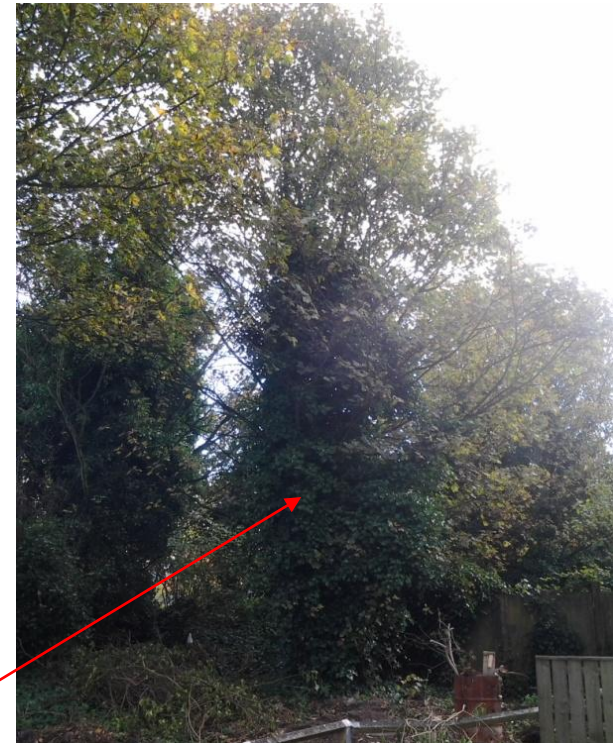
Tree T10

Survey Comment : Tree growing outside of site boundary.
 Possible root containment by compacted access road to southeast.
 Inspection limited due to dense Ivy growth.

- 11.4.1** It is noted within the Tree Schedule (Para. **8.0**), that tree **T10** offers evidence to indicate that the tree is not a good specimen, with a relatively short life expectancy (10-20 years).

Work Category	Action
Remove	Ivy
	<i>Sever at base</i>
Remove	Minor dead wood

- 11.4.2** Removal of the tree will have no major, detrimental effect upon the overall appearance of the combined canopy. Replacement planting, in agreement with the LPA and property owner, will ensure longer term continuity of tree cover within the area.

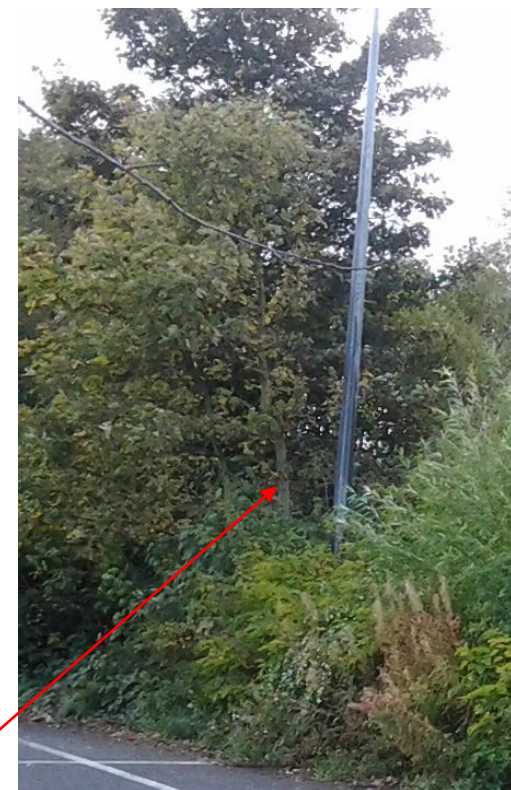
Tree T16

Survey Comment : Tree growing outside of site boundary.
Competition with surrounding trees and vegetation for growth space, ground moisture and nutrients.
Inspection limited due to dense Ivy growth.

Work Category	Action
Remove	Ivy

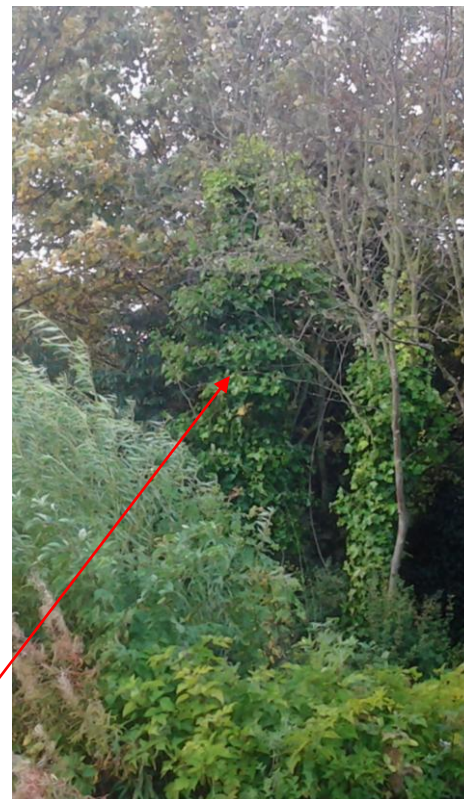
Tree T18

Survey Comment : Tree growing outside of site boundary.
Competition with surrounding trees and vegetation for growth space, ground moisture and nutrients.
Inspection limited due to dense Ivy growth.

Work Category **Action**
Remove Ivy
 Sever at base

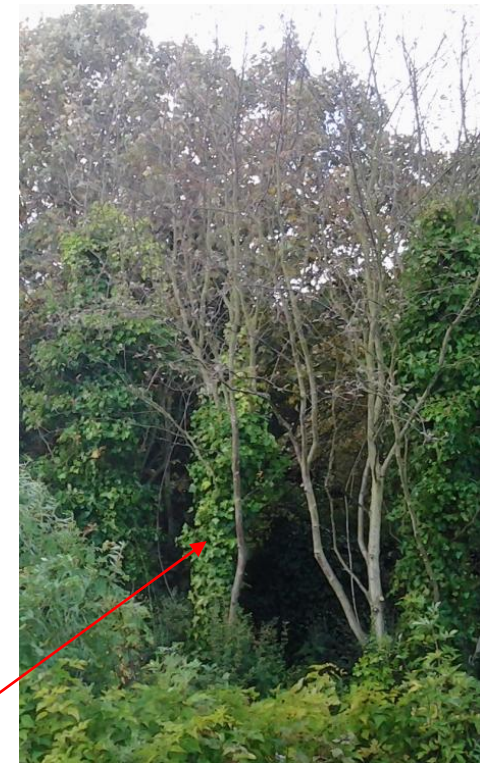
Tree T19

Survey Comment: Tree growing outside of site boundary.
Competition with surrounding trees and vegetation for growth space, ground moisture and nutrients.
Inspection limited due to dense Ivy growth.

Work Category **Action**
Remove Ivy
Sever at base

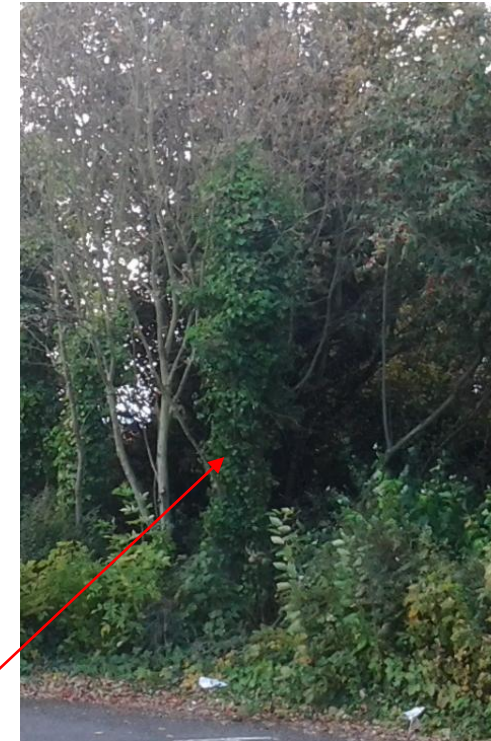
Tree T20

Survey Comment : Tree growing outside of site boundary.
 Competition with surrounding trees and vegetation for growth space, nutrients and ground moisture.
 Inspection limited due to dense Ivy growth.

Work Category **Action**
 Remove Ivy
Sever at base
