**Arboricultural Impact Assessment
Tree Report
Former 'Be Modern' Site
Western Approach, South Shields**

**Client: Travis Perkins
Date: 3rd August 2015
Our ref: 0007697**

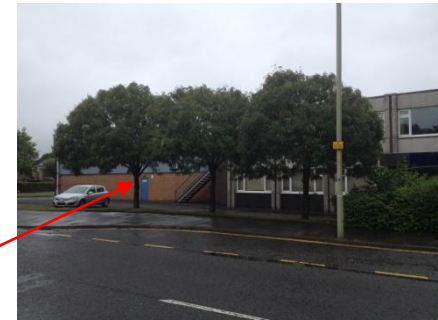
Tree T0129 –
Viewed from
northeast

Tree Comment : Relatively healthy in appearance.
2 stems form at 1.3m HGL with very tight union.
Relatively well balanced canopy.
Multiple stems form at 2.2m HGL.
Evidence of previous pruning on stem and within canopy.
Area of deadwood within canopy.

Survey Comment : Root containment by footpath to east and access road to west.

Work Category Action
Remove Minor dead wood

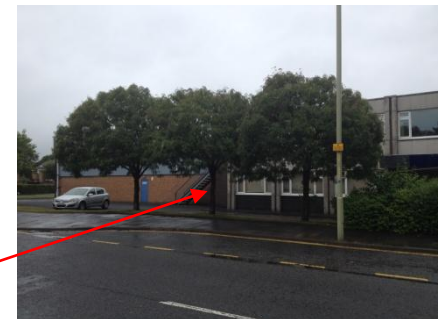
Tree T0130 –
Viewed from
northeast

Tree Comment : Relatively healthy in appearance.
Branching system forms at 2.2m HGL with tight unions.
Evidence of previous pruning within canopy.
Deadwood and snags evident within canopy.
Canopy towards east overhangs adjacent path.

Survey Comment : Root containment by footpath to east and access road to west.

Work Category Action
Remove Deadwood and snags

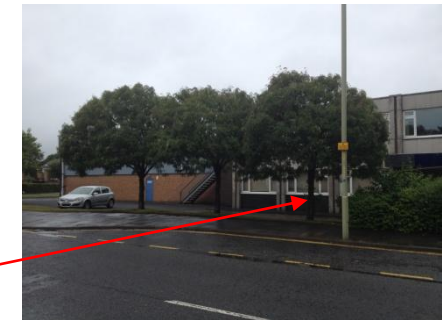
Tree T0131 –
Viewed from
northeast

Tree Comment: Relatively healthy in appearance.
 Codominant stem forms at 2.1m HGL with tight union.
 Minor epicormic growths at base of stem on western side.
 Relatively well balanced canopy with minor deadwood and snags.
 Evidence of previous pruning on codominant stems and within canopy.

Survey Comment: Root containment by footpath to east and access road to west.

Work Category Action
 Remove Deadwood and snags
 Remove Epicormic growths

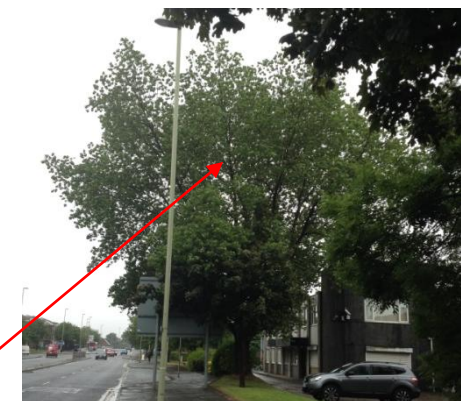
Tree T0132 –
Viewed from
north

Tree Comment: Dominant specimen, relatively healthy in appearance.
 5 codominant stems form at 3m HGL with included bark at POU.
 Relatively healthy canopy overhangs adjacent path and building.
 Evidence of previous pruning within canopy.
 Minor deadwood and snags within canopy.

Survey Comment: Root containment by footpath to east and access road to west.

11.2.1 The larger, more dominant species e.g. **T0132 & T0141** (Poplars), which are ‘high’ moisture demanders, will be growing at the expense of the smaller, less dominant specimens. All trees however, are competing with each other within this ‘hostile’ growing environment. The growth and development of the trees therefore, will exhibit less vigour and health than if growing in an optimum growing environment. The life expectancy of the trees will be reduced, and potentially, become more susceptible to pathogenic invasions.

Work Category Action
 Remove Deadwood and snags
 Prune From buildings/structure/tree by 3.0m

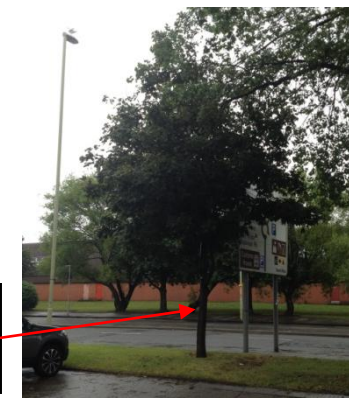
Tree T0133 – Viewed from west

Survey Comment : Root containment by footpath to east and access road to west.

Work Category Action
 Cut back growth From Road Sign

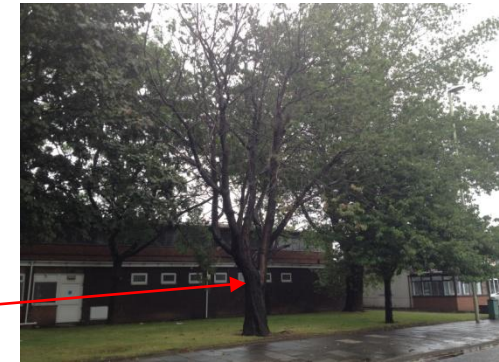
Tree T0139 – Viewed from southeast

11.1.2 As trees **T0139 & T0140** are growing adjacent to the Public Highway Footpath, there is risk of injury to people or damage to property in the event of tree failure. Consideration therefore, should be given to removal of the trees, and replacement planting be carried out in agreement with the Local Planning Authority (LPA).

Work Category	Action
Fell and replacement plant	In agreement with the LPA <i>Remove tree in the interests of Health & Safety.</i>

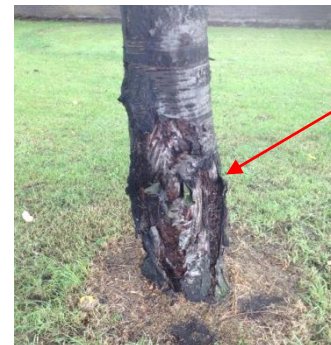
Tree Comment: Reasonably healthy in appearance.
 Large wound on east side of stem at 0.5m HGL, with evidence of decay.
 Branching system forms at 2m HGL with tight unions.
 Evidence of previous pruning.
 Snags within canopy.
 Canopy overhangs adjacent path.

Stem damage on Tree T0140 – Viewed from east

Work Category	Action
Fell and replacement plant	In agreement with the LPA <i>In the interests of Health & Safety.</i>

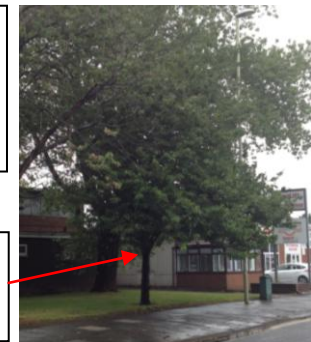
Tree T0140 – Viewed from southeast

Survey Comment: Root containment by footpath to east.

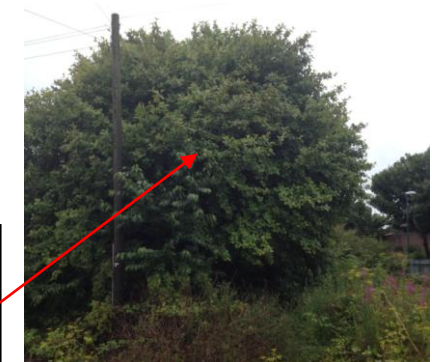
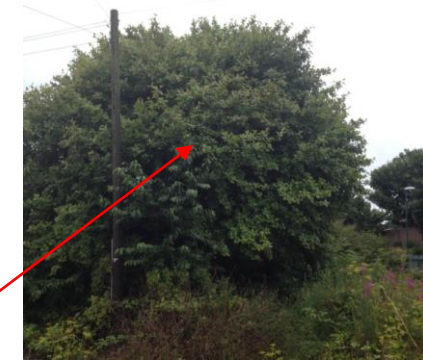
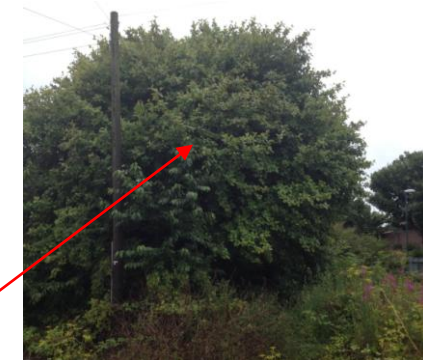
Tree Comment: Reasonable health and condition.
Tree forms part of group.
Tight unions where branching system forms.
Deadwood and snags within canopy.
Surrounded by dense understorey vegetation.

Combined canopies
of trees T0144,
T0145 & T0146 –
Viewed from east

Tree Comment : Reasonable health and condition.
 Tree forms part of group.
 Surrounded by dense understorey vegetation.
 Deadwood and snags within canopy.

Work Category Action
 Remove Deadwood and snags
