Date: 7<sup>th</sup> January 2016

**Bellway, Cleadon, South Shields**

**Cleadon Phase 10 – Gas Membrane Verification Report – Apartment Blocks**

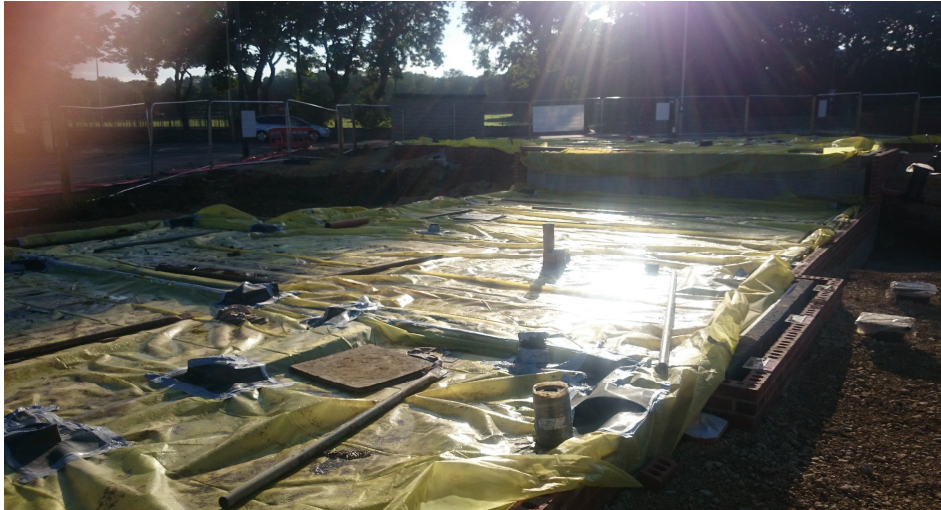
Photograph 1: Looking north at northeastern part of the apartment blocks

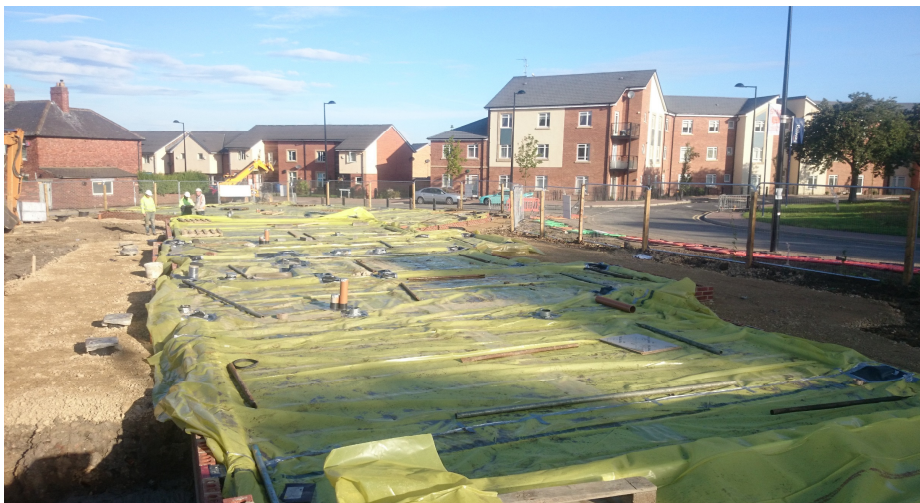
Photograph 2: Looking north west at the north western wing of the apartment blocks.

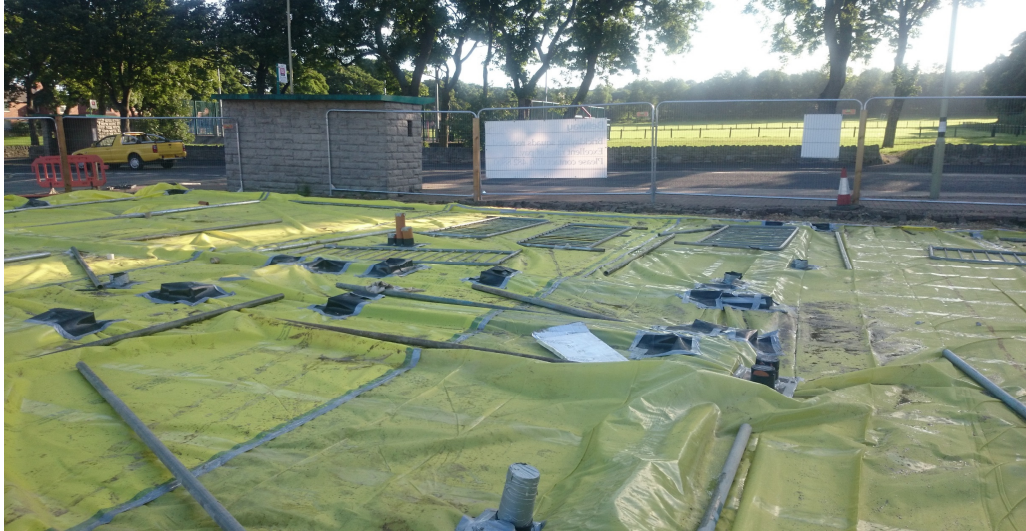
Photograph 3: Looking east at the eastern wing of the apartments.

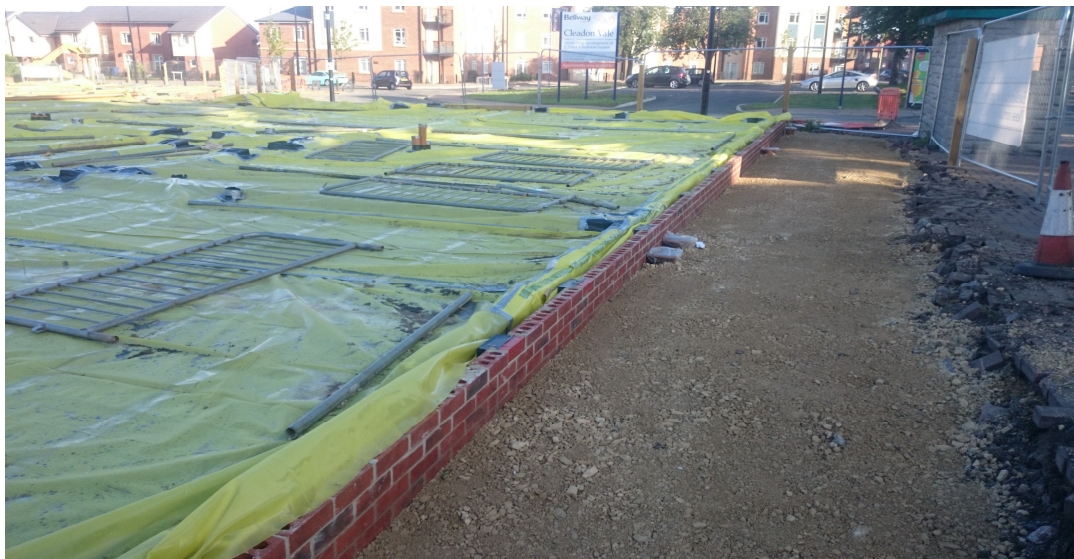
Photograph 4: Looking west along the central area of the apartment blocks.

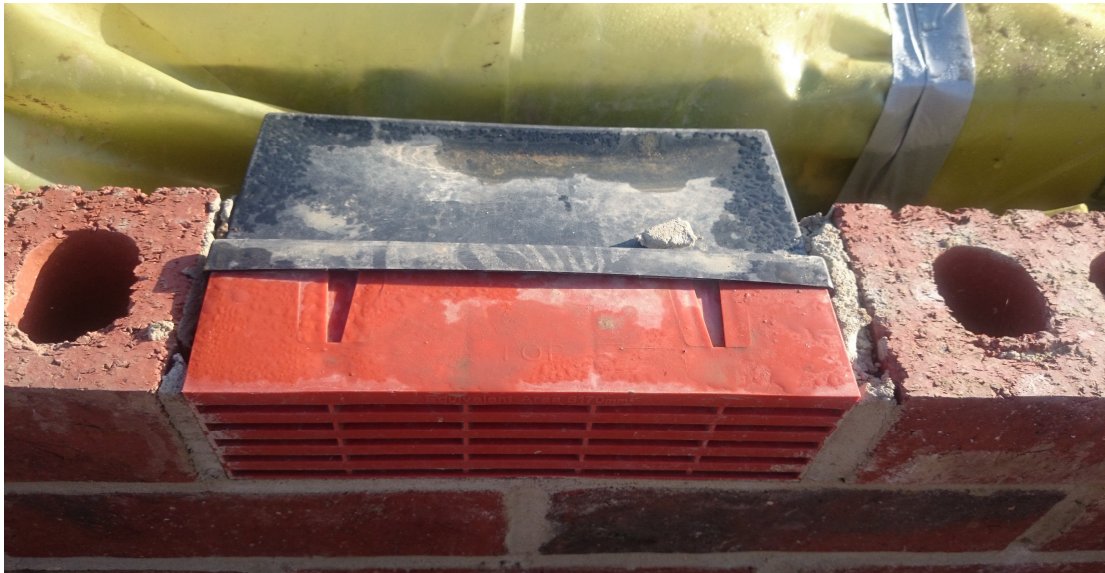
damp-proof course	<input type="checkbox"/>	13. TO GO ABOVE MEMBRANE.
service entries and seals	<input checked="" type="checkbox"/>	14. ALL TAPED + LAPPED - ADDITIONAL TAPE USED TO PROVIDE PROTECTION.
cavity inspection	<input type="checkbox"/>	15. CAVITY BUILT BY GAS MEMBRANE - WINDY AT TIME OF INSPECTION - MEMBRANE TUCKED INTO CAVITY - REQUESTED IT WAS PULLED OUT FOR PHOTOGRAPHS.

Photograph 5: Characteristic air brick with membrane pulled back from cavity.

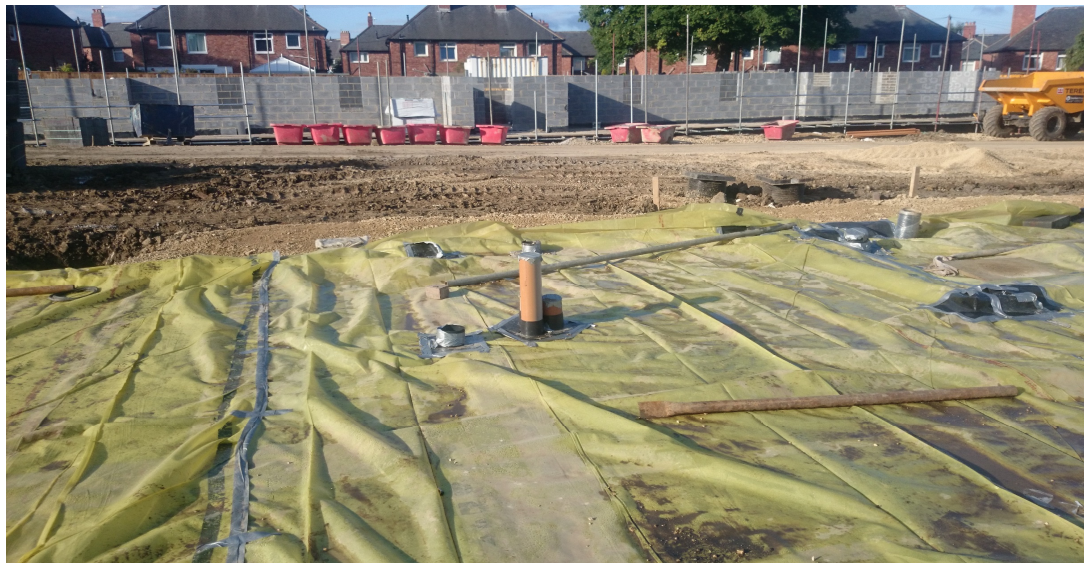
Photograph 6: View south of the central part of the apartments.

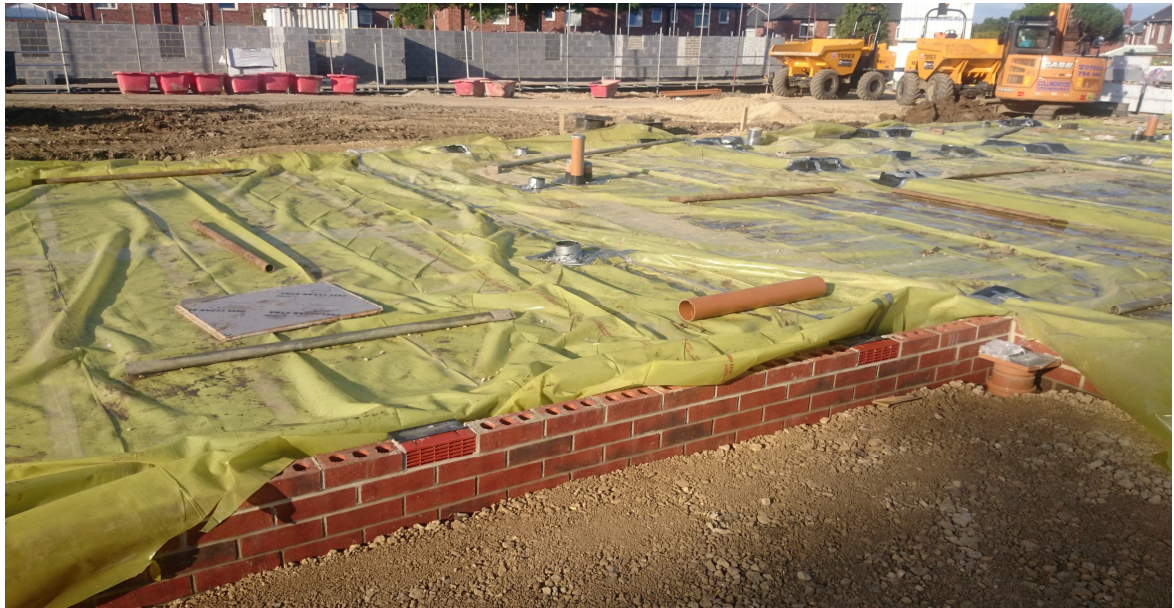
Photograph 8: Central area of apartment blocks.

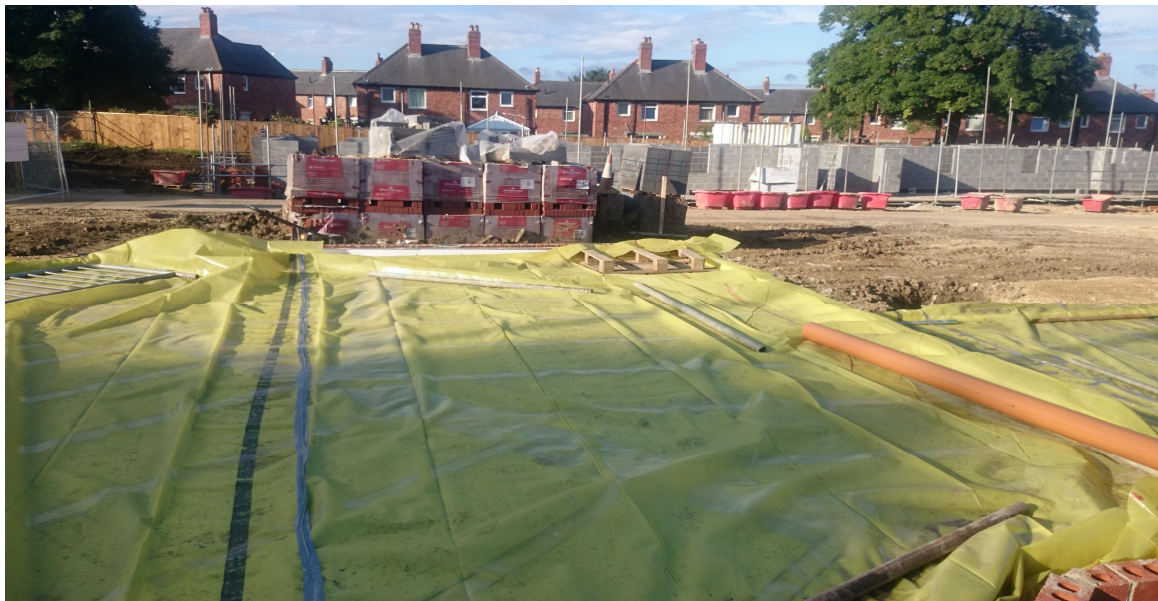
Photograph 9: View south of the eastern part of the northern apartment block.

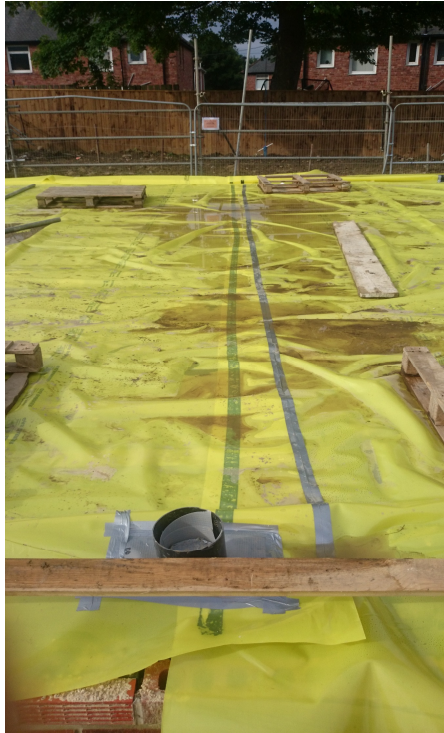
Photograph 8: View south of the southern apartments showing the taped and lapped membrane.

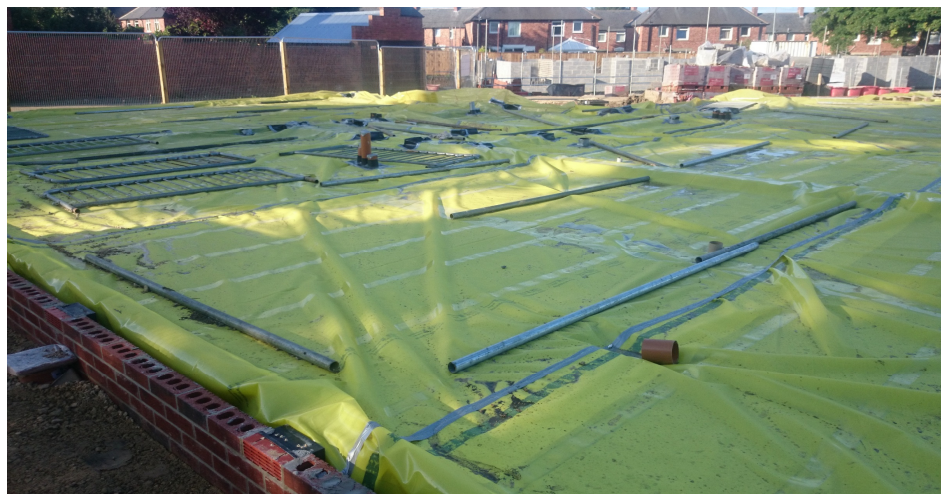
Photograph 9: South eastern area of apartment block.

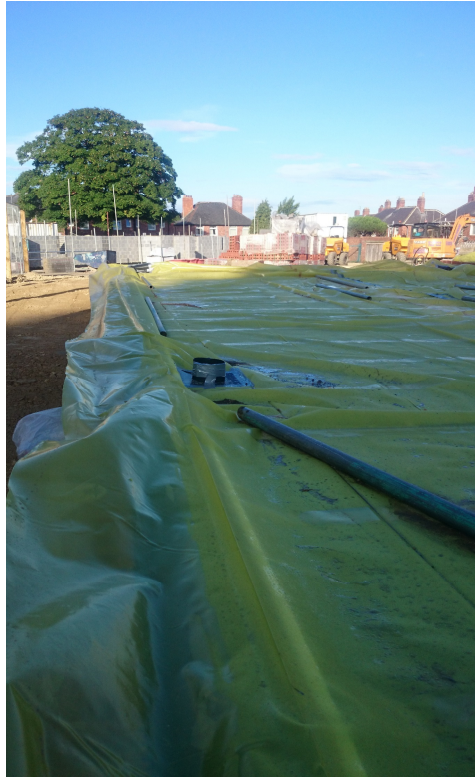
Photograph 8: Looking west along the central part of the apartment block.

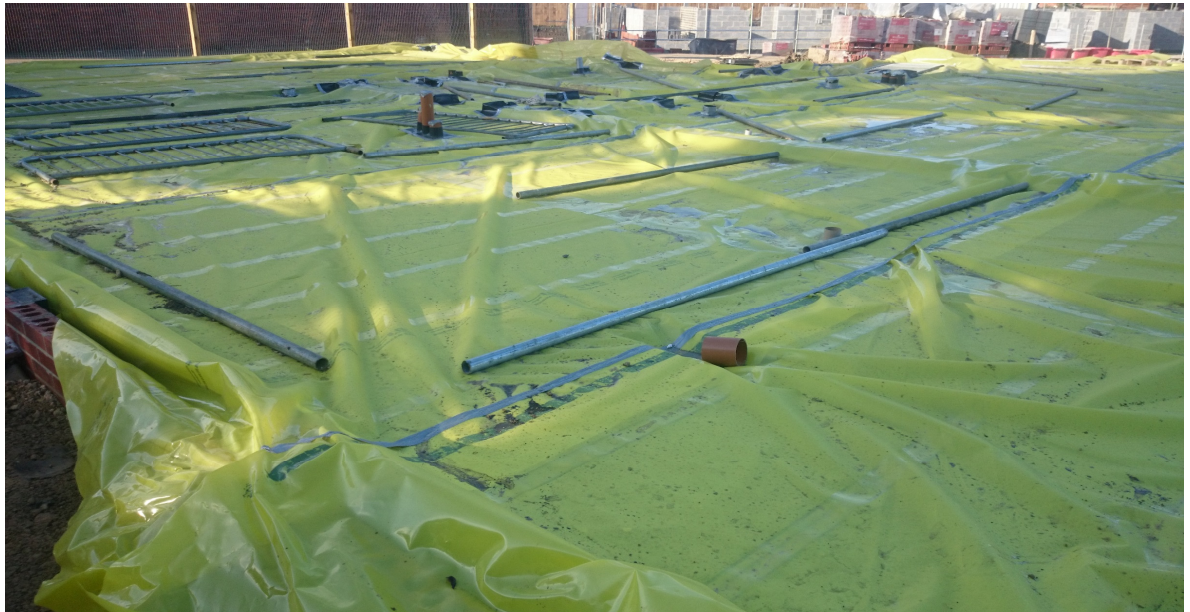
Photograph 9: Looking south from the western part of the apartment block.
