Electrical Inspection Report

at
McNulty Yard
for
Port of Tyne

Prepared for: Port of Tyne
Prepared by: M Banks
Reviewed by: T Clough
Date: December 2012

Project No: 5570

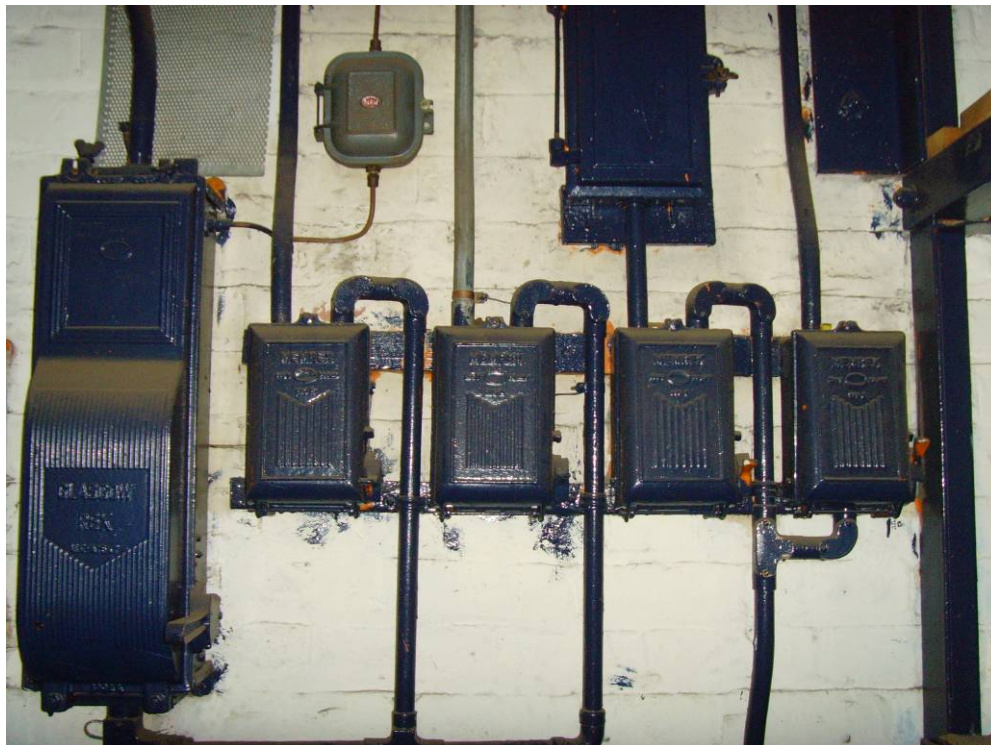
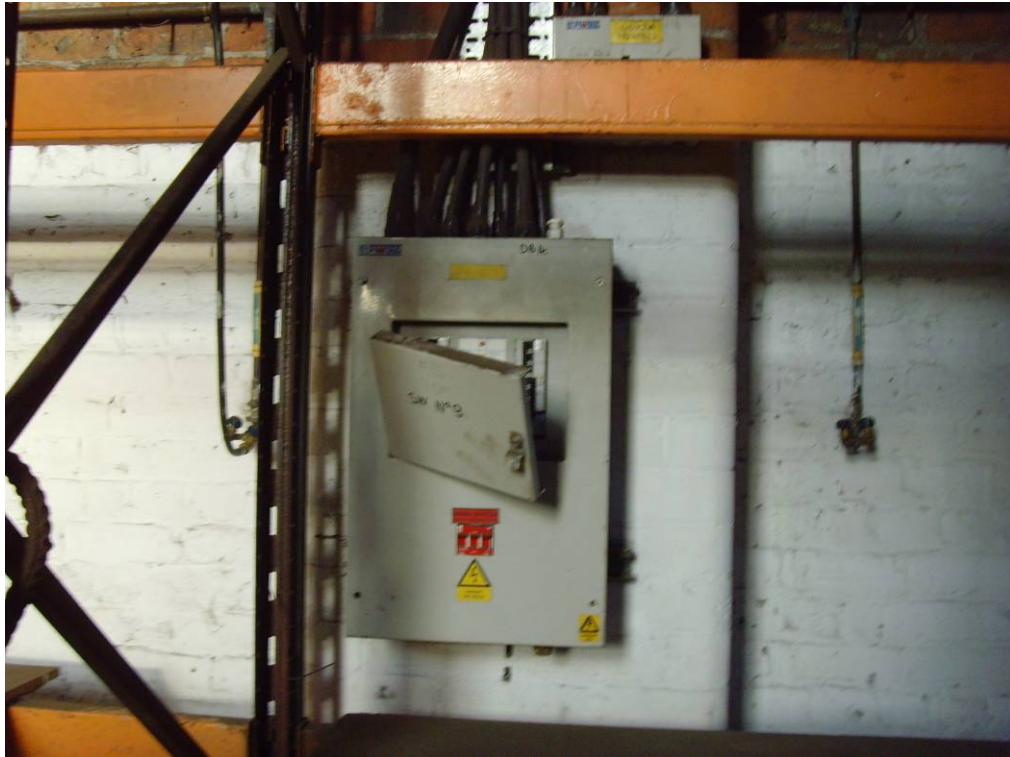
- 3.5 The main building distribution equipment located on the South Eastern wall of the building comprises a combination of Proteus and MEM switchgear and distribution boards. Both the Proteus and MEM equipment is some 30 years old and in poor condition. There are also numerous distribution boards installed throughout the pipe shop predominantly of Proteus, MEM and Hager manufacture all of which are of a similar age. Within the store area there are a number of items of switchgear of Memrex and Glasgowrex manufacture, this is probably circa 50 years old and in poor condition.

- 3.22 Although some minor elements of the electrical installation are in a serviceable condition the vast majority of the installation is at the end of its useful life and requires replacement.
- 3.23 Consideration should be given to the replacement of the distribution equipment, replacement of the inoperative general luminaires, the provision of emergency lighting and fire detection systems in accordance with the relevant British Standards and the upgrading of the earthing installation in accordance with BS7671.

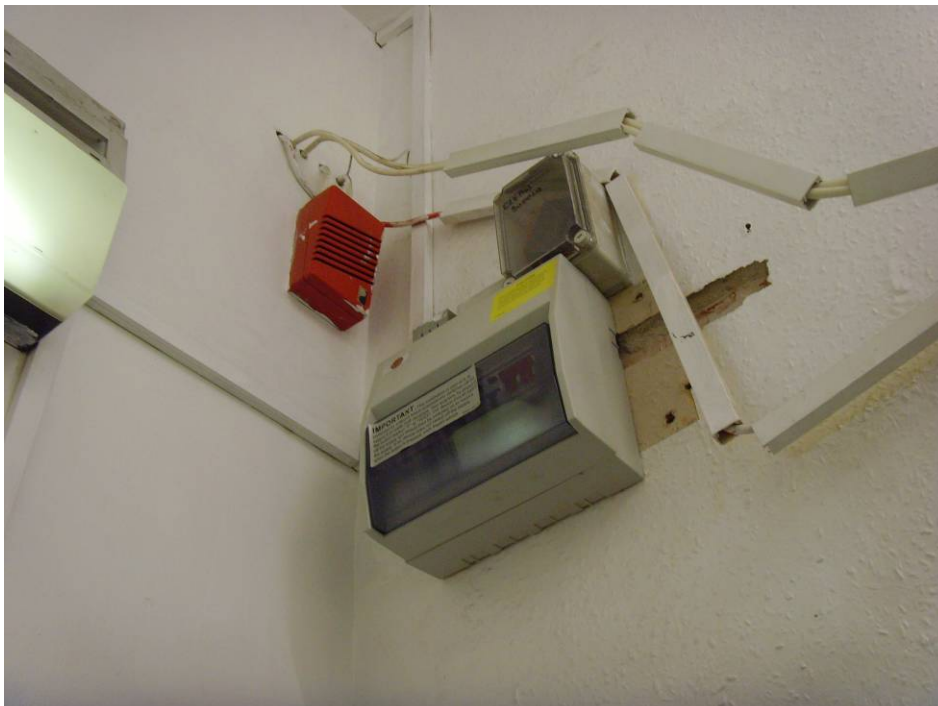
- 4.5 PVC mini/standard trunking is provided for the containment of final circuit cabling in all other areas the cables are flush within the building fabric. The containment systems in general appear to be in a reasonable condition however there are a number of areas where it is extremely poor having suffered mechanical damage.

- 4.23 Consideration should be given to the replacement of the distribution equipment, replacement of the inoperative general luminaires, the provision of emergency lighting and fire detection systems in accordance with the relevant British Standards and the upgrading of the earthing installation in accordance with BS7671.

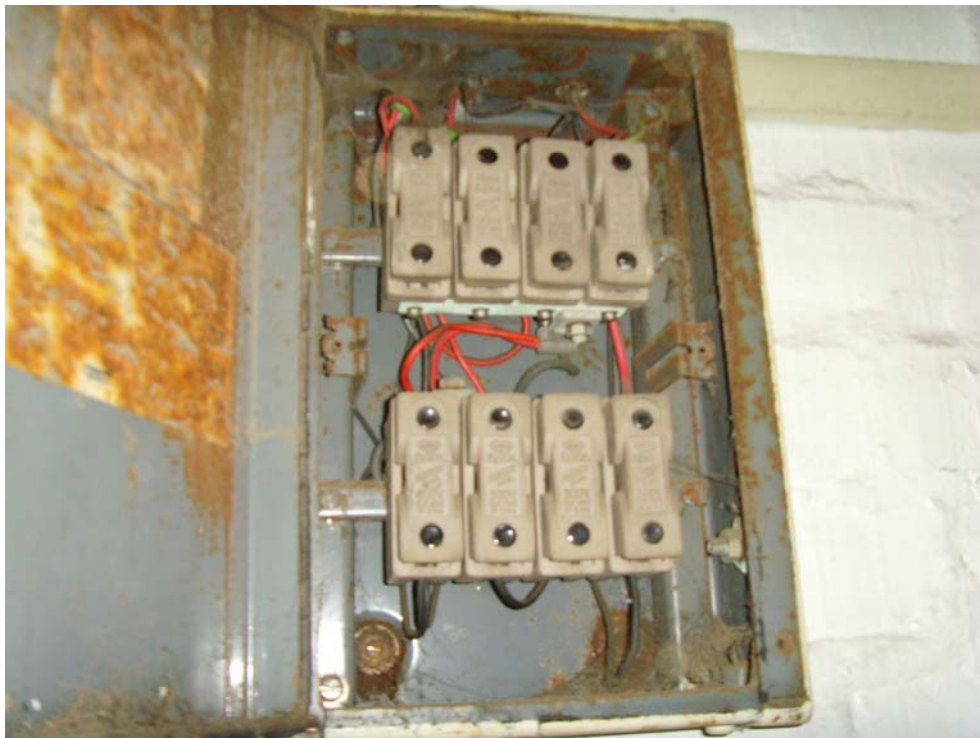
- 7.4 The main building distribution equipment comprises a wall mounted English Electric main switch and MEM distribution board located on the south wall of the building. The distribution board is some 40 years old and the existing cover is damaged.

7.18 Consideration should be given to the replacement of all the distribution equipment, replacement of the inoperative general luminaires, the provision of emergency lighting and fire detection systems in accordance with the relevant British Standards and the upgrading of the earthing installation in accordance with BS7671.

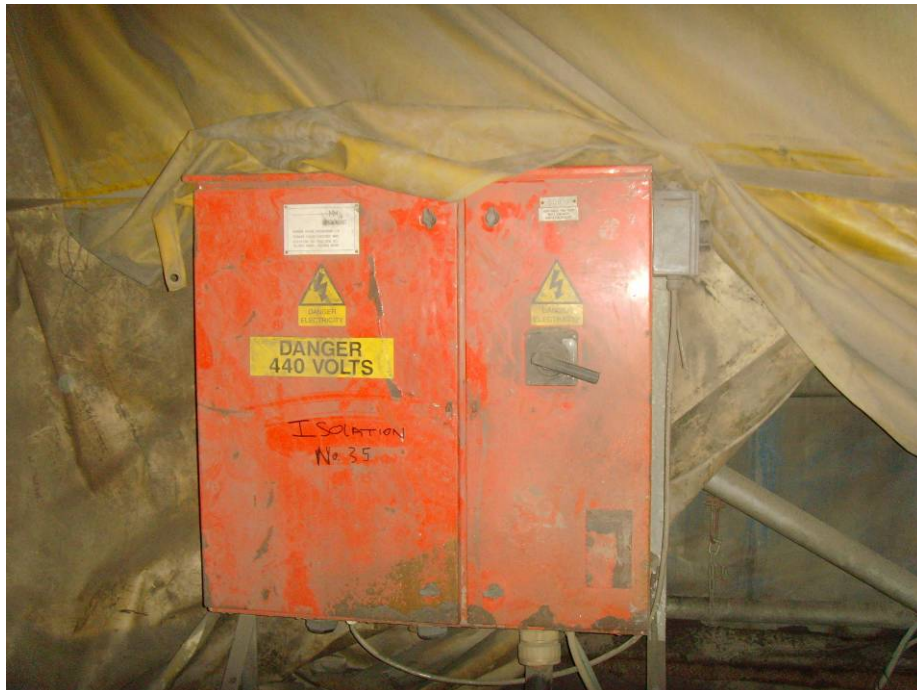
- 8.3 The main building distribution equipment comprises a floor mounted distribution board located on the south wall of the building. The distribution unit is in poor condition showing signs of corrosion and is presently isolated.

- 8.13 Consideration should be given to the replacement of the distribution board, replacement of the inoperative general luminaires, the provision of emergency lighting and fire detection systems in accordance with the relevant British Standards and the upgrading of the earthing installation in accordance with BS7671.

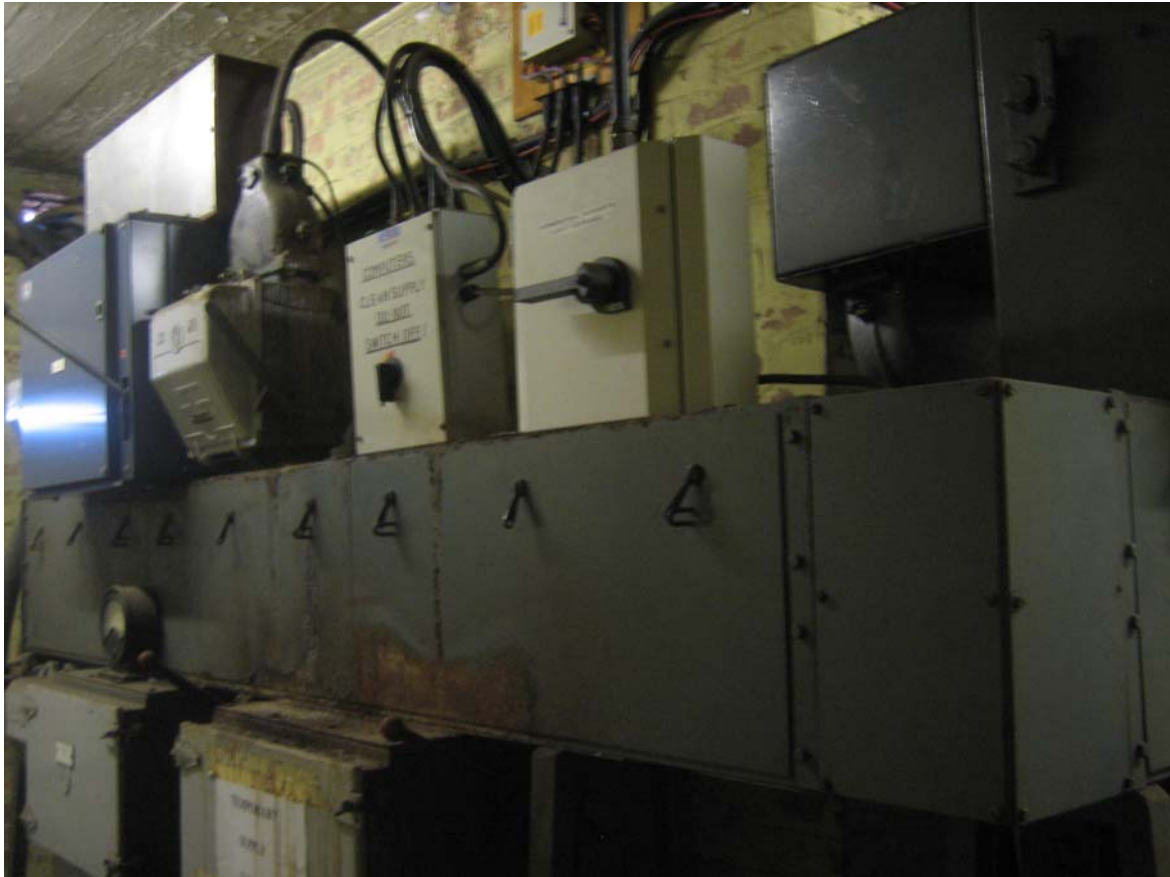
Incoming cabling to the switchboard from the transformers is single core P.I.L.C cable with outgoing cabling being a mix of multicore P.I.L.C and P.V.C/SWA insulated cables to distribution switchboards located across the site.

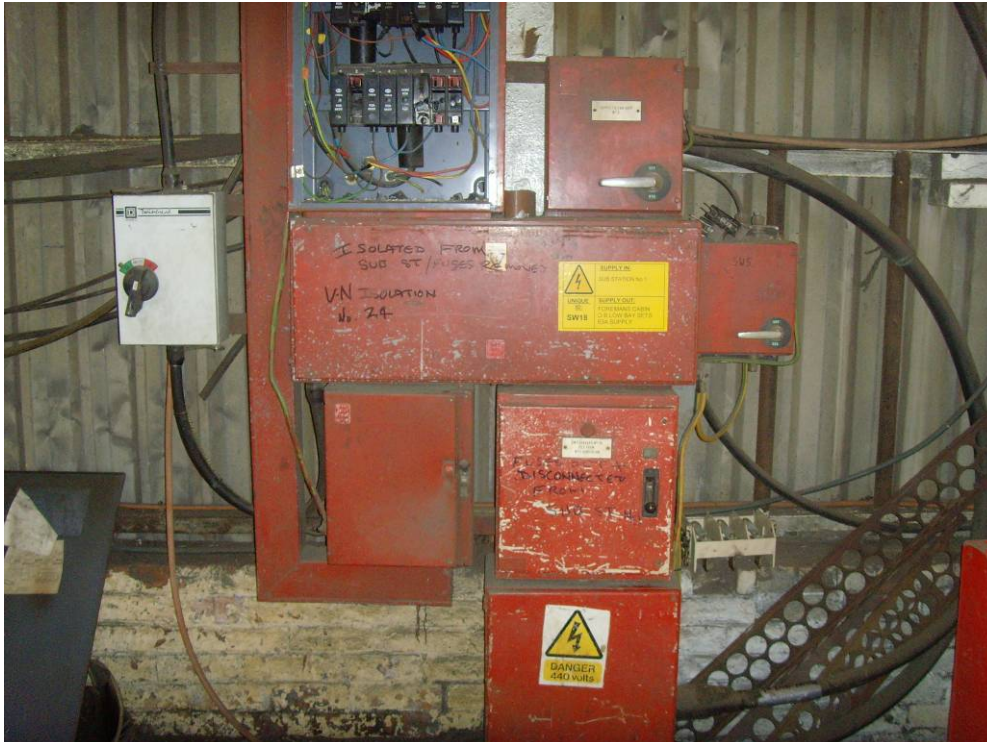
- 17.1 The main fab shop building has a number main supplies derived from sub No.1 located throughout the building terminating in English Electric manufacture switchgear and distribution equipment which supply all electrical services throughout the building. A number of the main switchboards have been isolated as part of the Veale Nixon Works.

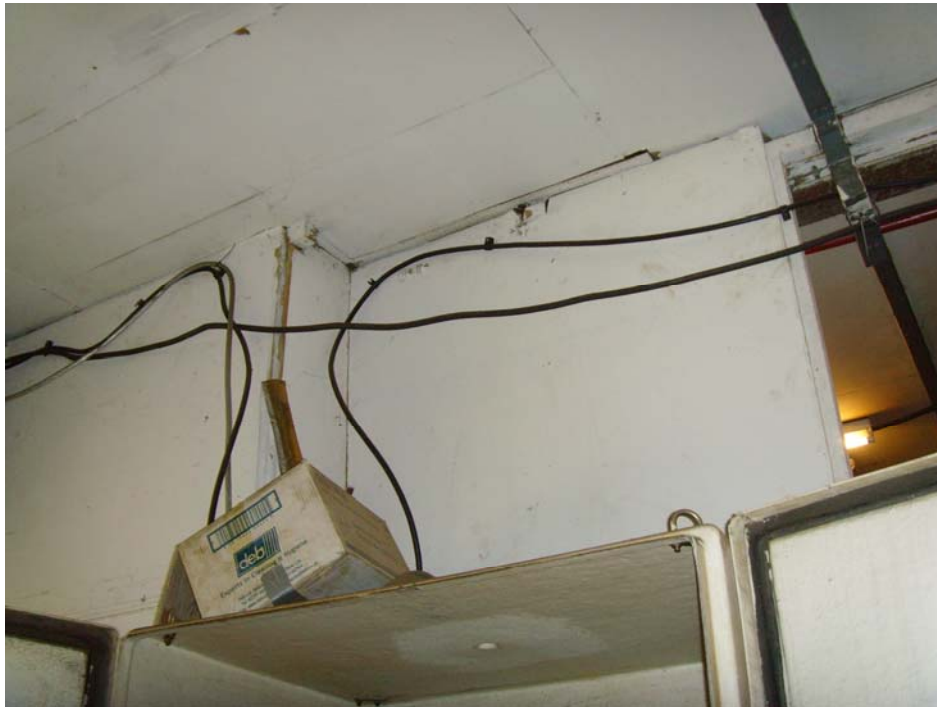
- 19.2 Mains' cabling takes the form of PVC/SWA/PVC cabling.
- 19.3 The cabling is circa 15-20 years old and appears to be in reasonable condition although access is not available to the majority of the cable run and in many locations the cabling installation does not meet current standards.
