McNulty Site Summary

Meeting 21st December 2012

Prepared for: Port of Tyne
Prepared by: M A Thompson
Reviewed by: M Frizzell
Date: 20th December 2012

Project No: 3245

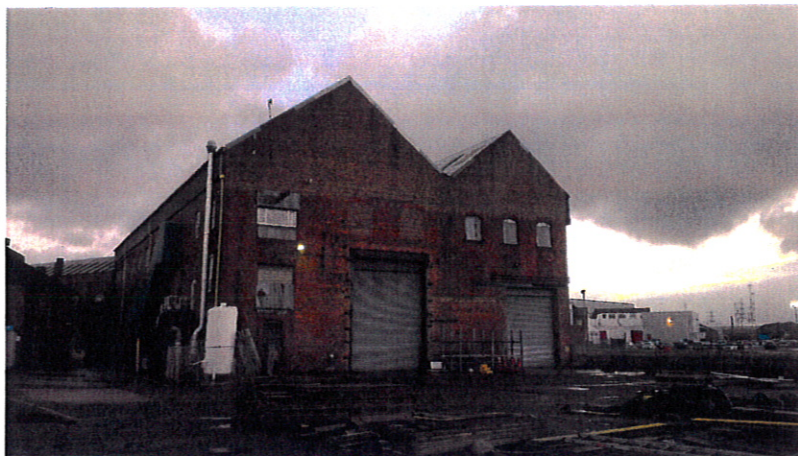
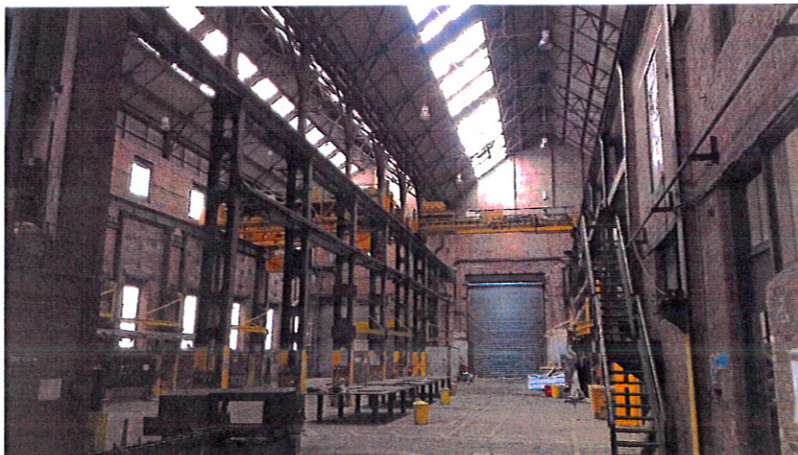
BUILDING No. 01 - PIPE SHOP

- Large fabrication shed in two sections with offices at the East end and on North side. Masonry and framed construction with a double span duo-pitched roof with metal cladding. The building has overhead cranes.

- May be considered as a building of historic interest.
- A number of structural defects noted, some of which will need further investigation.
- Nesting Kittiwakes would present a problem if demolition were considered without providing alternative nesting area.

- Retain.
- Investigate defects and establish cost for remedial works.
- Electrical circuits to have periodic inspection and testing undertaken and upgraded as necessary
- General Lighting, emergency lighting, earthing and Fire Alarms to upgraded to meet current standards
- Asbestos Survey

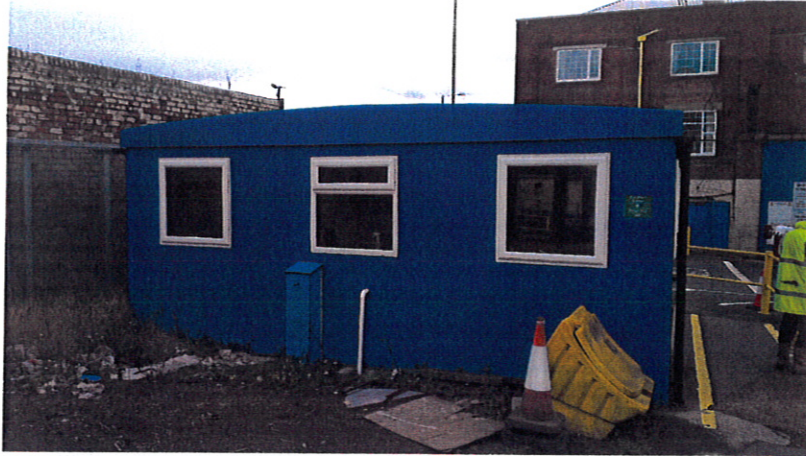
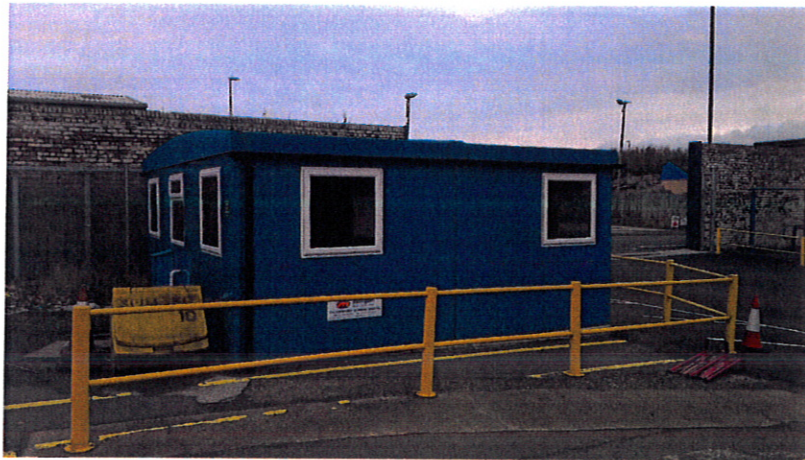
BUILDING No. 02 - GATEHOUSE

- In good condition.

- Retain.

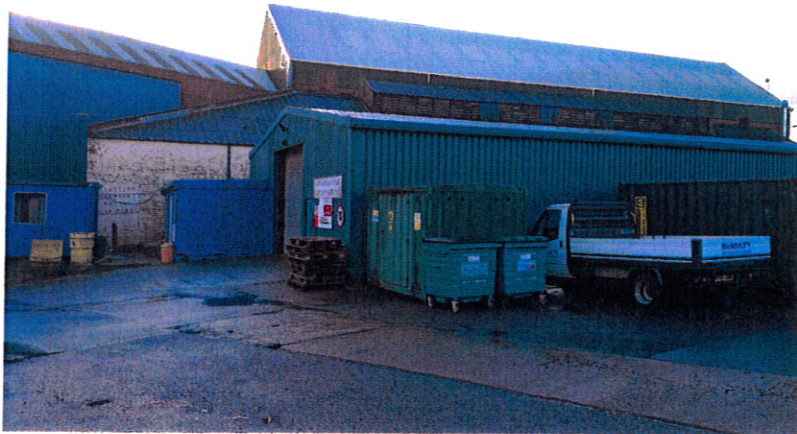
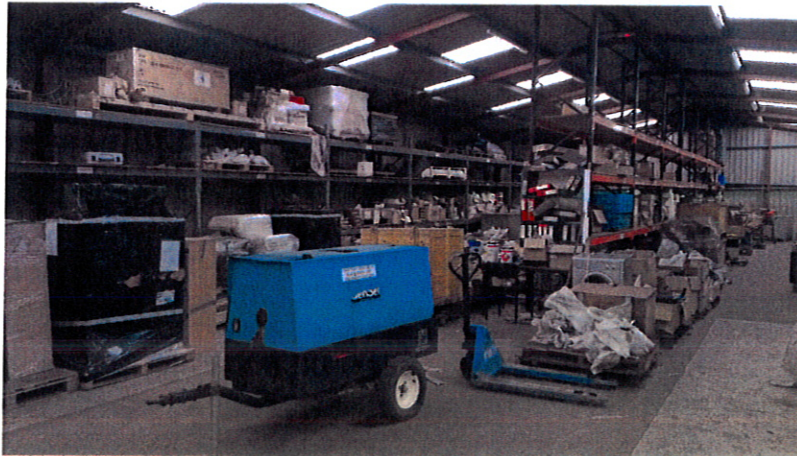
BUILDING No. 03 - STORES

- In reasonable condition but some remedials required.

- Retain.
- Electrical circuits to have periodic inspection and testing undertaken and upgraded as necessary
- General Lighting, emergency lighting, earthing and Fire Alarms to be upgraded to meet current standards
- Asbestos Survey

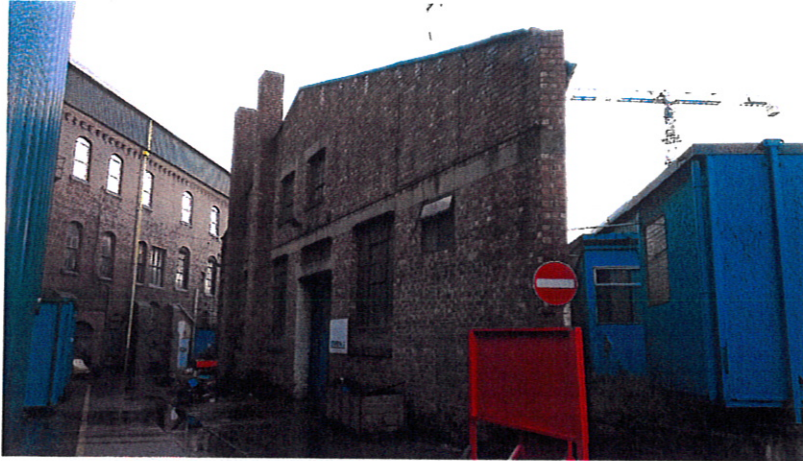
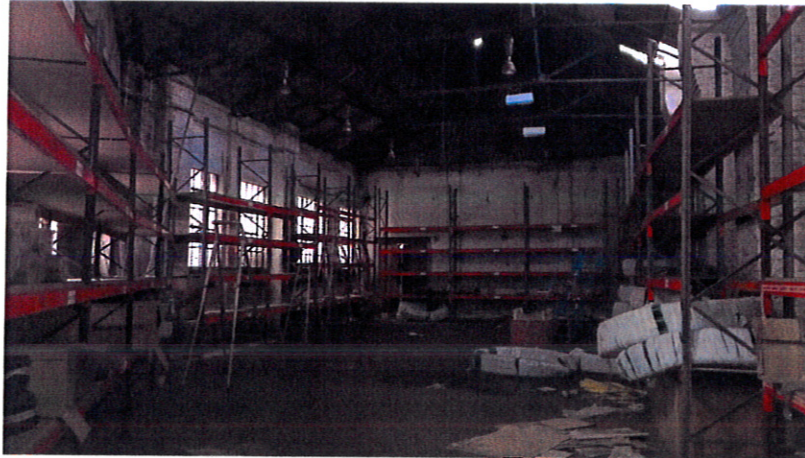
BUILDING No. 04 - WORKSHOP, STORES & OFFICES

- In poor condition with some remedials required (reroofing in particular).
- Parts of the buildings appear to be in poor condition and care is needed to access them.

- Could retain some of the parts, such as the main building.
- Option would be to demolish which would allow better access to Building No. 1 - Pipe shop.

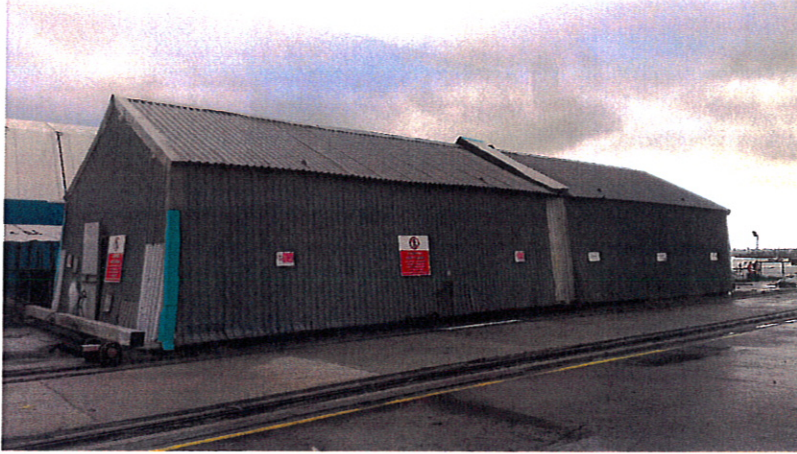
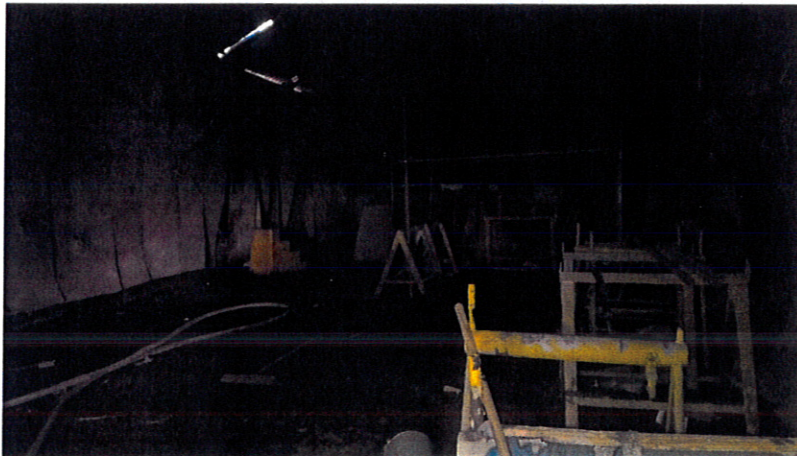
BUILDING No. 06 – Shot blast enclosure

- Poor condition.

- Demolish.

- Electrical circuits to have periodic inspection and testing undertaken and upgraded as necessary
- General Lighting, emergency lighting, earthing and Fire Alarms to upgraded to meet current standards
- Asbestos Survey

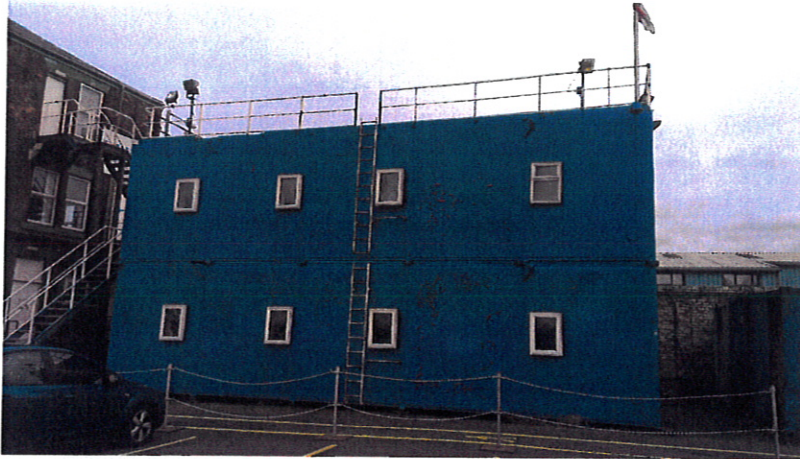
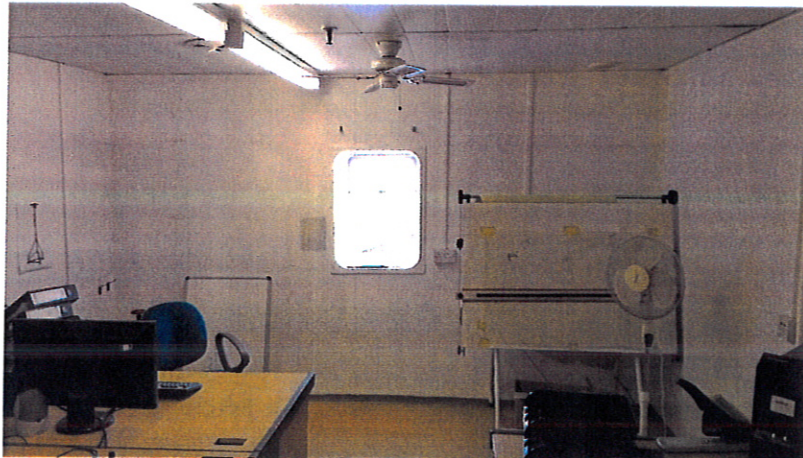
BUILDING No. 07 – BLUE SUBMARINE

- Although some defects are present the building is in reasonable condition

- Retain at this time - could be used as site offices.
- Electrical circuits to have periodic inspection and testing undertaken and upgraded as necessary
- General Lighting, emergency lighting, earthing and Fire Alarms to be upgraded to meet current standards
- Asbestos Survey

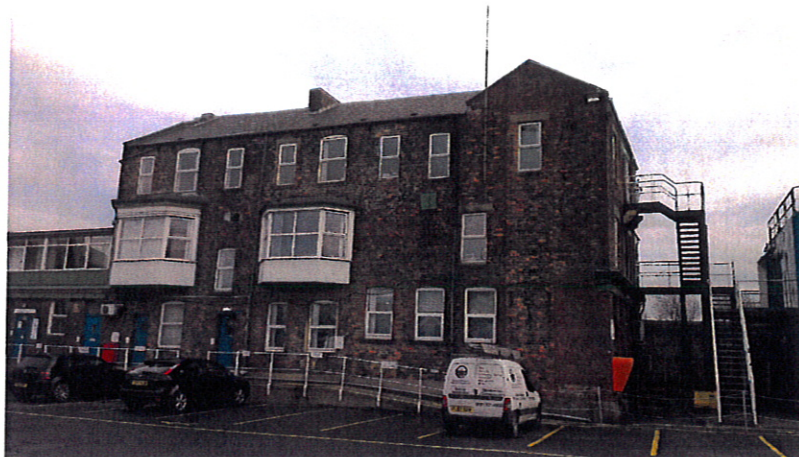
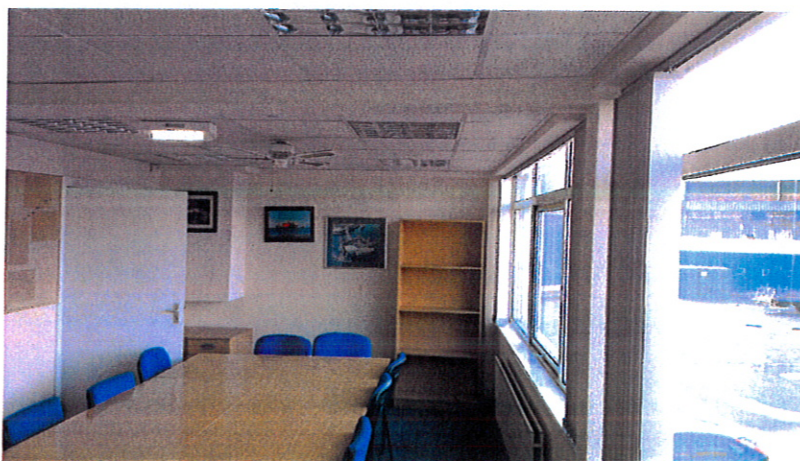
BUILDING No. 08 – MAIN OFFICE BUILDING

- Generally in reasonable conditions but some defects which will require further investigation and probably with some remedials required.

- Retain and refurbish
- Electrical circuits to have periodic inspection and testing undertaken and upgraded as necessary
- General Lighting, emergency lighting, earthing and Fire Alarms to upgraded to meet current standards
- Asbestos Survey

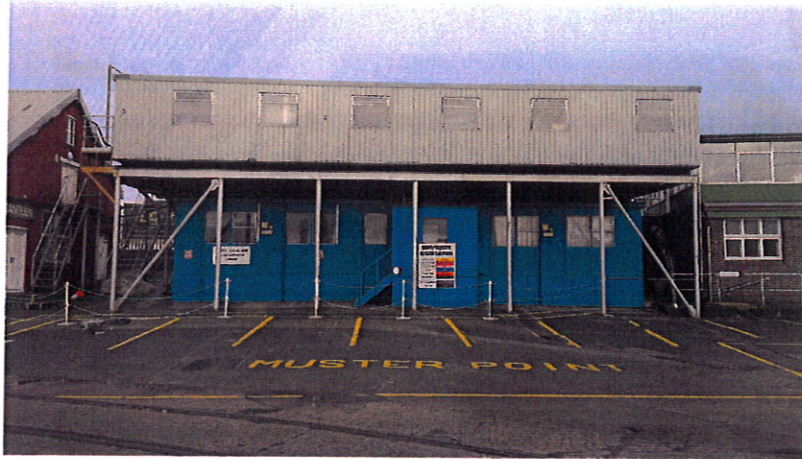
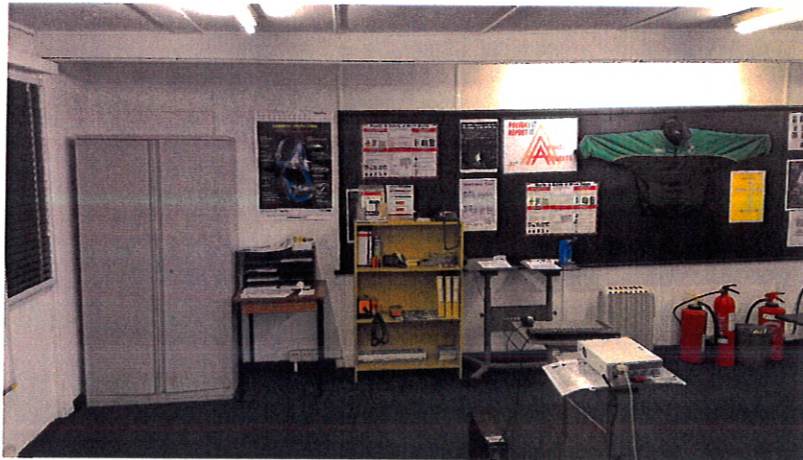
BUILDING No. 09 – SAFETY OFFICES

- Steel frame structure is suspect.

- Remove upper containers and steel frame.
- Lower timber framed construction could be retained but will need remedial works.

- Electrical circuits to have periodic inspection and testing undertaken and upgraded as necessary
- General Lighting, emergency lighting, earthing and Fire Alarms to upgraded to meet current standards
- Asbestos Survey

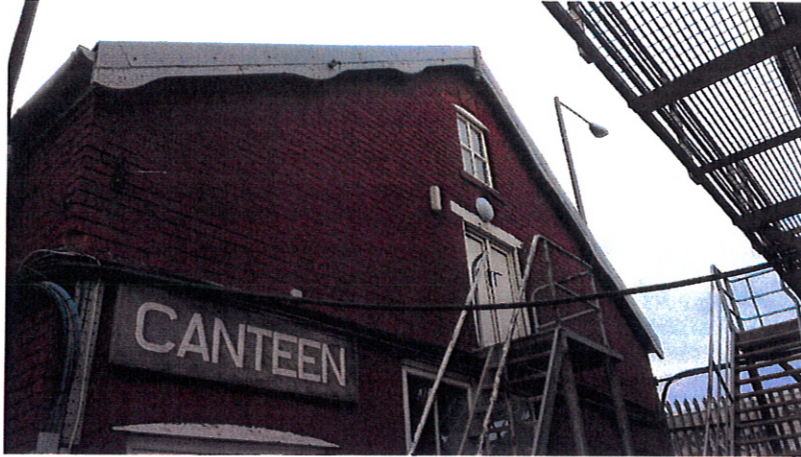
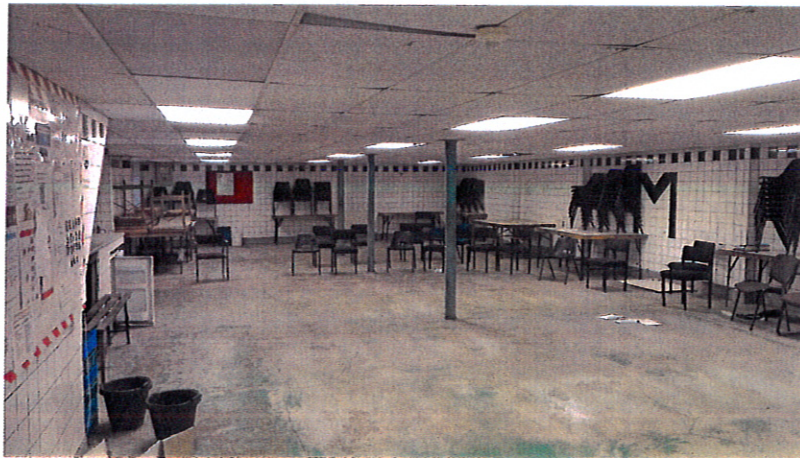
BUILDING No. 10 - CANTEEN

- In poor condition and investigations are required relating to the floor; and modification to the roof structure. It is anticipated that some remedials required.

- Could be retained depending on the outcome of investigations.

- Electrical circuits to have periodic inspection and testing undertaken and upgraded as necessary
- General Lighting, emergency lighting, earthing and Fire Alarms to upgraded to meet current standards
- Asbestos Survey

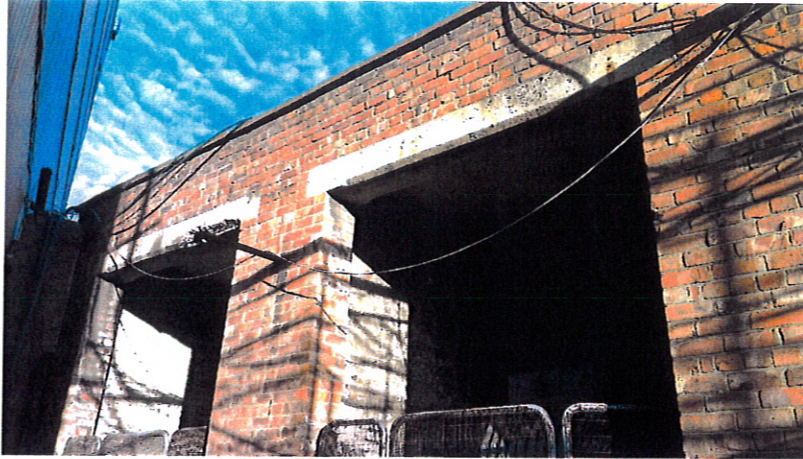
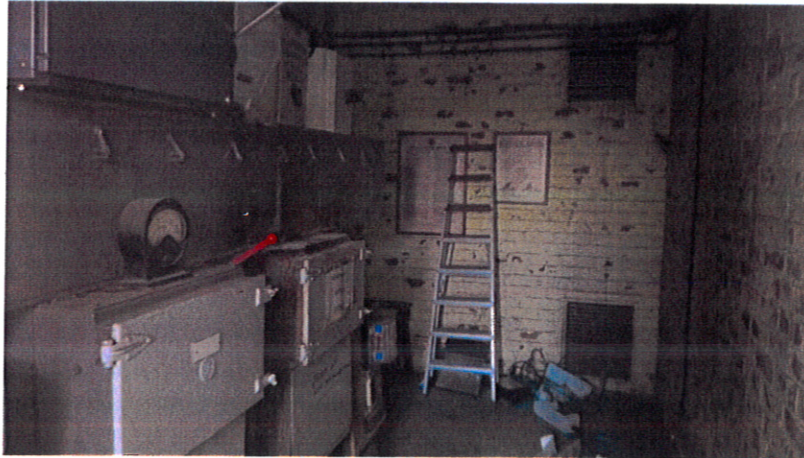
BUILDING No. 11 – SUB-STATION

- In reasonable condition but some remedial works required.

- Needs to be retained therefore - undertake remedial works.
- Electrical circuits to have periodic inspection and testing undertaken and upgraded as necessary
- General Lighting, emergency lighting, earthing and Fire Alarms to upgraded to meet current standards
- Asbestos Survey

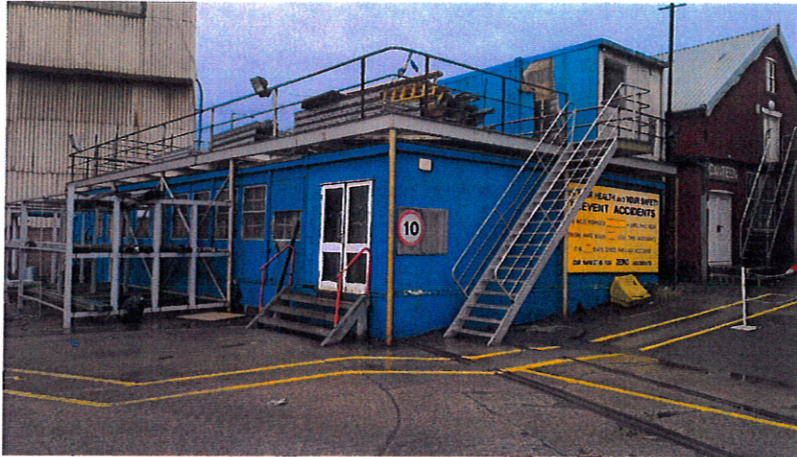
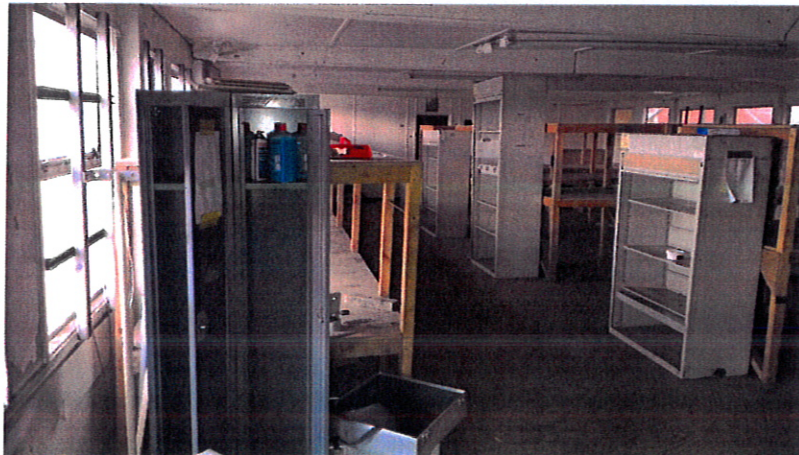
BUILDING No. 12 – ELECTRICAL STORE

- Steel frame structure is suspect and settlement to parts of the timber framed building is evident.

- Demolish.

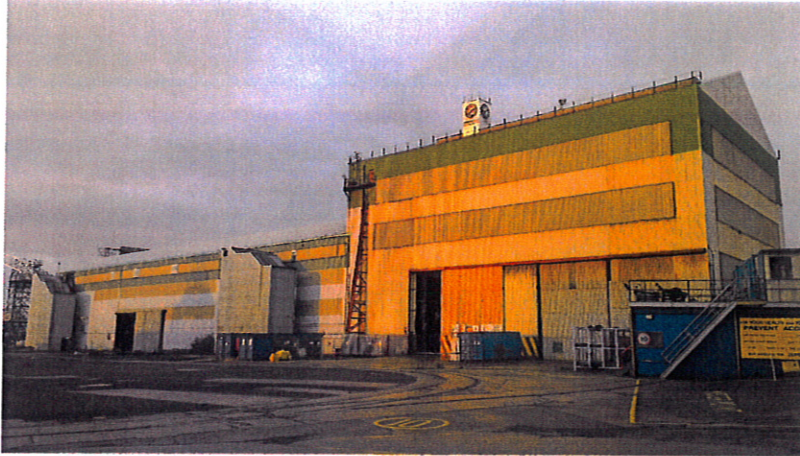
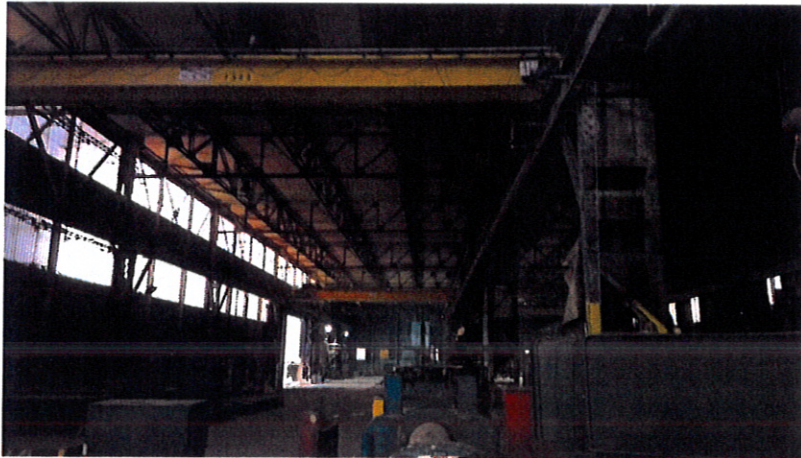
BUILDING No. 13 - FABRICATION SHOP AND LOFT OFFICES

- Access to the upper floor is via external staircases some of which are still the original scaffolding construction built as a temporary measure over 25 years ago.

- Retain and refurbish.
- Electrical circuits to have periodic inspection and testing undertaken and upgraded as necessary
- General Lighting, emergency lighting, earthing and Fire Alarms to be upgraded to meet current standards
- Asbestos Survey

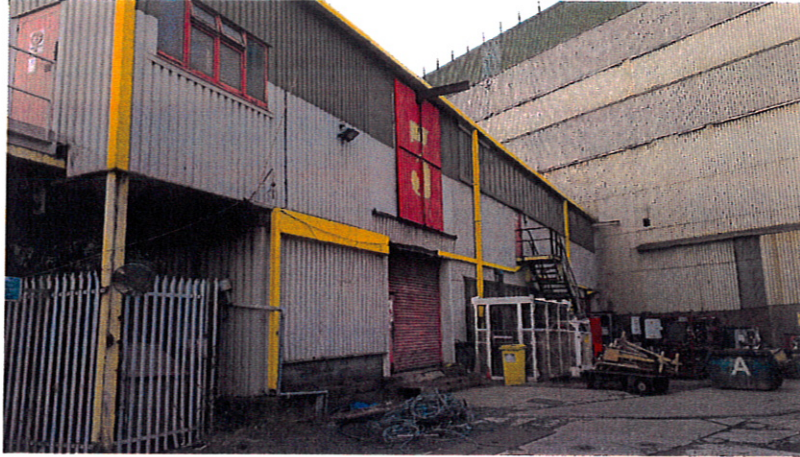
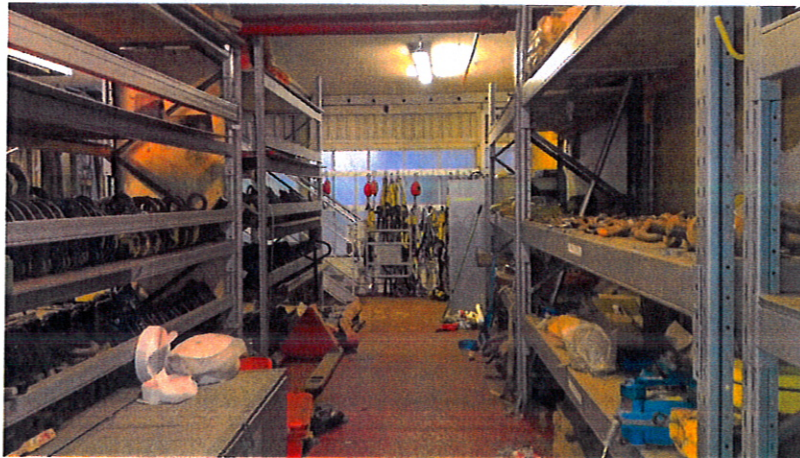
BUILDING No. 14 – RIGGING STORE

- Modifications have been undertaken adjacent to the Fabrication shop; Building No. 14 used to penetrate into Building No. 13 – investigations required.
- Problems with corrosion throughout, in particular within the ground floor maintenance area.

- Could be retained depending on outcome of investigations/full understanding of extent of corrosion.

- Electrical circuits to have periodic inspection and testing undertaken and upgraded as necessary
- General Lighting, emergency lighting, earthing and Fire Alarms to upgraded to meet current standards
- Asbestos Survey

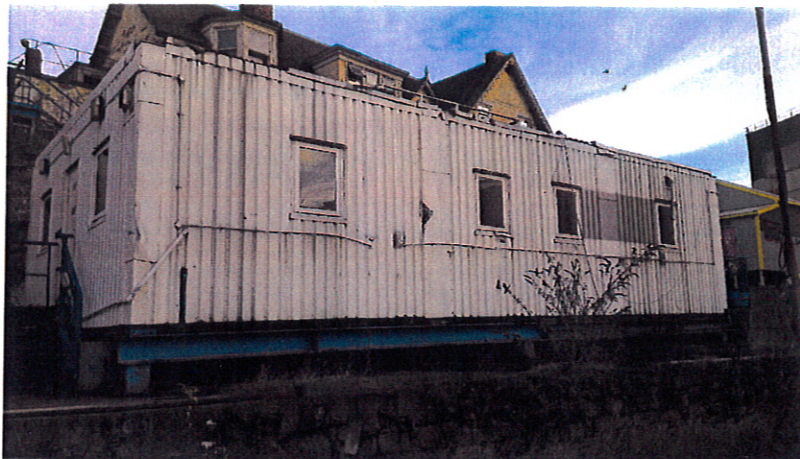
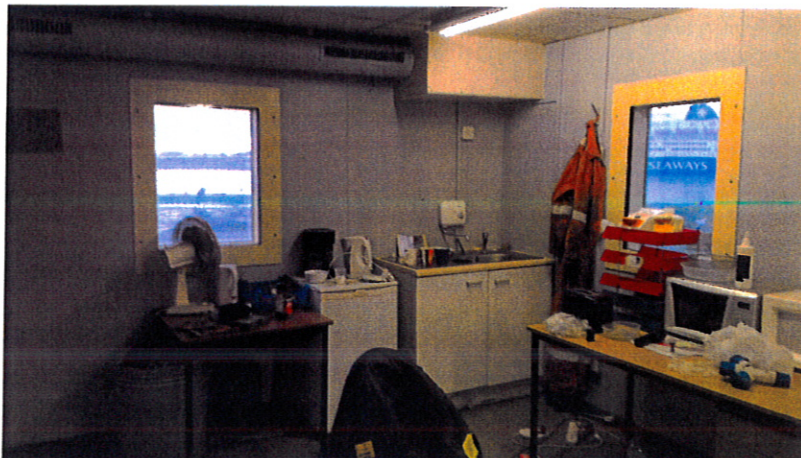
BUILDING No. 17 – OFFICE SPACE

- In reasonable condition with localised concerns regarding corrosion to the supporting grillage.

- Retain at present but might be worth considering its scrap value.
- Electrical circuits to have periodic inspection and testing undertaken and upgraded as necessary
- General Lighting, emergency lighting, earthing and Fire Alarms to be upgraded to meet current standards
- Asbestos Survey

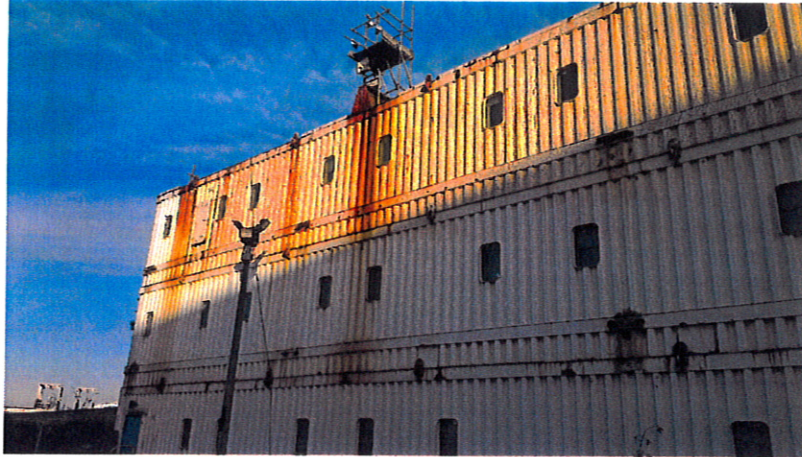
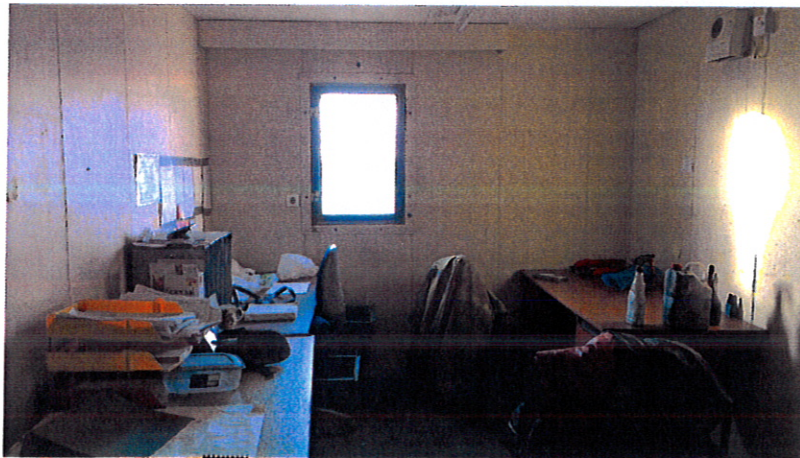
BUILDING No. 18 – MANDELA HOUSE

- In reasonable condition.

- Retain at present but might be worth considering its scrap value.
- Electrical circuits to have periodic inspection and testing undertaken and upgraded as necessary
- General Lighting, emergency lighting, earthing and Fire Alarms to upgraded to meet current standards
- Asbestos Survey

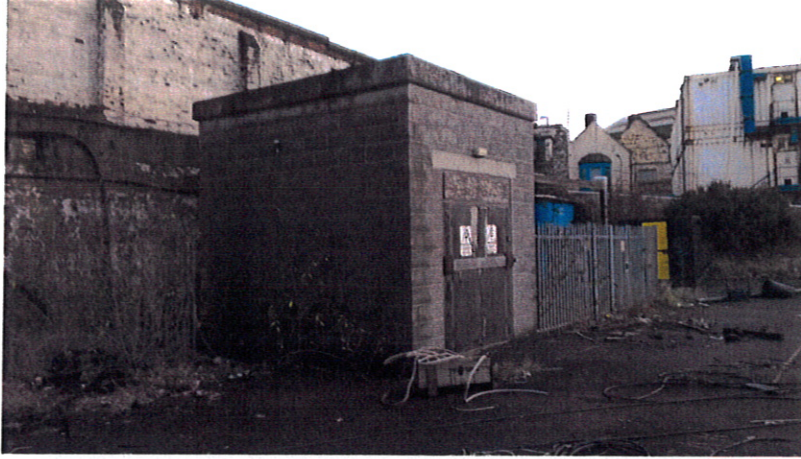
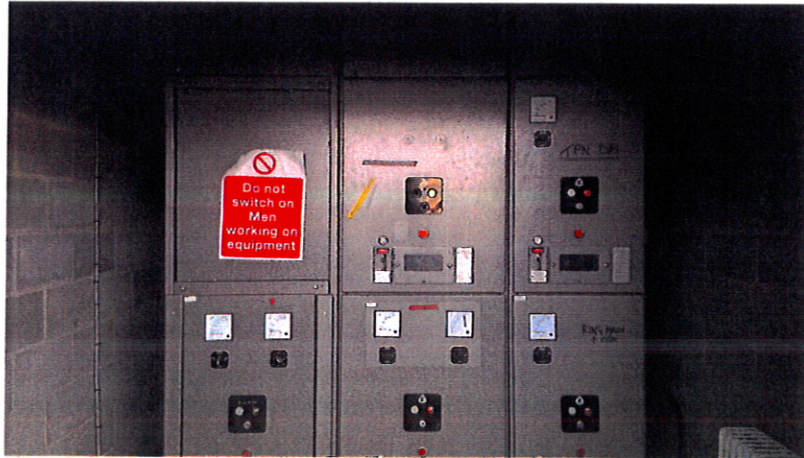
BUILDING No. 19 - SUBSTATION

- In reasonable condition.

- Need to be retained for site supply reasons.
- Electrical circuits to have periodic inspection and testing undertaken and upgraded as necessary
- General Lighting, emergency lighting, earthing and Fire Alarms to upgraded to meet current standards
- Asbestos Survey

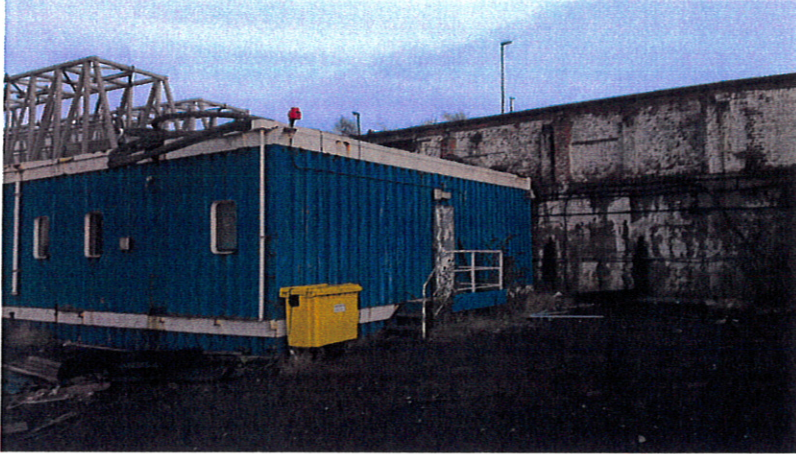
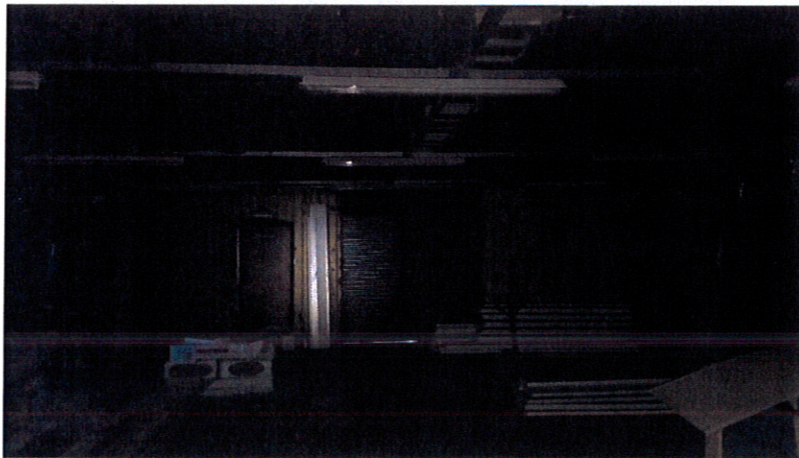
BUILDING No. 20 – STORE AND OFFICES

- In reasonable condition.

- Retain at present.
- Electrical circuits to have periodic inspection and testing undertaken and upgraded as necessary
- General Lighting, emergency lighting, earthing and Fire Alarms to upgraded to meet current standards
- Asbestos Survey

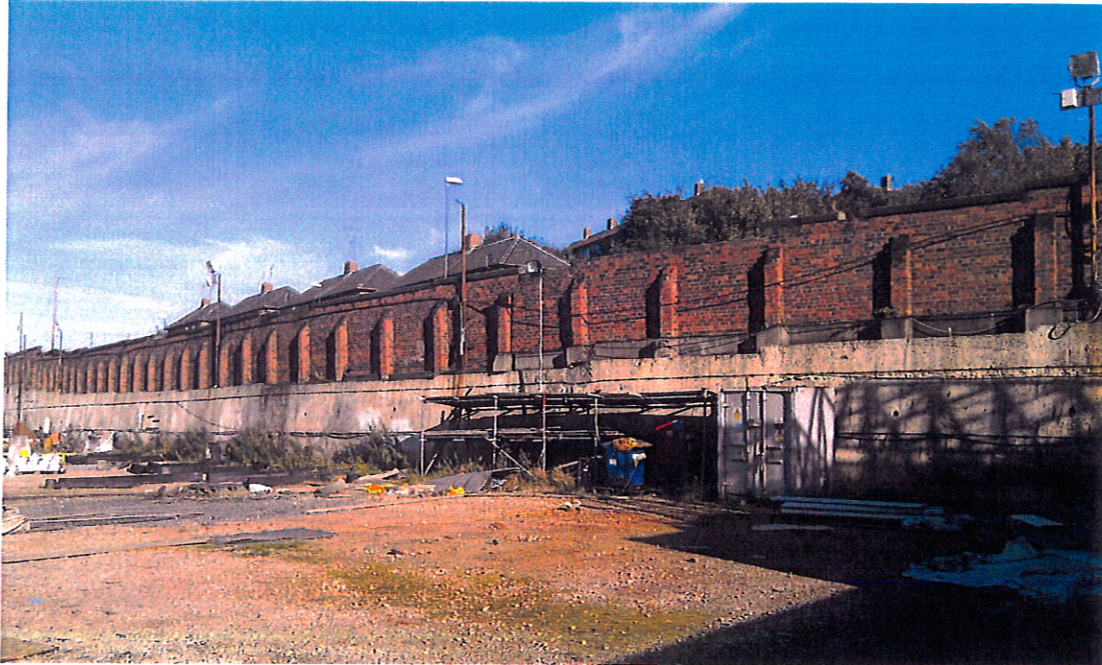
WEST HOLBORN BOUNDARY WALL

- Masonry wall is visible out of plumb

- Agreed that remedial works are required.

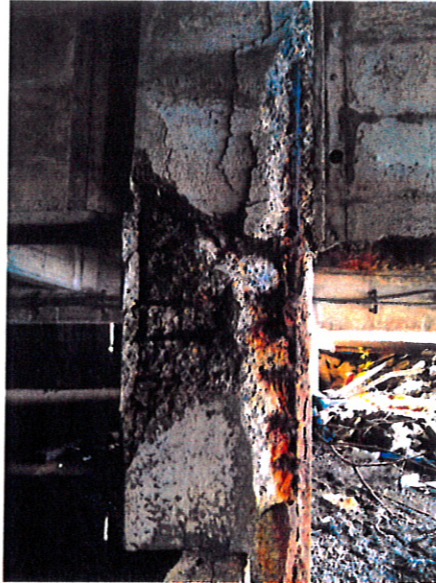
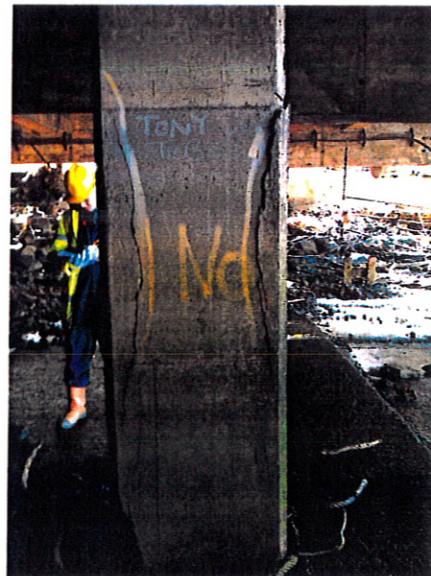
ELEVATED CRANE TRACK IN SOUTH YARD.

- Reinforced concrete construction.
- Part of which was demolished by McNulty recently.
- DTA inspected the section near the river in 2011 and this revealed it to be in poor condition with spalling concrete and exposed corroding reinforcement. This resulted in significant load reduction in the allowable load on the structure

- Suggest demolition and backfill most of the area apart from the tidal section as this avoids the cost at this stage of a quay wall construction
- This would provide more site area.

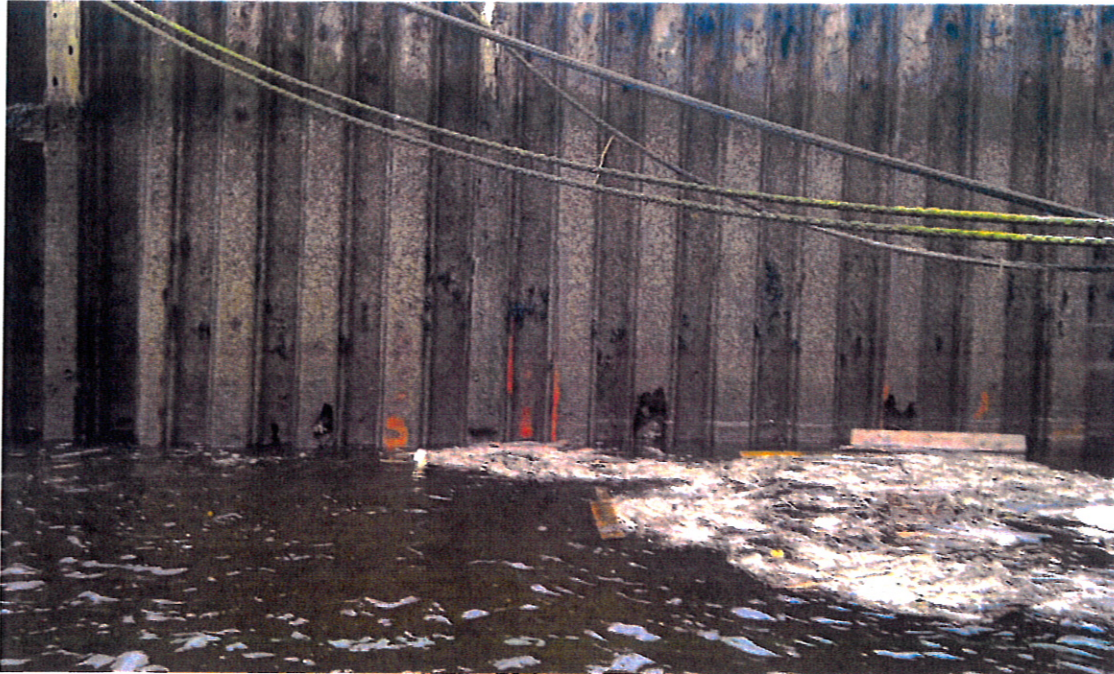
SOUTH SIDE FACING GUT

- Steel sheet pile wall is in extremely poor condition with many holes due to ALWC
- Holes in wall a number of years ago allowed a large void to be created consequently this area of quay is out of bounds.
- Quotes for radar scans being obtained

- Revetment to be constructed but needs to be coordinated with Riverside quay extension

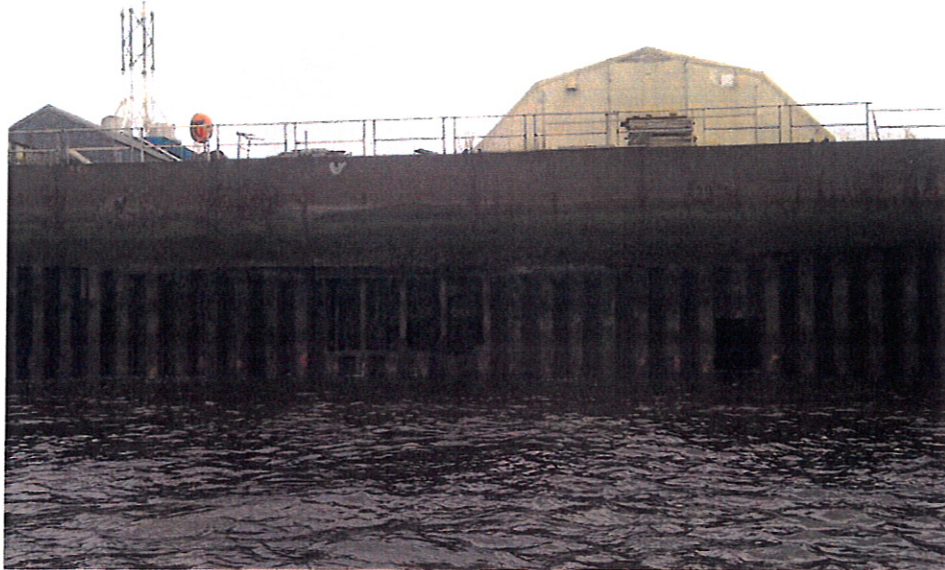
SHEET PILE WALL TO SOUTH YARD

- Steel sheet pile wall is suffering from ALWC and therefore its strength must be considered suspect.

- Detailed survey of pile wall thicknesses required to an appraisal can be undertaken and appropriate action considered.

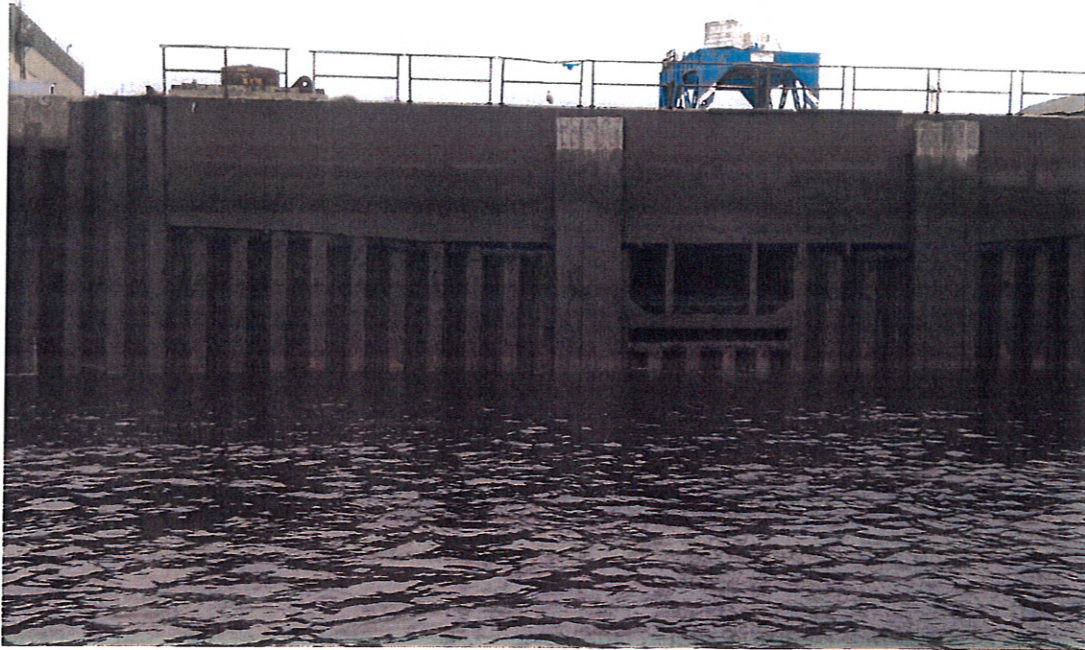
SOUTH LOAD OUT QUAY

- Reasonable but is suffering corrosion

- The exposed steel work columns need protection against ALWC - possible CP or applied finish.

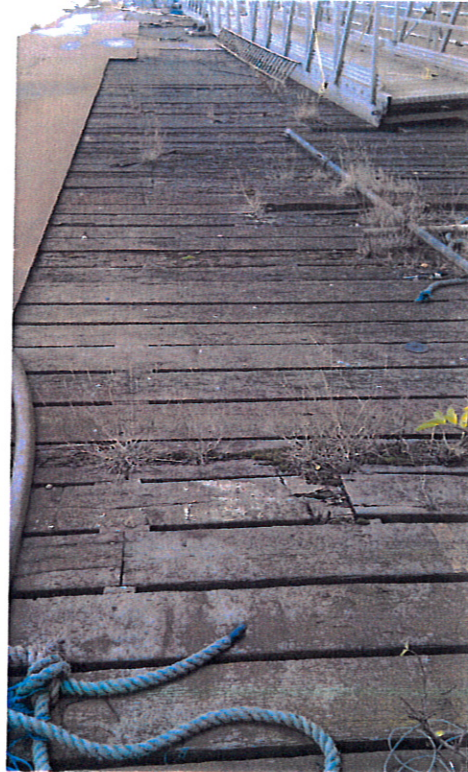
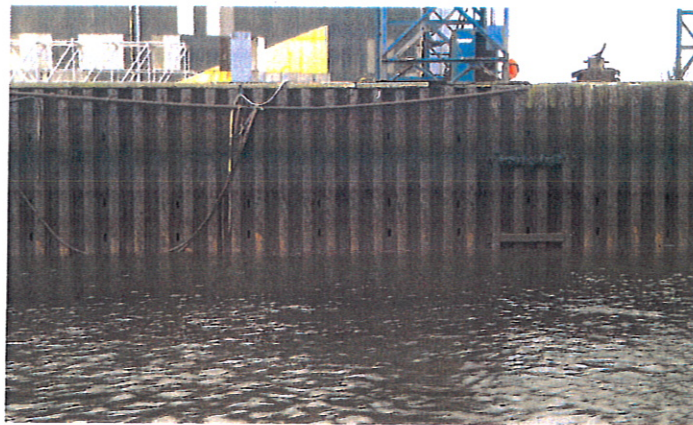
TIMBER STRUCTURE IN FRONT OF FAB SHOP

- Deck timbers unsafe
- Timber quay condition unknown
- Steel sheet piles suffering from ALWC

- Timber retaining structure needs more detailed intrusive investigations to determine its strength.

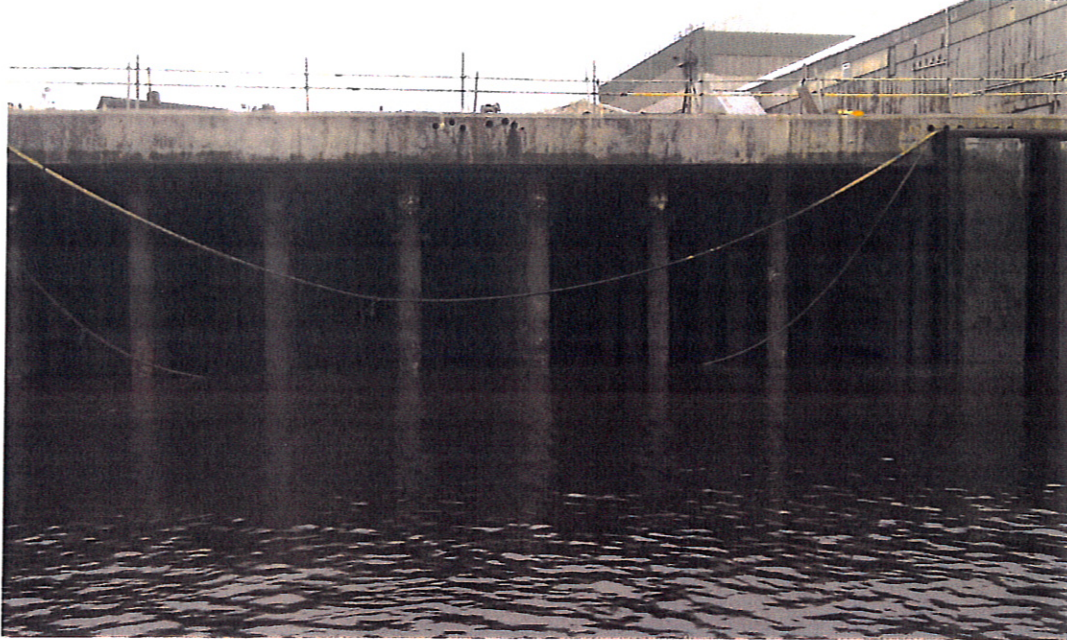
NORTH LOAD OUT QUAY

- Suffering very badly from ALWC with a number of repairs undertaken in recent years

- Repair and apply CP added and possibly with some other protective measures as major asset to site

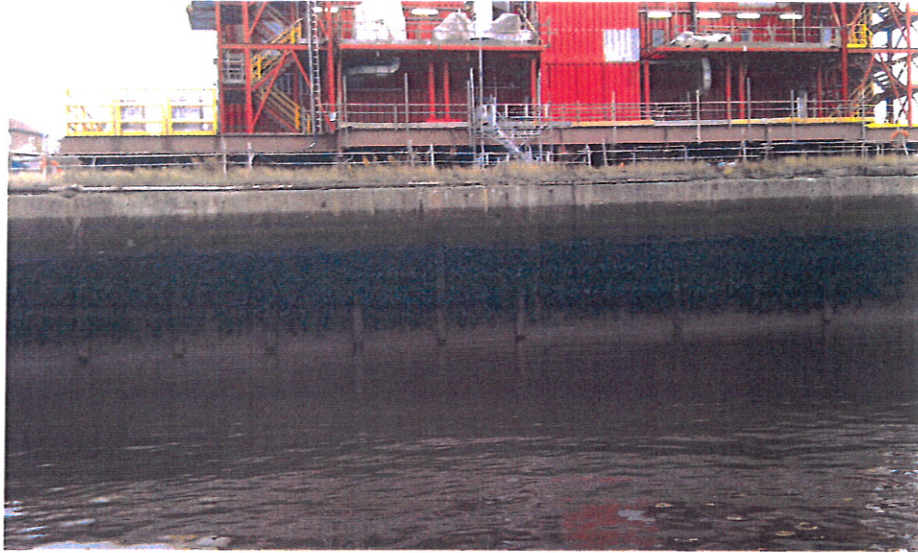
ORIGINAL MASS CONCRETE WALLS AROUND DOCK

- Seem in reasonable condition for age.

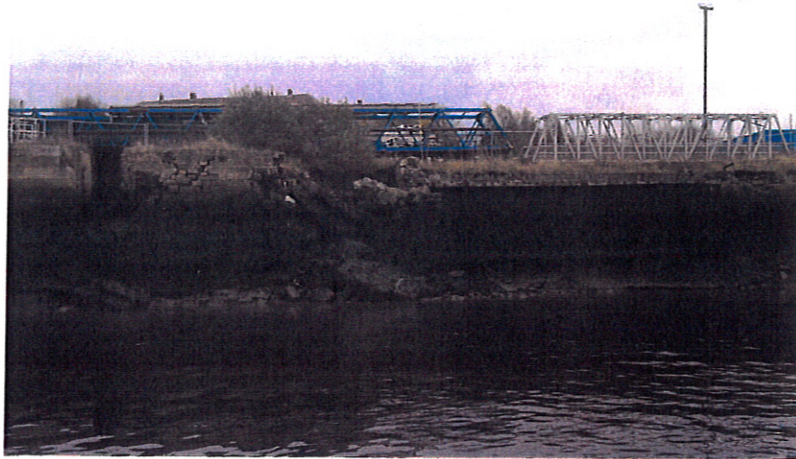
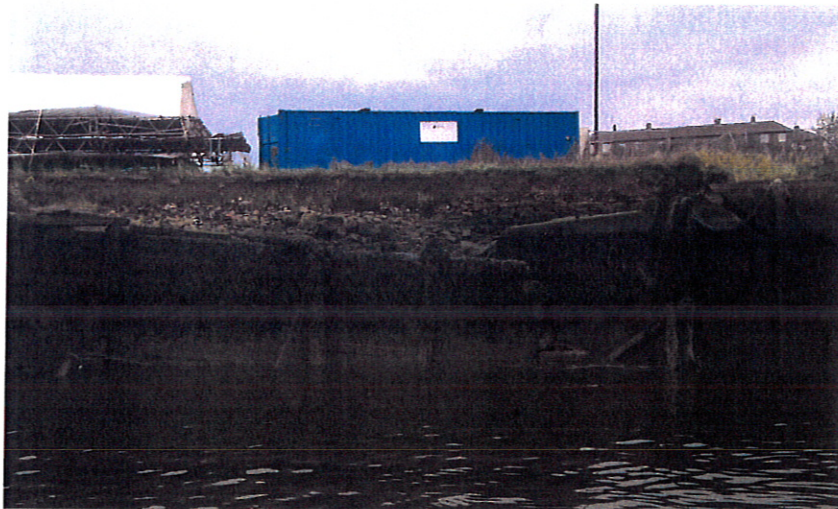
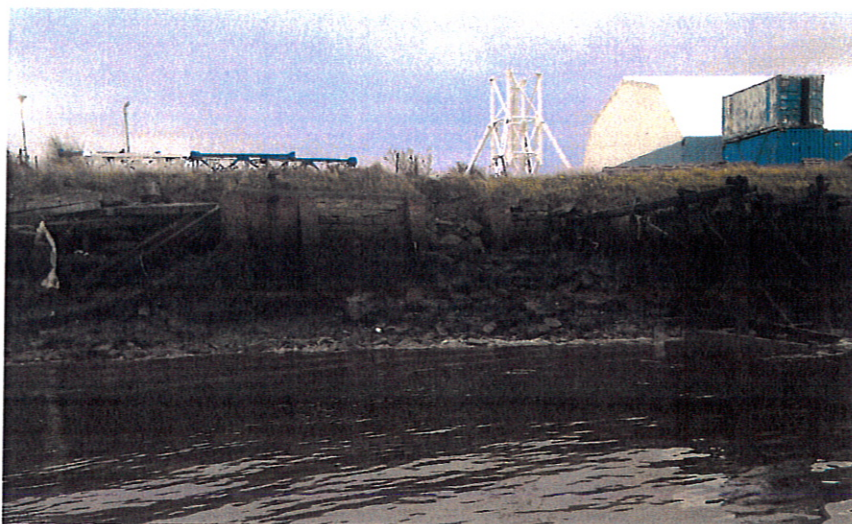
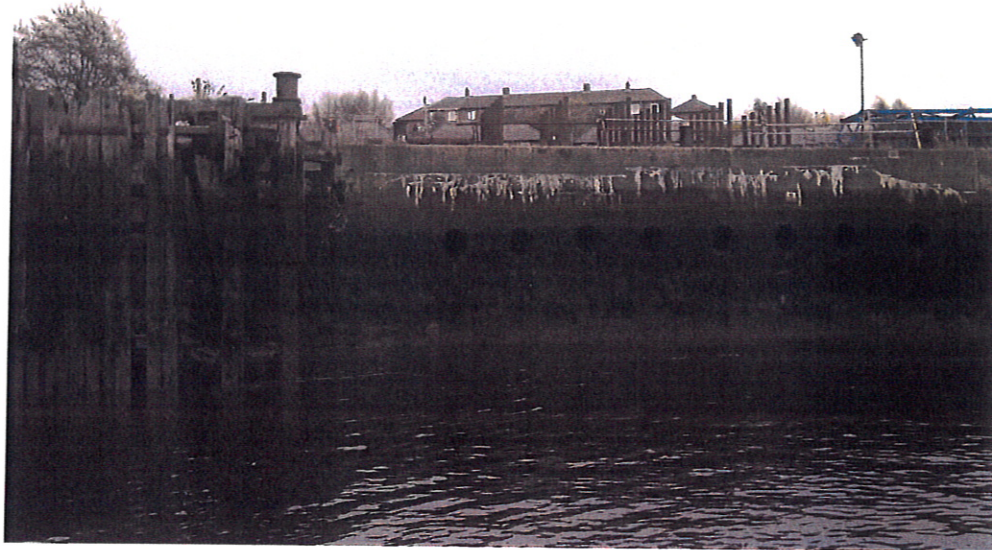
QUAY FOR REST OF NORTH YARD

- In a poor or very poor conditions and risk of further slippage of some slopes into the river

- If no short term plans to develop this length of quay then investigation into ways of stabilising the situation in the short term should be considered also the possible removal of the remnants of the timber structures
