Mechanical Inspection Report

at
McNulty Yard
for
Port of Tyne

Prepared for: Port of Tyne
Prepared by: P McKay
Reviewed by: P Appleton
Date: February 2013

Project No: 5570

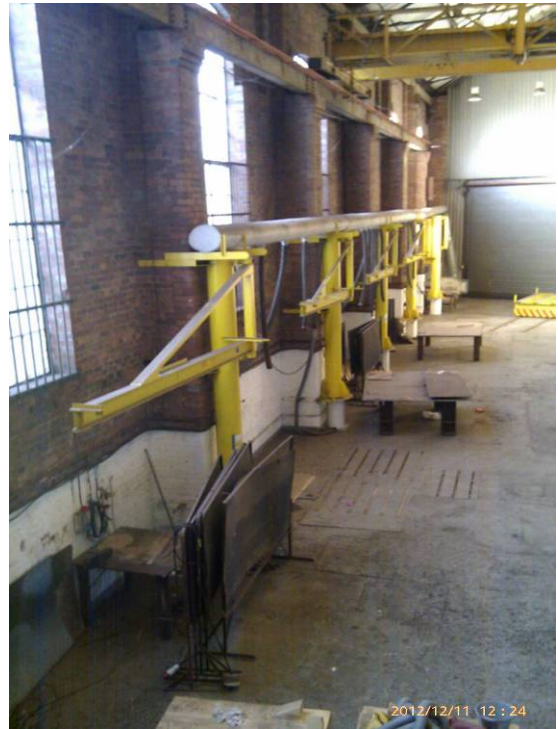
Main Pipe Shop. Specialist Extract Vent.

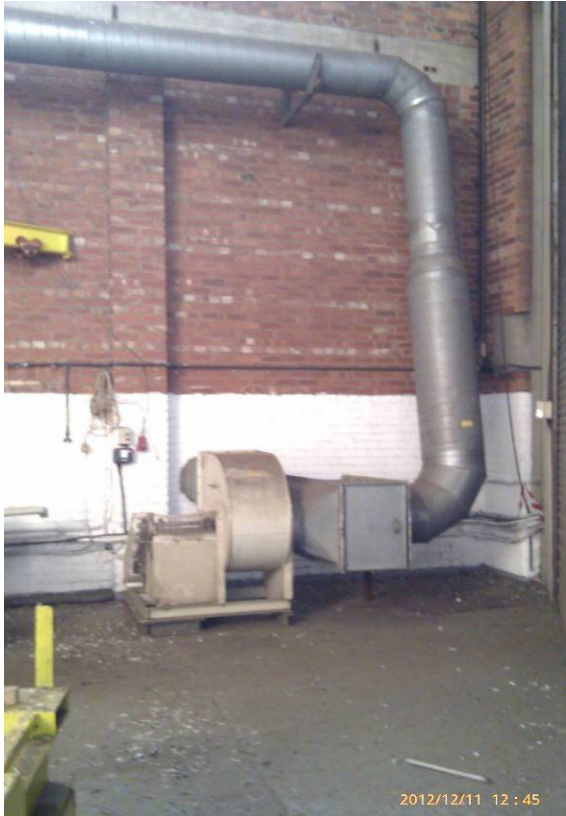
Main Pipe Shop Specialist Exhaust Ventilation System

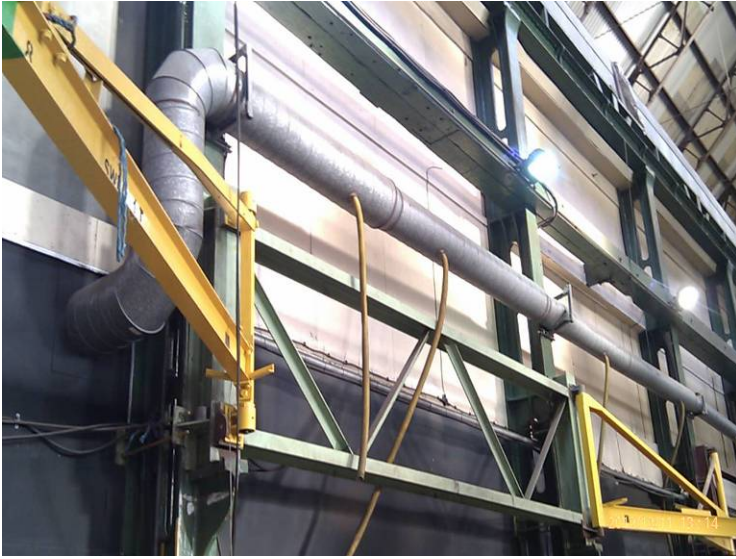
Welding Specialist Ventilation System

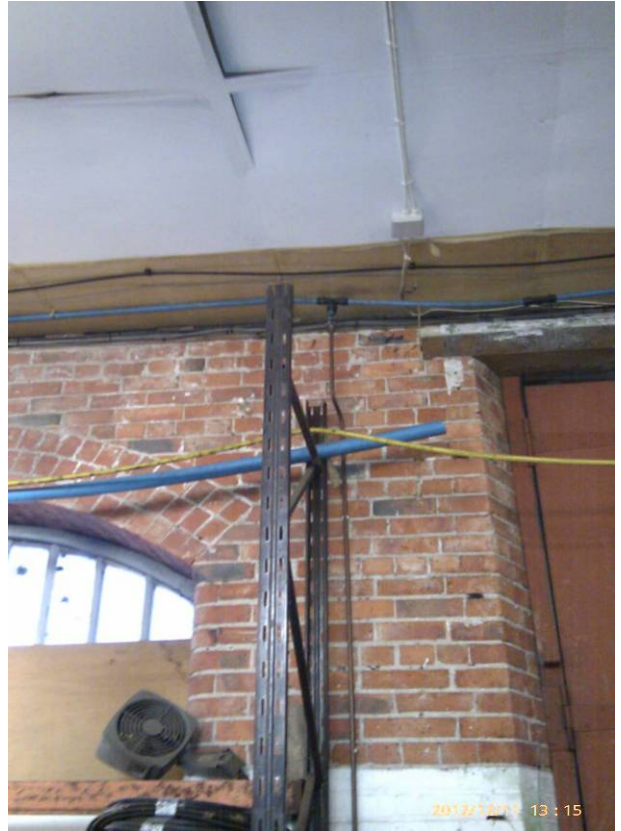
- 3.2 MCWS. Supplied from incoming mains that enter the building in MDPE on East façade. Condition: fair / poor. Installation poor.
- 3.3 A Gas meter is installed at lower ground floor level of the brick built offices adjacent to the road side.

MDPE Water Services Distribution

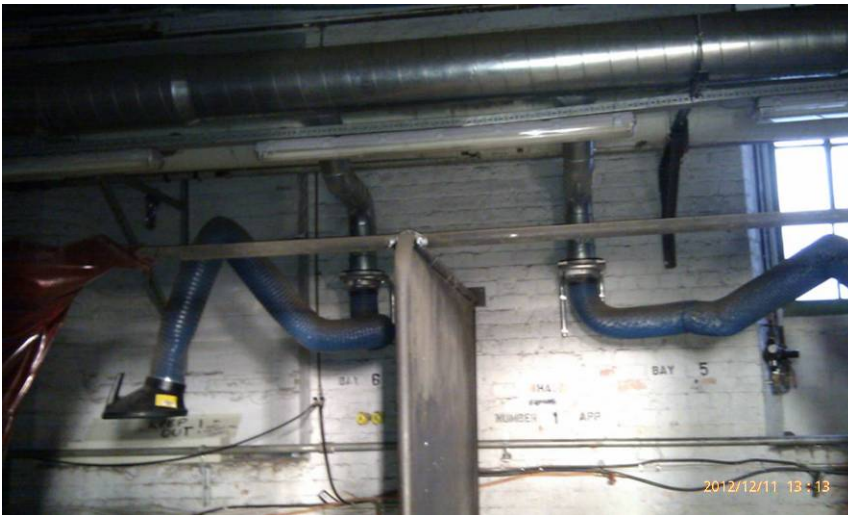
Welding Extract Ventilation System

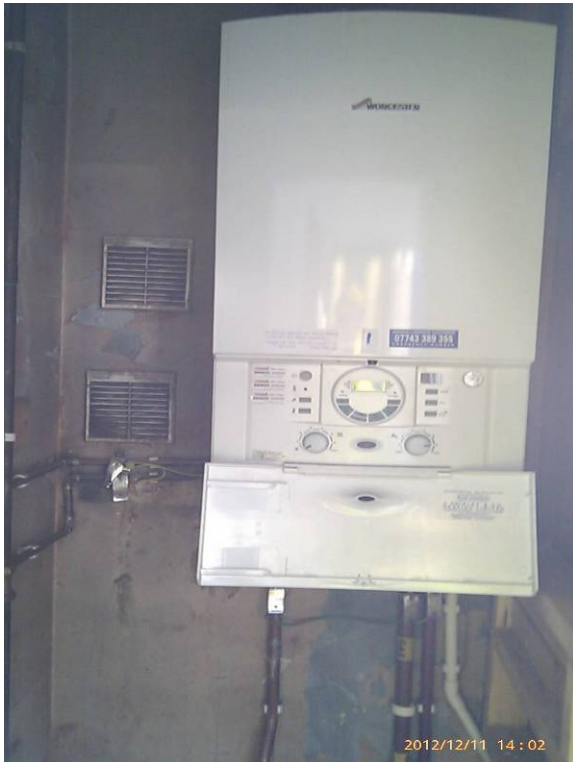
- 3.6 Gas fired LPHW radiator system. Condition: Good

Offices LPHW Boiler

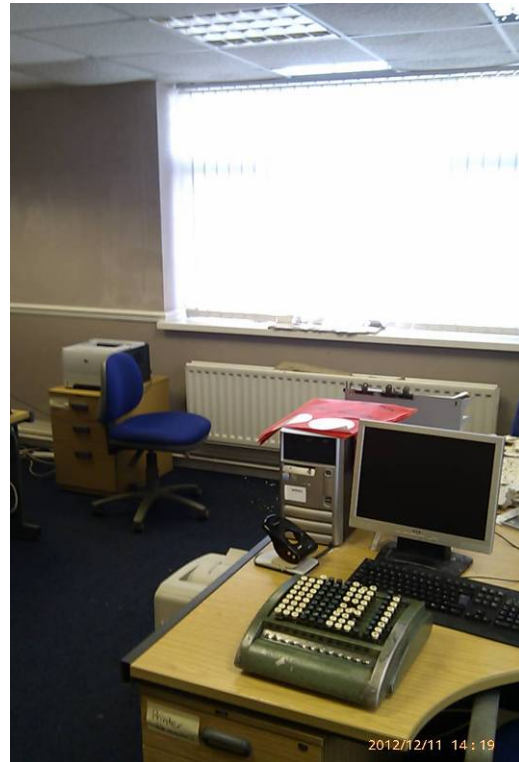
LPHW Heating in Offices (South)

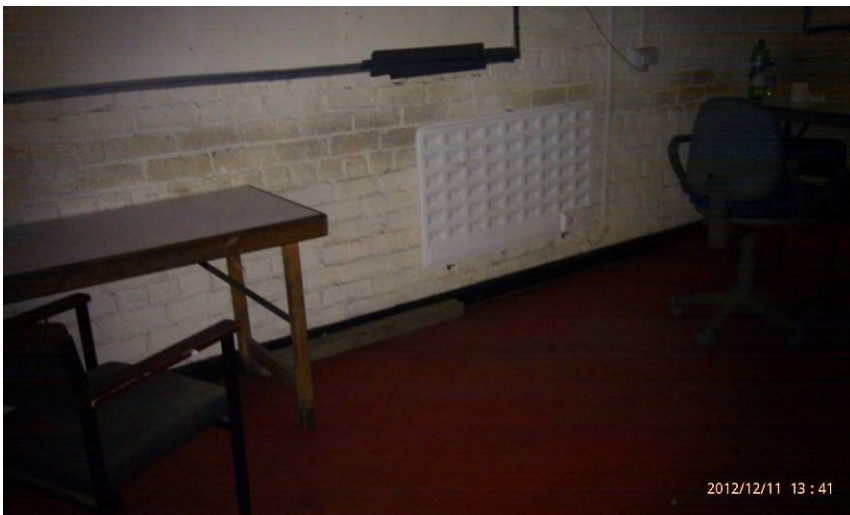
Pipe Shop Mess. Electric Heater

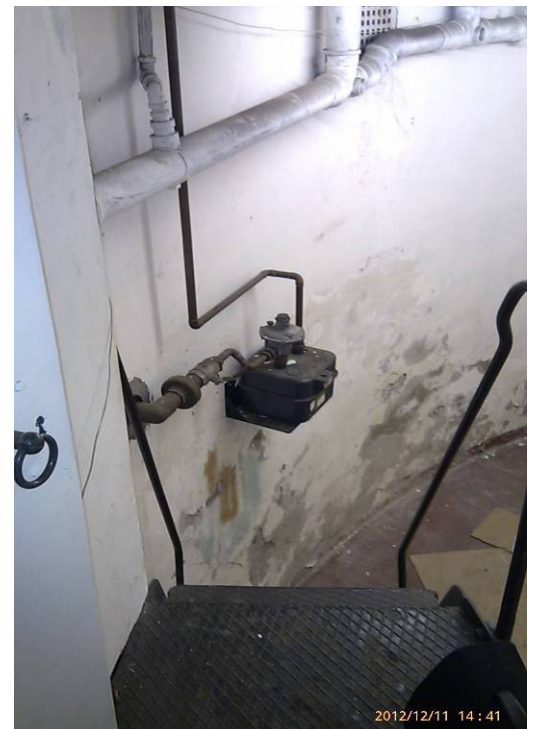
Offices (South) Gas Meter

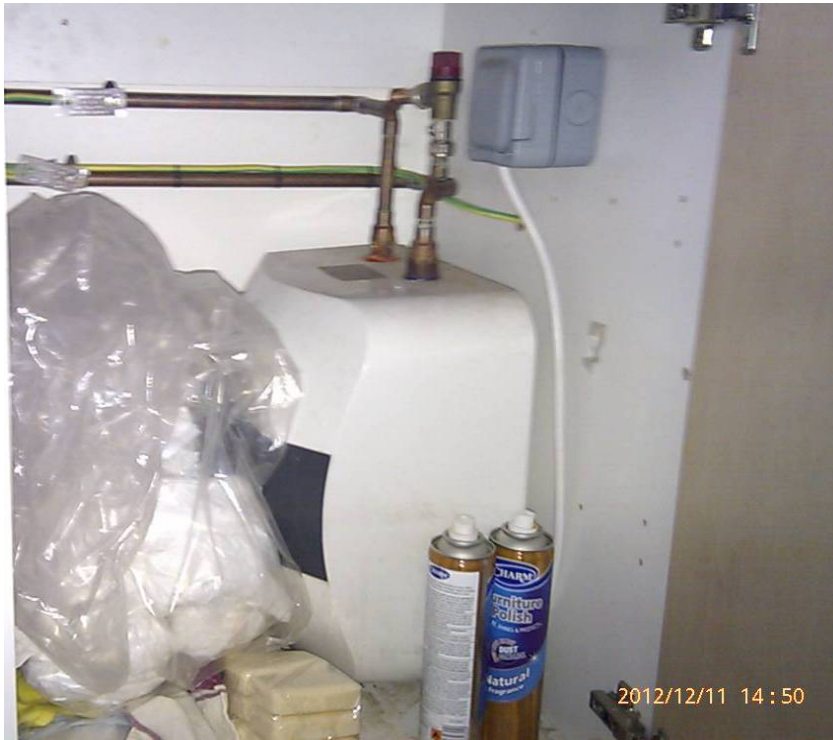
4.6 Mains cold water and hot water, via an electric water heater are in good condition.

DHWS Electric Water Heater

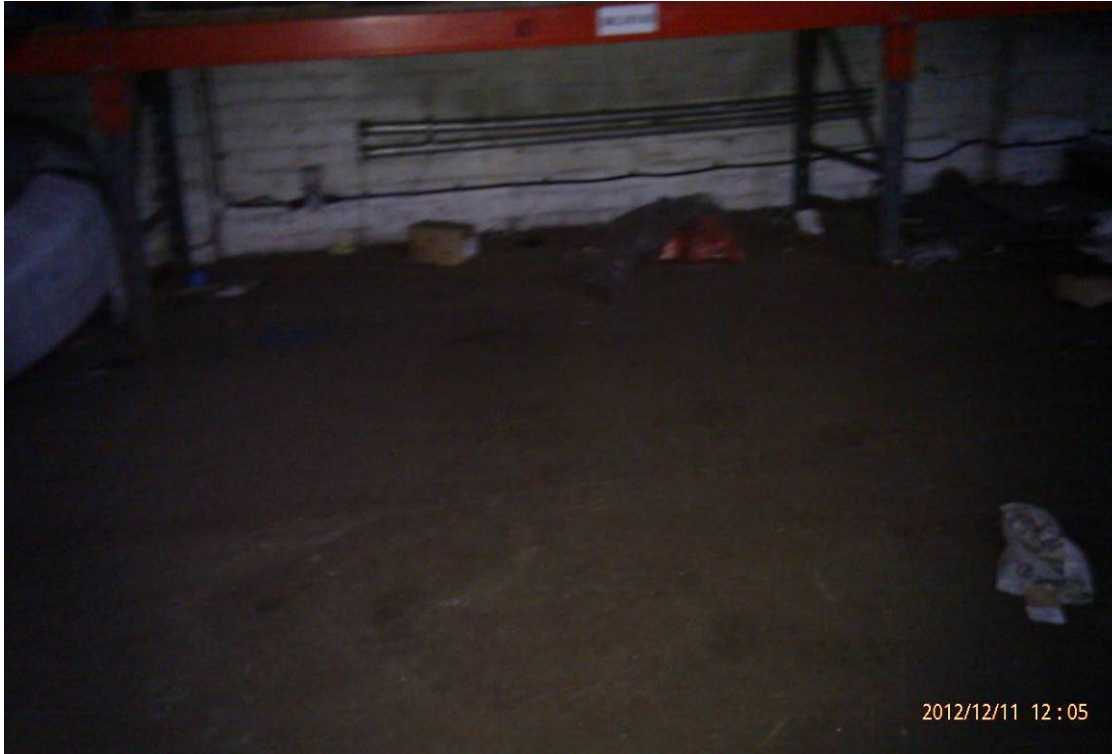
- 6.4 Heating: Electric tubular Condition: Poor

Electric Tubular Heaters

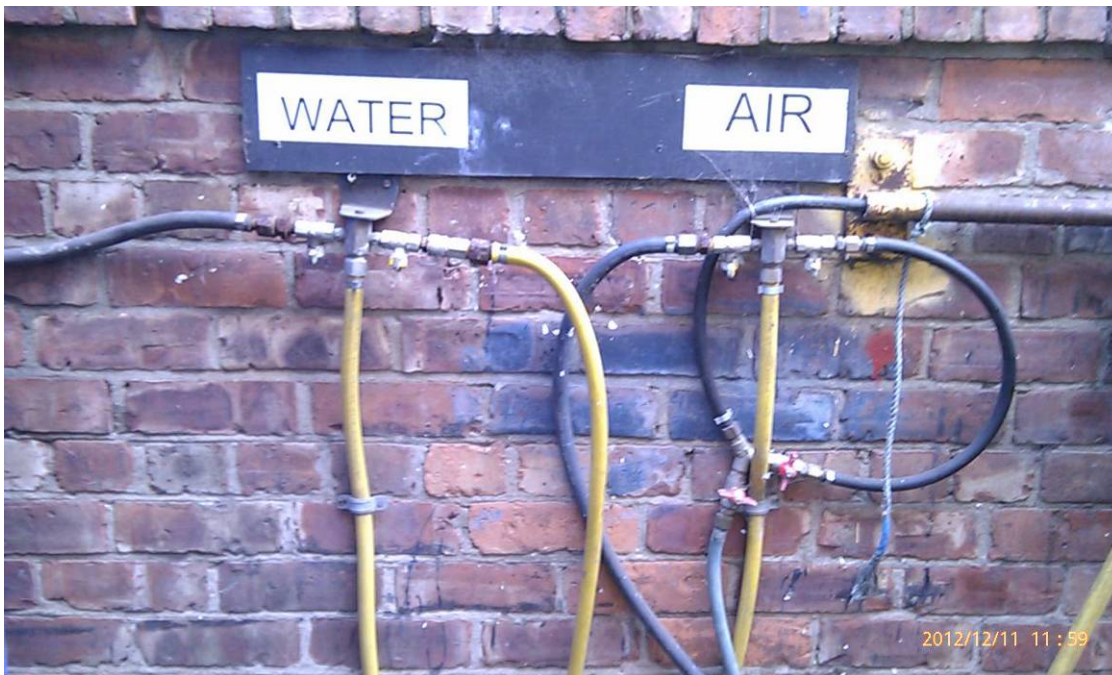
- 6.2 Poorly installed MDPE CWS pipework.
6.3 Poorly installed compressed air pipework

Water & Compressed Air Lines

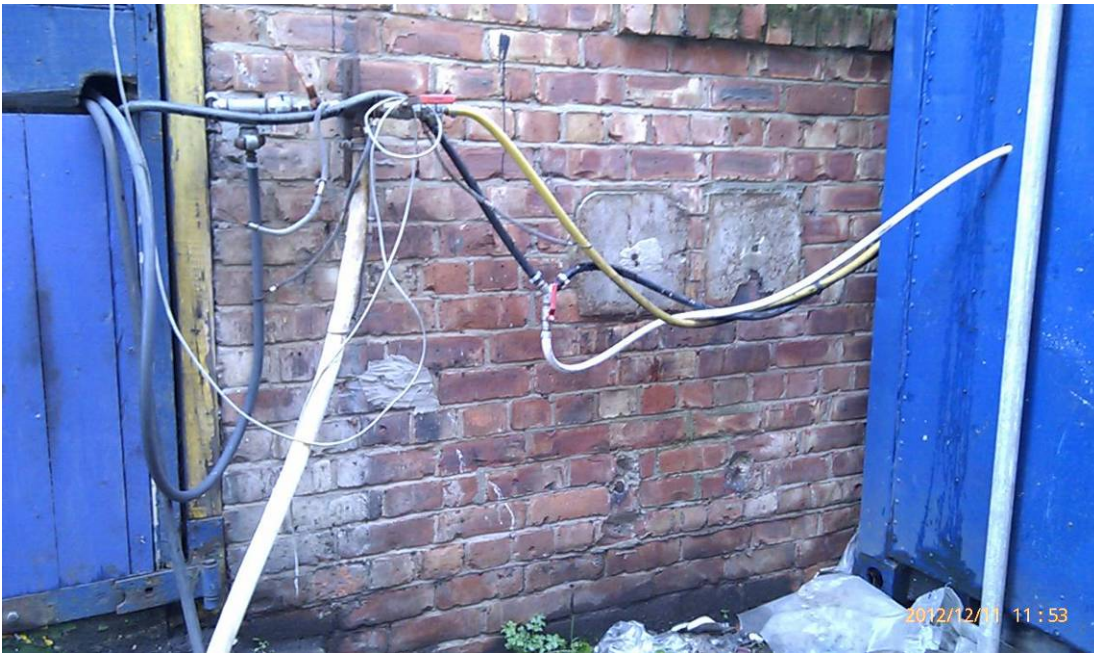
Water & Compressed Air Lines Feeding Portable Building Annex & Outside Discharge Valves

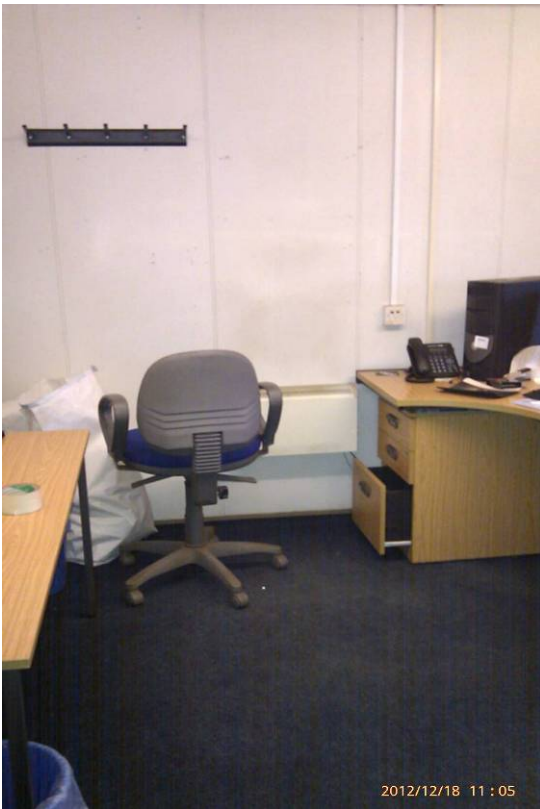
9.3 Heating: Electric convectors and wall mounted electric fan heaters. Condition: Good

Electric Heater

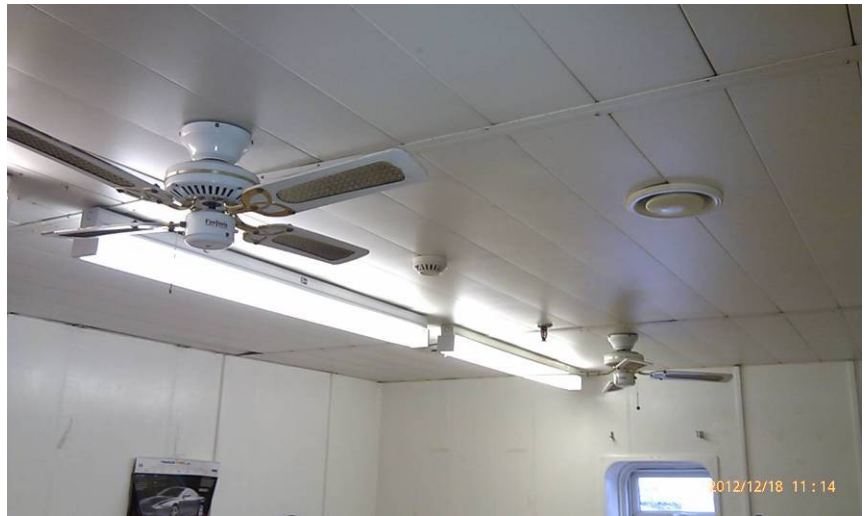
9.5 As above but with Punka ceiling fans installed. Condition: Good

Punka Fan. Upper Floor

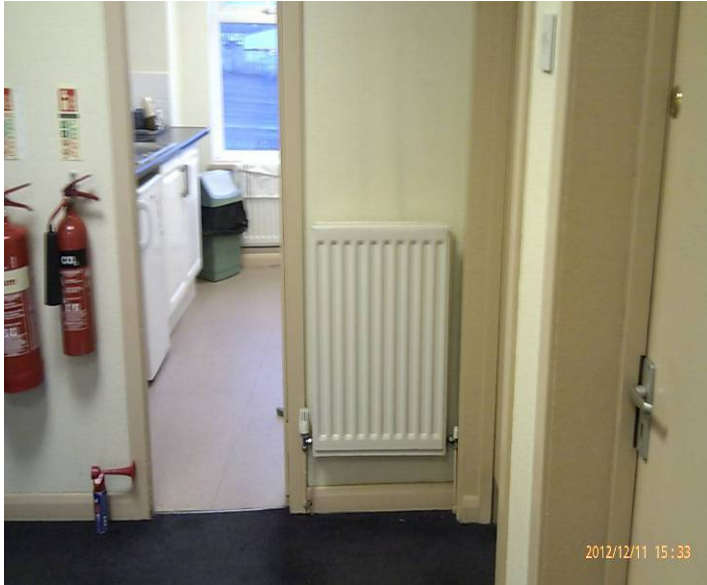
10.4 Heating: Via 2 gas fired LPHW heating systems. Condition: Good

Radiator

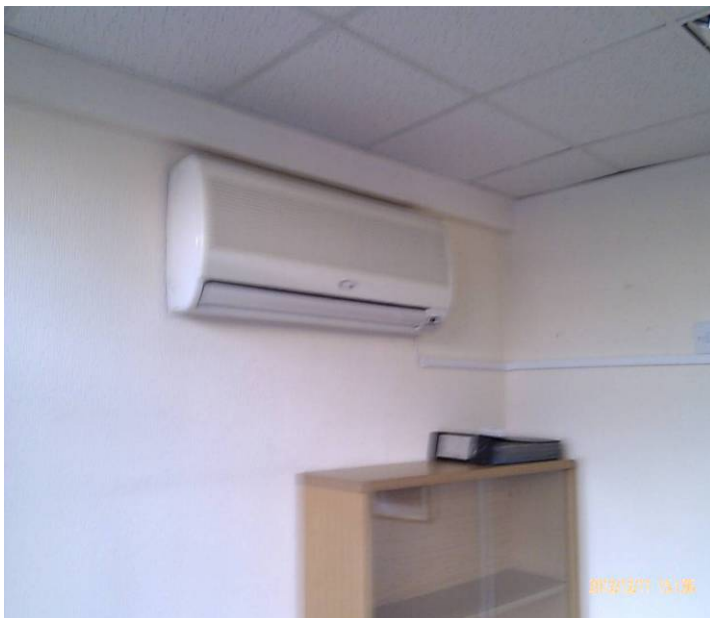
10.6 Air Conditioning: 2 Split AC systems in Conference rooms. Condition: Good

AC Unit. Conference Room

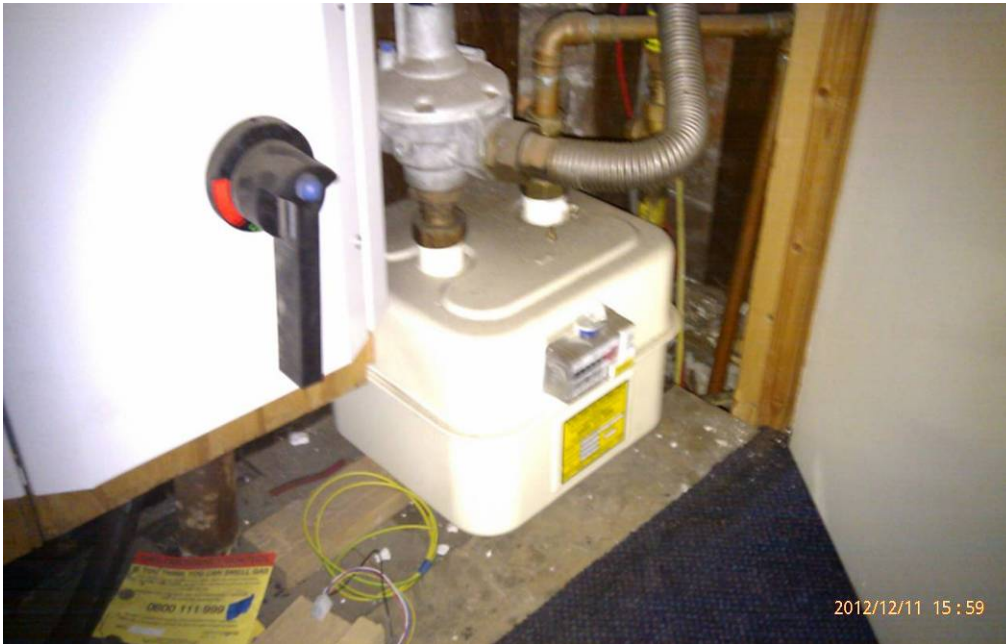
10.3 Incoming metered gas supply and MCWS service. Condition: Poor

Gas Meter (Ground Floor Lobby)

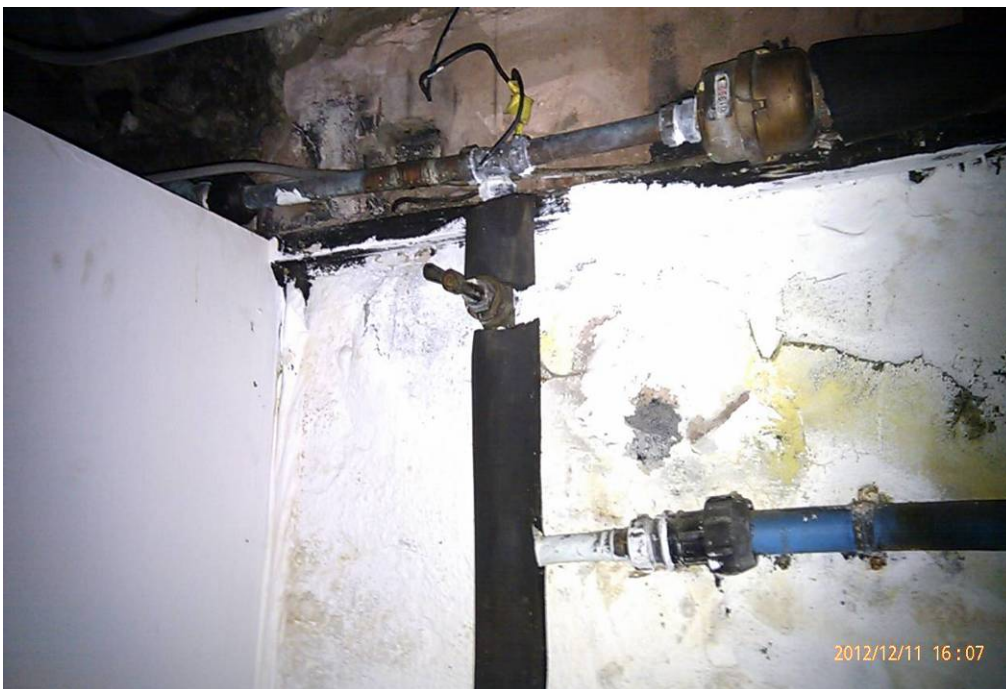
Water Meter (Basement)

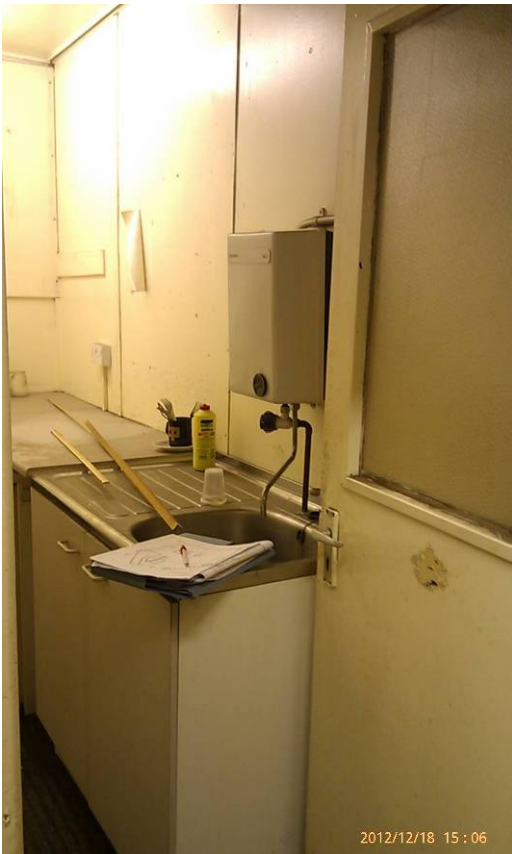
11.6 DHWS: Electric water heaters. Condition: Good

Electric Water Heater

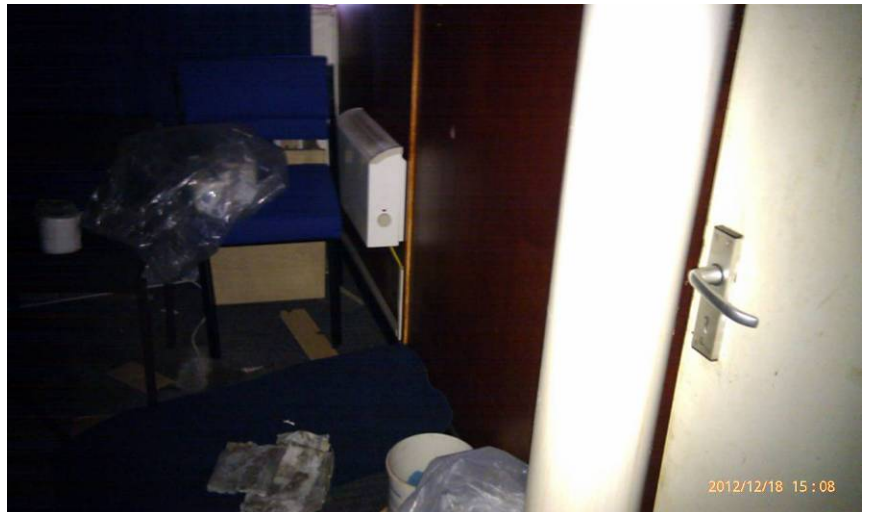
11.3 Heating: Electric Convectors. Condition: Good

Electric Heater

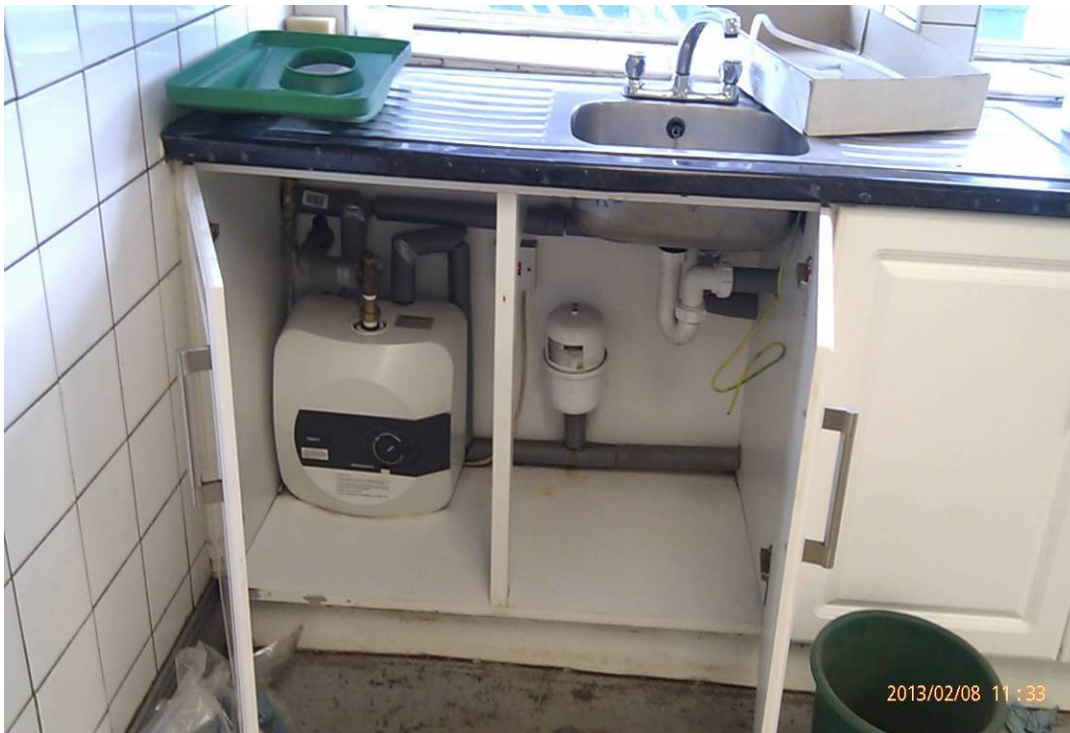
- 12.6 Kitchen & Mess Area have sinks. An electric water heater sited under the mess room sink and supplies both the mess and kitchen.

Mess/Kitchen Electric Water Heater

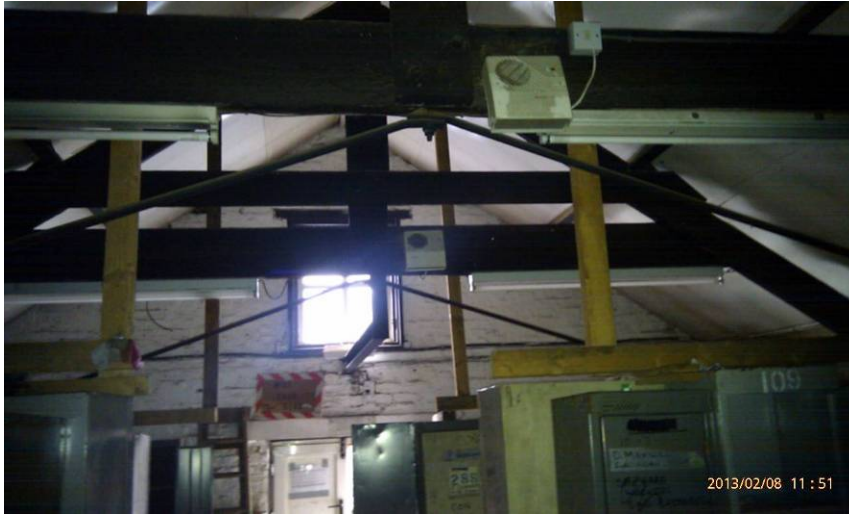
- 12.3 Electric Convectors. Ground Floor, Condition Poor.
12.4 Electric Fan Heaters First Floor. Condition Poor.

Locker Room Electric Fans

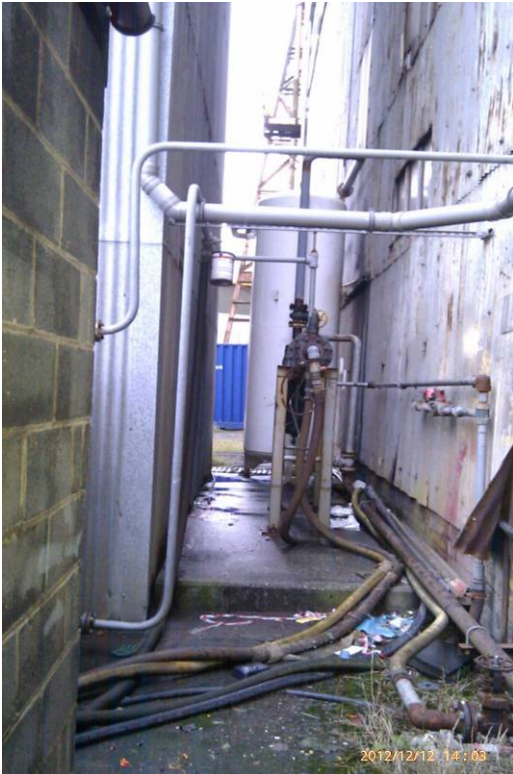
15.11 Compressed Air: Installed around the perimeter of the building, with droppers to welding booths. Fed from external plant. Condition: Pipework: Fair. Plant: Poor

Comp Air Plant

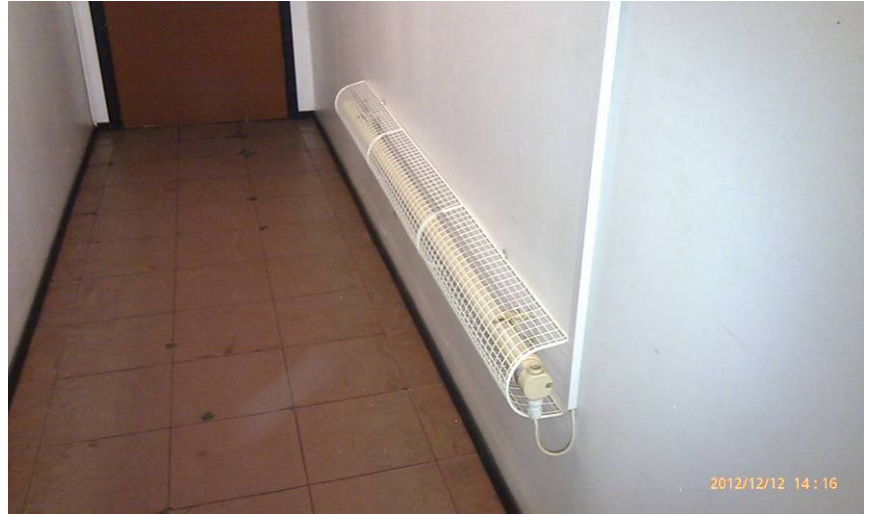
15.4 Electric convectors and fan heaters in offices and tubular heaters in corridors. Condition: Fair/Poor

1st Floor Offices, Corridor Electric Tubular Heater

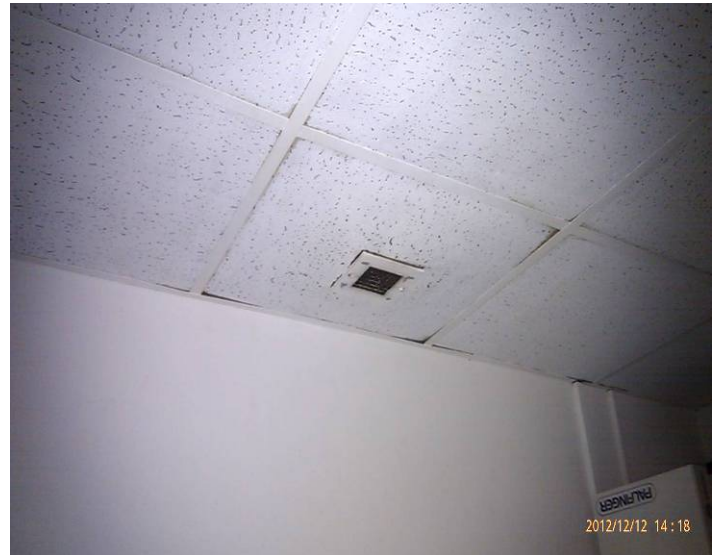
15.6 Ventilation in most offices and canteen. From central ducted systems.

1st Floor Offices, Corridor Ventilation Grille

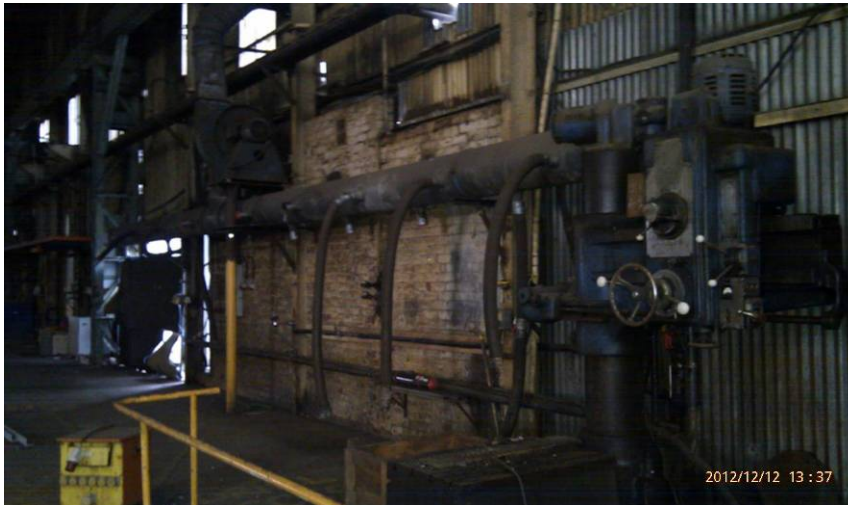
Vent Duct

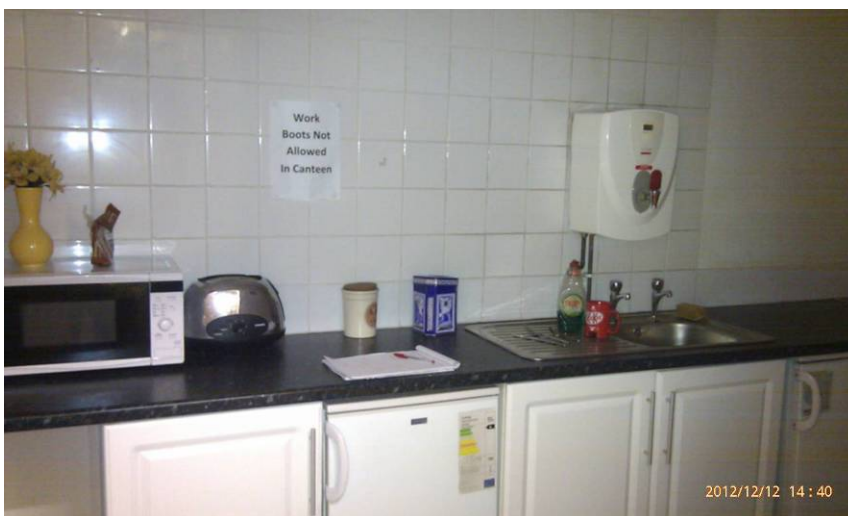
15.12 DHWS Electric water heaters. Condition Good.

Kitchen. Electric Water Heater

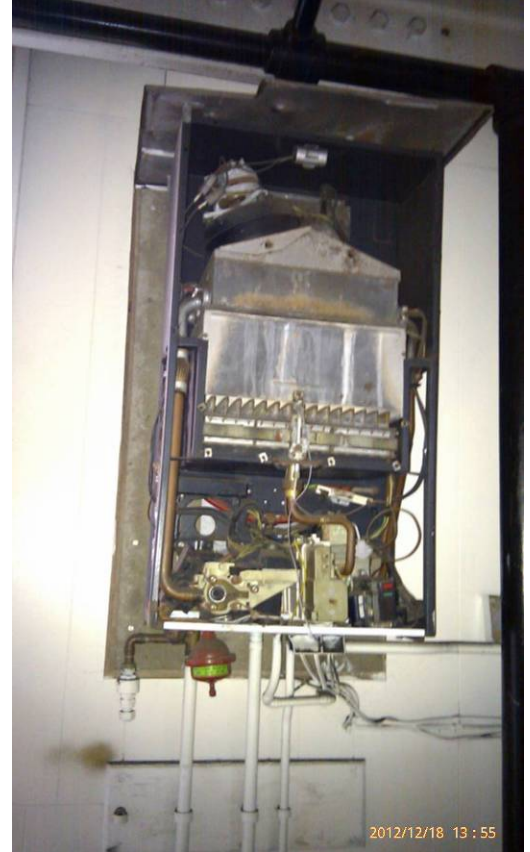
16.4 LPHW gas fired heating system installed on upper floor. Boiler stripped down and out of use.

Heating Boiler

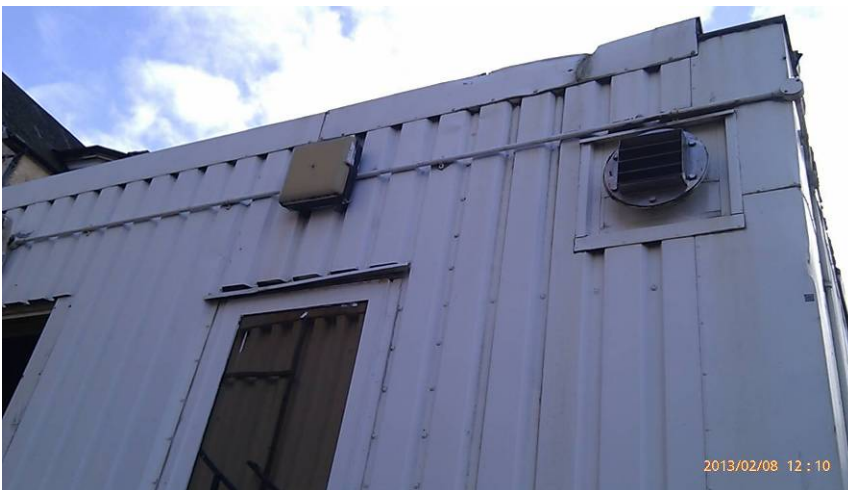
External Vent Duct

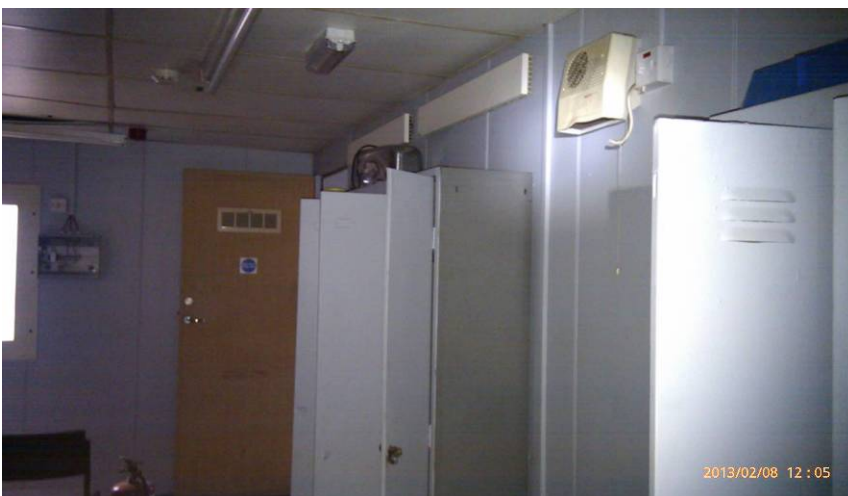
19.5 Presently heated via portable electric convectors. Condition: Fair/Poor.

Electric Fan Heater

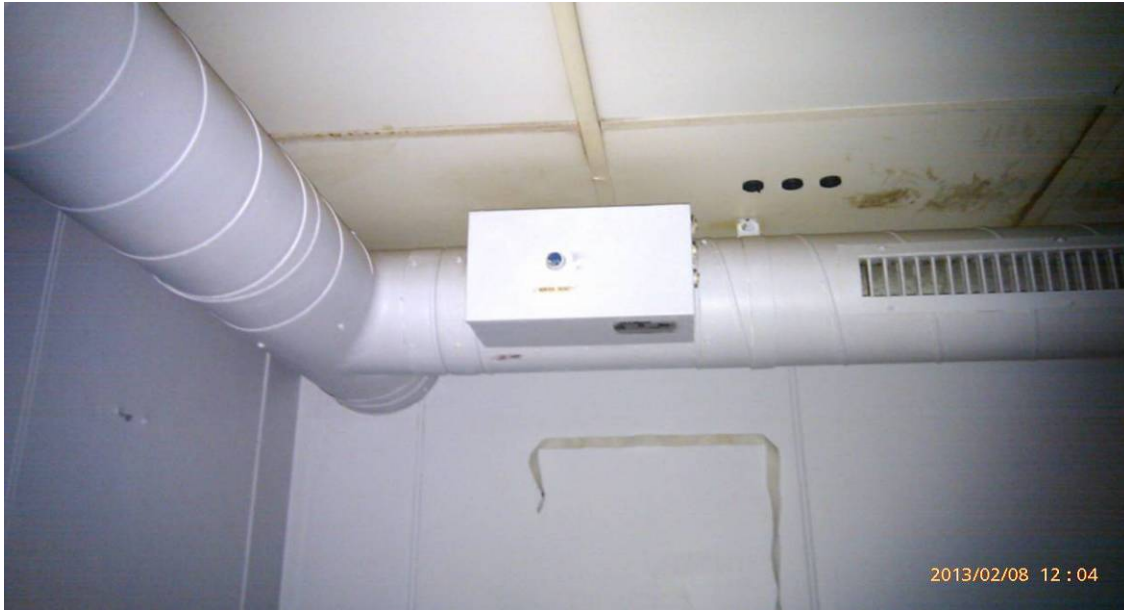
19.4 Previously by ducted warm air vent systems (electric) now disconnected.

Redundant Duct Heating System

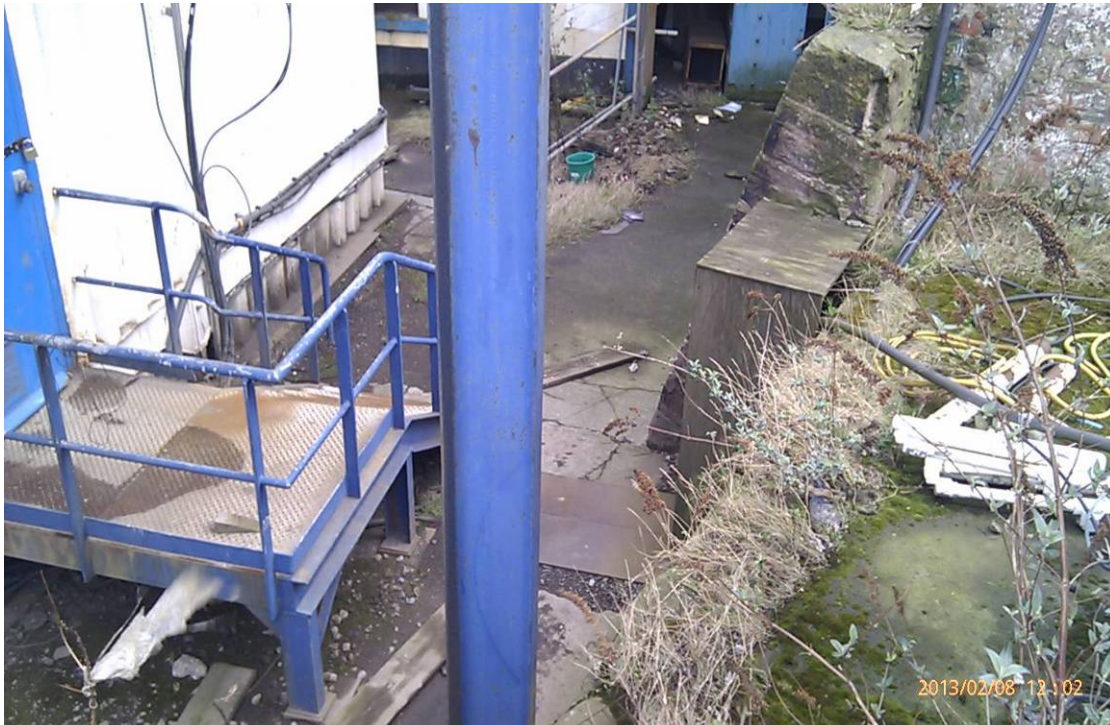
19.2 MCWS fed in MDPE to the building from the mains serving building 18. Condition: Poor

External MCWS

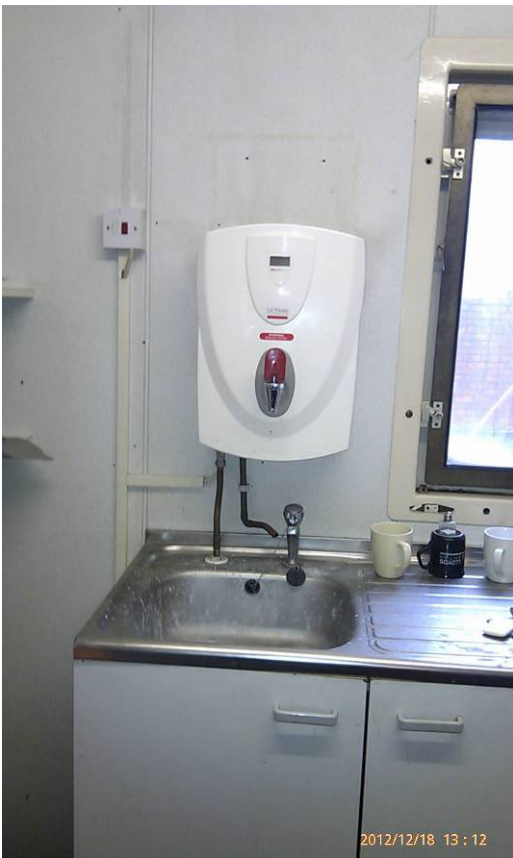
20.5 DHWS: Point of use electric water heaters. Condition: Fair

Water Heater
