Structural Appraisal

St Hilda's Colliery South Shields

Tyne and Wear Building Preservation Trust

**October 2014
Project Reference: Q117**

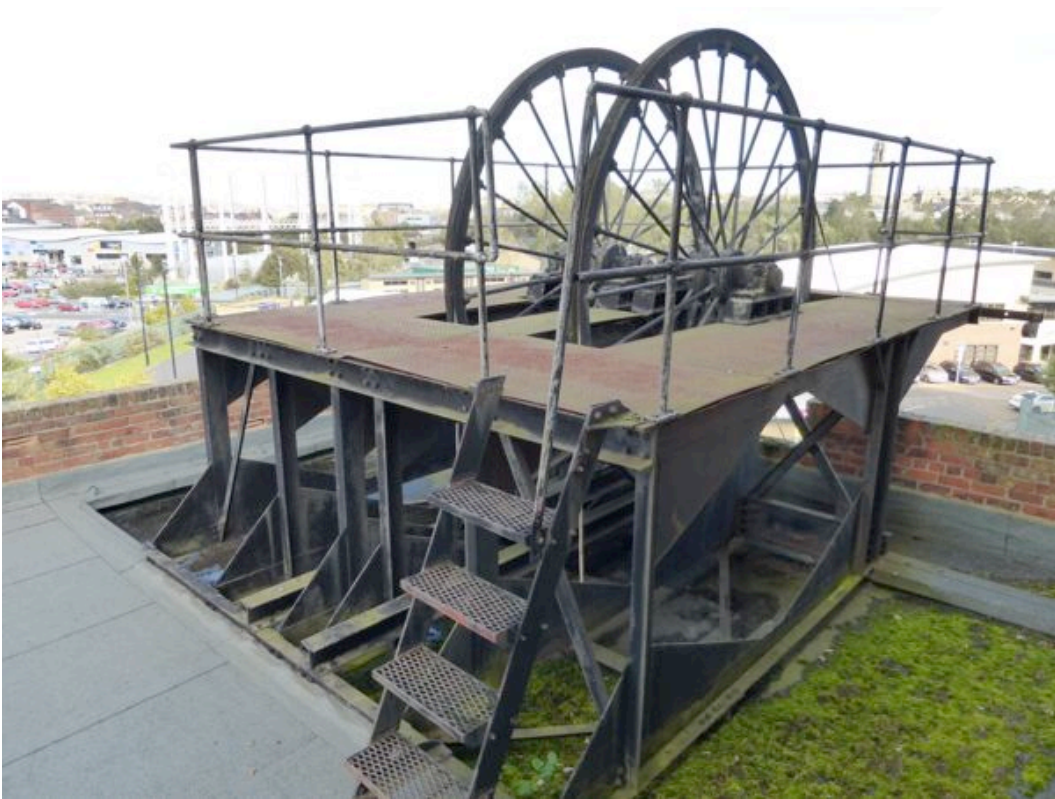
Winding Gear on top of Winding House

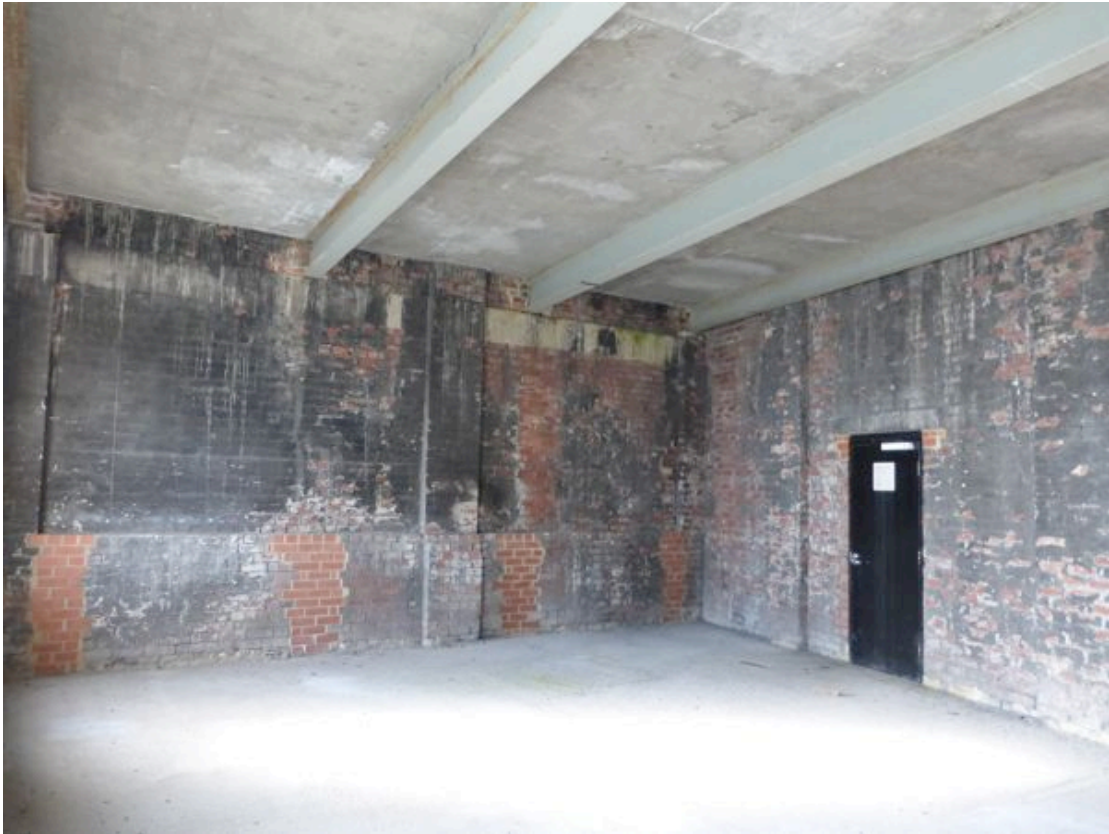
corroded and expanded. In the Pump House for instance, although a new floor and roof structure has been provided the old beam ends are still in place and may still be contributing to the cracking. It is on the other hand possible that moisture levels within the building and now drier than previously, in which case continued corrosion will be less of a problem.

Top Floor of Pump House

The Pump House is in sound structural condition, but the new steel beams should be painted, as corrosion is starting to affect the surfaces.

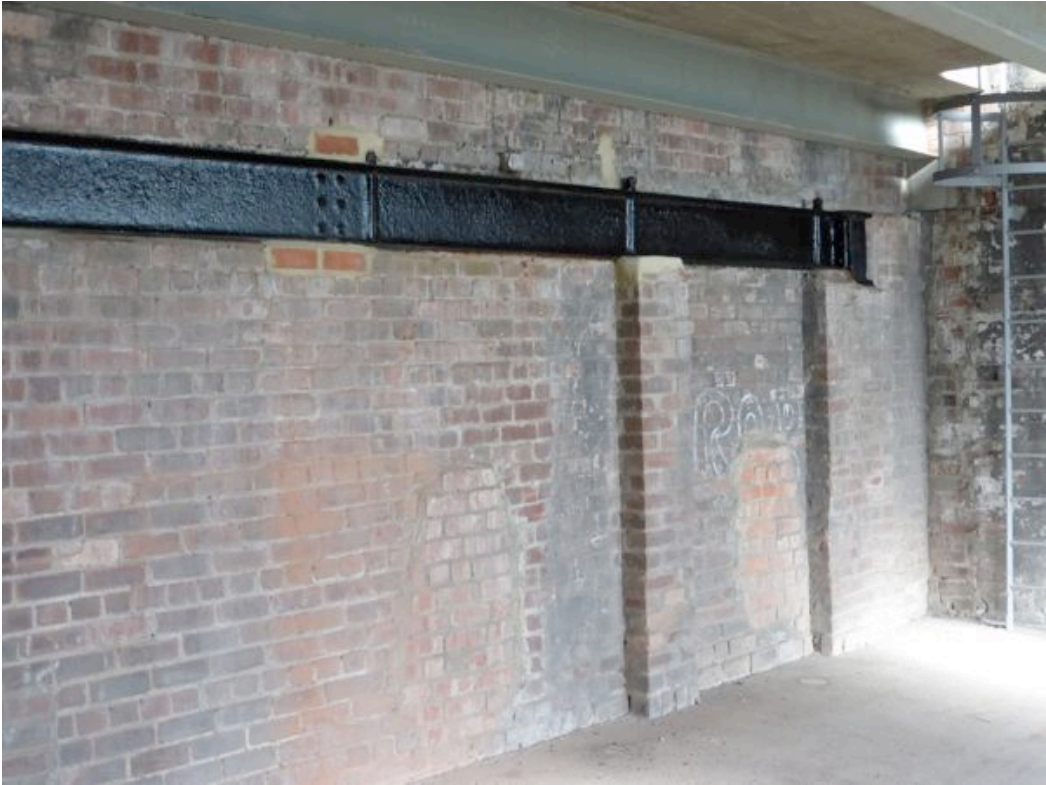
There are also iron beams at Winding House roof level, in the dividing wall between the Winding House and the Pump House. Although recently painted these are signs that corrosion is continuing.

Embedded Beam between Pump House and Winding House

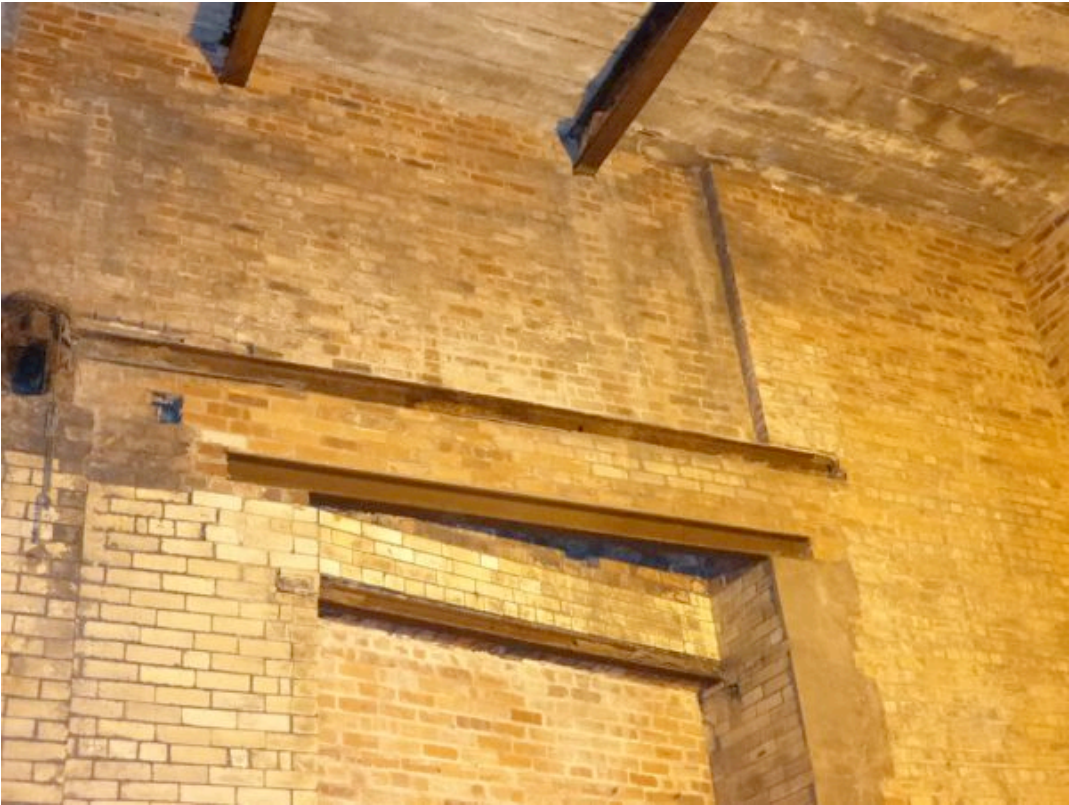
There are also some heavily corroded beams over the entrance passageway through the Pump House. These are not of high significance structurally, but there is a risk of small pieces of rusting metal falling off.

Beams over Entrance Passageway

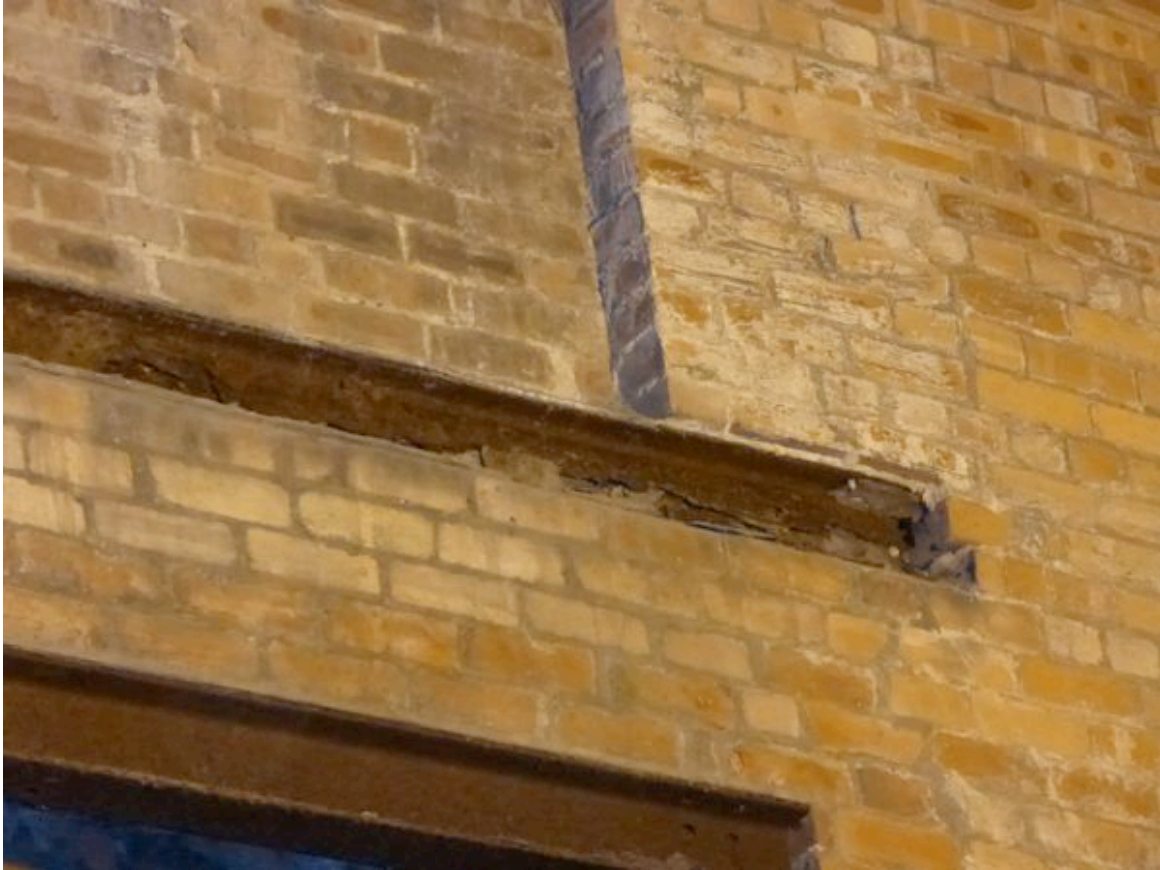
Corrosion in Beams over Entrance

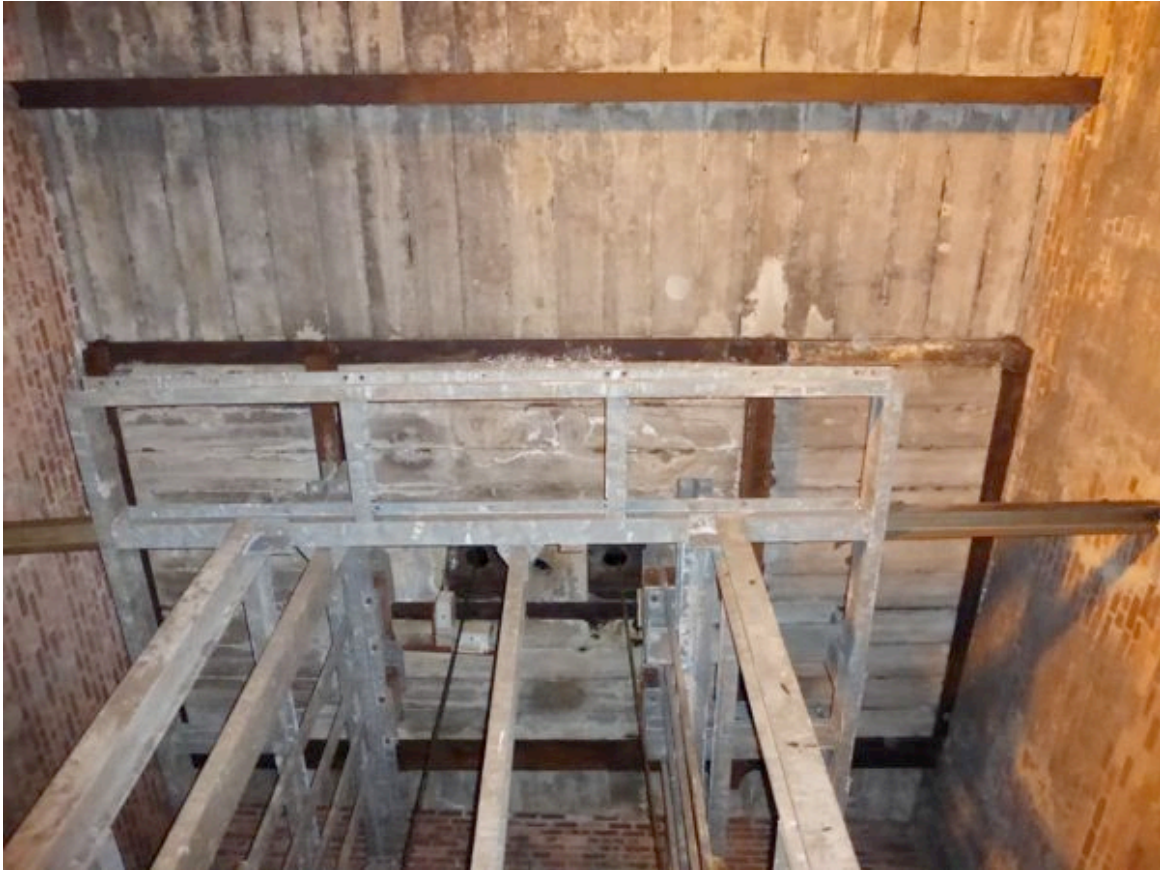
It has not been possible to assess the steelwork supporting the winding gear at roof level. This is given additional support from the internal steel frame, which could be strengthened if necessary.

Steel Framework under Winding Gear

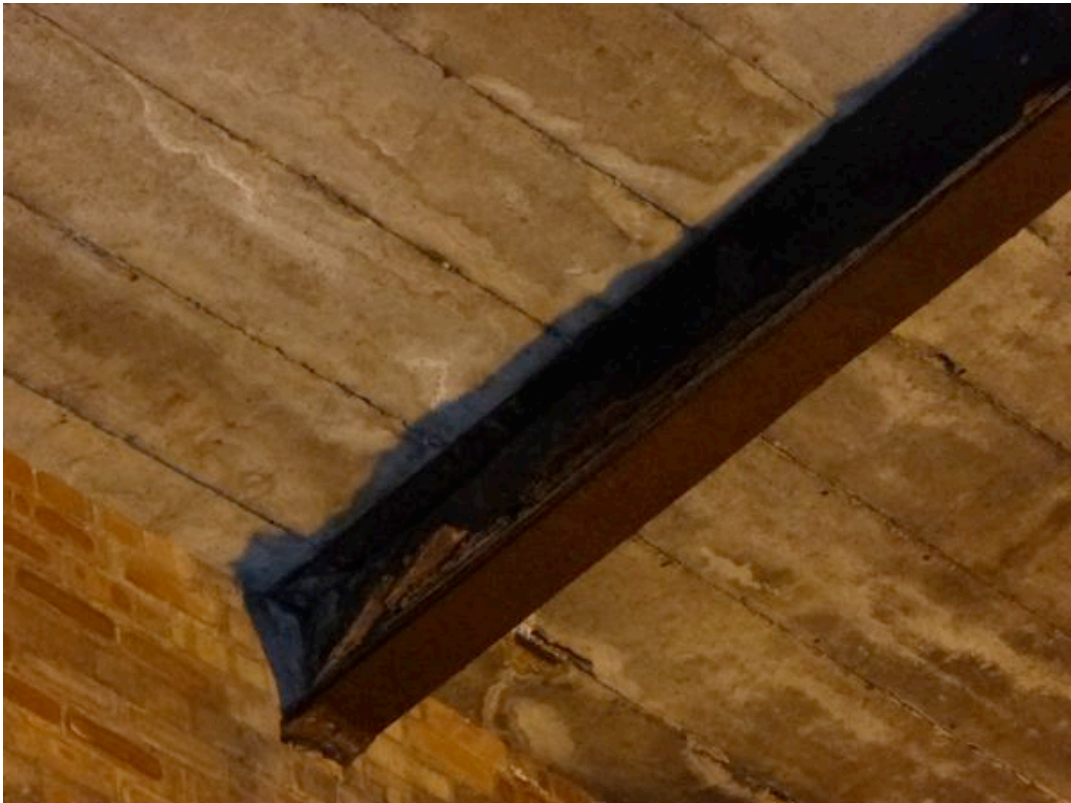
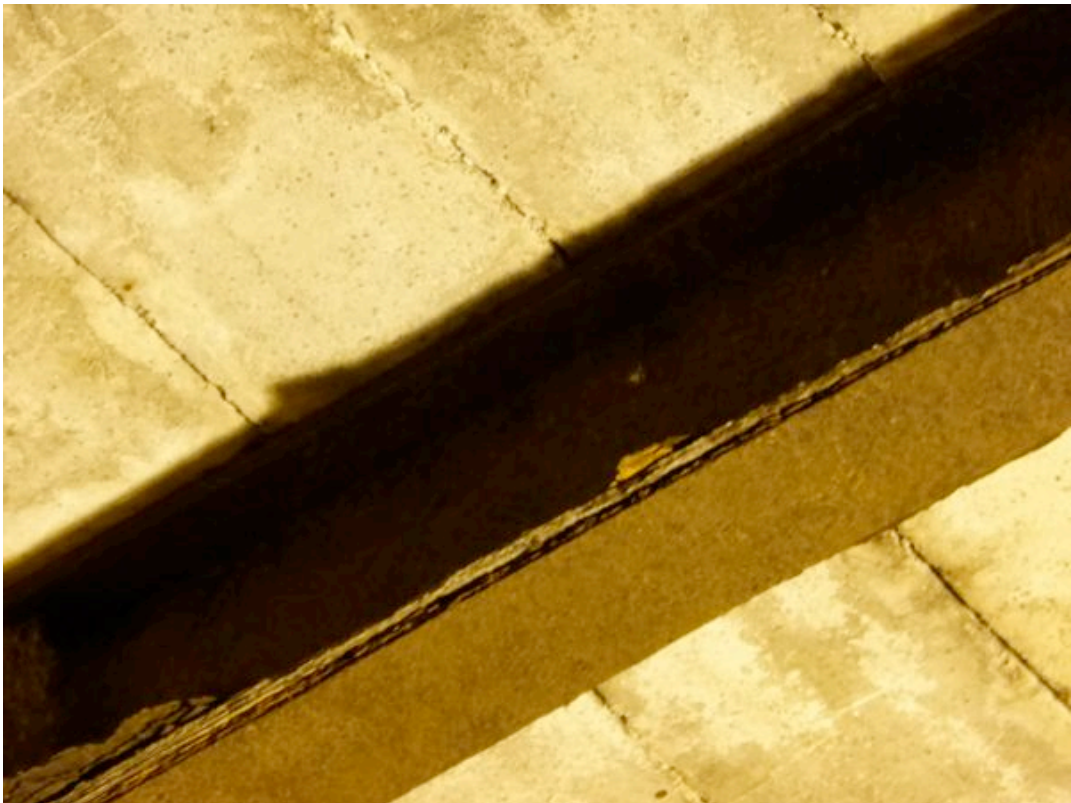
Of greatest concern however is the Winding House roof. The exposed steel beams are very corroded and large flakes of rust from the webs are lying on the flanges. The south end of one of the beams has corroded right through in places on its bottom flange.

Corroding Roof Support Beam

The Winding House roof needs urgent replacement. It is not practicable to repair it in-situ because the steel beams need to be replaced and they must be located in the same place as the existing, because the concrete planks span from one to the next. The concrete condition is more difficult to assess from ground level, but if the beams are to be replaced the concrete will have to be renewed too.

The roof should be propped with scaffolding as an interim measure and public access should not be allowed to this part of the building.

A close inspection should be made from a hydraulic access platform, which, if the cage was moved from the ground floor, could be located so as to enable an

inspection to be made of the underside of the roof and the upper steelwork. This would enable the condition of the roof support beam to be confirmed.
