Structural Appraisal

St Hilda's Colliery South Shields

Tyne and Wear Building Preservation Trust

**October 2014
Project Reference: Q117**

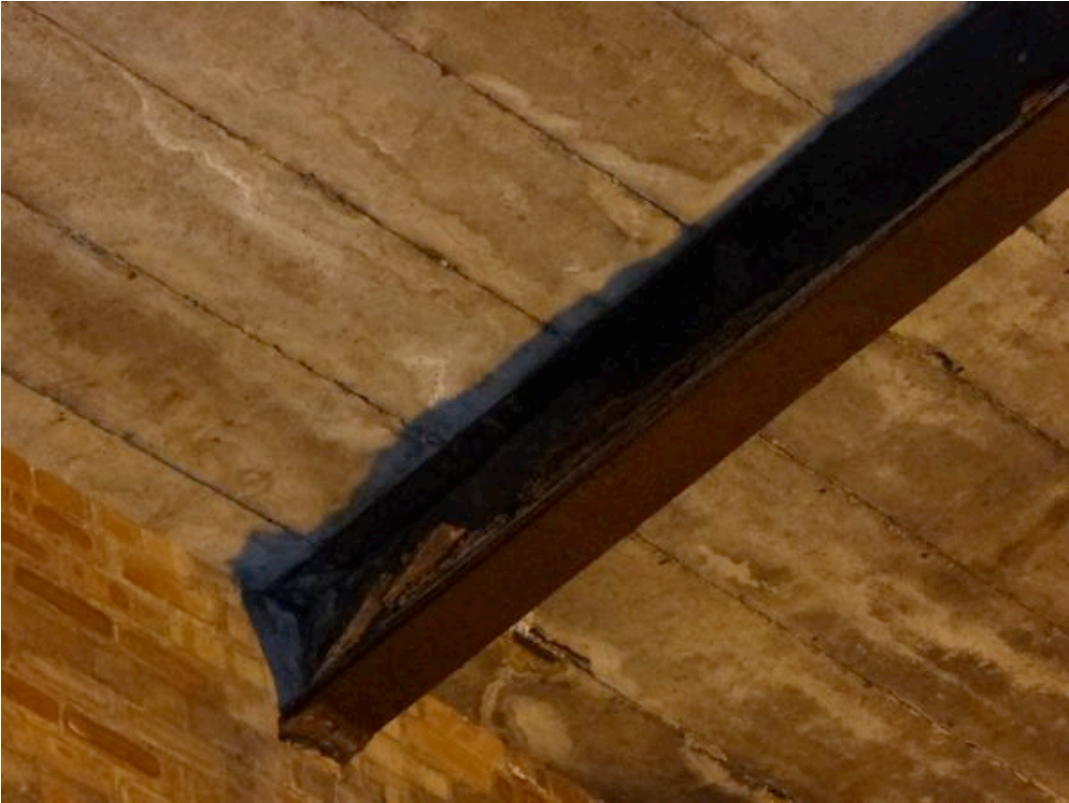
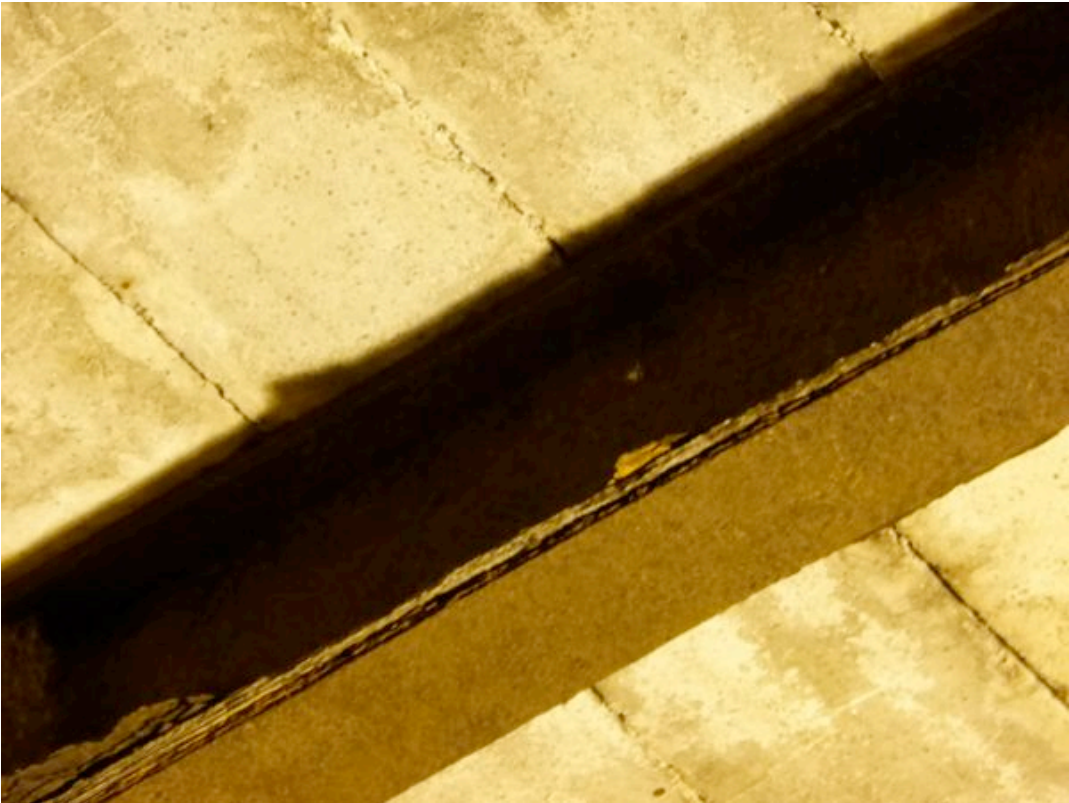
Of greatest concern however is the Winding House roof. The exposed steel beams are very corroded and large flakes of rust from the webs are lying on the flanges. The south end of one of the beams has corroded right through in places on its bottom flange.

Corroding Roof Support Beam

The Winding House roof needs urgent replacement. It is not practicable to repair it in-situ because the steel beams need to be replaced and they must be located in the same place as the existing, because the concrete planks span from one to the next. The concrete condition is more difficult to assess from ground level, but if the beams are to be replaced the concrete will have to be renewed too.

The roof should be propped with scaffolding as an interim measure and public access should not be allowed to this part of the building.

A close inspection should be made from a hydraulic access platform, which, if the cage was moved from the ground floor, could be located so as to enable an

inspection to be made of the underside of the roof and the upper steelwork. This would enable the condition of the roof support beam to be confirmed.
