**BUILT HERITAGE RECORDING OF
MILL DAM WALL,
HARTON QUAY,
SOUTH SHIELDS,
TYNE AND WEAR**

PCA REPORT NO: R14457

MARCH 2021

PRE-CONSTRUCT ARCHAEOLOGY

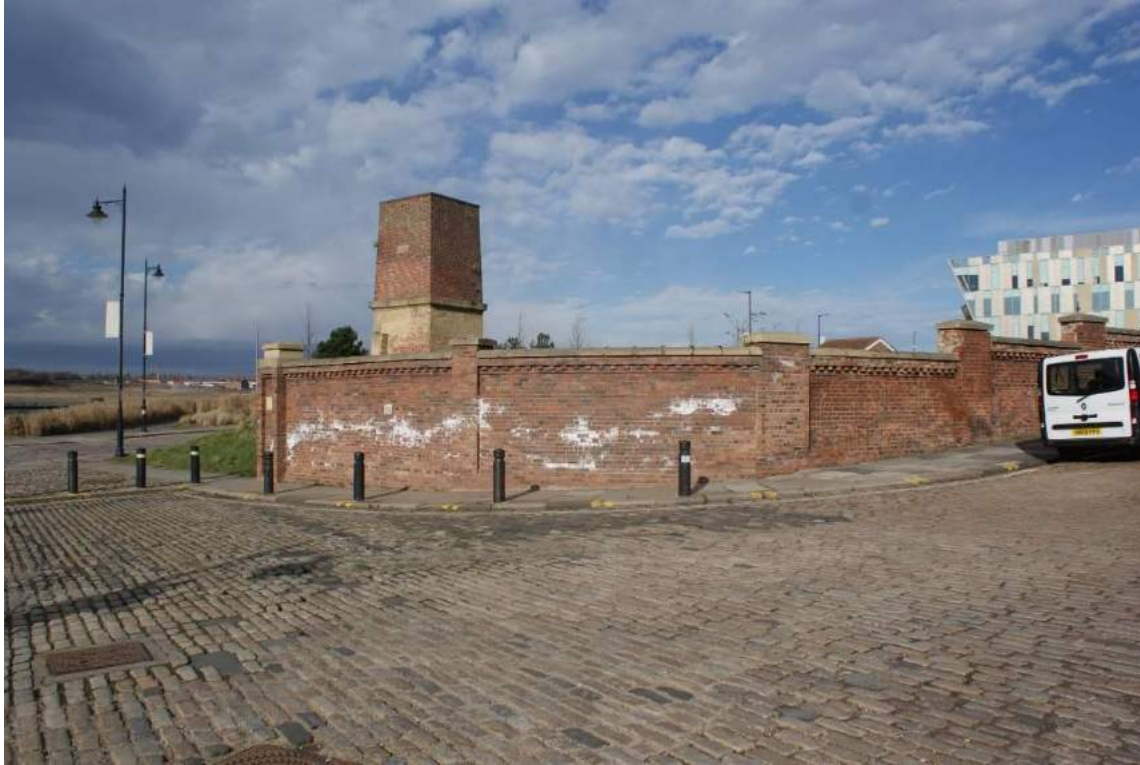
Plate 1 Mill Dam Wall, Rebuilt southern end of wall, looking north-west

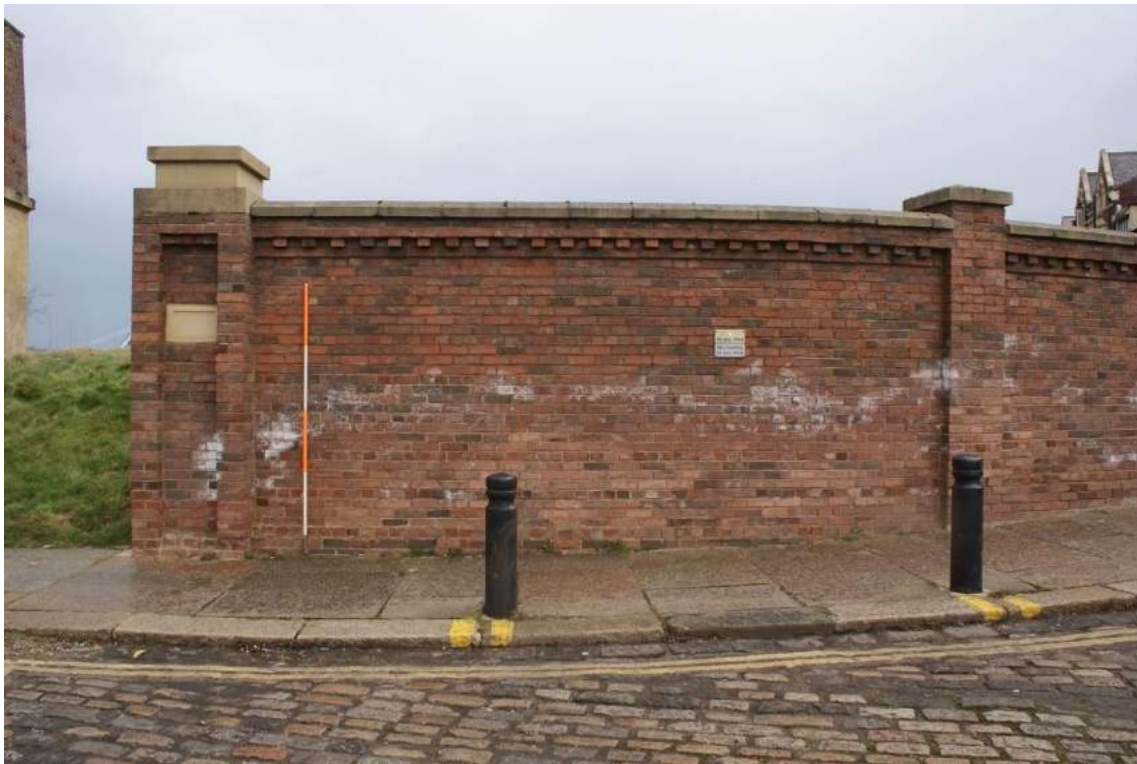
6.3.1 The southern wall section A is a modern replica wall built in the same style as the historic wall. Extending for two bays and comprising three piers and two wall panels, it adopts the same English Garden Wall brick bonding and a similar pier and panel construction as the rest of the wall (**Figure 10; Plates 1, 2 and 8**). Unlike the historic wall, it incorporates a dentil course to both its fair and internal elevations, the latter also built with recessed wall panels. A heavier-built pier (c.900mm) capped with an ornate fake stone pyramidal coping, forms the terminal to the southern end of the wall. The character of the wall supports the assertion that this section of wall was constructed during the 1980s.

Plate 8 Rebuilt southern wall (Section A1), looking north

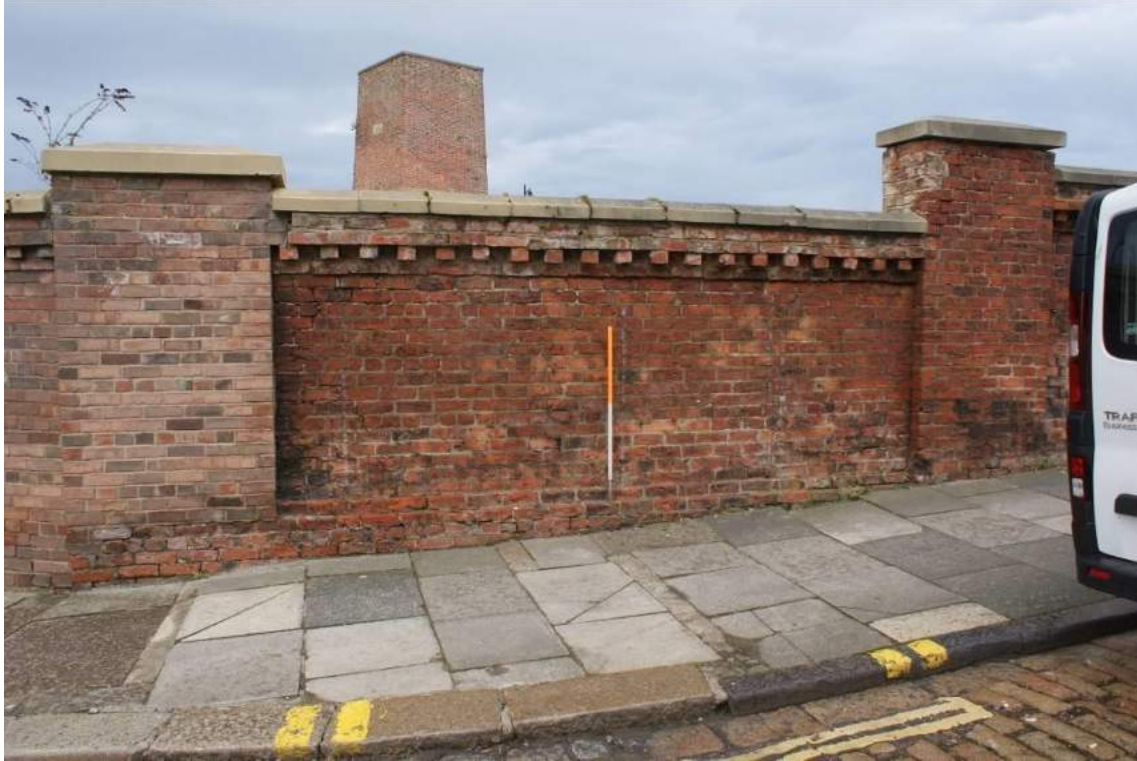
- 6.4.2 The southern pier to section B1 had been rebuilt as part of the reconstruction of the southern wall (section A), although four to five courses of the original brickwork survived at the base of the rebuilt pier (**Figure 11, Plate 9**). The brickwork to the half brick recessed wall panel survived in reasonably good order with a limited occurrence of brick spalling. The dentil course and brickwork above has been extensively rebuilt using a modern cement-based mortar. The rebuilding of the original dentil does not appear to be tied back into the pier to the north. The northern pier shows evidence of mortar repair infilling an opening up in a joint along the south side. Generally, both wall and pier had been repointed using a sandy cement mortar, although evidence of the original lime mortar is still visible in some areas.

Plate 9 Wall section (B1), looking north-west

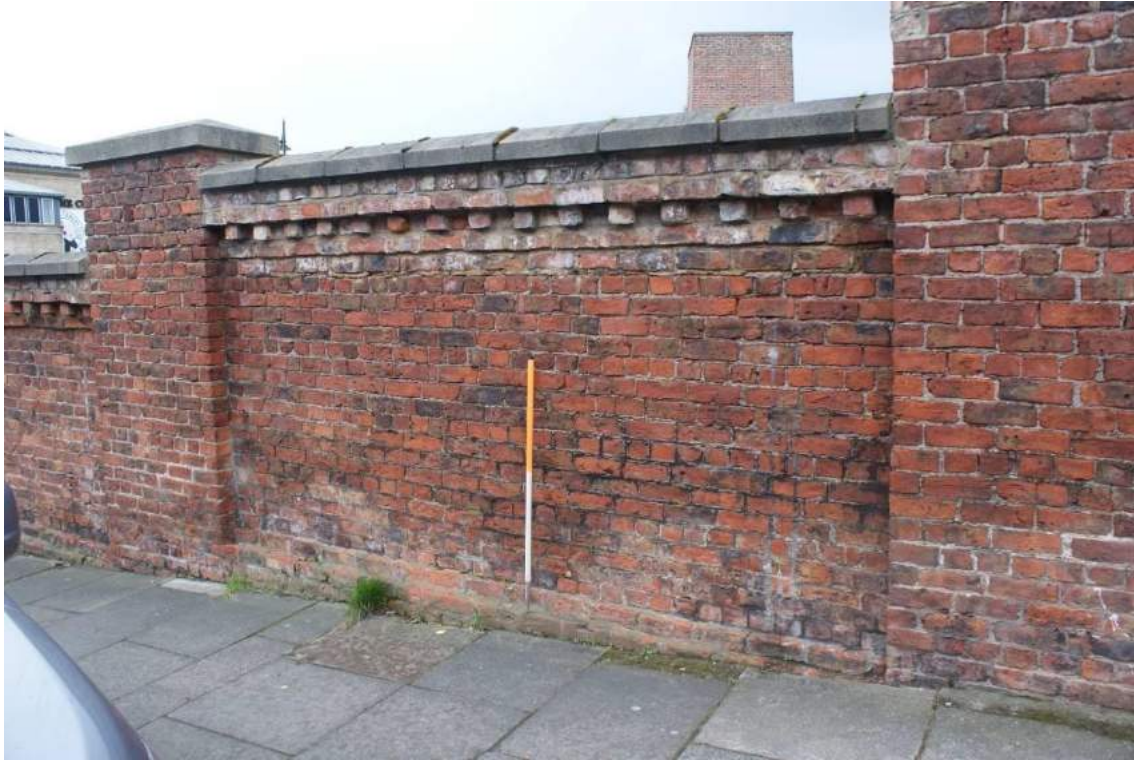
- 6.4.4 Section (B3) follows the same pattern, with a rebuilt upper part of the wall, comprising the upper five brick courses, including the brick dentil (**Plate 11**). In fact, the upper two brick courses of the adjacent pier to the north have also been rebuilt using a similar brick, so it appears that the upper part of the wall and upper piers were rebuilt prior to the addition of the new copings. The brickwork to the wall panel is in good condition and as elsewhere retained evidence of penny struck pointing to the lime mortar.

Plate 11 Wall section (B3), looking west

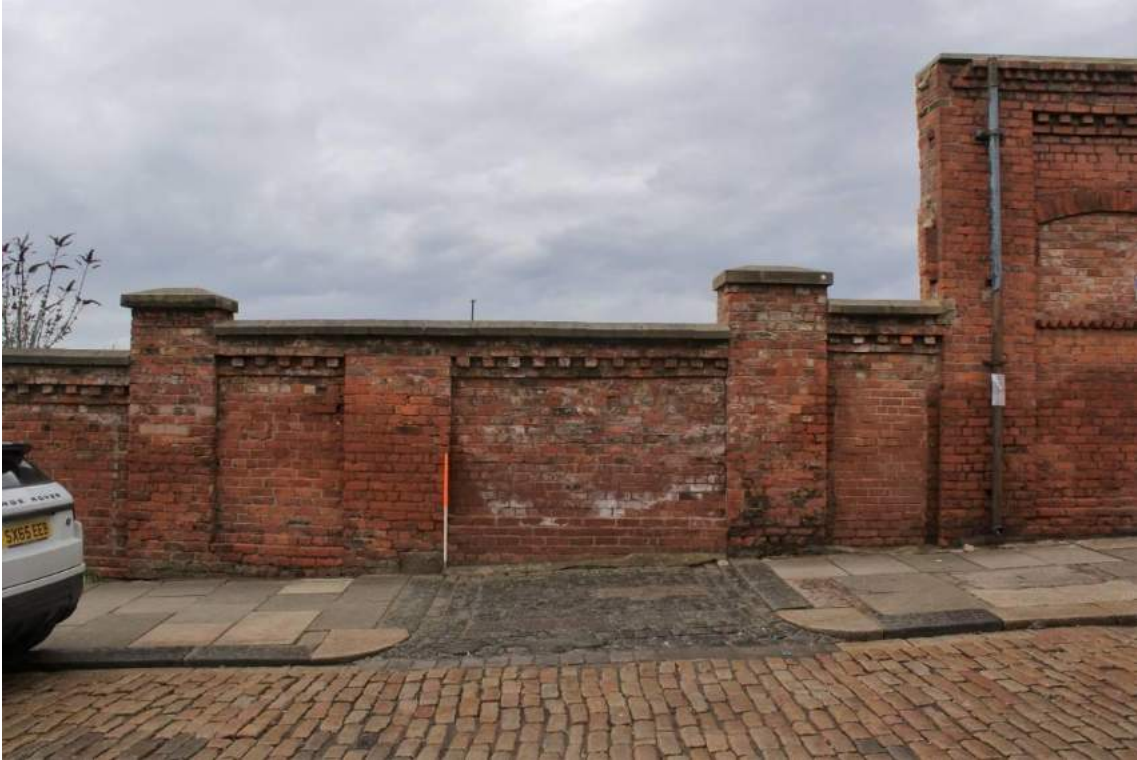
- 7.7 The lower part of the southern wall section (B) primarily survives as built, retaining evidence of its original appearance such as penny struck pointing to the mortar joints. However, the top of the wall in section (B) had been rebuilt, both repairing the wall (following the removal of the southern range; **Historical Plate 1**) and preparing its upper courses for the modern copings. No evidence of an original or earlier wall coping, if they did exist, was present. The carriage entrance in (B8) was clearly part of the wall's original construction and not a later insertion, evidenced by both its structural relationships with the wall, the roadway (**Plate 16**) and appearance on the Ordnance Survey map of 1912 (**Figure 6**).

Plate 16 Former entranceway (B8) looking north-west

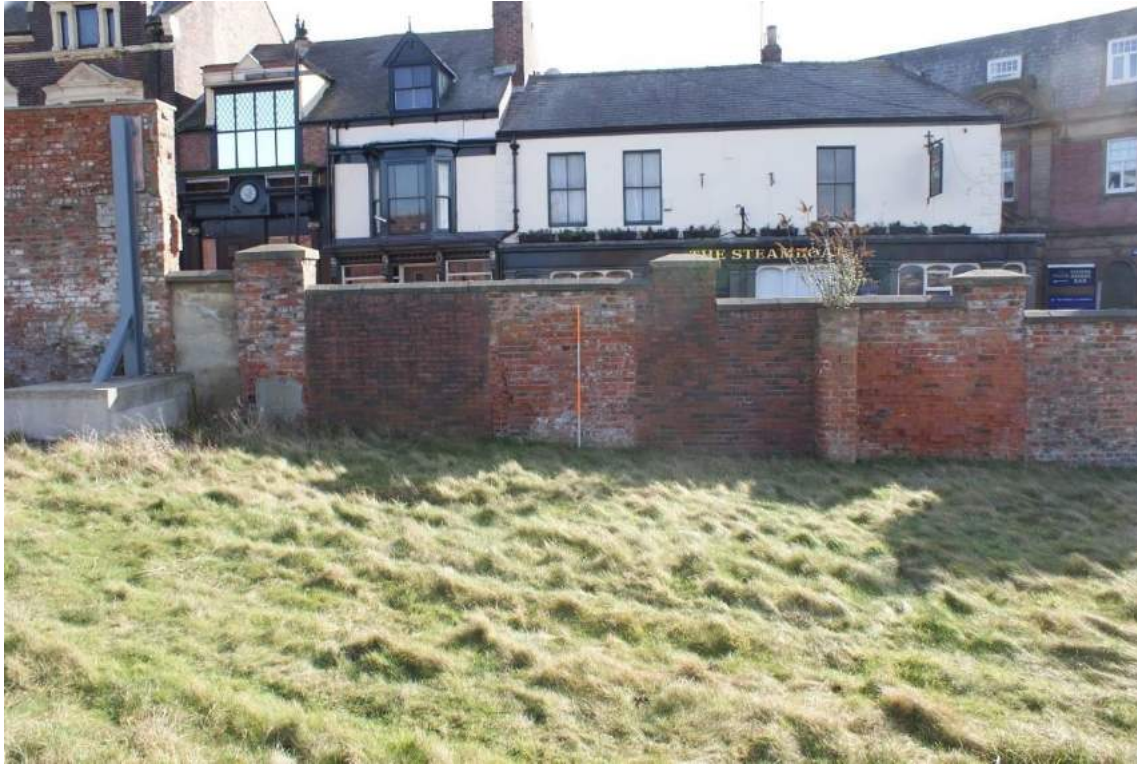
- 6.4.10 The next section of wall to the south represents the blocking of the carriageway opening described above (B8). It measures 2.61m in width and is built using dark red/purple, modern bricks laid in stretcher bond, with a header course below the coping. The next section to the south reverts back to the original wall, showing some instances of patch repairs and rebuilding along the upper part of the wall.

Plate 18 Blocked entranceway (B8) looking south-east

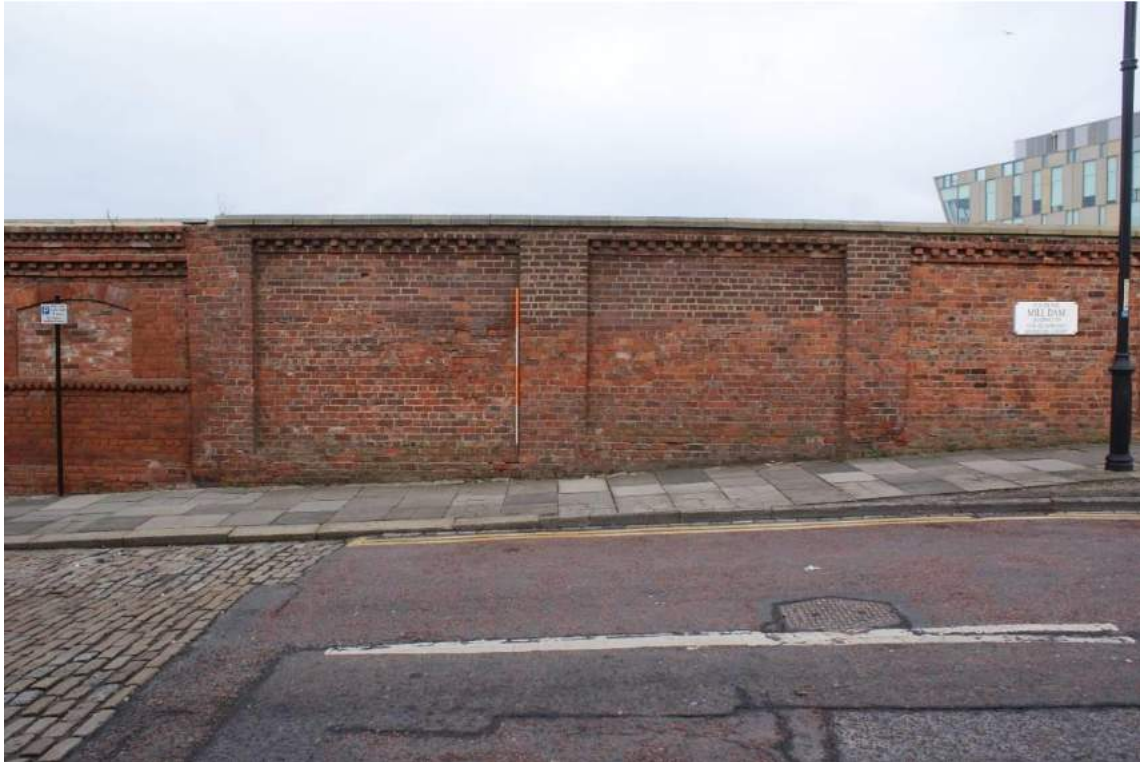
- 6.6.2 The southern two bays (D1 and D2) have both been considerably repaired and rebuilt at the same time (**Figure 13; Plate 27**). At its most extensive the rebuilding comprises the upper 15 brick courses and incorporates the upper section of the intervening pier (to this depth), the upper seven courses of the southern pier along its north side and the upper thirteen courses of the northern pier. This later brickwork is modern in appearance, using a hard brown/red machine-made brick, laid in cement mortar, in English Garden Wall and includes the brick dentil course. The original brickwork survives across the lower wall to both bays. It adopts the same brick and bonding characteristics as described for the walls in sections B and C. The most obvious departure is the piers which do not project above the wall line but are built as pilasters, framing the recessed wall panels.

Plate 27 Wall Sections (D1 and D2), showing rebuilding to top of wall, looking north-west

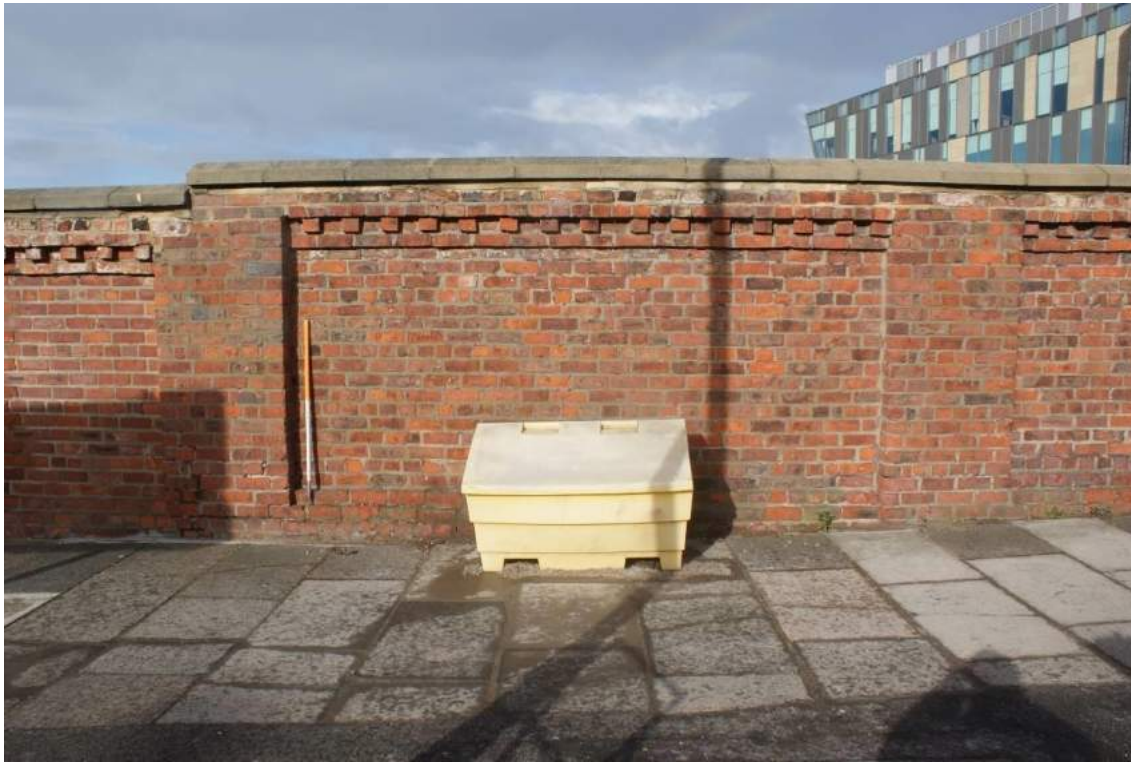
- 6.6.6 The next two bays (D7 and D8) form the last two historic bays of the wall at the northern end (**Figure 13; Plates 31 and 32**). At the junction of bay (D6) and (D7) the wall steps up in height by at least two brick courses, again a response to the slight gradient falling away to the south (**Plate 31**). These two bays (D7 and D8) follow the built characteristics already noted. The top of the wall above the dentil course has been rebuilt in preparation for the modern copings and the wall panels and piers

Plate 31 Wall Section (D7) looking north-west

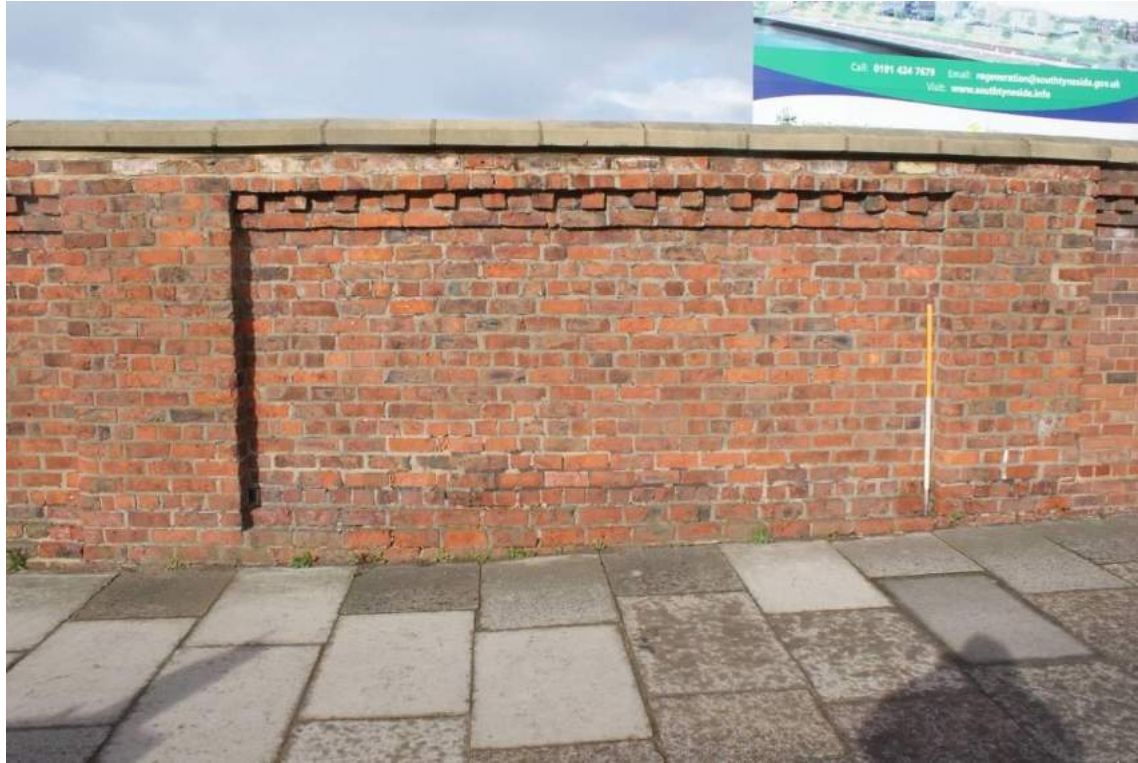
Plate 32 Wall Section (D8) looking north-west

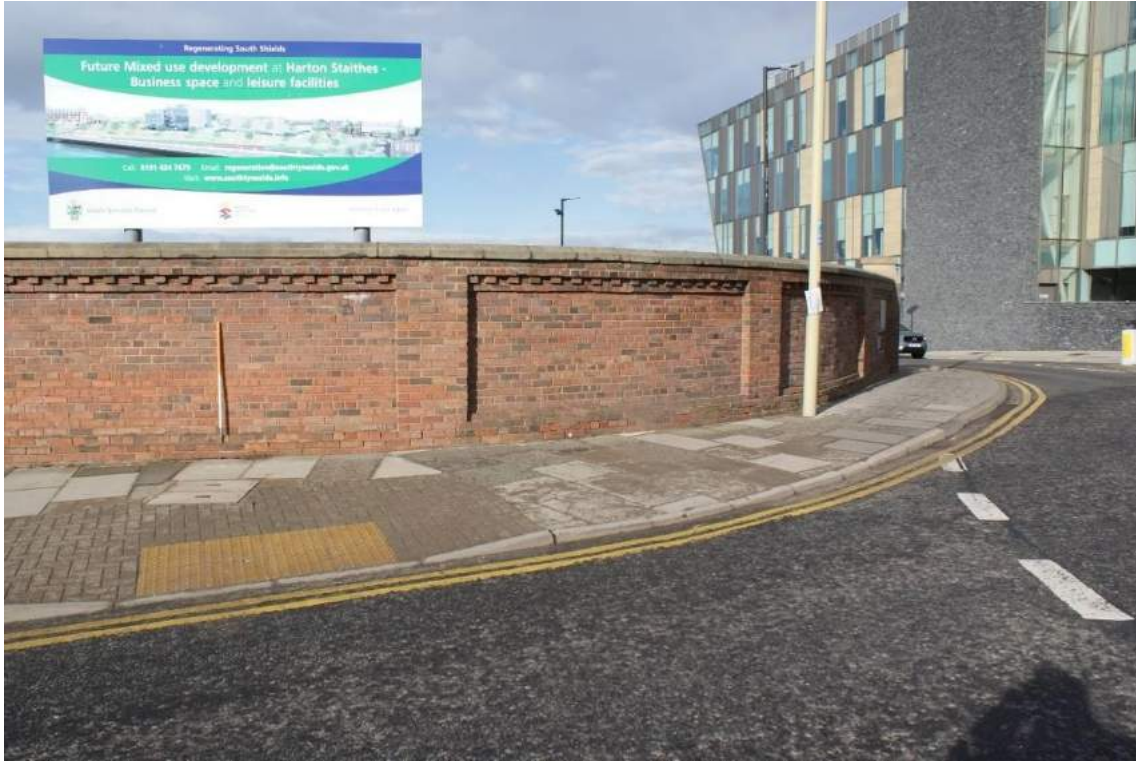
Plate 34 Rebuilt northern section (E), looking north-west

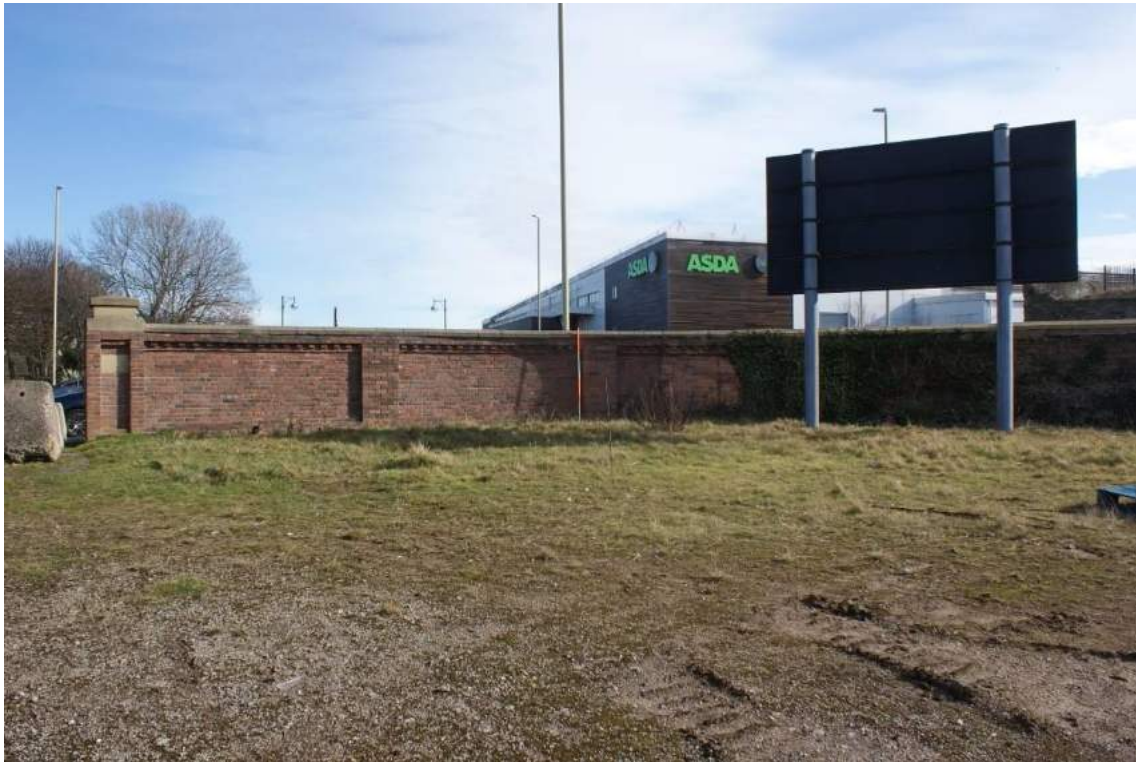
Plate 35 Rebuilt northern section (E), looking north-east
