# Harton Quays, South Shields, Tyne and Wear.

## Historic Wall Survey

Curtins Ref: 076755-CUR-XX-XX-RP-S-00101

Client Name: Muse Developments Ltd

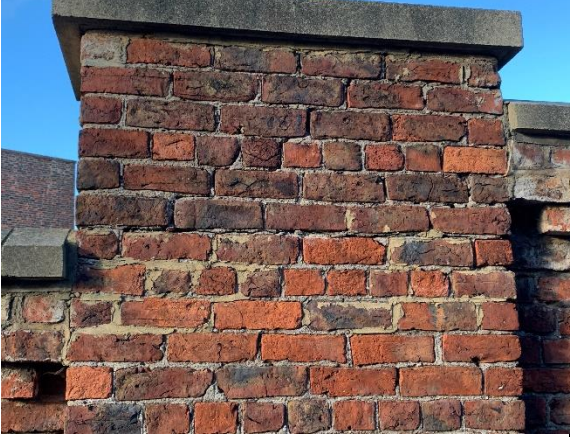
- A diagonal crack in masonry pier was observed near the head of the pier, some mortar loss and local repointing was also evident. This pier was located towards the western end of this section of wall. (Refer to Photograph 2 in Appendix A)

<p><b>Photograph 1:</b> <i>Wall Section 1, Replica of historic wall.</i></p>	<p><b>Photograph 2:</b> <i>Wall Section 2 diagonal crack to masonry pier</i></p>

- We recommend that the cracks in the front facing façade of the wall are re-pointed with a lime-based mortar. Similarly, areas of missing mortar to joints should be repointed with a lime-based mortar. Repairs to the front facing façade of the wall will likely require consent from the local conservation officer. See Appendix C for the Conservation Officer's repair specifications.

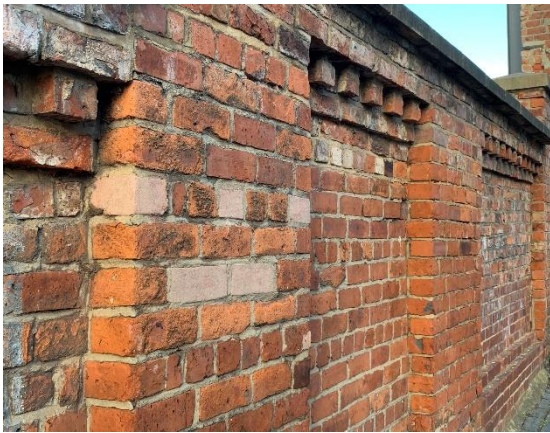
**Photograph 5:** *Wall section 2 replacement bricks*

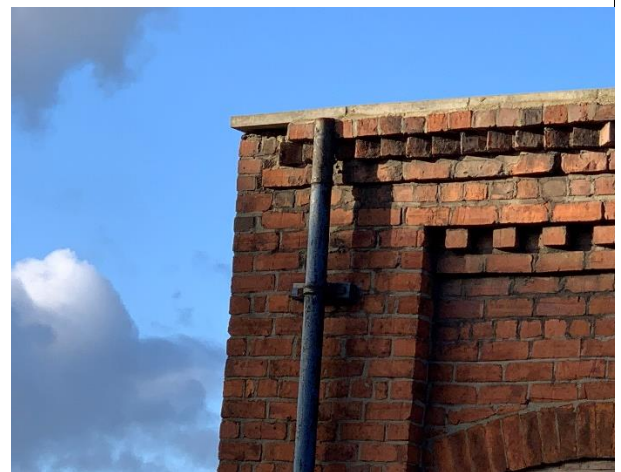
- The head of the wall now includes concrete coping where the eaves gutter would have been. The end coping has missing mortar and missing brickwork below it. (Refer to photograph 8 in Appendix A)

**Photograph 8:** *Wall Section 3, loose / missing mortar to coping.*

- There was one very large coping stone to a pier along section 2 of the wall. Mortar loss to this pier should be replaced.
- The coping stone to the high-level section of the remaining façade to Staiths house should be cut back or removed and replaced so that does not overhang the missing dental masonry directly below. (See Photograph 8 in Appendix A).

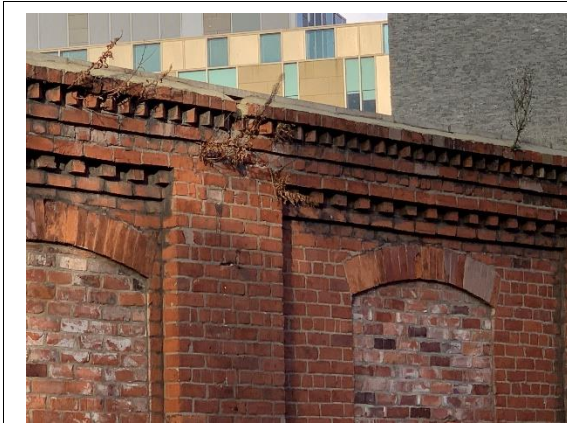
- Vegetation was observed growing out of some areas of dental work masonry at the head of this wall. (Refer to Photograph 9 in Appendix A)
- Some missing mortar was observed to the piers. This was not extensively but just some small localised areas. (Refer to Photograph 10 in Appendix A)

**Photograph 9:** *Wall Section 3, vegetation growing for the old gutter position at the wall head.*

- Vegetation growing along the back of the wall should be removed. If these were left in place the roots would expand and cause more mortar to be dislodged. Similarly, vegetation should be removed from the pier along wall section 2 and from the façade of wall section 3 (Staiths House Façade).

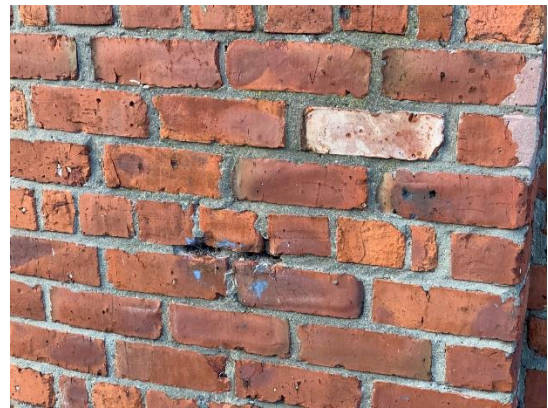
**Photograph 10:** *Wall Section 3, mortar loss to joint.*

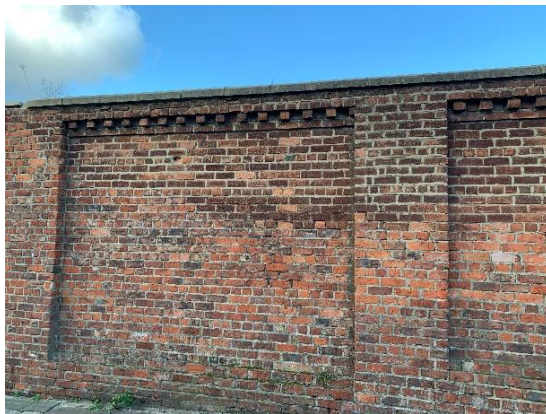
**Photograph 11:** *Wall Section 4, top section of wall has been re-built with brickwork to try and match original brick.*

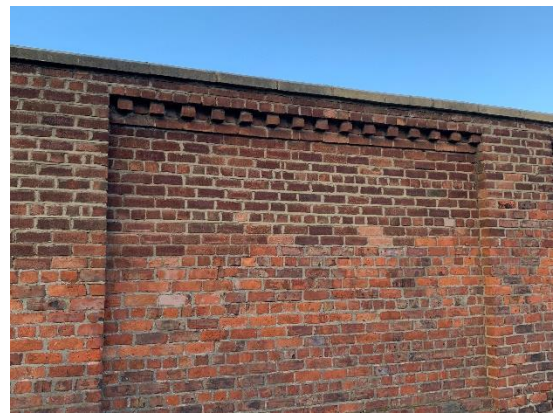
**Photograph 12:** *Wall Section 4, top section of wall has been re-built with brickwork to try and match the original brick.*

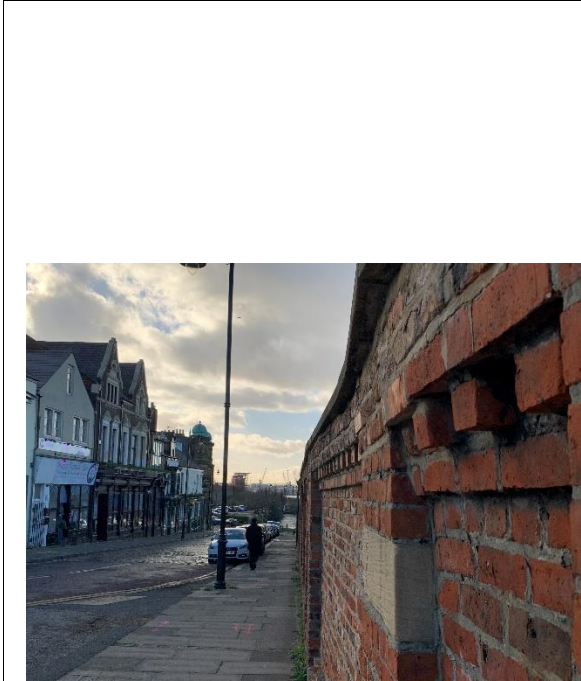
- A section of the wall appeared to be misaligned at the head and curve inwards towards the site. At this location the masonry pier appears to incorporate a large stone padstone halfway up. inspection from the rear also shows a large stone padstone with corroded steel hinge connected to it. The photographs taken to the rear of this area also indicated that masonry wall panel coursing is discontinuous with the masonry pier and does not appear to tooth into the pier. (Refer to Photographs 13 & 19 in Appendix A)

- There was a length of wall along section 4 that appeared mis-aligned and leaned out approximately 75-80mm at the top. There did not appear to be any cracking to this wall suggesting that it was in distress. It may be that the wall had previous been damaged and had been re-built locally, however the building tolerance may not have been maintained which is why the wall appears mis-aligned at this point. Given the wall is 500mm thick and the wall lean is only 75-80mm the centre of gravity of the wall still remains within its middle third suggesting that it is stable in its current condition.

**Photograph 13:** *Wall Section 4, mis-alignment the wall at the head..*

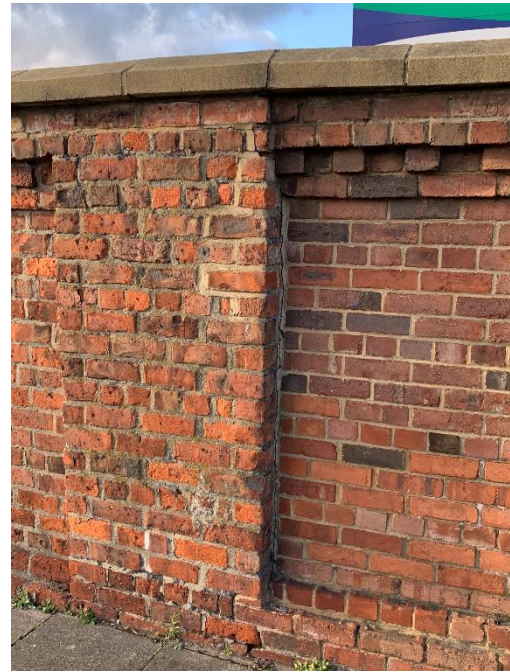
**Photograph 14:** *Wall Section 4&5, mortar repair to joint and butt joint between masonry types.*

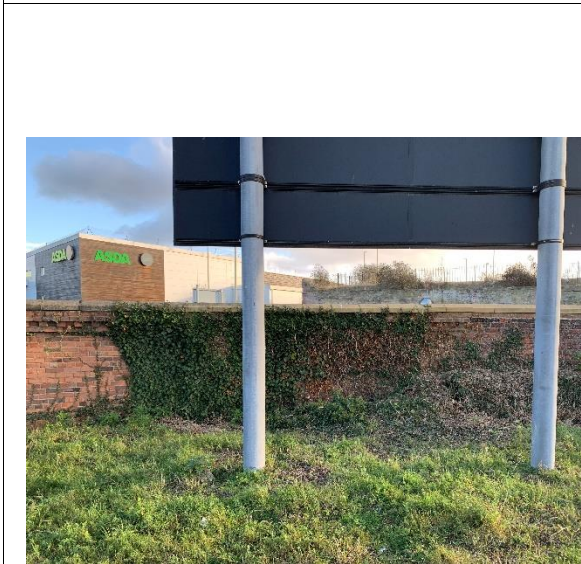
- This section of wall is similar to section 1 in that it is a new build extension to the original historic wall built to replicate the existing. This wall appeared in good condition with obvious signs of defects.
- Vegetation growth was observed growing up the rear face of the wall. (Refer to Photographs 15, 16 & 17 in Appendix A)

**Photograph 15:** *Wall Section 4 & 5, vegetation growth to rear of wall.*

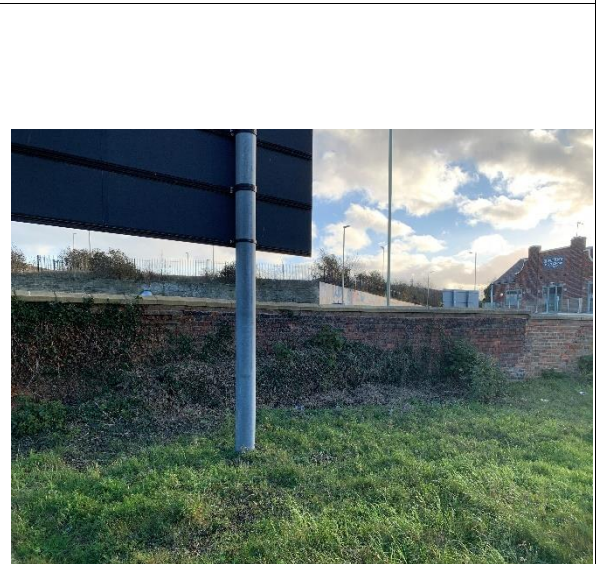
**Photograph 16:** *Wall Section 4 & 5, vegetation growth to rear of wall.*

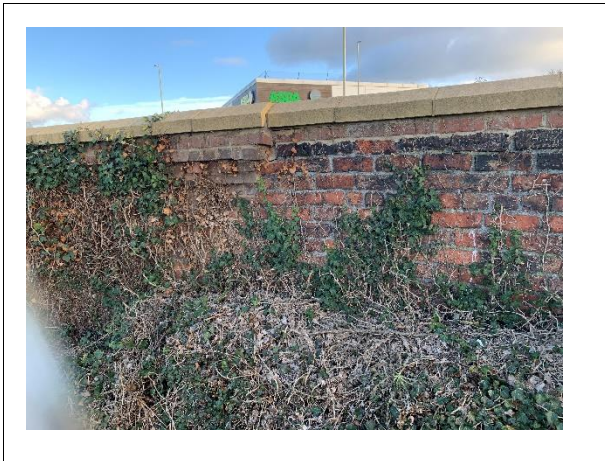
**Photograph 17:** *Wall Section 4&5 junction with, vegetation growing up the rear face.*

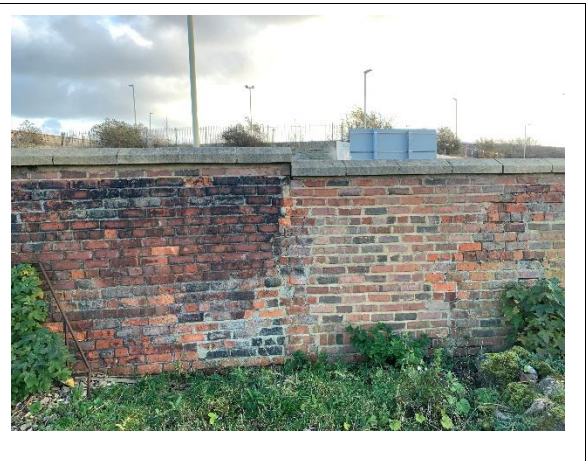
**Photograph 18:** *Wall Section 4, Repair to rear of wall with different brickwork.*

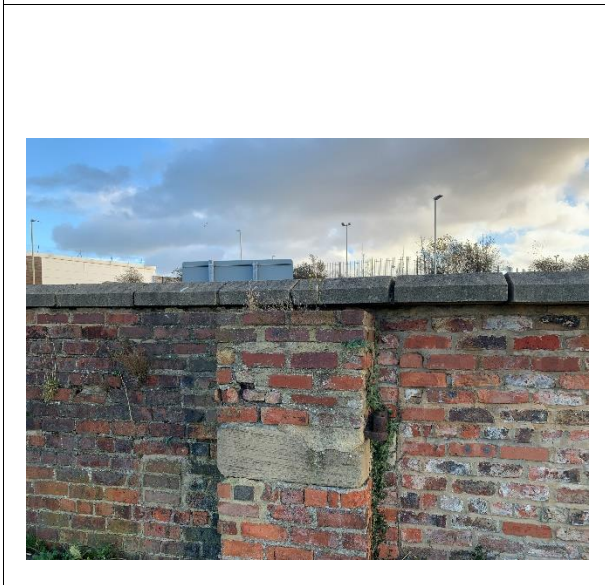
The coping along this length of wall had missing mortar to the underside.

- Vegetation was observed growing out of the rear face of this section of wall. (Refer to Photograph 19 in Appendix A)
- Other sections to the rear of this section wall appeared to have mixed masonry panels suggesting that over the year's sections of the rear leaf of masonry have been repaired and rebuilt. (Refer to Photograph 18 in Appendix A)
- There was some evidence of diagonal cracking to the rear wall section 4. (Refer to Photograph 20 in Appendix A)

**Photograph 19:** *Wall Section 4, missing mortar to underside of copings..*

- There were several coping stones with mortar missing, we recommend that that the coping stones have any loose mortar raked out and replaced with new mortar to match the existing. This mortar should be a lime-based mortar and will likely require consent from the local conservation officer. See Appendix C for the Conservation Officer's repair specifications.

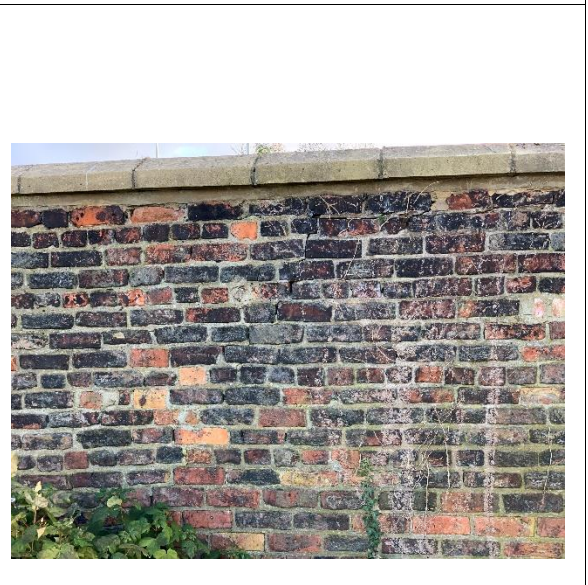
**Photograph 20:** *Wall Section 4 rear.*

- Cracks and mortar loss from joints along the rear of the wall should be re-pointed with a lime based mortar. This again is likely to require consent from the local conservation officer. See Appendix C for the Conservation Officer's repair specifications.

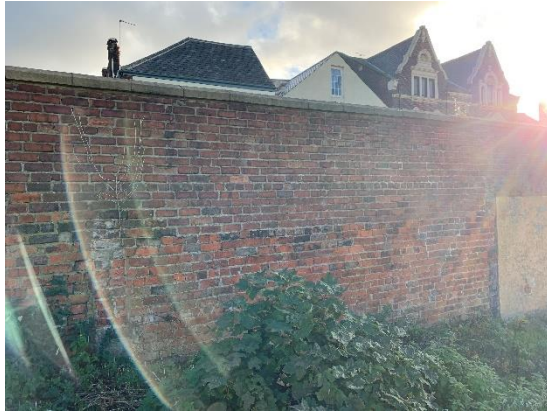
different colour of brickwork at higher level suggesting the upper section of the wall may have been re-built / repaired at some stage. (Refer to Photographs 21 & 22 in Appendix A)

**Photograph 21:** *Wall Section 4, Rebuilt at high level to the rear.*

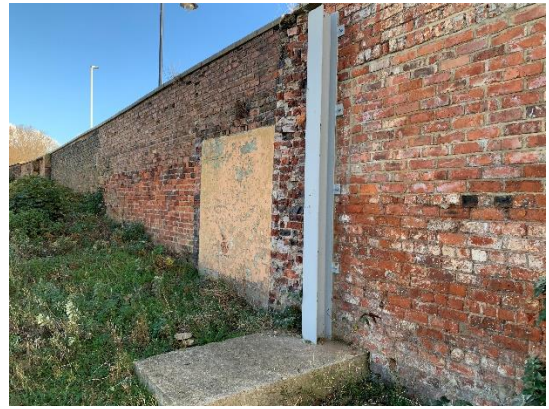
**Photograph 22:** *Wall Section 3, restraint post to rear.*

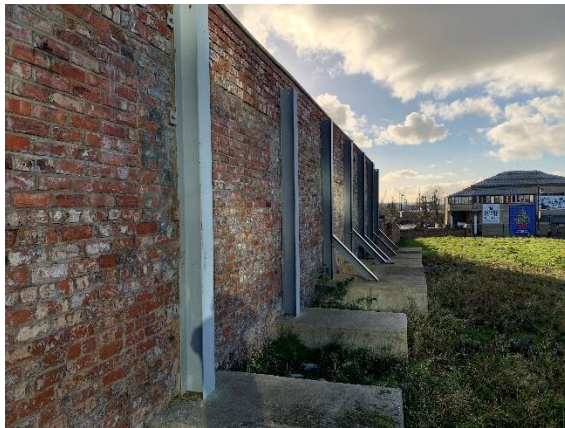
- The increased height of the historic wall along this section where it is the means of the Staithes House façade is higher than the other sections of the historic wall. Consequently, the rear elevation has steelwork restraint posts fixed to the masonry wall and supported on concrete foundation behind. (Refer to Photographs 23 and 24 in Appendix A)

**Photograph 23:** *Wall Section 4, restraint posts and infill masonry to windows.*

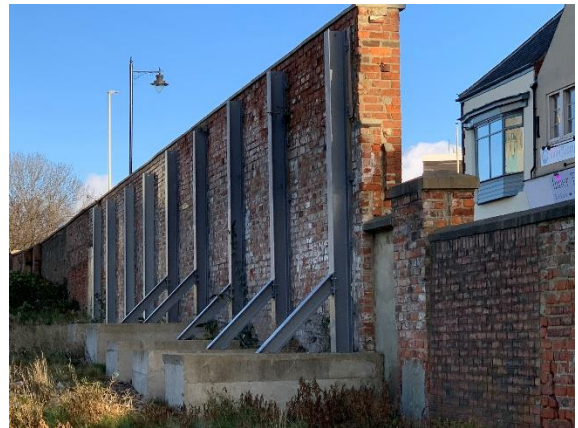
**Photograph 24:** *Wall Section 4, restraint posts.*

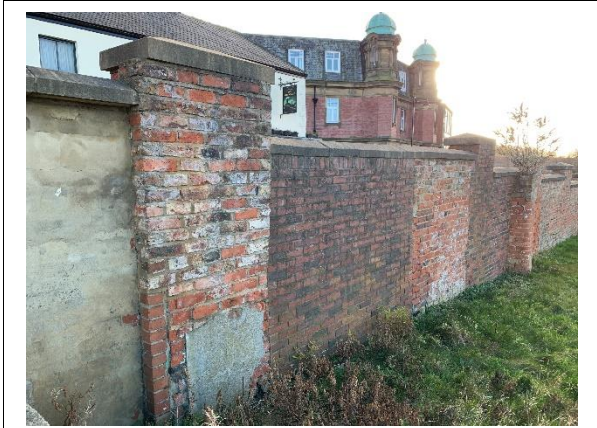
- The rear of the wall shows evidence of numerous repairs and re-building of sections. There is a short section near to the Staithes House façade that has been rendered. There are a couple of sections of masonry that look to be lot newer than the original Historic Wall condition suggesting parts of the rear leaf of masonry have been re-built. (refer to Photographs 25 & 26 in Appendix A)

**Photograph 25:** *Wall Section 2, rear face has been repaired and rebuilt in local sections. Joint not bonding through*

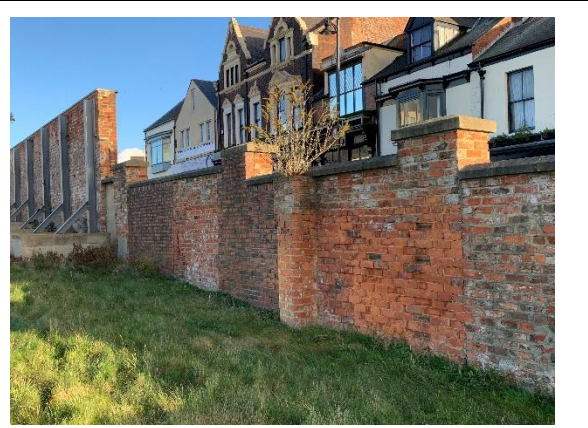
**Photograph 26:** *Wall Section 2, vegetation growth and local rebuild.*

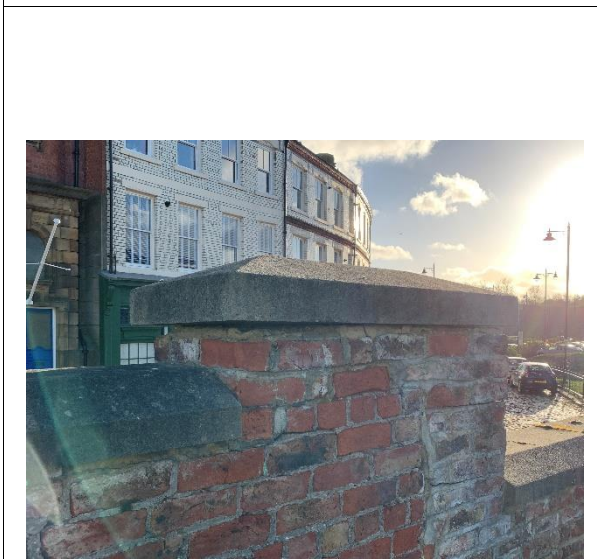
- The second pier away from the retained Staithes Façade has evidence of damaged bricks being replaced with new brickwork.
- Inspection the rear of this sections revealed missing mortar to a large coping above a masonry pier. The masonry to the rear of this pier also had evidence of a diagonal crack that had been repointed. Effervescence was also observed. (Refer to Photographs 27 & 28 in Appendix A)

**Photograph 27:** *Wall Section 2, missing mortar to coping and brick repair to pier.*

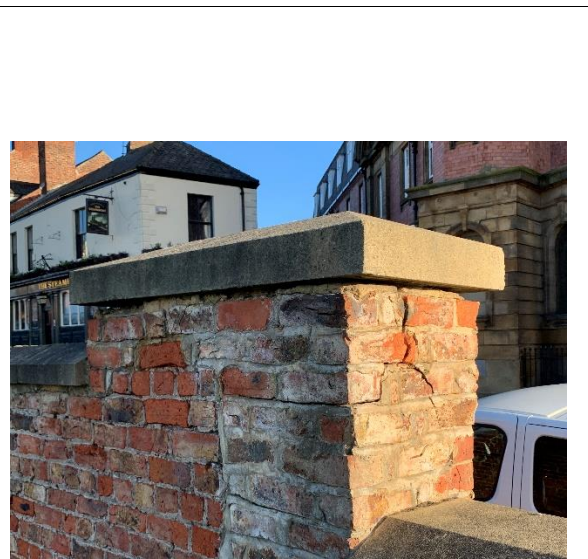
**Photograph 28:** *Wall Section 2, missing mortar to coping and brick repair to pier.*

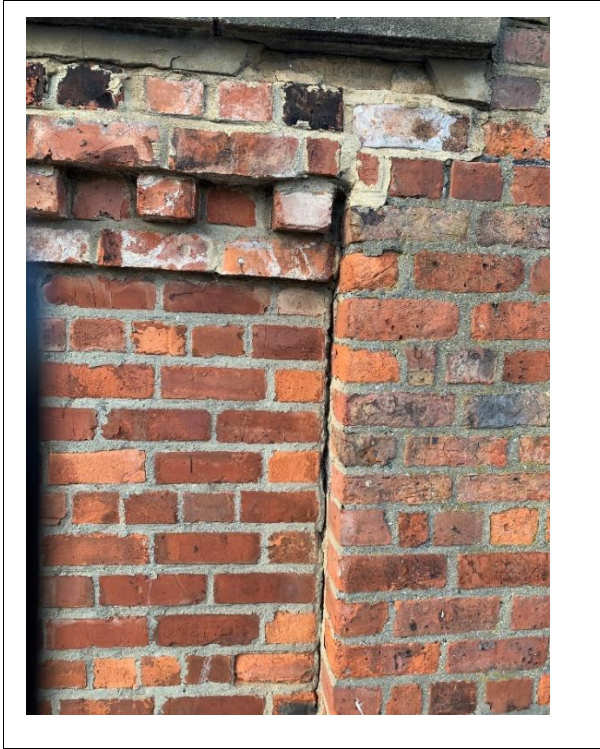
**Photograph 29:** Wall Section 2, No bond between infill panel and pier.

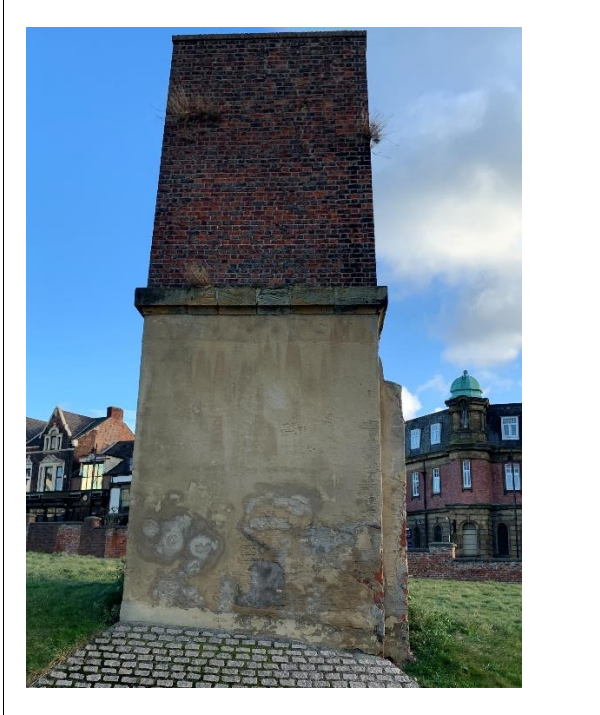
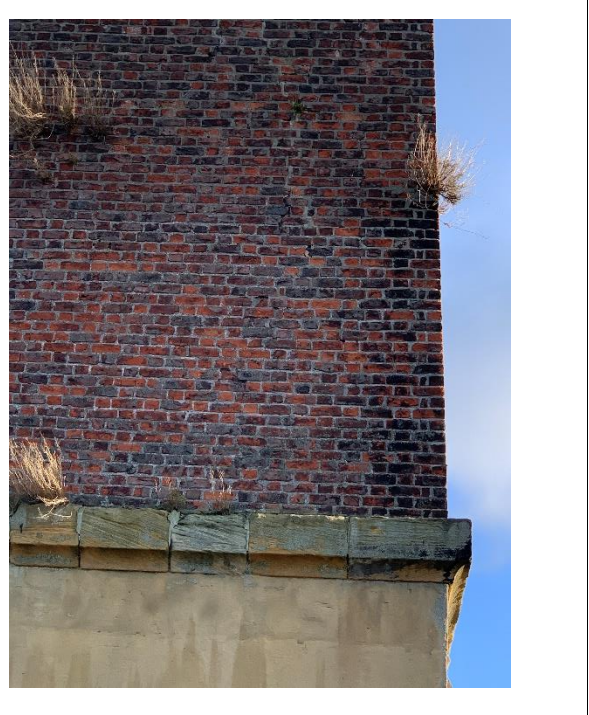
There was some evidence of a vertical crack in the chimney and this looked to have been pointed at some stage. (refer to Photographs 31 & 32 for North Elevation in Appendix A).

- The existing chimney appeared in reasonable condition given its age appeared structurally stable. The masonry was weathered, and mortar loss was observed to some joints. Vegetation growth was also observed in several masonry cracks and to the stone feature band. If the vegetation is left to grow, then the roots will expand and force more mortar to become dislodged from the joints. We therefore recommend that the vegetation is removed, and the joints re-pointed with a suitable lime based mortar that matches the existing. Some other joints will require re-pointing where mortar has also been lost. These remedial works to the chimney will require consent from the local conservation officer. See Appendix C for the Conservation Officer's repair specifications.

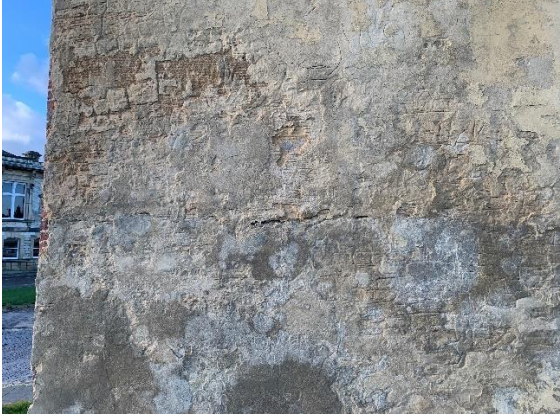
<p><b>Photograph 37:</b> <i>Chimney South Elevation</i></p>	<p><b>Photograph 38:</b> <i>Chimney South Elevation</i></p>

- The upper section of the west elevation appeared in reasonable condition for its age although it was heavily weathered with some mortar loss to joints. The lower section of wall has been rendered however most of this render had now been weathered and fallen off with 20% remaining on the wall. The render that remained was loose in several areas and could be dislodged with little effort. The brickwork now exposed by the loss of render appeared in reasonable condition given its age. (Refer to Photographs 33, 34, 35 & 36 for West Elevation in Appendix A)
- The south elevation had a horizontal crack in the render that appeared to emanate from the brickwork below. (Refer to Photograph 38 in Appendix A)

- The loose render to the west elevation of the chimney should be removed and the exposed masonry repointed where necessary as described above.
- The horizontal crack in the south elevation should have the render removed locally and mortar joint raked out and repaired. This should then be re-rendered to match the existing. This will also have to be agreed with the local conservation officer. See Appendix C for the Conservation Officer's repair specifications.
