Rev	Date	Dwn	Chk	Notes
DO NOT SCALE				
Project	Originator	Zone	Level	Type
WCRR - ASA	- XX	- RF	- DR	- A
				Role
				Number
				010

Suitability/S0	Revision/P01	Preliminary
Client	Wellesley Court	
Job	4502	Wellesley Court Roof Repairs
Content	Existing Roof Plan	
Date	07.07.20	Drawn PBN
Scale	1:100 @ A3	Checked WRA

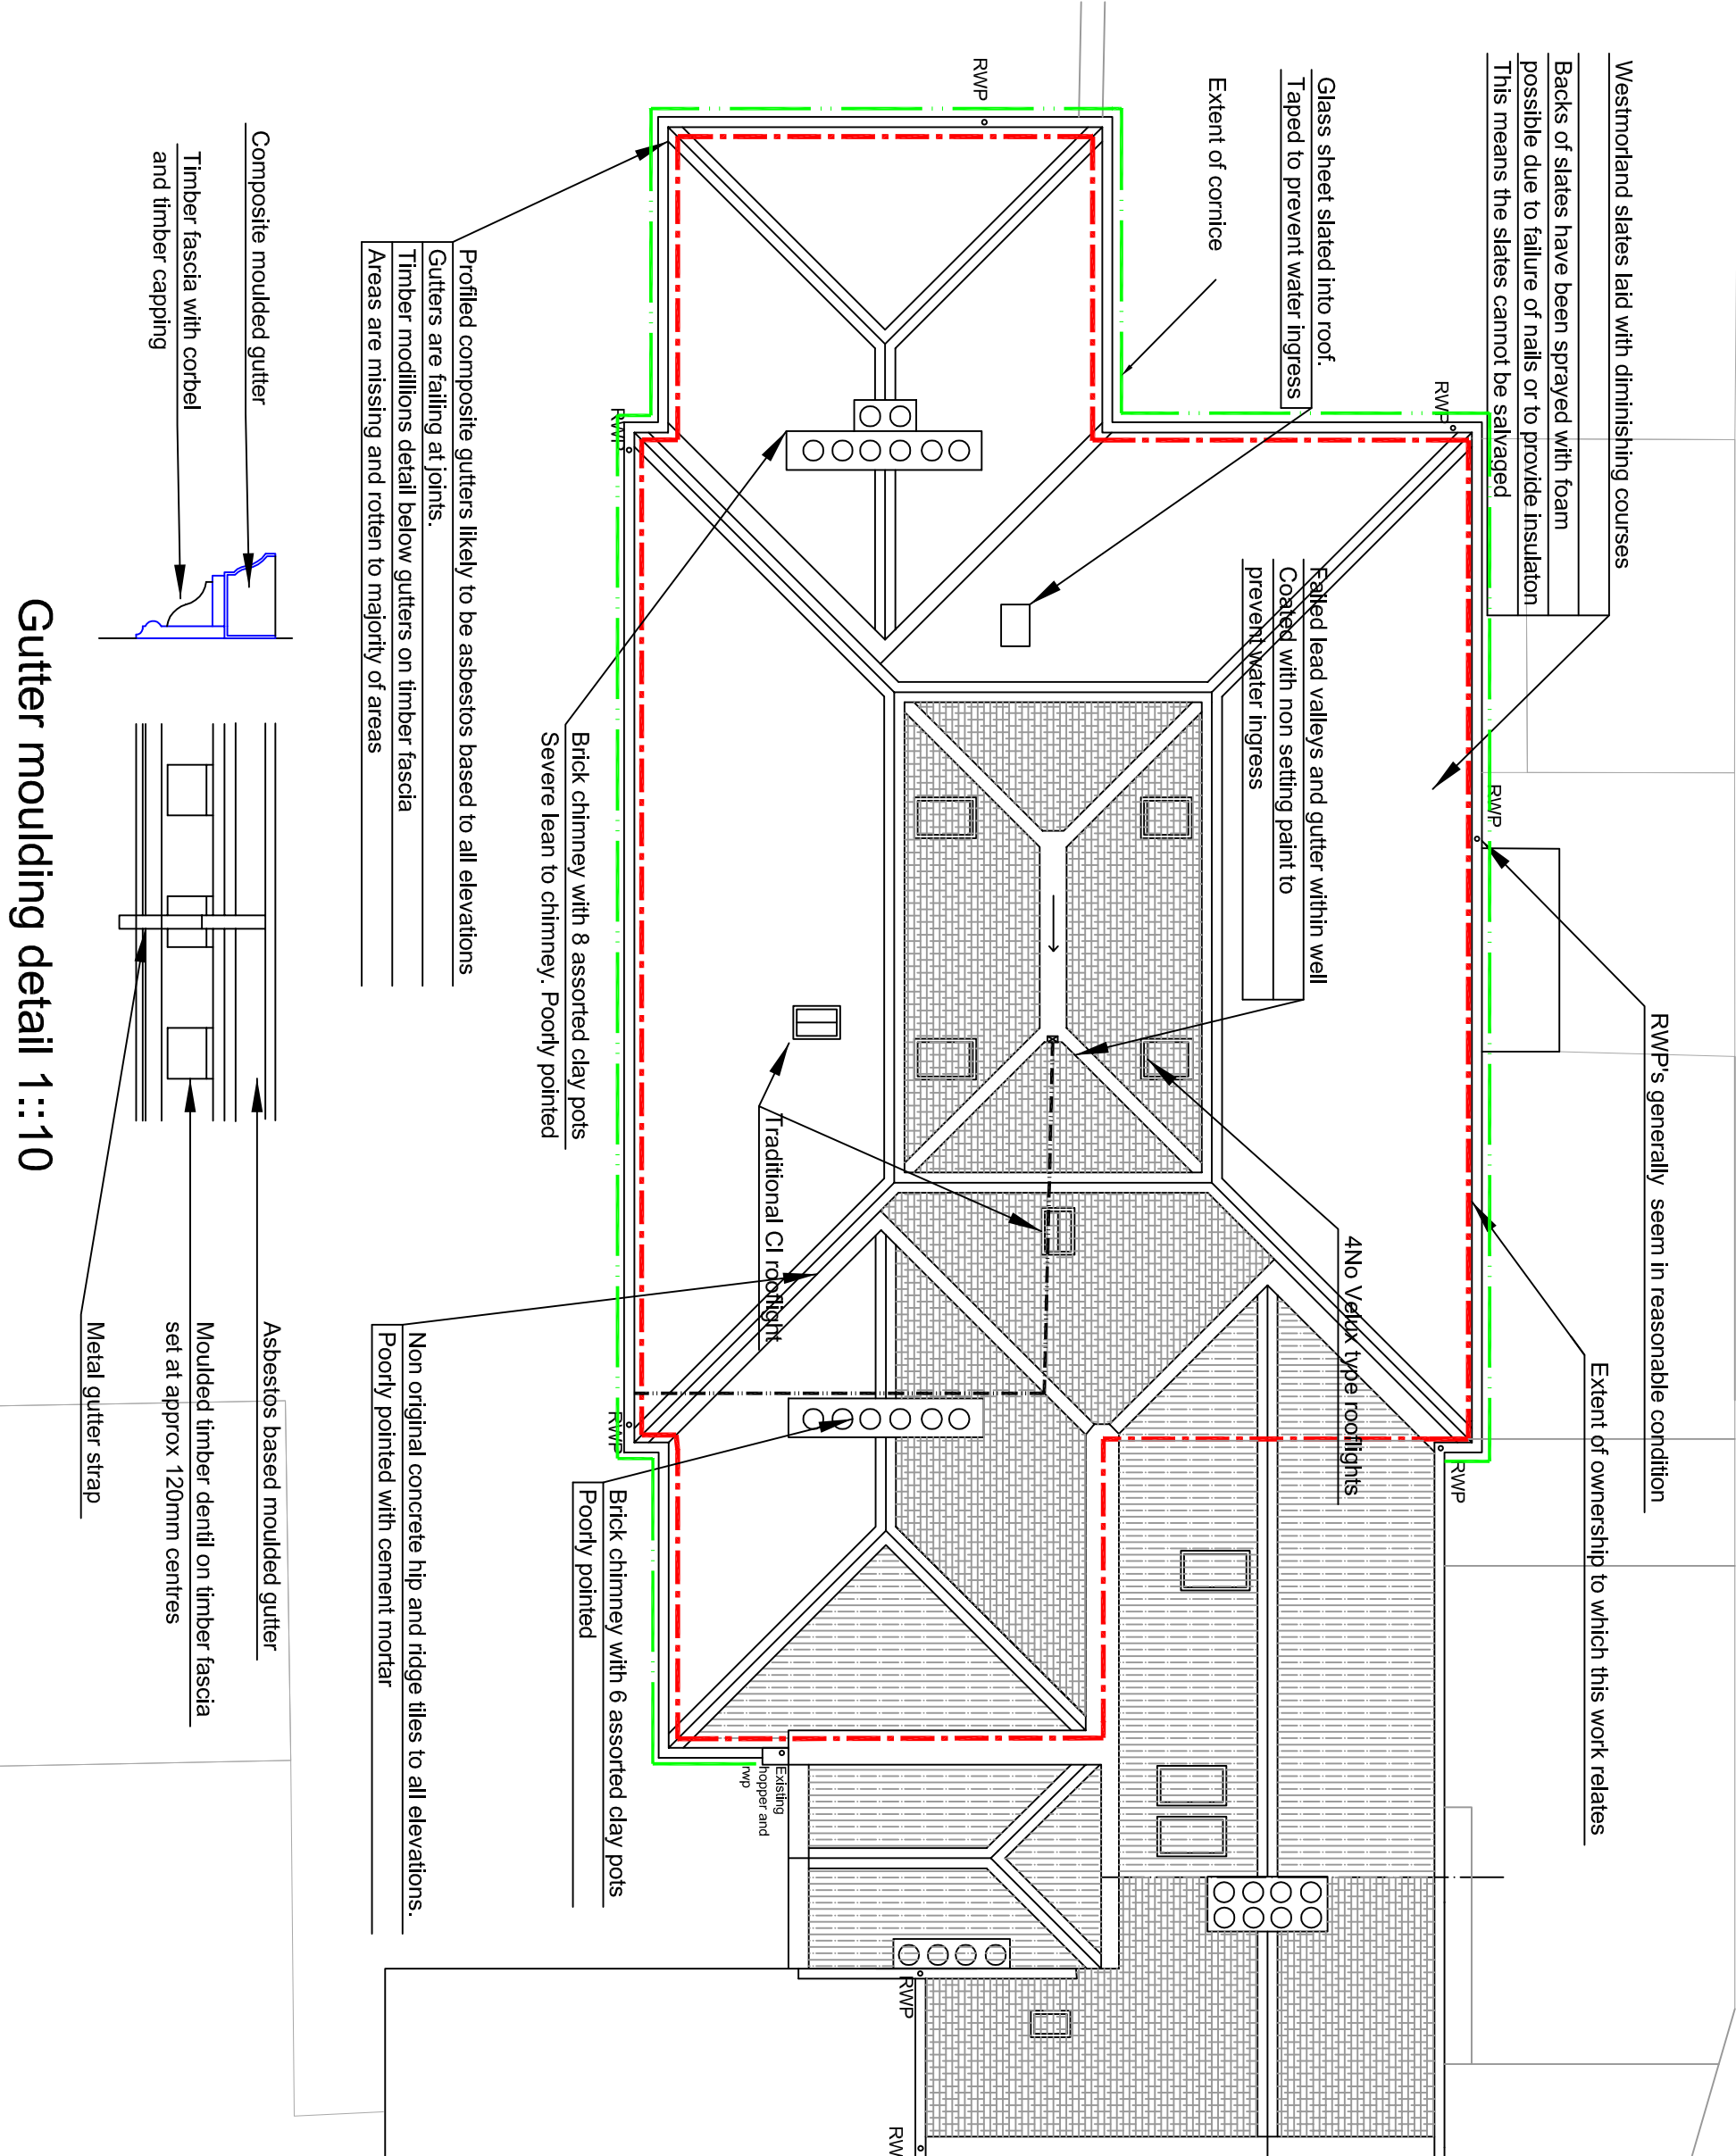
Westmorland slates laid with diminishing courses

Backs of slates have been sprayed with foam possible due to failure of nails or to provide insulation This means the slates cannot be salvaged

Glass sheet slated into roof. Taped to prevent water ingress

Failed lead valleys and gutter within well Coated with non setting paint to prevent water ingress

RWP's generally seem in reasonable condition

Brick chimney with 8 assorted clay pots Severe lean to chimney. Poorly pointed

Brick chimney with 6 assorted clay pots Poorly pointed

Profilled composite gutters likely to be asbestos based to all elevations
Gutters are failing at joints.
Timber modillions detail below gutters on timber fascia
Areas are missing and rotten to majority of areas

Non original concrete hip and ridge tiles to all elevations.
Poorly pointed with cement mortar

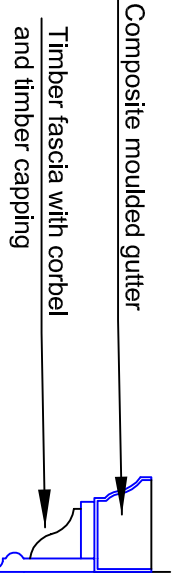
Gutter moulding detail 1::10

Asbestos based moulded gutter

Moulded timber dentil on timber fascia set at approx 120mm centres

Metal gutter strap
