Rev	Date	Dwn	Chk	Notes		
<b>DO NOT SCALE</b>						
Project	Originator	Zone	Level	Type	Role	Number
WCRR - ASA	- XX	- RF	- DR	- A	- 010	
Suitability	S0	Revision	P00	Preliminary		
Client	Wellesley Court					
Job	4502	Wwlwesley Court Roof Repairs				
Content	Existing Roof Plan					
Date	07.07.20	Drawn	PBN			
Scale	1:100 @ A3	Checked	WRA

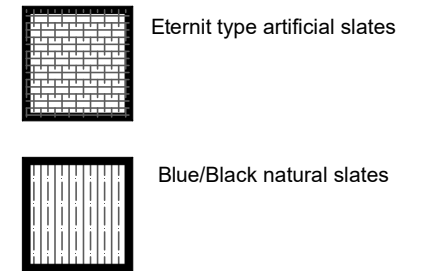
Westmorland slates laid with diminishing courses  
 Backs of slates have been sprayed with foam  
 possible due to failure of nails or to provide insulation  
 This means the slates cannot be salvaged

RWP's generally seem in reasonable condition

Glass sheet slated into roof.  
 Taped to prevent water ingress

Failed lead valleys and gutter within well  
 Coated with non setting paint to  
 prevent water ingress

Brick chimney with 6 assorted clay pots  
 Poorly pointed

Brick chimney with 8 assorted clay pots  
 Severe lean to chimney. Poorly pointed

Profiled composite gutters likely to be asbestos based to all elevations  
 Gutters are failing at joints.  
 Timber modillions detail below gutters on timber fascia  
 Areas are missing and rotten to majority of areas

Non original concrete hip and ridge tiles to all elevations.  
 Poorly pointed with cement mortar
