## BUILDING SURVEY

**Property Address**The Former Coach House & Link  
Structure to Original Building  
Single Storey Offshoot:3 Beach Road  
South Shields  
Tyne & Wear  
NE33 2QA

The instructions are specific and restricted to inspection and assessment of structural condition of the Coach House and adjoining single storey structure built up between the Coach House and the gable wall of the original single storey offshoot structure built out to the rear of 3 Beach Road, South Shields, Tyne & Wear, NE33 2QA.

Tuesday 8 May 2018

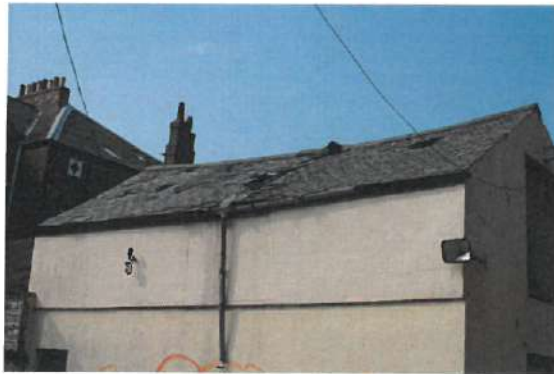
The Welsh slate roof demonstrates extensive deflection from original set and level position at centre point position to the building, that at a point equidistant to the north and south gable wall peaks.

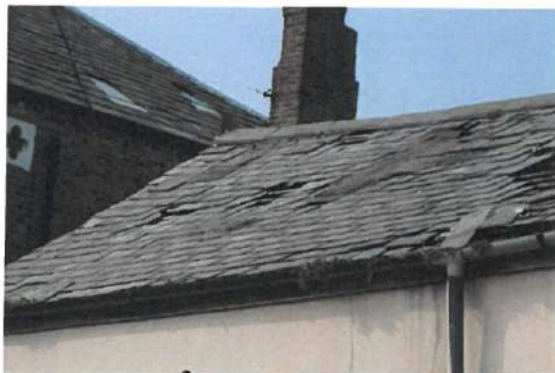
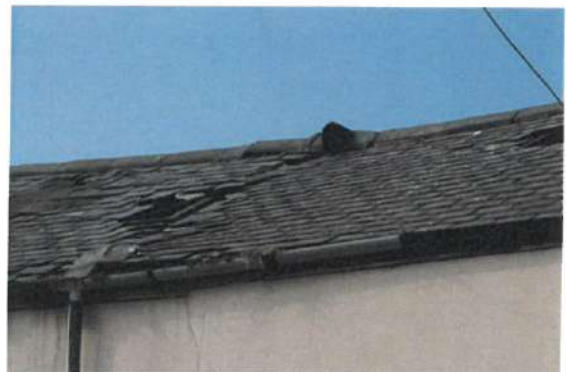
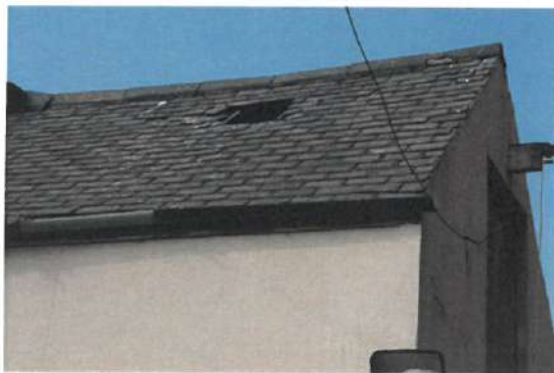
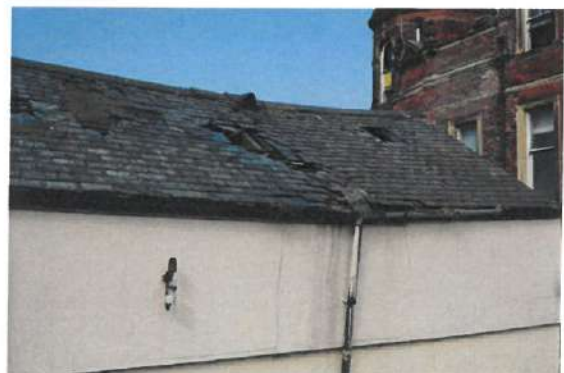
The Welsh slate roof surface is in poor condition to the extent that it is classified as being at the end of its effective life and not capable of overhaul and repair.

The external to the structure substantial extent of structural distortion of the roof structure, as a whole, is readily apparent and the view is taken that the roof covering and the roof support structure are beyond repair and would require full extent replacement.

Repair and strengthening of the existing roof structure is not considered to be a viable option.

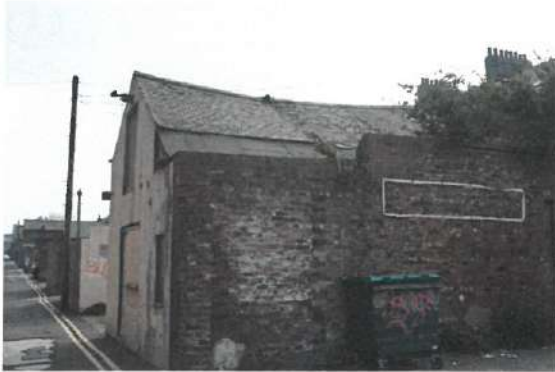
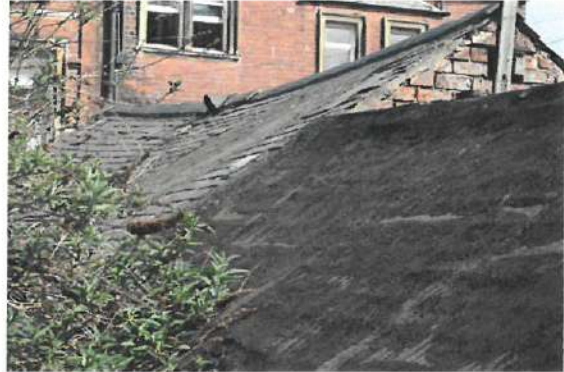
The roof surface demonstrates defined distortion from original set level position at a point that is at lowest level at the point equidistant between north and south gable wall peaks.

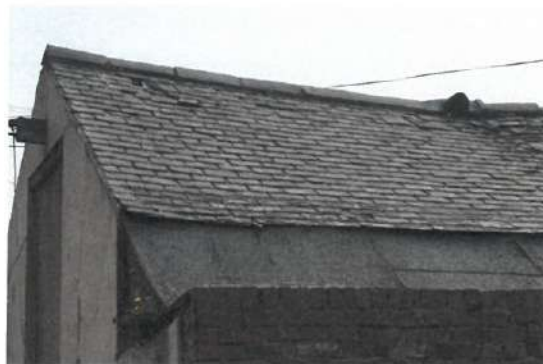
To the south section of the roof, the Welsh slate covering is in poor condition and holed to upper sections of that roof surface.

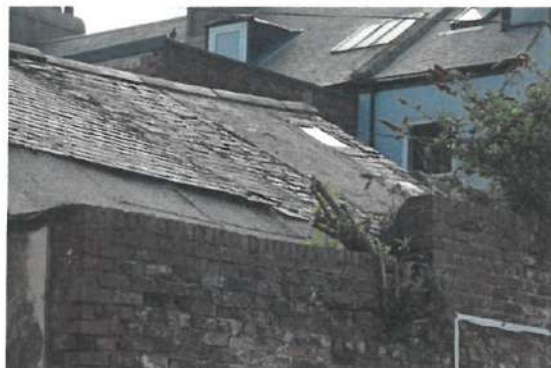
To the south side of the west facing roof pitch, slatework is in exceptionally poor condition and has been part oversurfaced with a mineralised felt application as an attempt to repair.

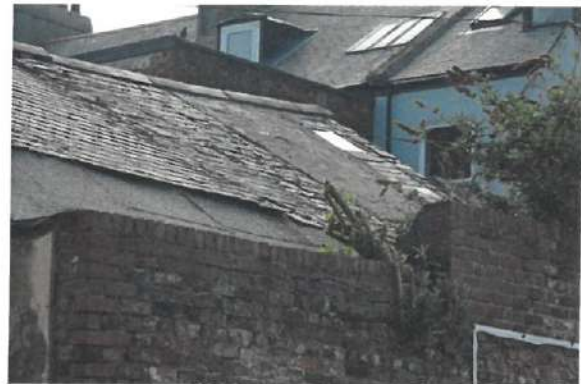
The mineralised felt roof covering applied to enclose the passageway that was positioned between the west wall face of the Coach House structure and the west of site boundary wall has a mineralised felt covering.

The mineralised felt roof covering is a basic grade oversurface application, as demonstrated by the securing to position of feltwork elements with zinc nails.

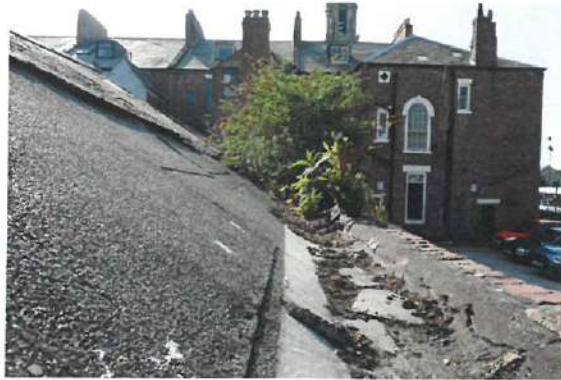
To the base of the single pitch felt roof there is a formed and lined gutter, that lining material defective and substantially blocked with mature growth vegetation.

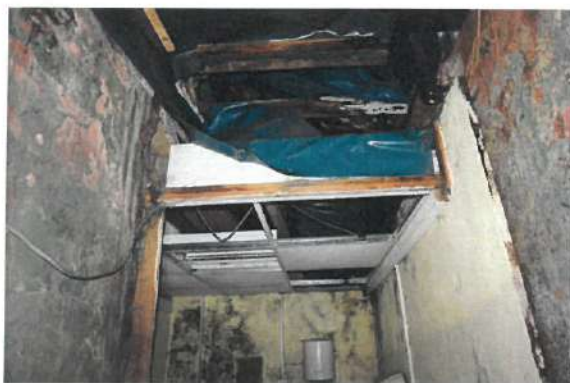
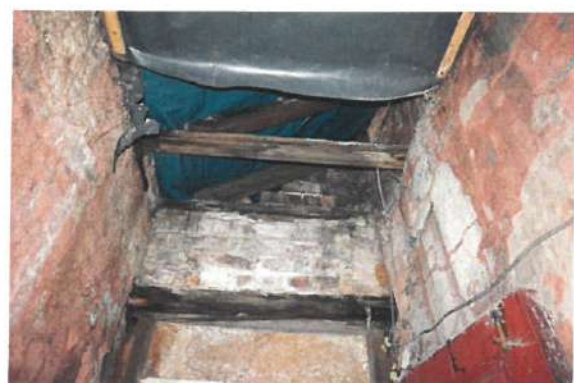
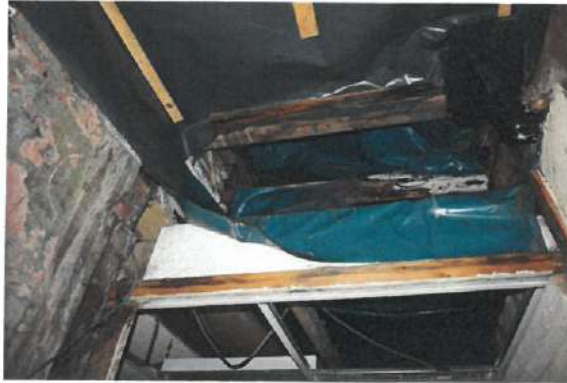
When viewed within the ground floor accommodation there is extensive demonstration of ongoing water penetration through the defective roof covering which can be taken to have been a factor that has substantially contributed to diminishment in bearing capability of the timber roof support structure main frame and common rafter elements to the Coach House roof.

Water penetration is ongoing.

Elements of the roof support structure to the covered passage area can be seen to partial extent, timbers viewed having taken in water, over time, and subsequently deteriorated as a result of promotion of rot.

The single pitch mineralised felt surfaced roof covering to the enclosed passage would require replacement, in full, to achieve an effective extent and longstanding repair.

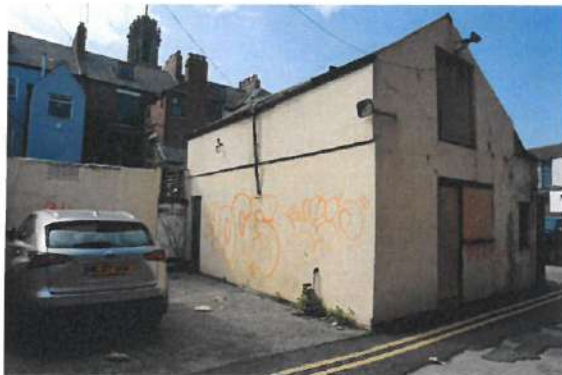
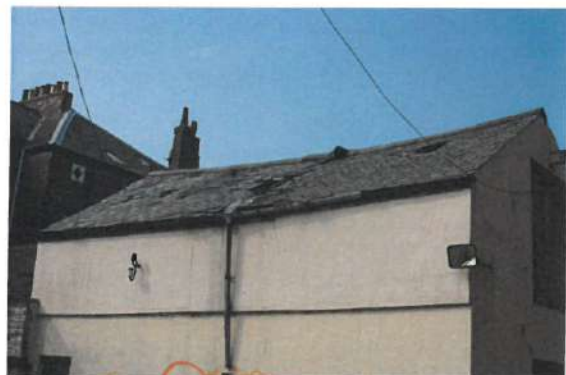
The east wall face of the Coach House has likely been modified and built up to enclose openings, in the past, as a full extent cement render with paint finish is applied.

The rendering has substantially de-bonded and demonstrates extensive and relatively fine extent fracturing that passes through the render surface.

The applied render has de-bonded, in places.

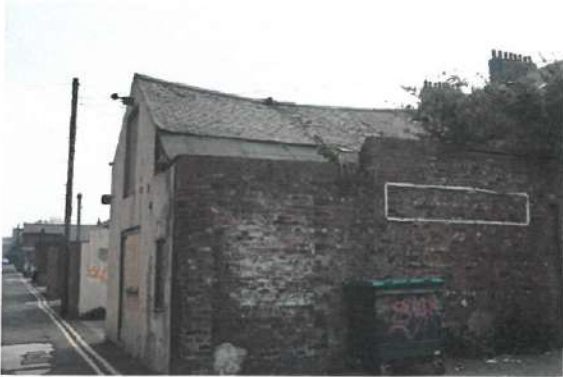
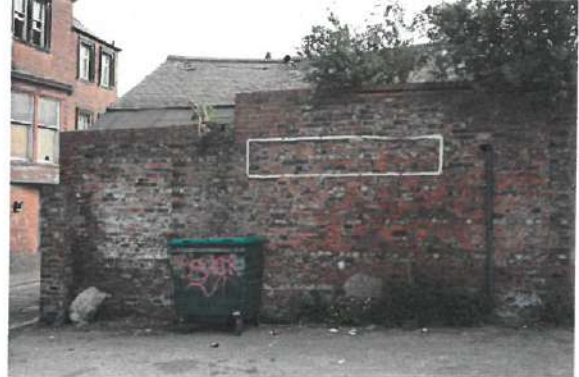
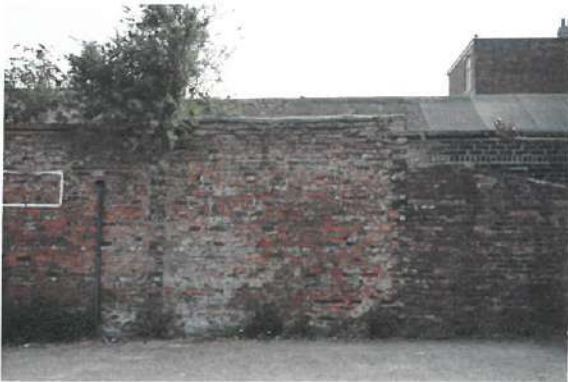
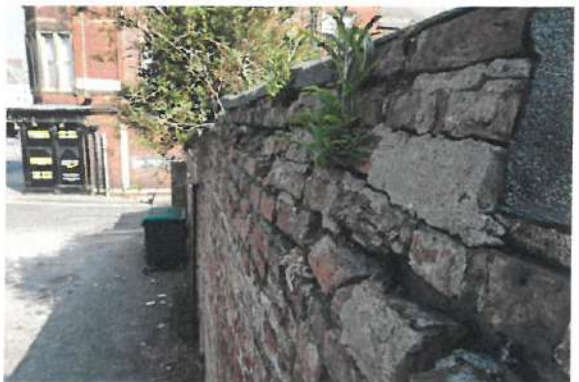
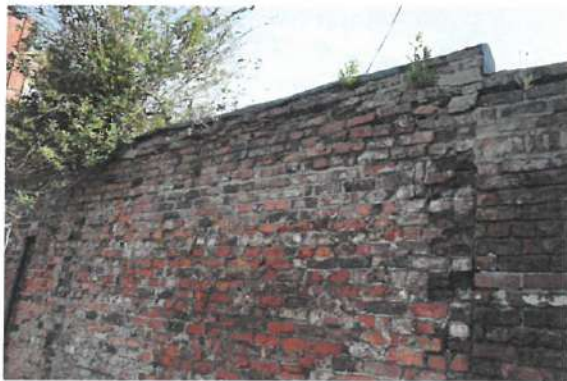
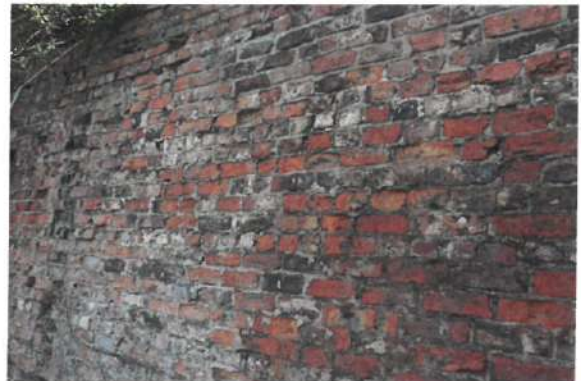
The wall demonstrates substantial extent ageing deterioration and weathering to brickwork and pointing.

This west of site wall is in exceptionally poor condition with loose brickwork to upper courses within which vegetation has grown and been allowed to mature.

This west facing wall is considered to be in poor condition, in overall terms, will require substantial extent repair and overhaul to return to good order, that work to include taking down and re-building substantial elements of the wall to the extent that its ongoing viability as a structure is called into question.

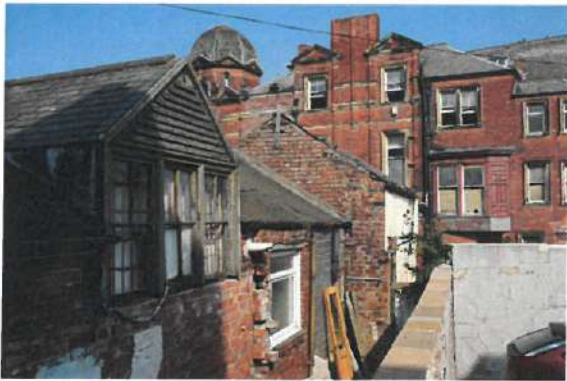
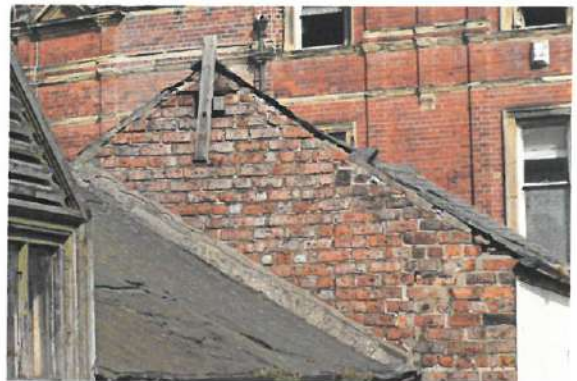
The south elevation gable wall of the Coach House demonstrates extensive ageing deterioration and weathering to brickwork pointing, openings present to the head of the wall at the gable peak and structural movement disturbance to the upper eastern corner of that wall.

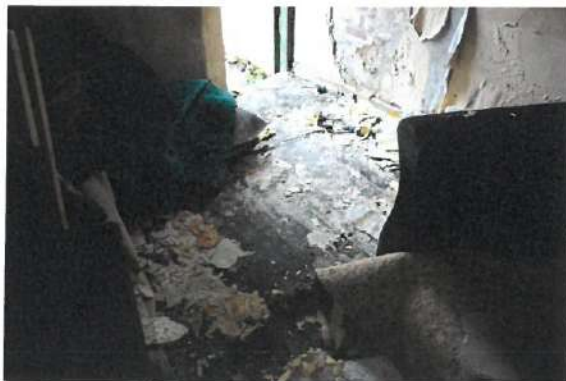
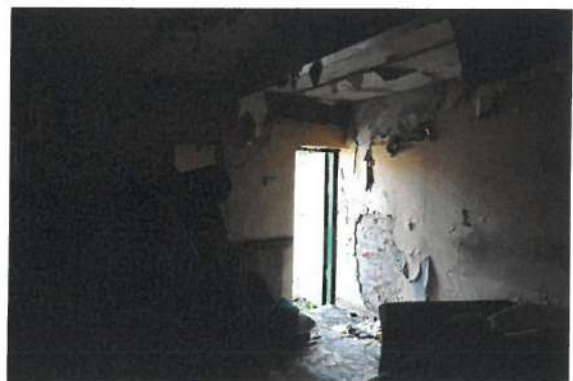
The internal face to the south gable wall demonstrates extensive damage as a result of penetrating and rising dampness on what is indicated to have been a long term basis.

The main structure walls to the Coach House and roof enclosed passage structure will also require Specialist Contractor work to deal with rising and penetrating dampness and structural strengthening to elements of the structure where structural distortion and disturbance has occurred.

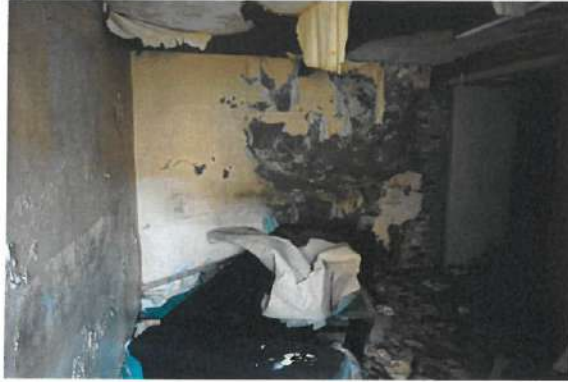
The internal face of the original west wall to the original Coach House structure, that the wall that separates the Coach House from the enclosed passage formed, provides demonstration of extensive rising and penetrating dampness.

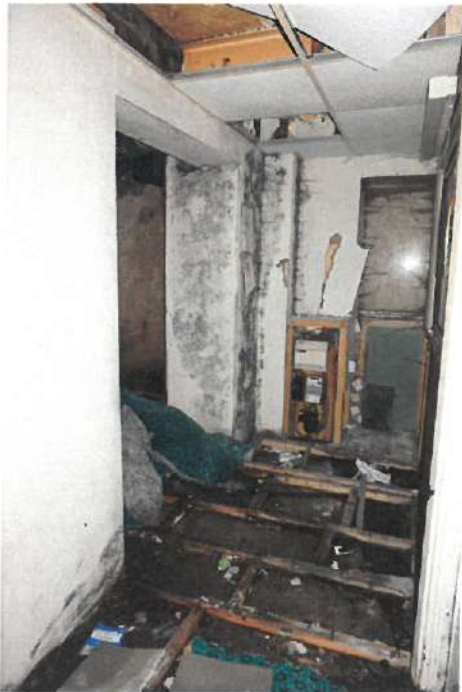
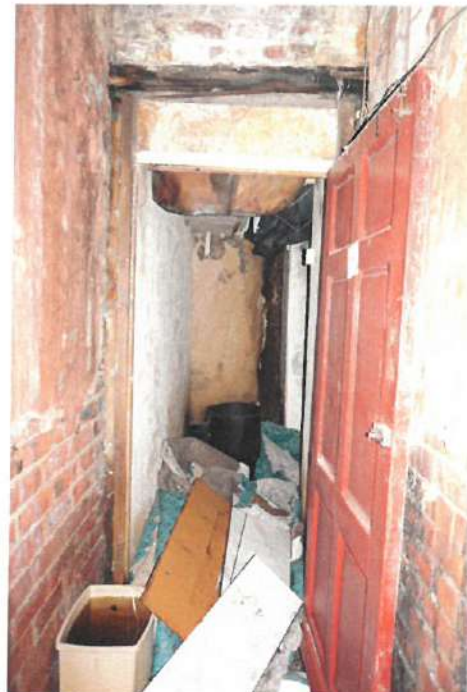
The internal faces of the west walls of the Coach House and the enclosed linking structure are extensively damaged as a consequence of water penetration and root growth encroachment from vegetation growing within the west of site boundary wall.

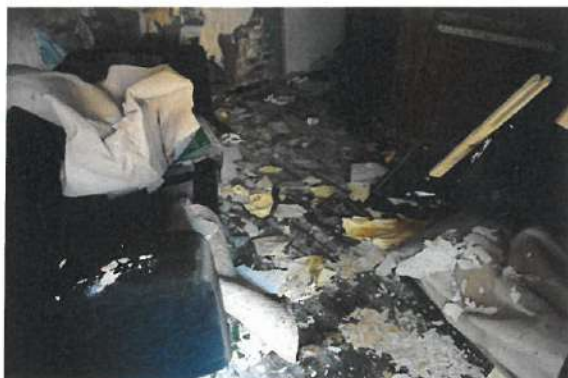
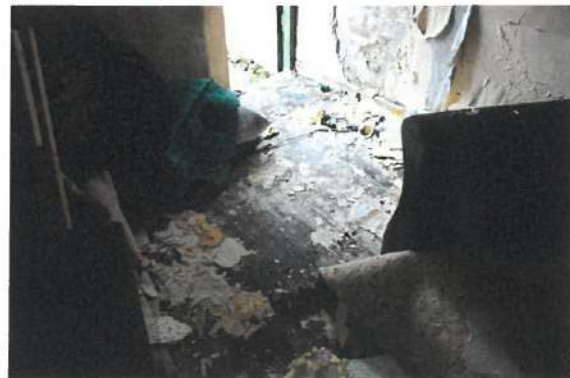
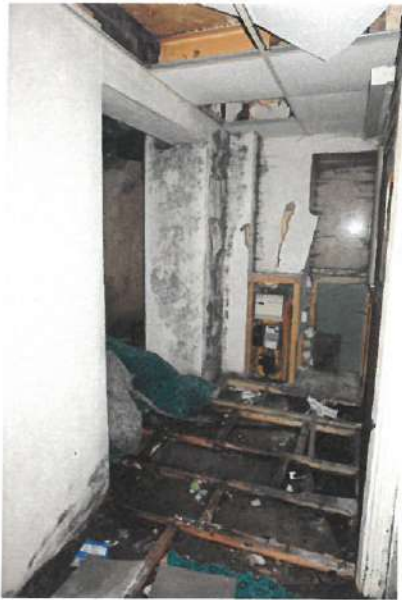
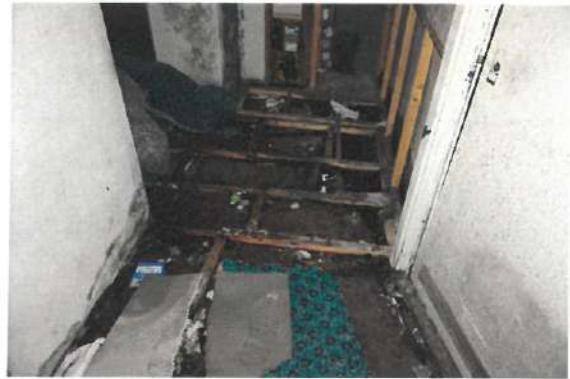
The floating timber floor is extensively water damaged, elements of the floorboard surface have been removed and all timbers will need to be stripped out.

The concrete floor slab is visually indicated to be of substantial age and is considered unlikely to have been laid incorporating a damp proof membrane.

The concrete floor would need to be broken up and re-laid incorporating insulation and a damp proof membrane.

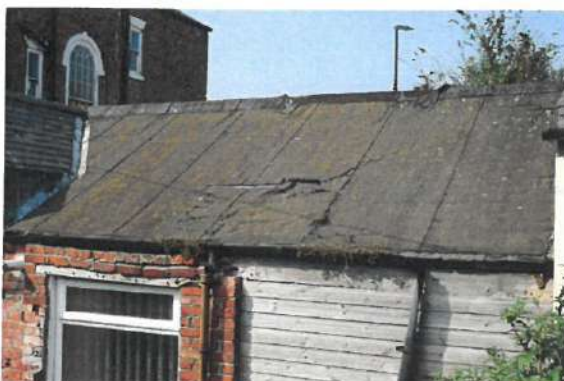
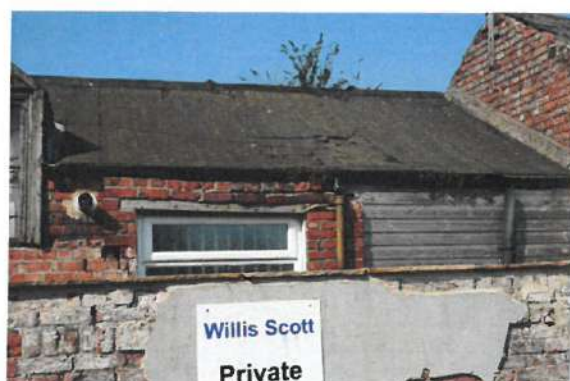
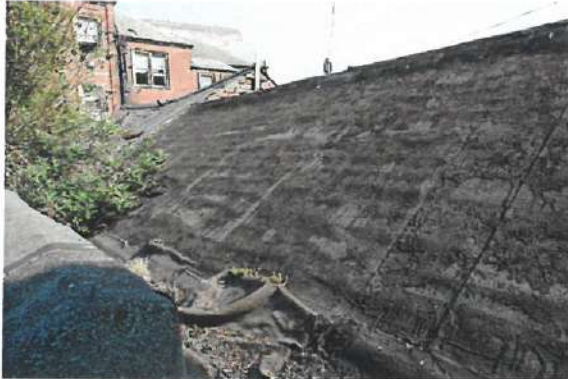
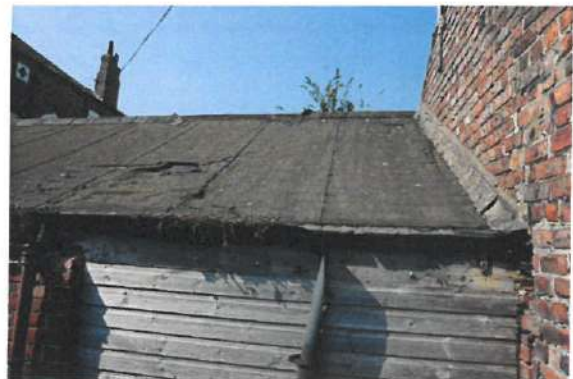
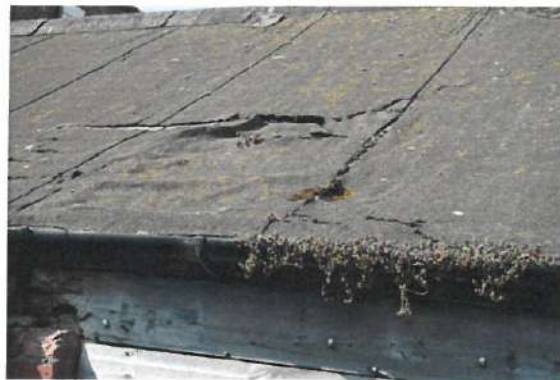
To the east facing pitch, the mineralised felt roof covering is in poor condition and its application over the Welsh slates renders those materials beyond salvage.

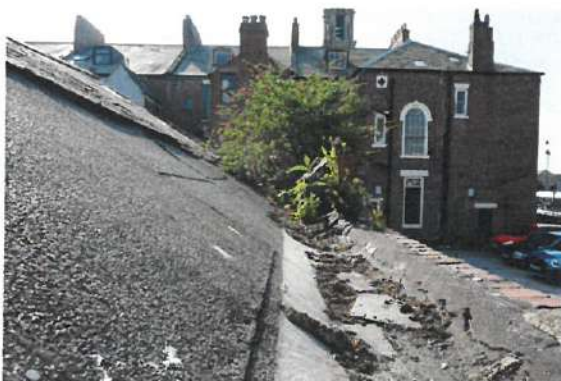
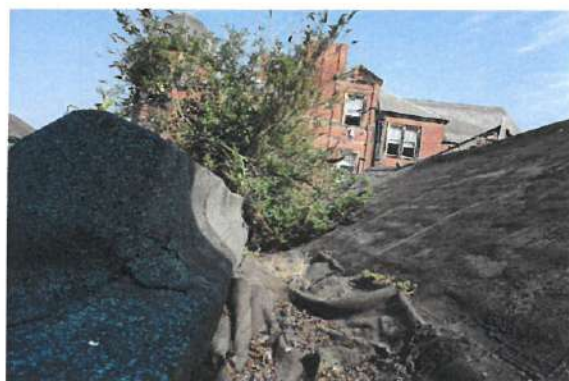
To the base of the west facing roof pitch there is a formed and felt lined valley gutter, the lining material having failed to full extent and there being extensive mature vegetation growth within brickwork to the west site boundary wall.

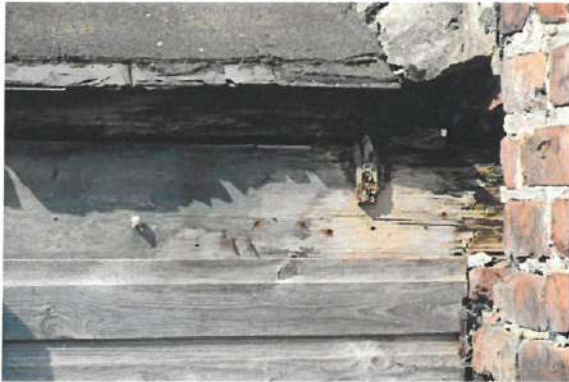
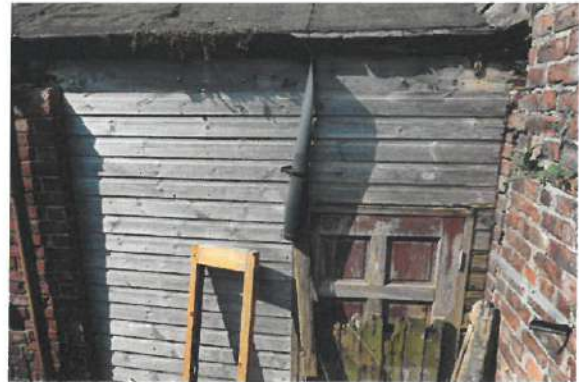
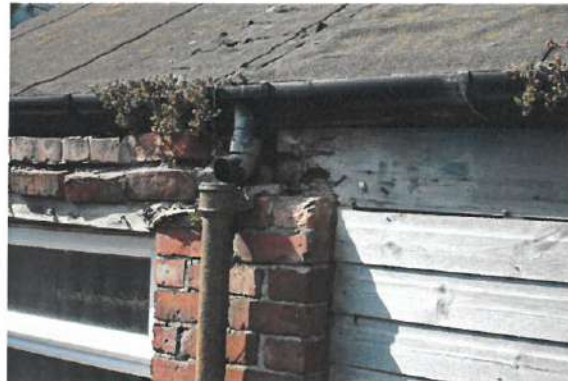
To the base of the east roof pitch, the roof support structure base timbers bear onto a timber lintel that was provided with support by the south gable wall of the Coach House and the north facing wall of the single storey offshoot structure.

The bearing ends to that timber support beam have rotted extensively to the point of failure.

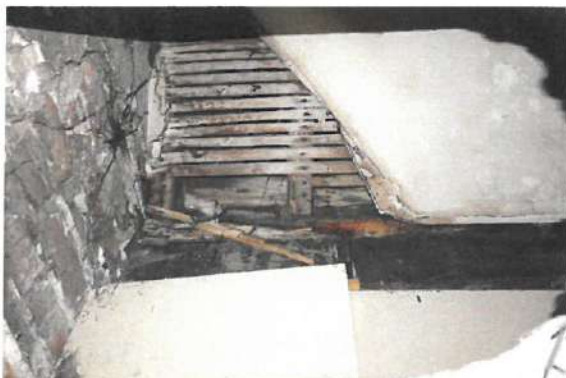
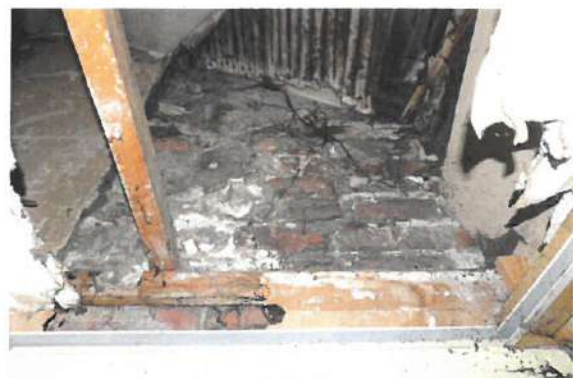
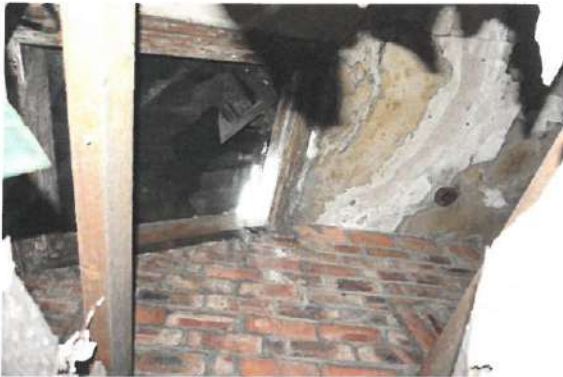
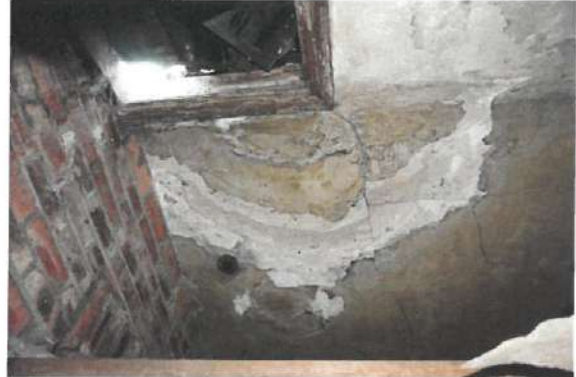
Elements of the timber roof structure to the link building that can be seen without carrying out destructive exposure work are established to demonstrate areas of extensive water penetration, which has resulted in promotion of rot to the point of structural failure of those elements of the timber roof support structure.

The external to the structure substantial extent of structural distortion of the roof structure, as a whole, is readily apparent and the view is taken that the roof covering and the roof support structure are beyond repair and would require full extent replacement.

Repair and strengthening of the existing roof structure is not considered to be a viable option.

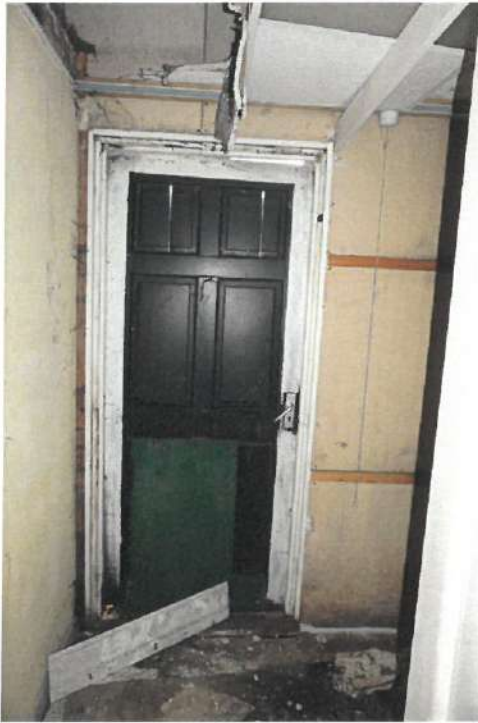
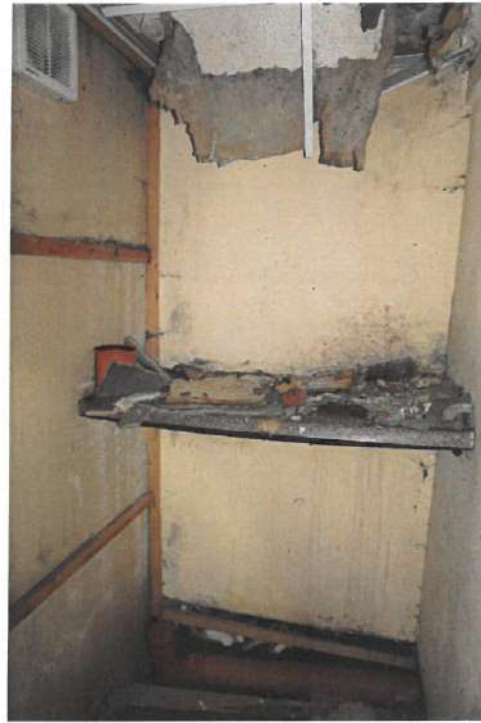
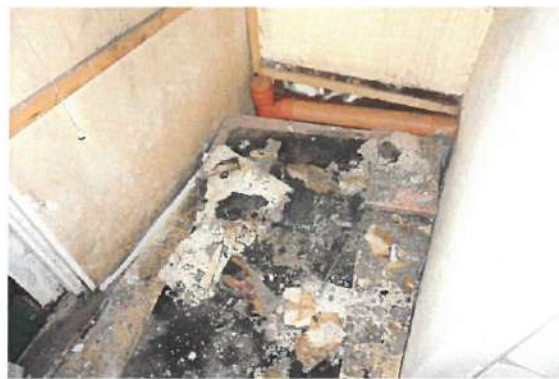
The internal face of the east wall to the link structure is of plasterboard form.

Base elements of the wall are wet and the enclosed timbers within the support frame are indicated to have taken in water on a long term basis and are anticipated to demonstrate rot.

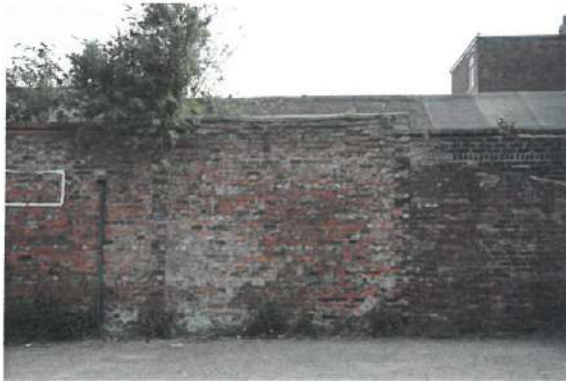
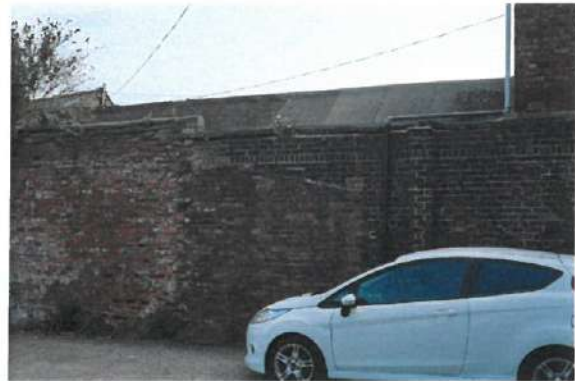
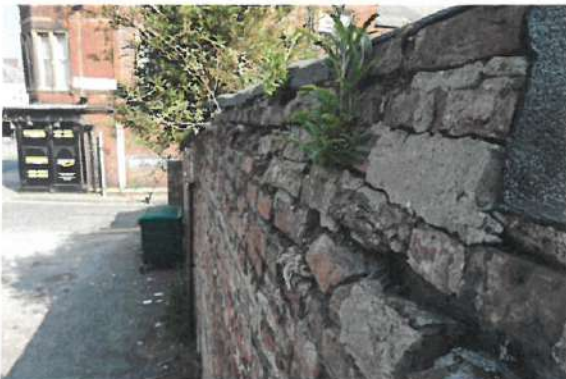
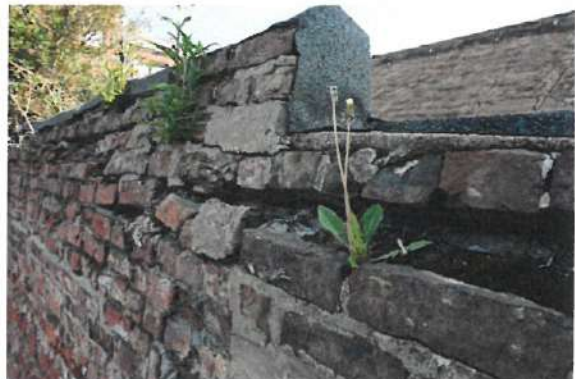
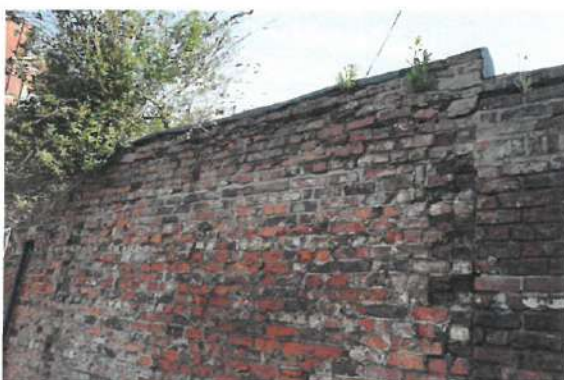
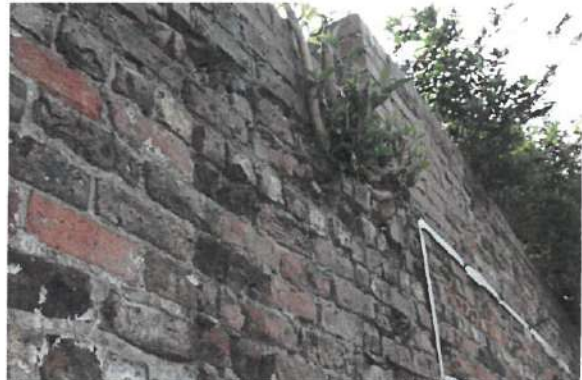
The external wall face, as viewed from the rear site of 1 Beach Road, is in poor and unsatisfactory condition to brickwork and pointing, upper elements of the wall demonstrating mature vegetation growth and physical deterioration of brickwork and pointing to the extent that upper sections of the wall are classified as unsafe.

The west wall to the built up link structure is in poor condition to the extent that the wall should be reduced in height and brickwork re-built, as far as is necessary, to place in good and structurally sound condition.

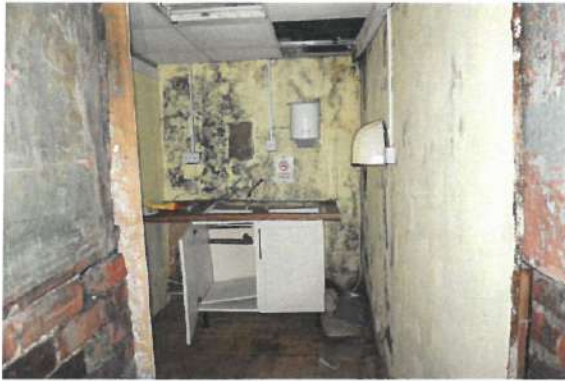
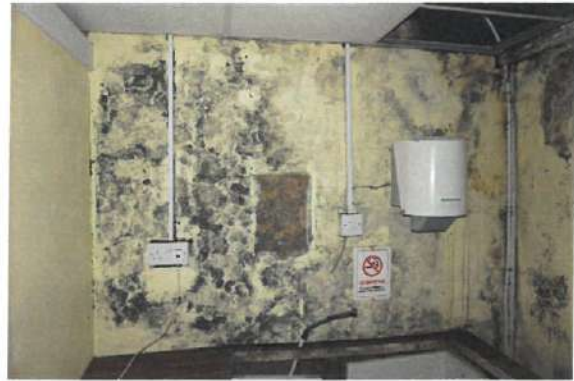
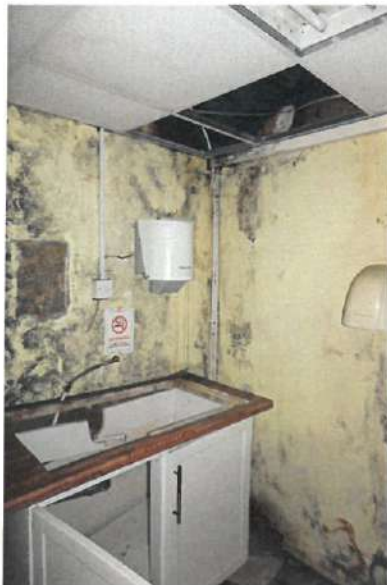
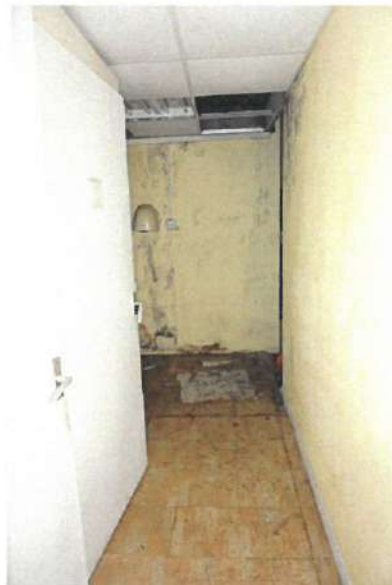
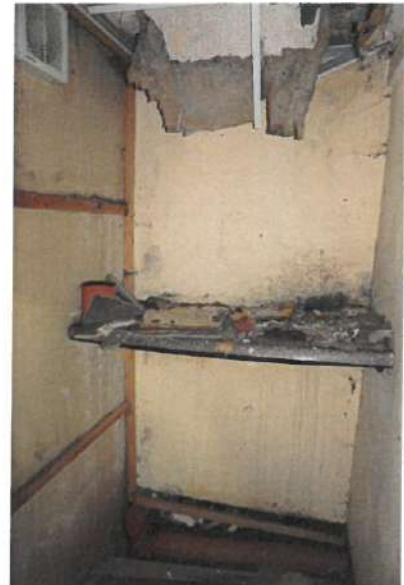
The internal wall faces demonstrate extensive water damage as a result of rising dampness, penetrating dampness and black spot mould growth.

All internal wall finishes require removal and replacement.

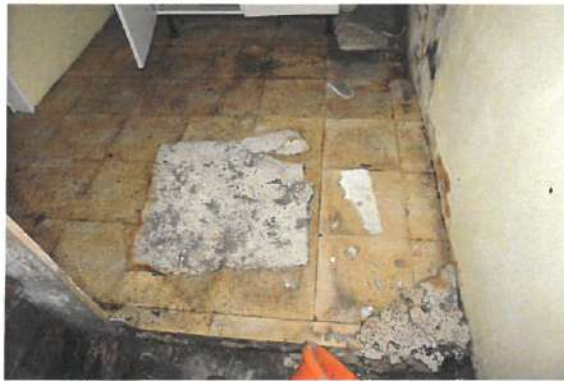
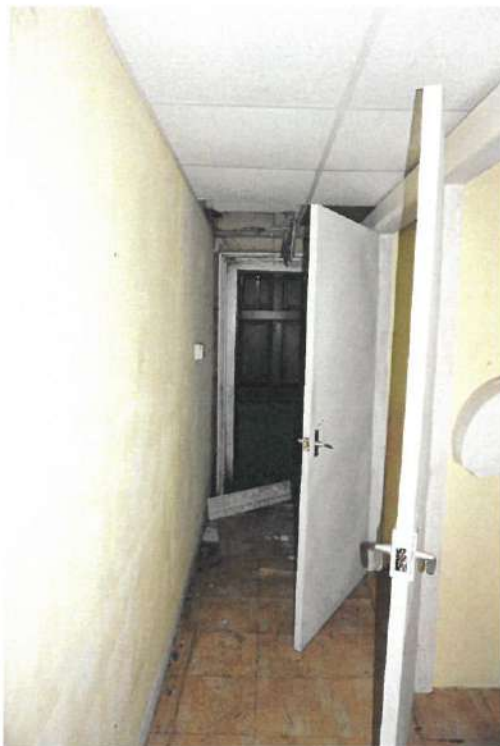
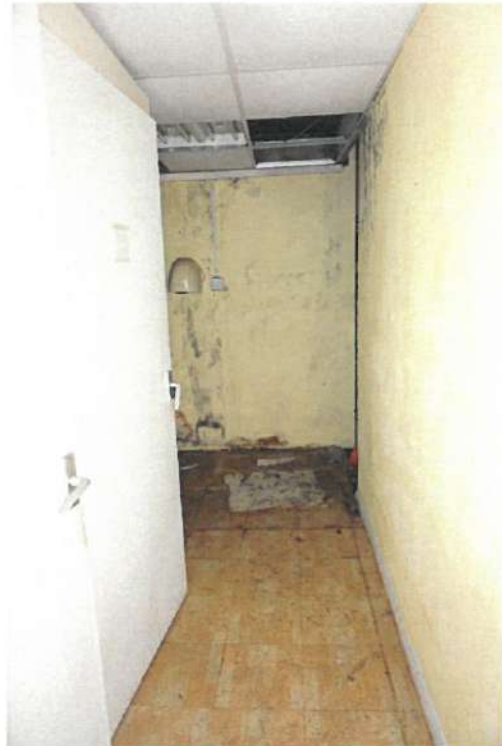
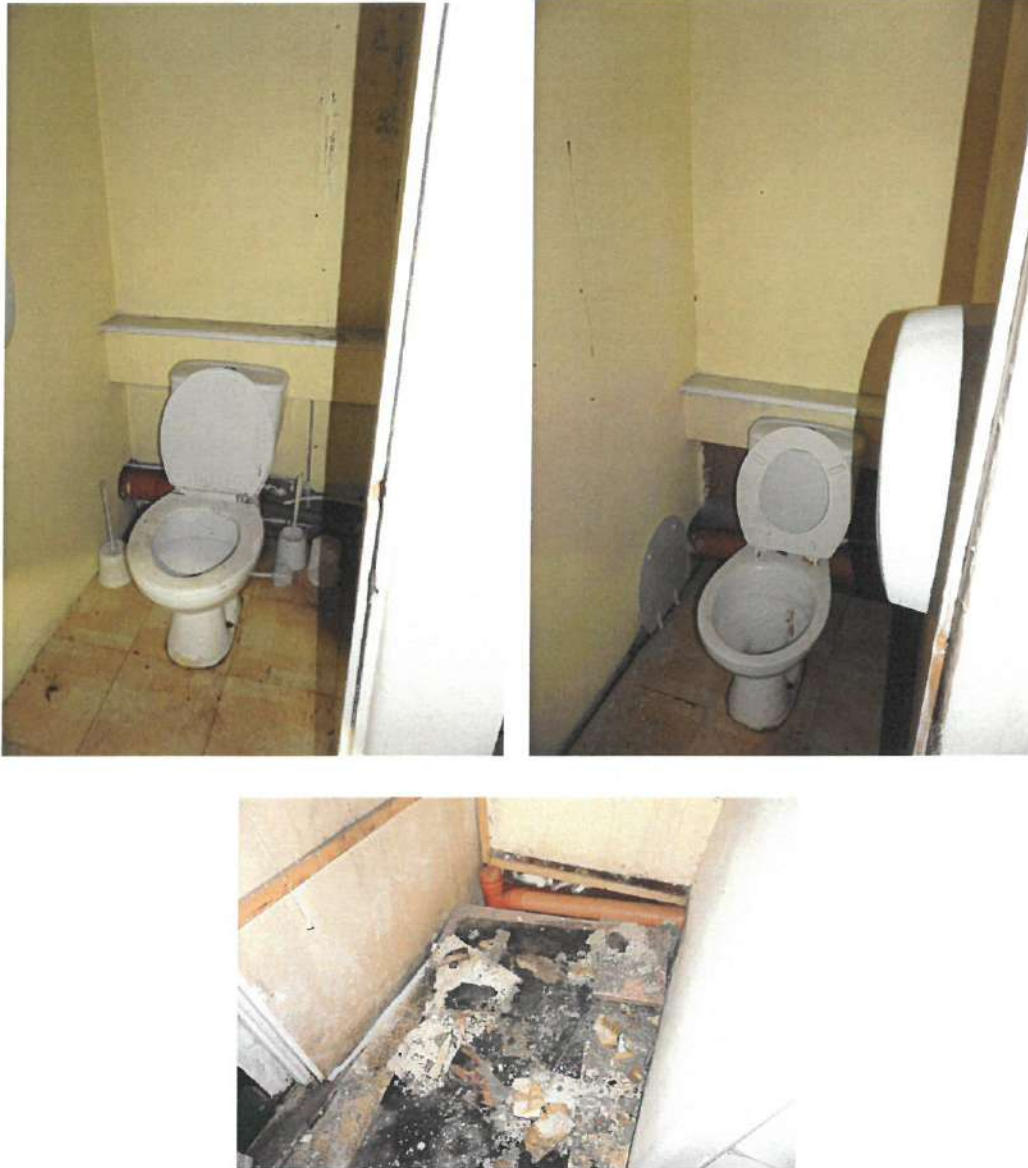
The floating timber floor has bene excessively damaged as a result of water penetration into the structure and is classified as requiring replacement, in full.

The concrete floor slab is visually indicated to be of substantial age and is considered unlikely to have been laid incorporating a damp proof membrane.

The concrete floor would need to be broken up and re-laid incorporating insulation and a damp proof membrane.
