## Damp Survey

1 & 3 Beach Road, South Shields, NE33 2QA

Glen Griffiths

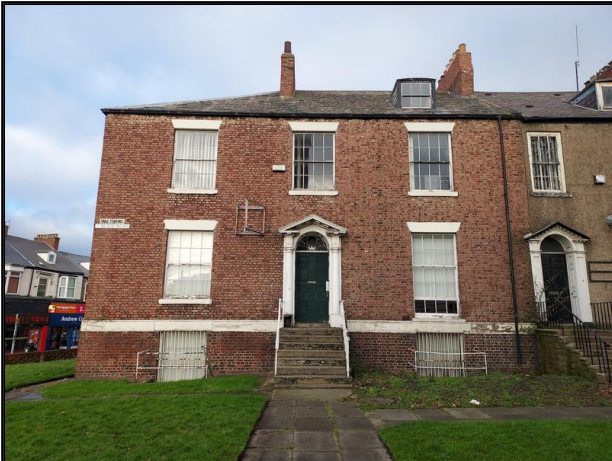
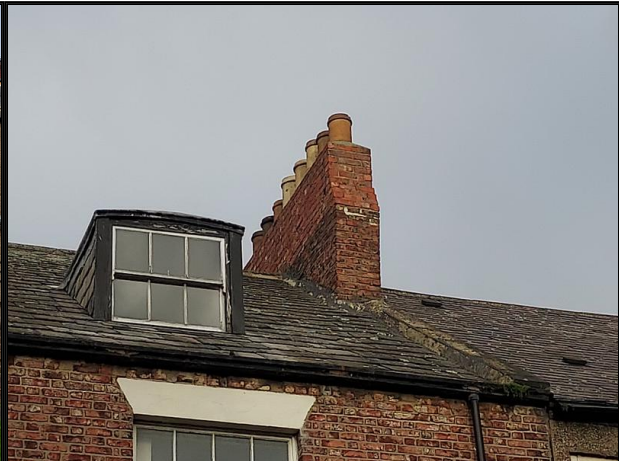
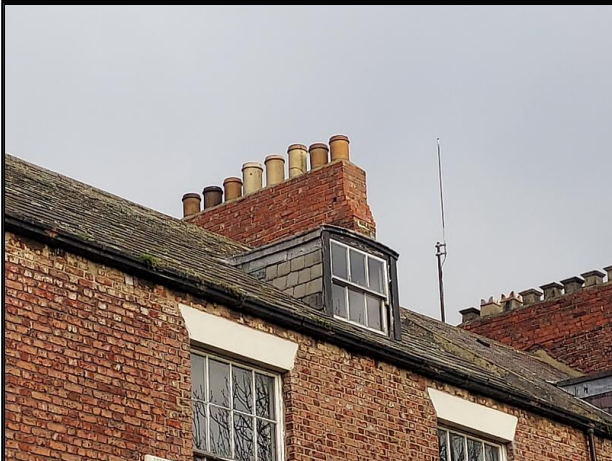
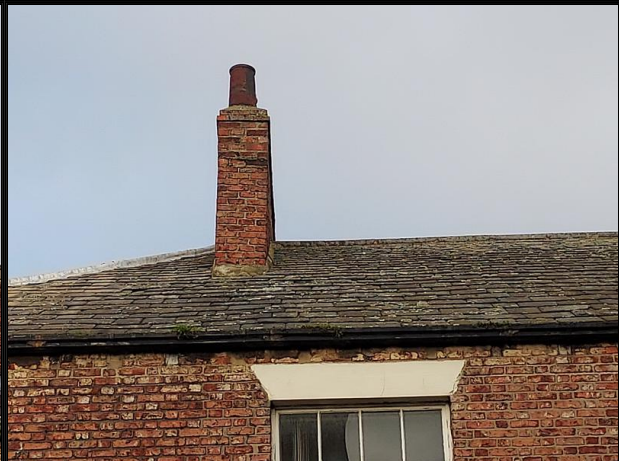
- 5.1 A brick chimney stack measuring approximately 1800mm in height (measured from its lowest intersection), is positioned at the party wall and saddles both the front and rear pitch of the the roof. From a ground level inspection it appears that the top 10-courses of brickwork have been rebuilt in more recent times; however a review if historic images suggests that no obvious work has been undertaken after 2008. There are 8nr. terracotta chimney pots which all appear to be intact and in reasonable condition. The surveyor was able to observe several small openings in the side of the chimney stack which appear to have been created where mortar joints have spalled away or brick fragments have detached.

It would appear that weatherproofing at the junction between the roof and chimney stack has been formed using mortar, which appears to exhibit evidence of cracking and some detachment. In addition it appears that there has been a prior attempt to further protect this area where evidence of a material reminiscent of a black bituminous paint has been applied to the flashing detail.

It is believed that the flashing detail is of poor quality and the element is vulnerable to rainwater penetration.

- 7.1 Redundant chimneys are vulnerable to rain penetration through the sides of the stack, which can cause damp issues in the accommodation below as observed. All chimneys should have a cap with a drip to shed water clear of the brickwork below, flashing to prevent rain passing between the chimney and adjacent roof coverings and a DPC built in to the chimney at lowest intersection to prevent downward transmission of dampness within the masonry. From a ground level the inspection

deficiencies in the chimney stack can be observed; however to provide a detailed repair schedule it is recommended that high level access equipment is provided.

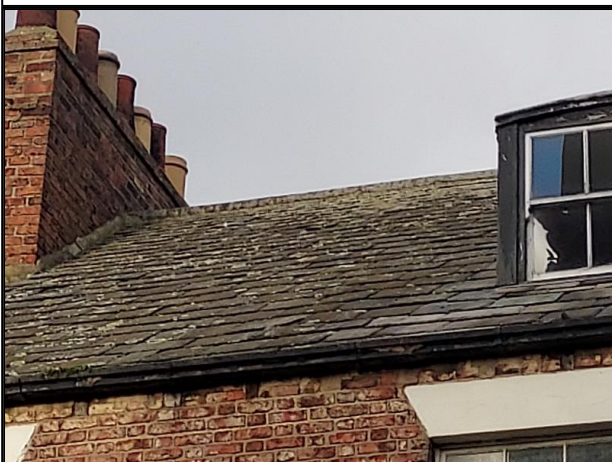
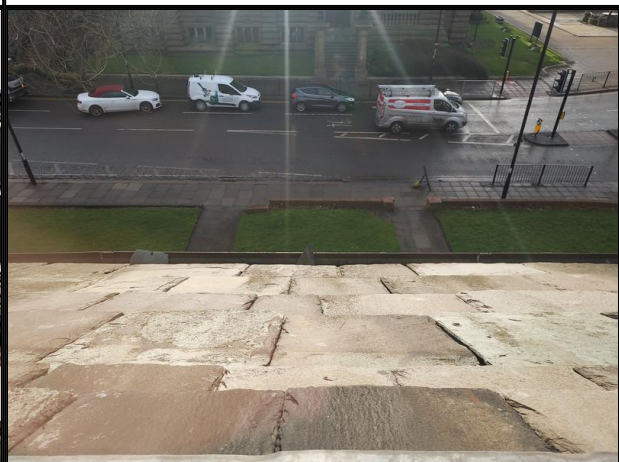
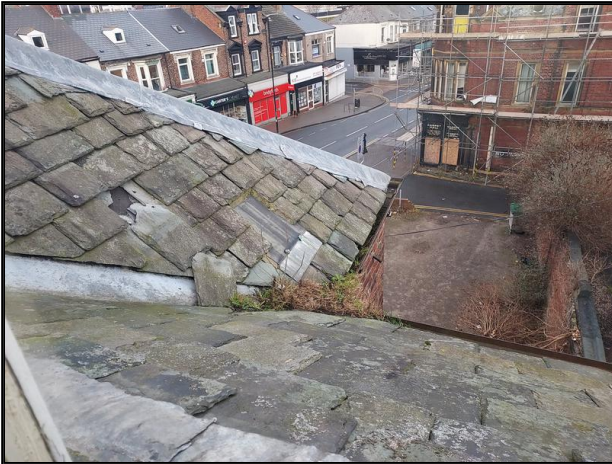
- 5.2 The natural slate roof coverings at the front of the the property were inspected from ground level; however the surveyor was able to observe a number of slipped and absent tiles; some of which were shown to have collected within the rainwater goods.

The surveyor noted that there is evidence of remedial works to the clay ridge tiles where a rudimentary repair has been undertaken by roughly applying mortar to re-bed loose coverings.

Conversely the hip tiles appear to have been neatly dressed in rolled lead (pre 2008) to provide additional weather proofing.

- 7.2 Again it is evident from a ground level inspection that a significant number of roof slates have cracked and fallen from their fixed position, which has left the roof structure vulnerable to rainwater penetration. Replacement slates should be reinstated and securely fixed into place where absent. It is recommended that a high level inspection be undertaken to determine whether nail holes have cracked or whether nail sickness is a contributory factor.

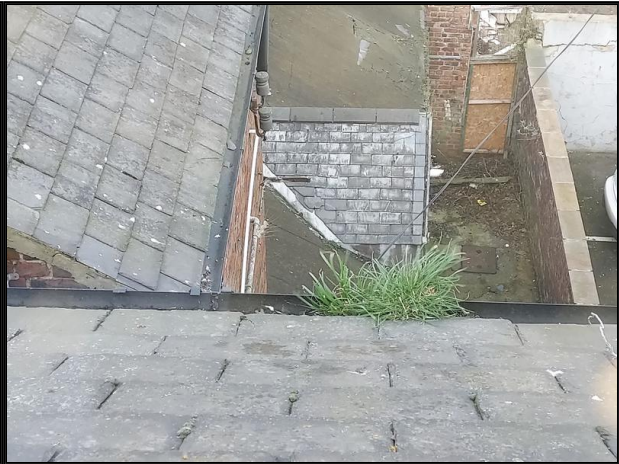
Figure 8

- 5.4 Vegetation was observed to be established and growing within the gutters, which can form an obstruction preventing rainwater from dispersing into the downpipes and away from the property. Furthermore the timber fascia board exhibited evidence of decay in isolated areas which is likely attributed to sustained wetting as a result of this defect.
- (See figure 8)

- 7.4 The rainwater goods and waste pipework on both properties are believed to be at the end of their predicted life expectancy and it is advised that they be replaced to prevent rainwater discharging against the face of the external walls. It would also be considered prudent to replace the damaged timber fascia boards in conjunction with this element of work.

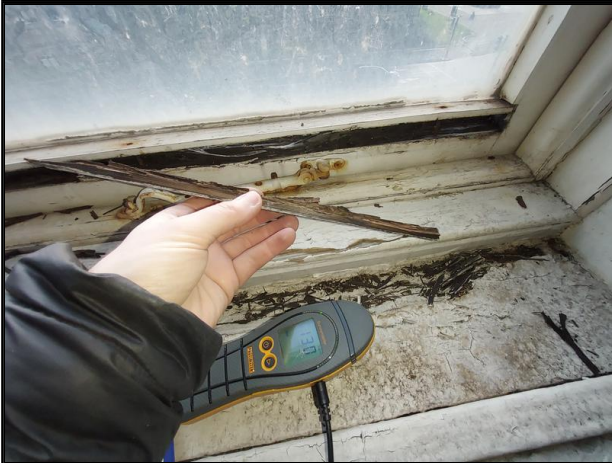
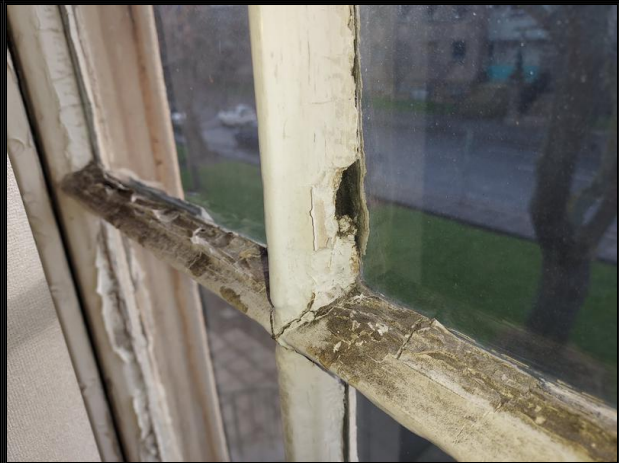
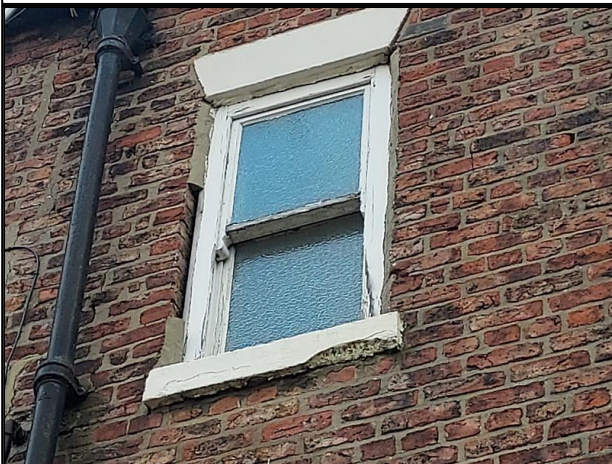
- 5.5 The timber sash windows are in a poor state of disrepair, with evidence of rot and decay documented in varying levels of severity within both properties. In many cases the surveyor discovered sizeable gaps formed around the window openings, where mortar fillets have cracked and detached facilitating water ingress within the property.  
(See figures 9 - 11)

- 7.5 Similarly, the timber window frames within both properties are in a poor state of disrepair and it is envisaged that replacement will be required to a number of units; however others can potentially be salvaged and overhauled.

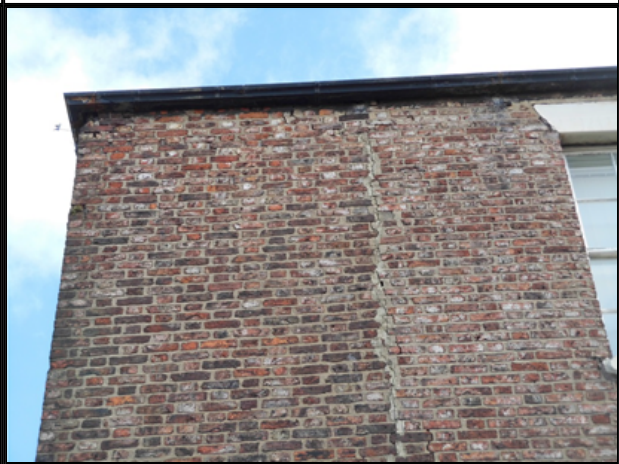
Figure 12

- 5.6 The surveyor identified appreciably recessed mortar joints to all elevations on both properties, which can form a passage for rainwater penetration.

Moreover, a structural survey undertaken by a third party consultant (Arc Associates) in March 21 documented evidence of vertical cracking estimated to measure between 8-10mm at the rear gable of the property, where some historic remedial and re-building work appears to have been undertaken and is identifiable by the discoloration of the brickwork. Cracks were also documented at the gable elevation under the ground floor level at the right hand side of the window sill (3-4mm wide). There is also evidence of vertical cracking at the rear elevation where again some historic remediation works has been undertaken however movement has manifested again with a 5-7mm wide fracture at the joint between original and comparatively newer masonry appearing. In all cases it is advised any recommendations to stabilize the properties and prevent any further movement are undertaken prior to pointing the property and preventing water ingress.

- 7.6 A full repoint of the dwelling is recommended to improve the aesthetics and to weather proof the open joints; however, owing to the cost implications the client may wish to consider treating isolated areas where openings have manifested in the external leaf. Lime gives better adhesion to bricks and improves the mortars ability to cope with thermal and moisture movement: -

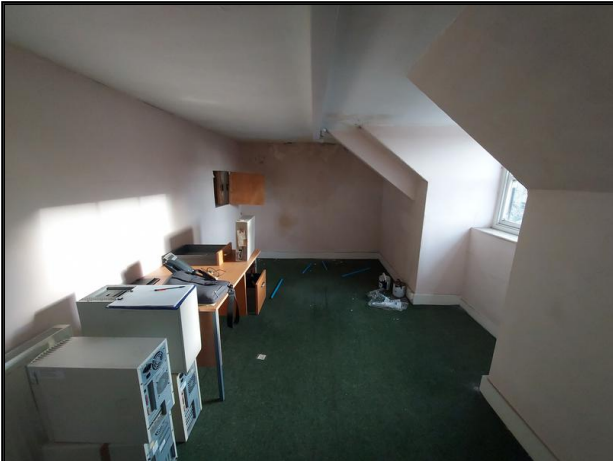
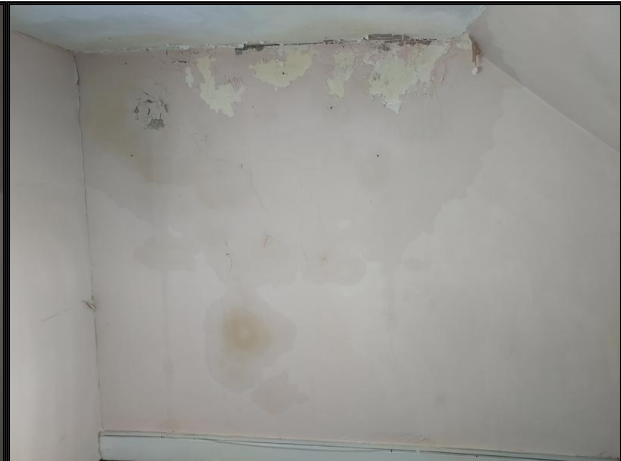
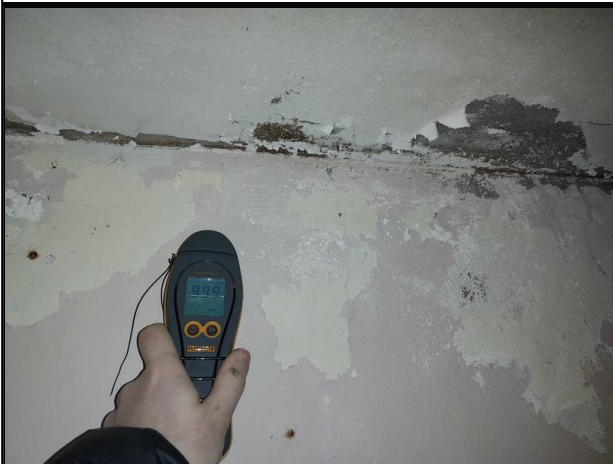
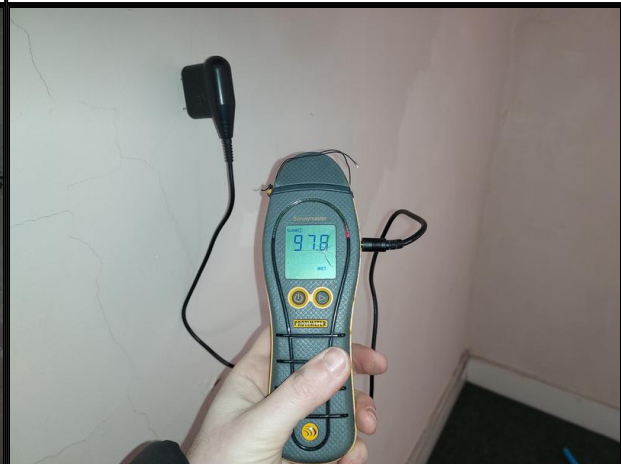
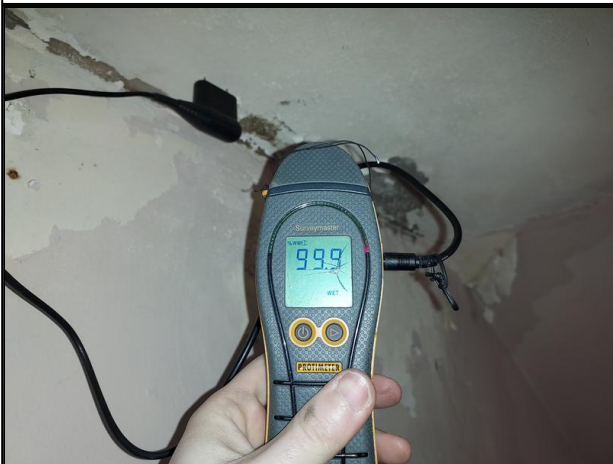
- 5.7 On the party wall the surveyor identified a large prominent area of water staining (circa 2m<sup>2</sup>), which appears to be emanating from the ceiling level. The surveyor plotted the relative moisture content of the wall, which revealed high 'wet' readings (999REL) within a concentrated patch and a sharp change to 'dry' conditions (166REL) outside of the discoloured surface.

The surveyor also captured the wood moisture equivalent (%wme) of the ceiling at the party wall junction, which confirmed excessively 'wet' readings i.e., 99.9%wmc.

It is noted that a chimney stack is positioned against the party wall separating properties 1 & 3 Beach Road; and penetrates the roof at the gable peak.  
(See figures 13 - 17)

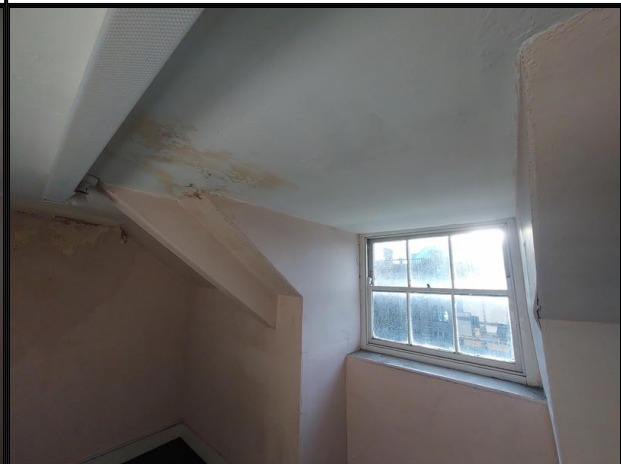
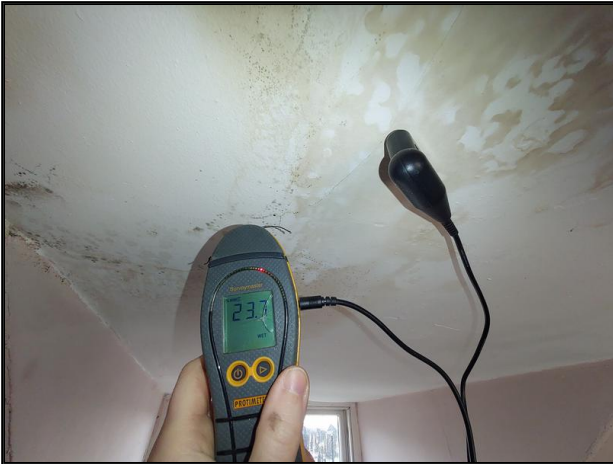
- 5.8 In addition to the water staining identified at the ceiling junction with the party wall; dark brown water marks have also manifested in concentrated patches above the dormer window. The surveyor recorded the wood moisture equivalent of the ceiling within this area and discovered 'wet' readings (23.7%wme). The profile and characteristics of the symptoms are believed to be synonymous of penetrating damp.  
(See figures 18 - 19)

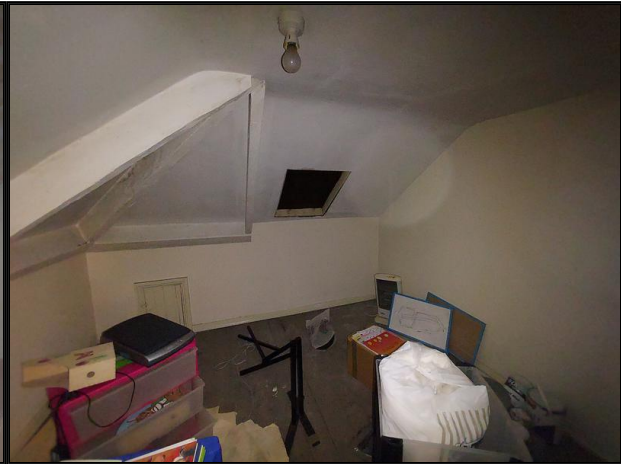
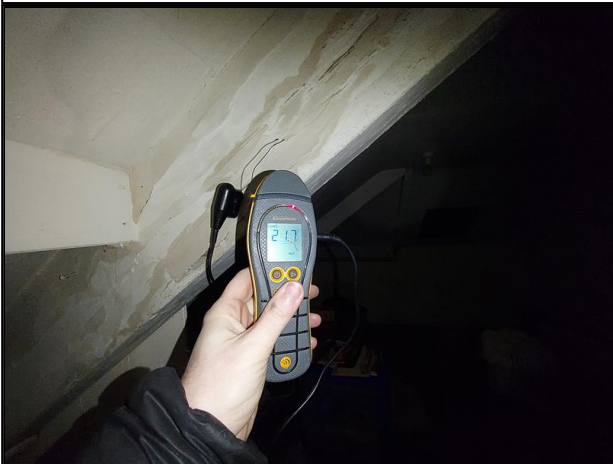
- 5.9 The hip rafter is exposed within the bedroom; however has been painted, which can conceal underlying defects. The surveyor noted that water staining is visible to the decorated surface finish and the timber exhibits a wood moisture content of 21.7%wmc, which illustrates 'wet' conditions.  
(See figures 20 - 21)

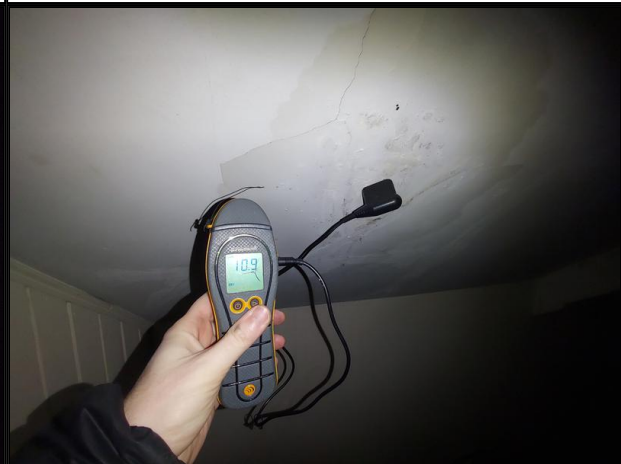
- 5.10 As observed elsewhere within the second floor accommodation, large areas of staining have appeared on the ceiling finish. The surveyor captured the wood moisture equivalent of the ceiling, within the affected area, which in this instance revealed 'dry' readings (i.e., 10.9%wme), suggesting that the source of water ingress has been removed or is potentially intermittent in nature. (See figure 22)

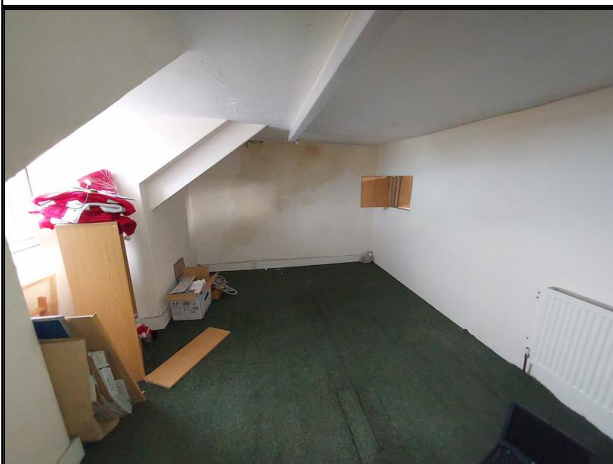
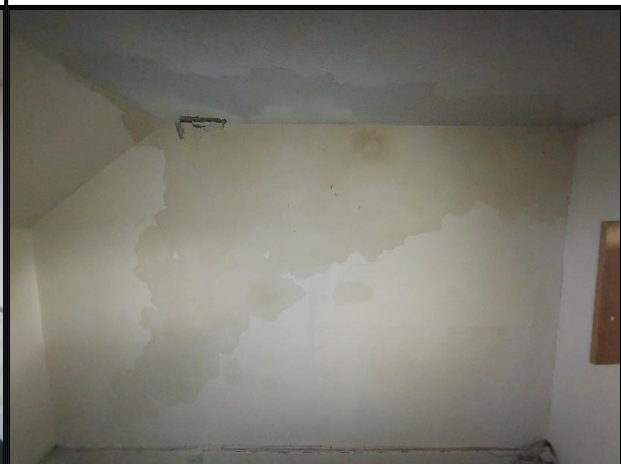
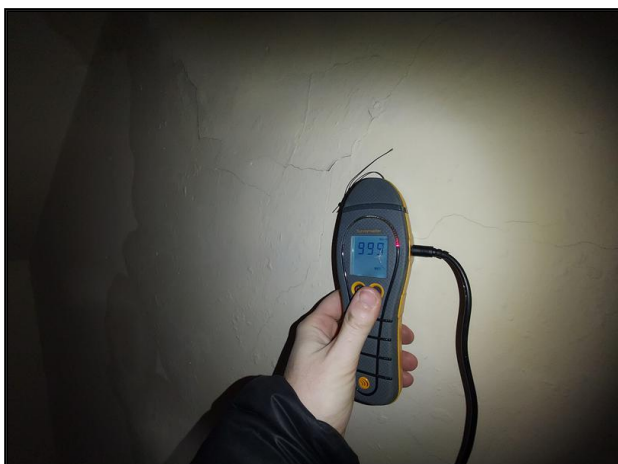
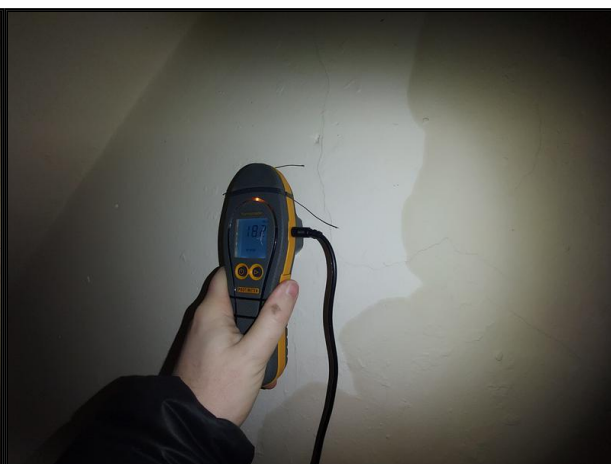
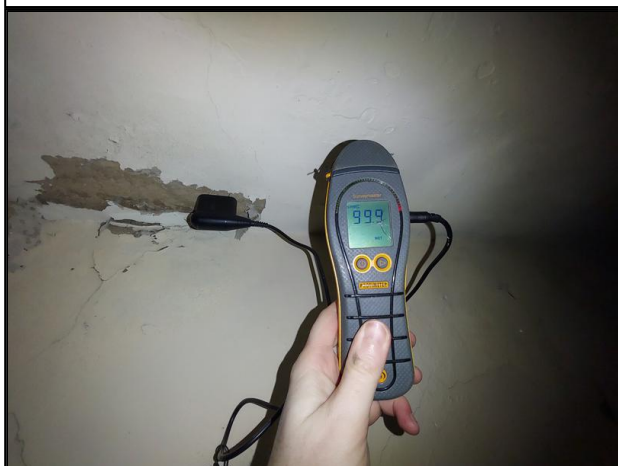
- 5.11 The profile and damp contours exhibited on the party wall within the rear, second floor bedroom are comparable to those evidenced within the accommodation at the front of the property and are likely attributed to the same defect. For assurance the surveyor captured the relative moisture content within the stained area, which confirmed 'wet' readings (999REL) before exhibiting a sharp change to 'dry' condition outside of the visible area (i.e., 182REL). (See figures 23 - 27)

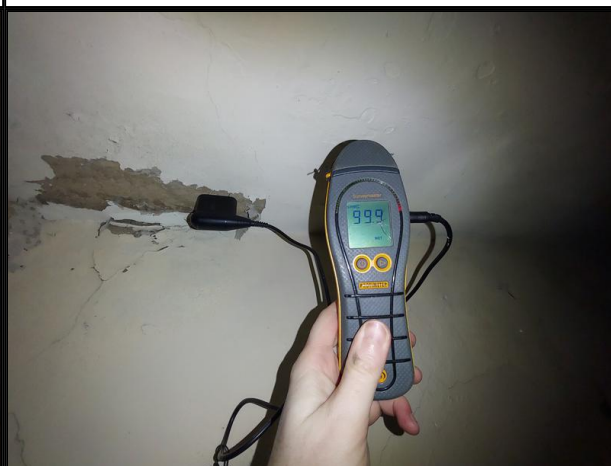
- 5.12 Emulsion paint was observed flaking from the ceiling at the junction with the party wall. The surveyor captured the wood moisture equivalent within the affected area which confirmed high 'wet' readings (99.9%wme). (See figure 28)

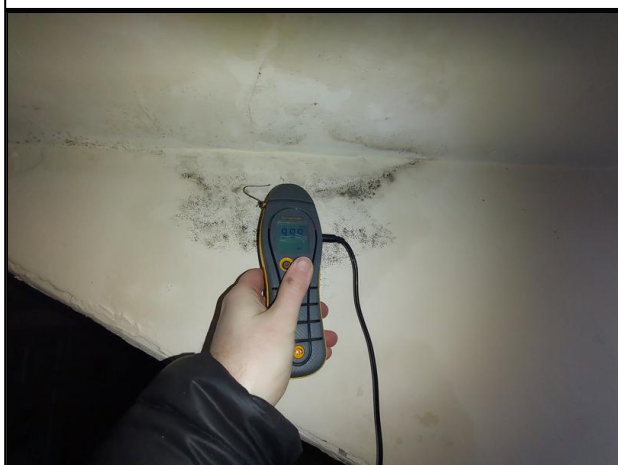
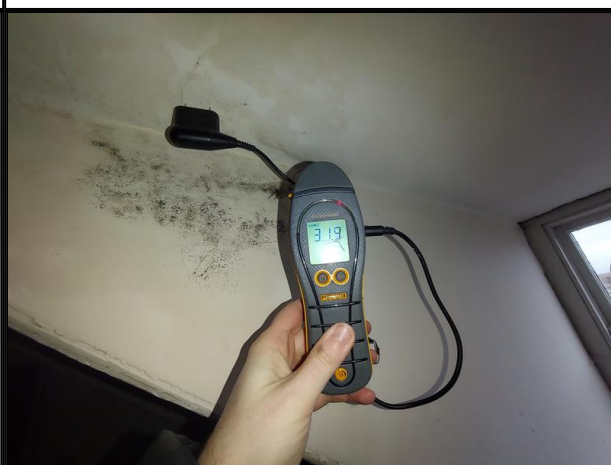
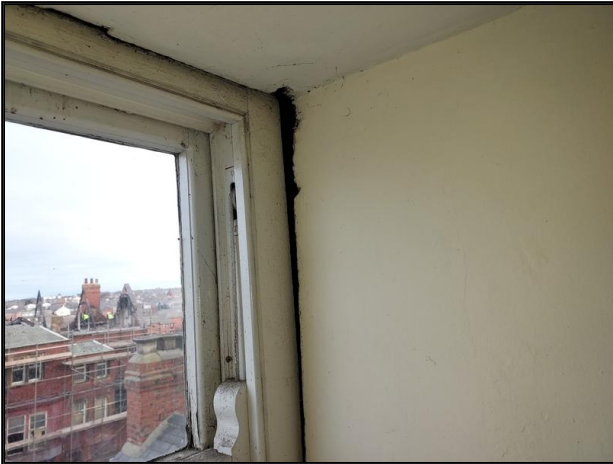
- 5.13 Water staining and black spot mould (*Aspergillus Niger*) was recorded on the internal face of the dormer cheeks. The surveyor recorded the relative moisture content within the affected area, which illustrated high 'wet' readings i.e., 999REL. Similarly, the wood moisture equivalent of the ceiling was documented as 31.9%wme which again represents 'wet' conditions.

The surveyor noted a gap (circa 25mm wide) between the right-hand side of the window jamb and dormer cheek, which is considered to impair the weathertightness of the property. (See figures 29 - 31)

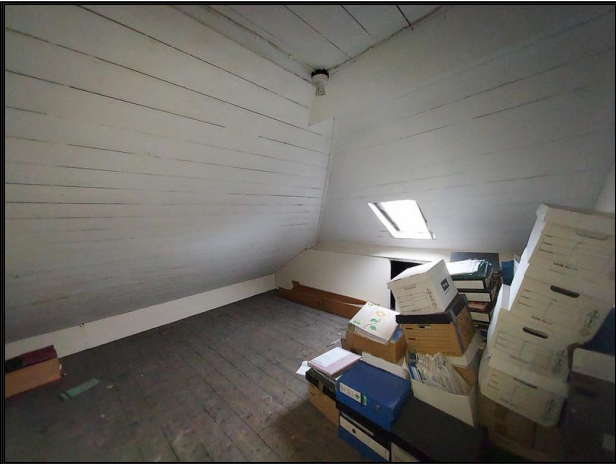
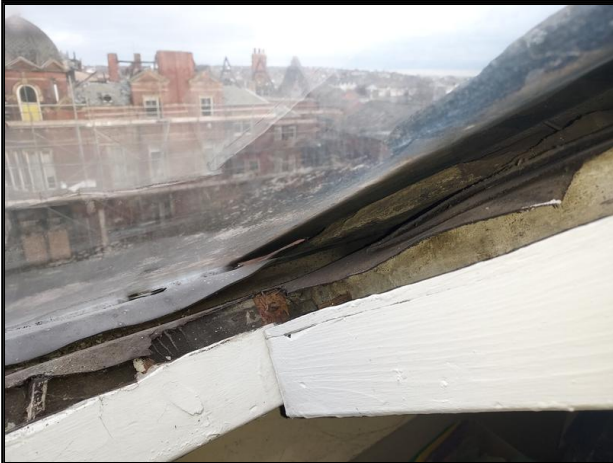
- 5.14 The underside of the roof and walls are finished with timber panelling, which has potential to conceal underlying defects; however no obvious evidence of damp or water damage was observed to the surface finish on the date of inspection.

The surveyor noted significant gaps around the edge of the roof light, which are considered to be vulnerable to rain water penetration. The timber frame on the roof light is considered to be at the end of their predicted life expectancy where evidence of rot and deterioration is evident. (See figures 32 - 33)

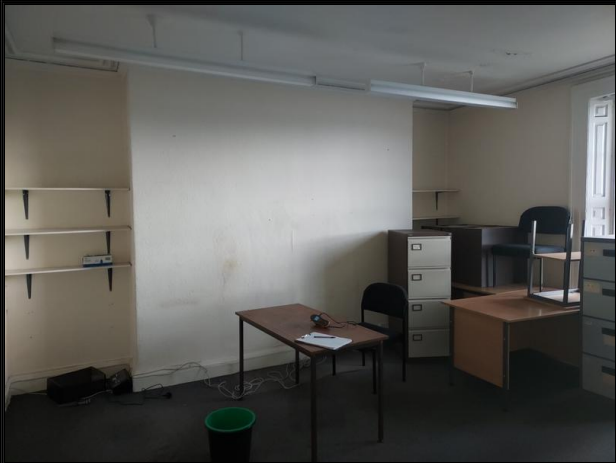
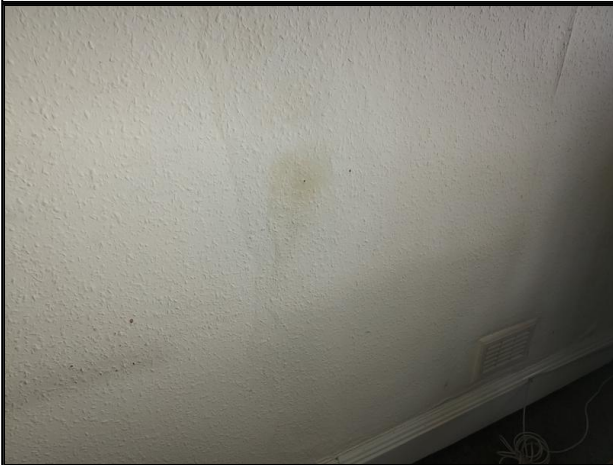
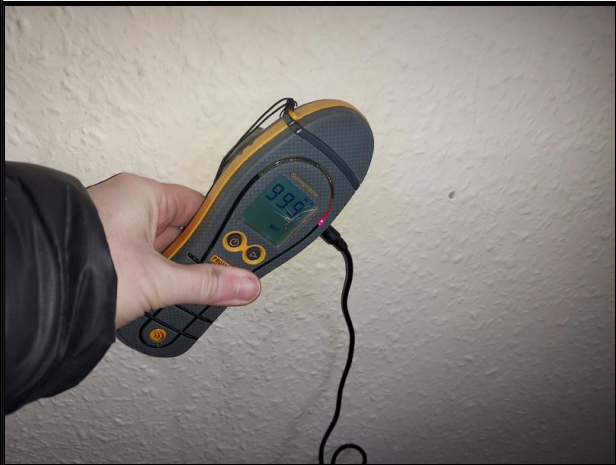
- 5.15 A large chimney breast is sited against the party wall, and is finished with a decorative textured wall paper finish. As observed in the accommodation directly above; the chimney breast exhibits localised areas of dampness confirmed by high moisture readings to the fabric within the affected areas (i.e., 999REL).

A static vent was documented at the foot of the chimney breast, confirming that it is redundant.  
(See figures 34 - 36)

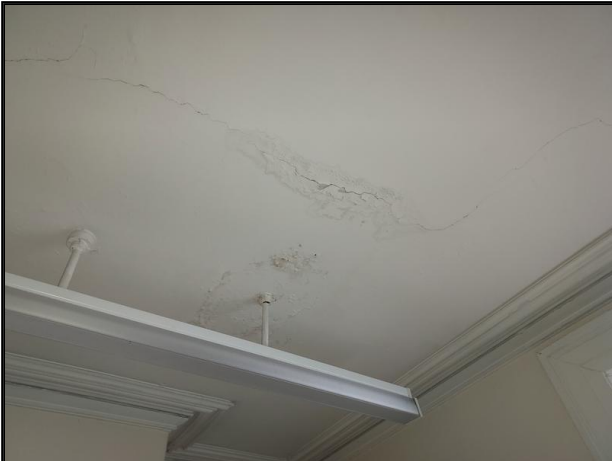
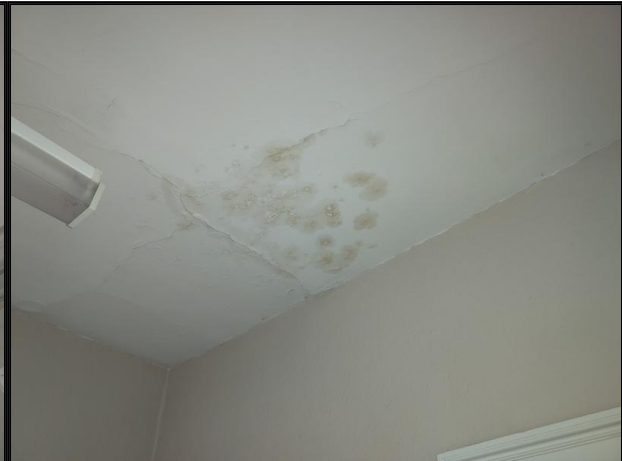
- 5.16 The plaster on the ceiling was noted to be blistered and cracked in isolated areas toward the front elevation. Owing to the height of the ceiling and restricted access the surveyor was unable to record the current moisture content of the ceiling finishes; however the pattern is believed to be indicative of penetrating damp.  
(See figures 37 - 38)

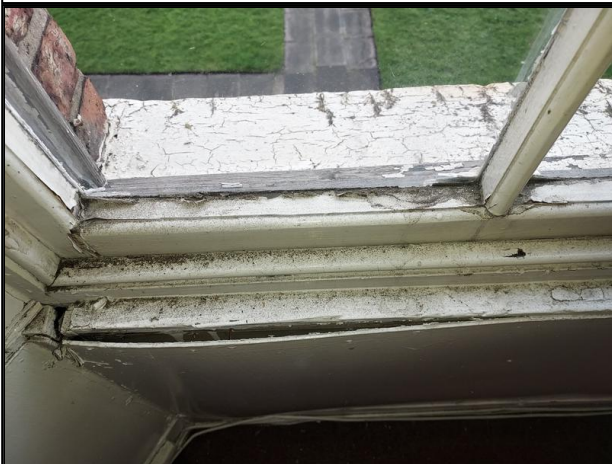
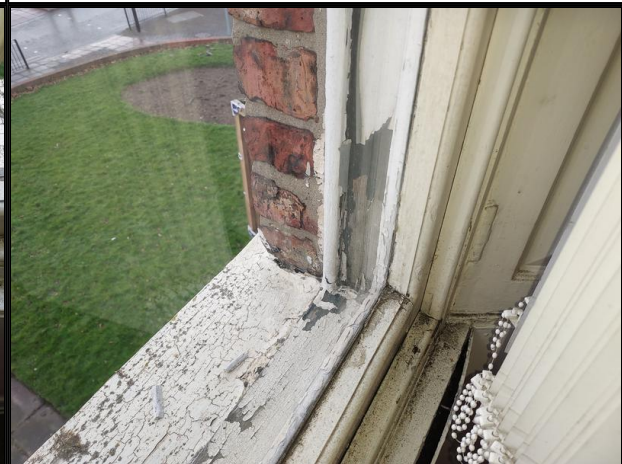
- 5.17 The sash timber window frames are in a poor state of disrepair where the external paint has cracked and flaked away to expose the underlying surface to the elements. The timber components were shown to be suffering from evidence of rot and decay, which is a progressive defect.  
(See figures 39 - 40)

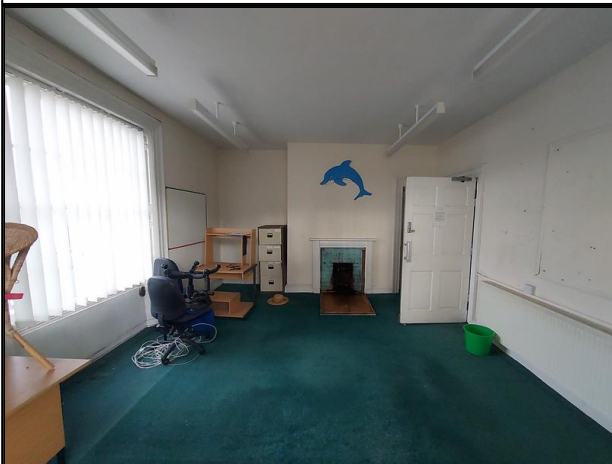
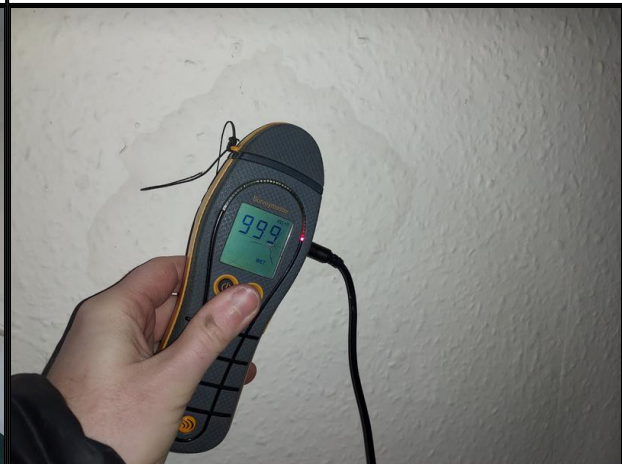
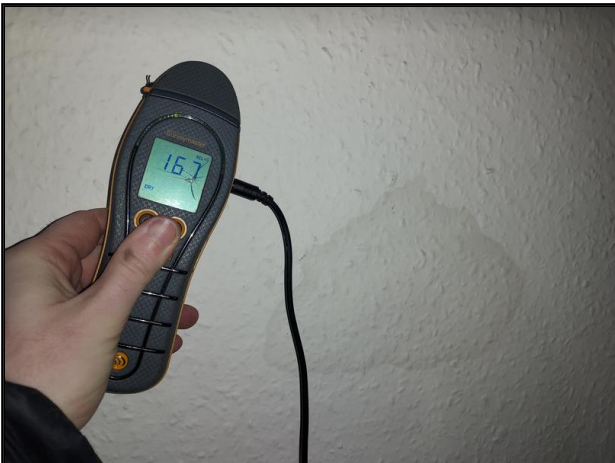
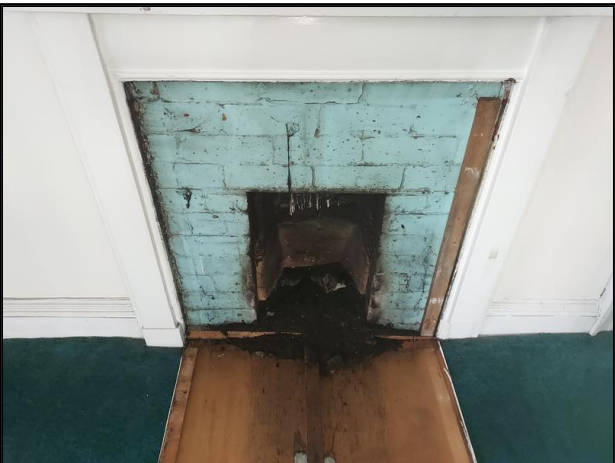
- 5.18 Defined isolated patches of water staining were recoded on the face of the chimney breast, which is covered with a decorative textured wall paper finish. Inside of the discoloured area the surveyor captured high relative 'wet' readings (999REL), which illustrated a sharp change to dry conditions outside of the affected area. This profile is considered to be indicative of penetrating damp.

The surveyor noted that a timber panel concealing the fire place had been removed prior to the inspection by the client. A significant amount of soot and debris was noted to have accumulated in the mouth of the fire opening.  
(See figures 41 - 44)

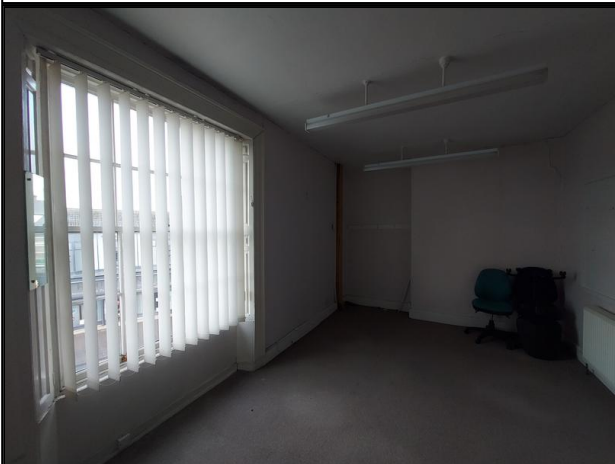
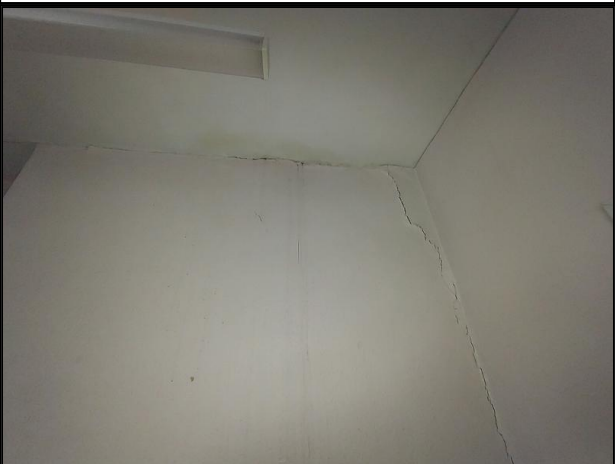
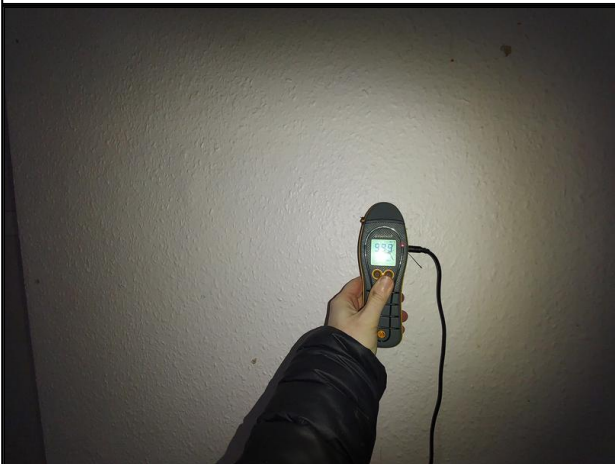
- 5.19 As observed elsewhere within the dwelling the chimney breast is finished with a textured wall paper finish.

Water staining can be observed streaking down from the ceiling level and a vertical hairline crack has manifested at the junction with the solid partition, which has torn the wall paper.

A moisture meter was used to record the relative moisture content on the face of the chimney breast, which illustrated concentrated patches of damp, exhibiting high 'wet' readings (999REL).  
(See figures 45 - 47)

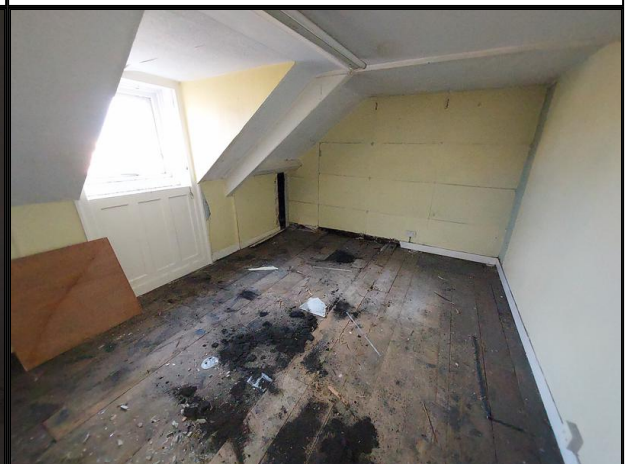
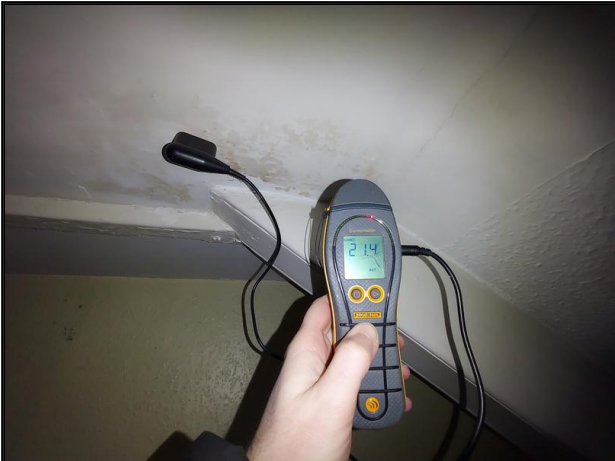
- 5.22 No visible damp symptoms were identified on the party wall shared with '5 Beach Road' however damp staining was evidenced around the dormer window. A moisture meter was used on the ceiling within the dormer, which revealed a wood moisture equivalent of 21.4%wme 'wet'.  
(See figures 54 - 55)

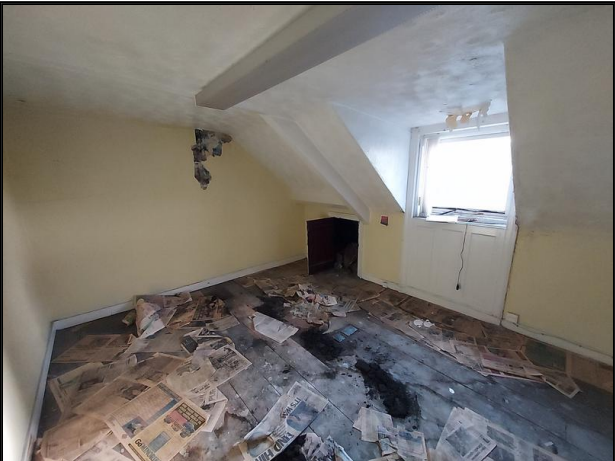
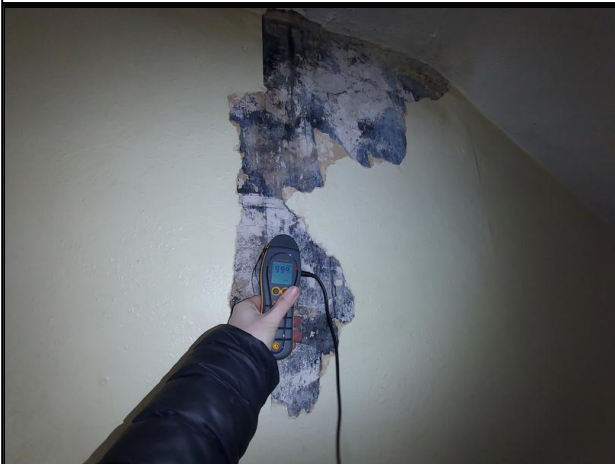
- 5.23 On the party wall (shared with '5 Beach Road') the wall is finished with a decorative textured wall paper, which appears to have suffered from water damage and has been torn away in areas. The surveyor recorded the relative moisture content, which revealed high 'wet' readings (999REL) within the affected area.  
(See figures 56 - 57)
