## **VISUAL STRUCTURAL DEFECT APPRAISAL**

1 Beach Road  
South Shields  
NE33 2QA

15 March 2021

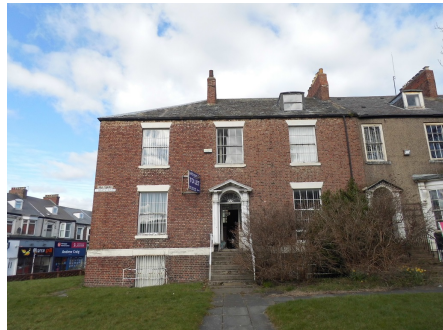
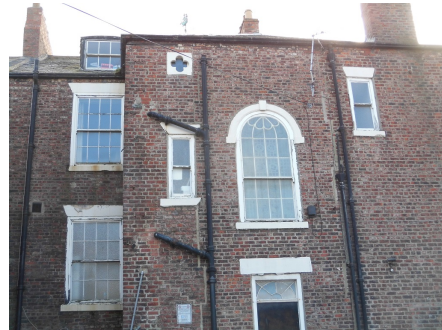
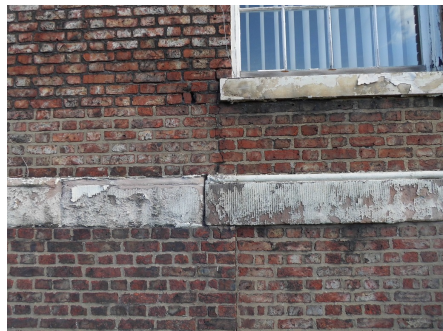
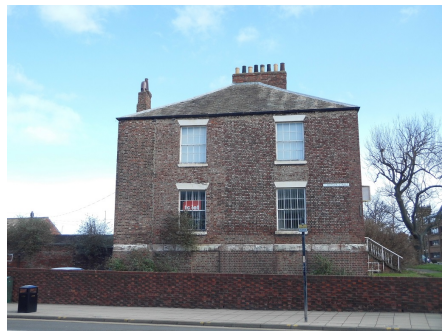
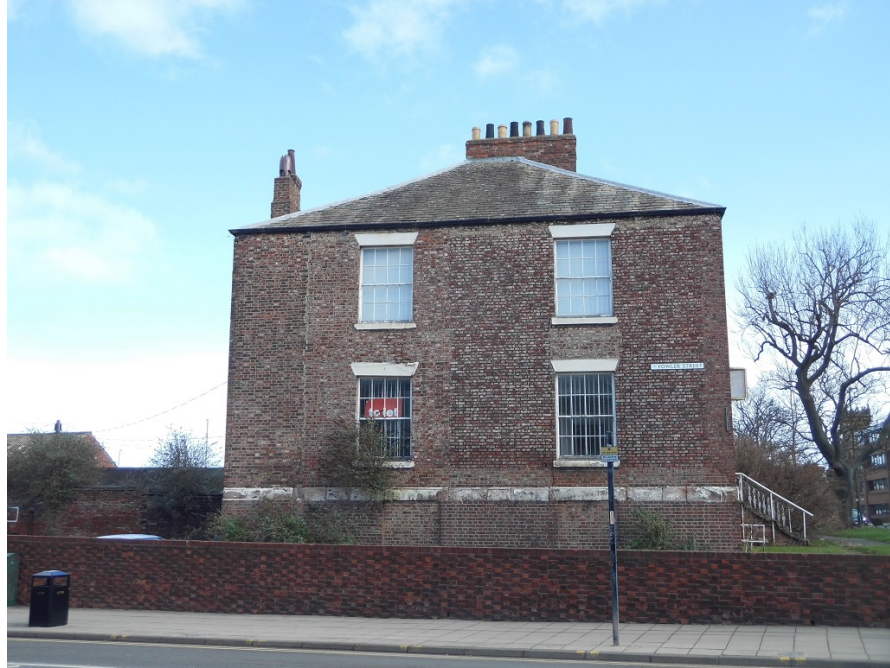
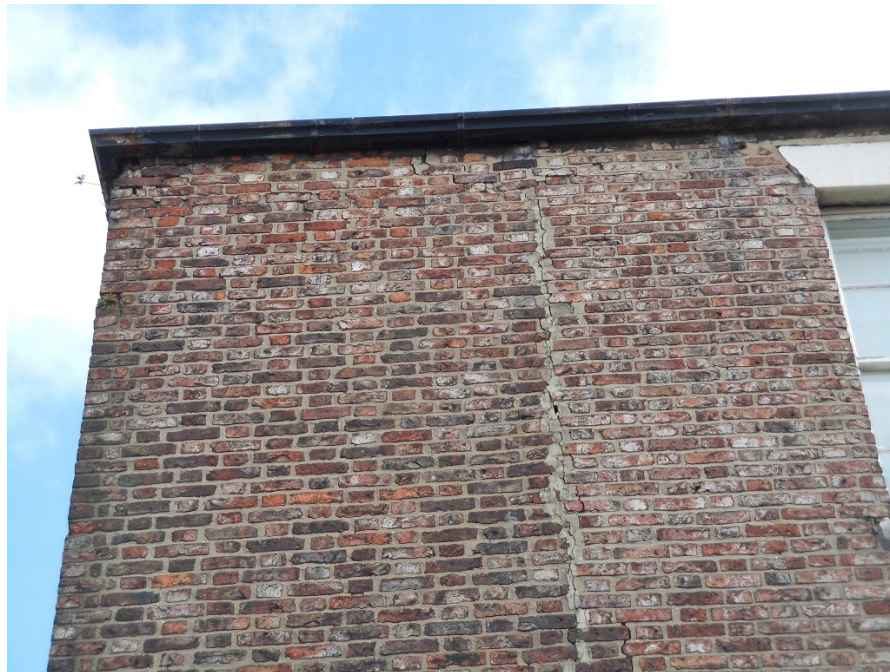
The masonry to the rear of the gable elevation appears a differing brick colour and the brickwork to the chimney gable elevation also appears a differing colour to the rear section. Previously remediated vertical cracking is noted at the juncture of the brick colours. The vertical cracking is a maximum at high level with the current crack width estimated at 8-10mm and tapering to 1mm near to ground level. The original crack width is difficult to assess due to remediation with excess mortar and an overall maximum crack width of 20-30mm is estimated as indicative of the overall lateral movement. There is a similar vertical brick colour differential and associated cracking and remedial work to the rear elevation and the new crack width is estimated at 5-7mm with overall movement estimated at 30-40mm.

A small height of vertical cracking of maximum width estimated at 3-4mm is noted to the gable elevation under the ground floor level right side window cill.

There is evidence of vertical movement of masonry to the right side of the left ground floor window lintel, allowing the right side of the stone lintel to drop an estimated 15-20mm.

- The property has been subject to significant historic structural movement (BRE 251 Category 4) which is exhibited in settlement of external walls and external cracking as the later rear extension has rotated away from the original building an estimated 35-40mm in each orthogonal direction (ie both sideways and rearwards).

- The movement has not affected the structural integrity of the building.
- New rotational cracking of width estimated upto 10mm as occurred in the interval since the cracking was last remediated. This is estimated as 10-15 years ago.

- The movement appears concentrated to gable and rear offshoot elevation as far as the staircase, this is the region of the later extension.
- The movement above the ground floor gable window appears isolated and has allowed the right side of the stone lintel to drop an estimated 15-20mm.

- The original timber roof structure appears retained and unmodified, no defect of roof structure was apparent.
- The external masonry walls show extensive loss of mortar to brickwork joints. All loose, cracked, failed and open mortar joints should be raked clean and made good with a graded mortar to match original. Due to the age of the building, this is likely to require a specialist lime mortar.

- There is little evidence of movement has ceased, however, the likelihood of severe ongoing movement is deemed low.
- Further rotational movement of the rear extension away from the original building may be mitigated by structural stitching of affected masonry walls using a proprietary system such as Helifix. Such systems adopt stainless steel ties across cracks and through the masonry to control further movement.

- Structural stitching can also be used to remediate the cracked masonry in the vicinity of the dropped lintel at the ground floor gable window.
- See [www.Helifix.com](http://www.Helifix.com) or equivalent [www.twistfix.co.uk](http://www.twistfix.co.uk) for further proprietary information. (Helifix BowTie and Helifix Helibar or equivalent).

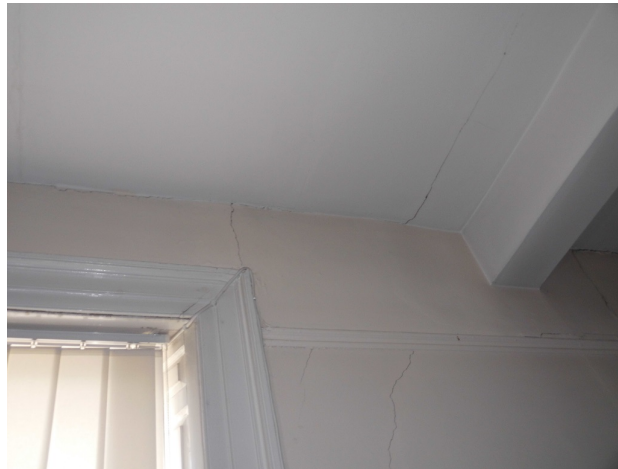
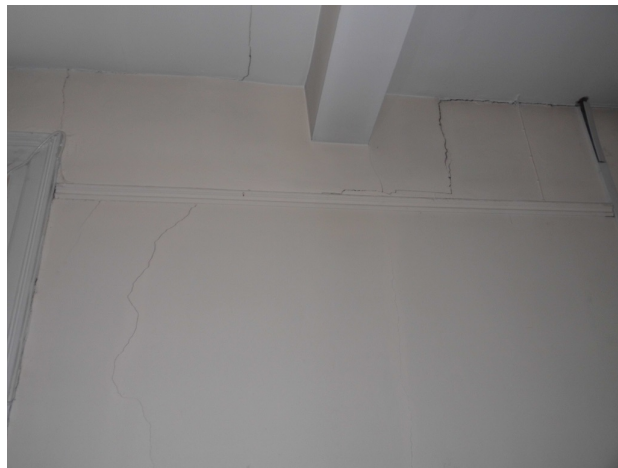
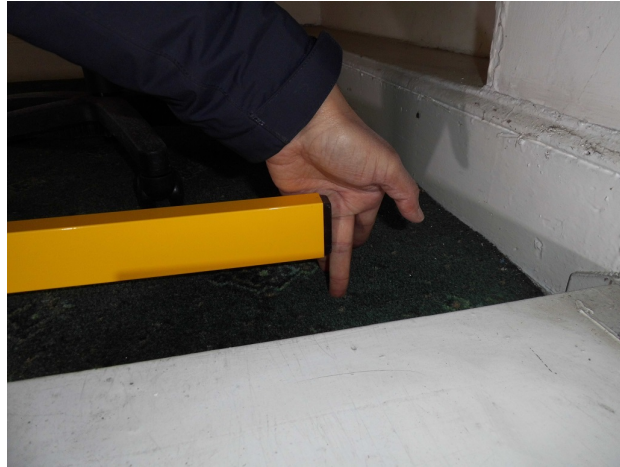
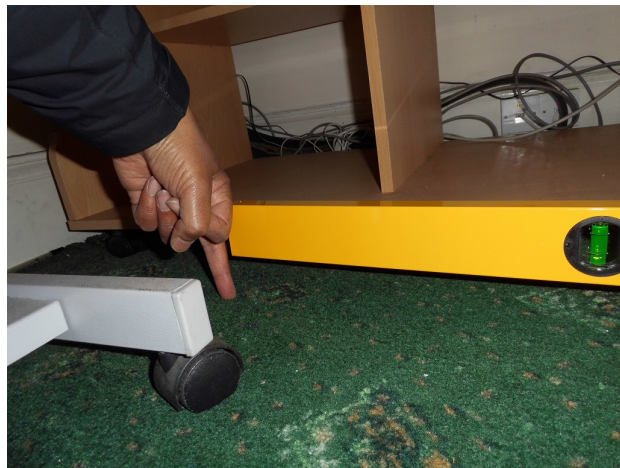
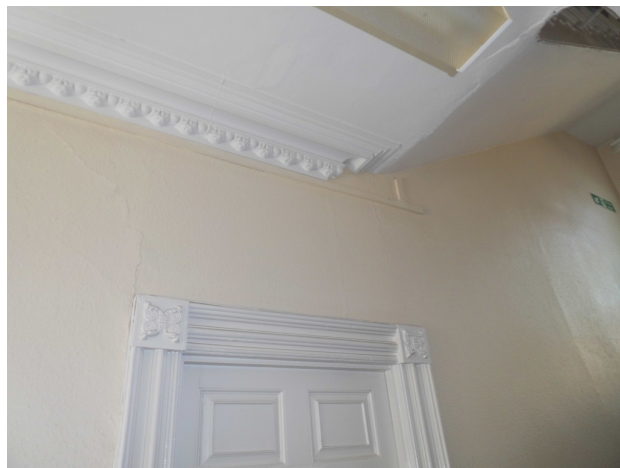
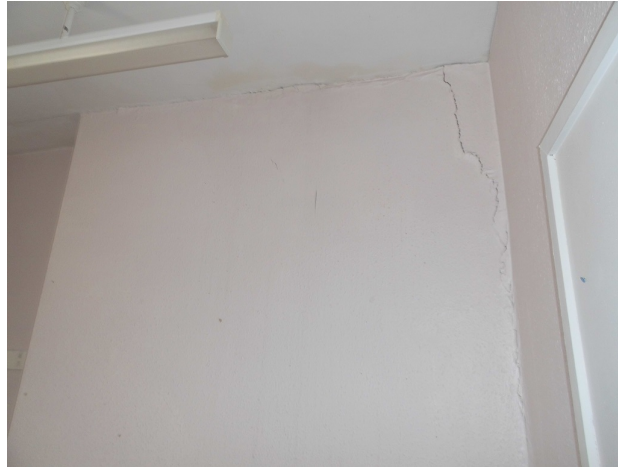
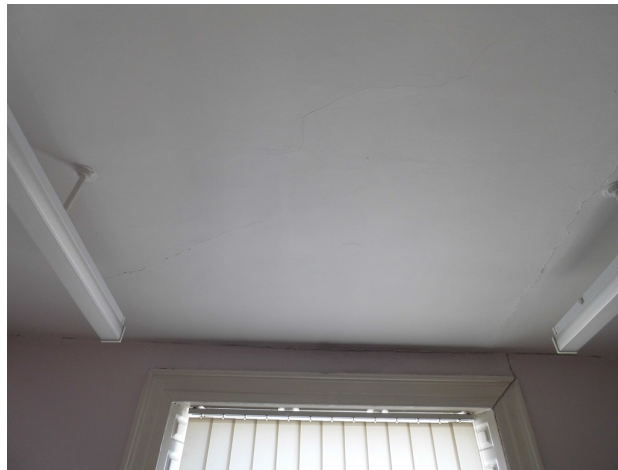
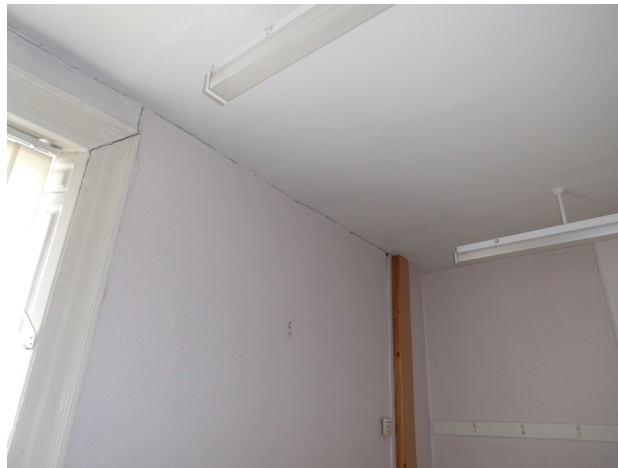
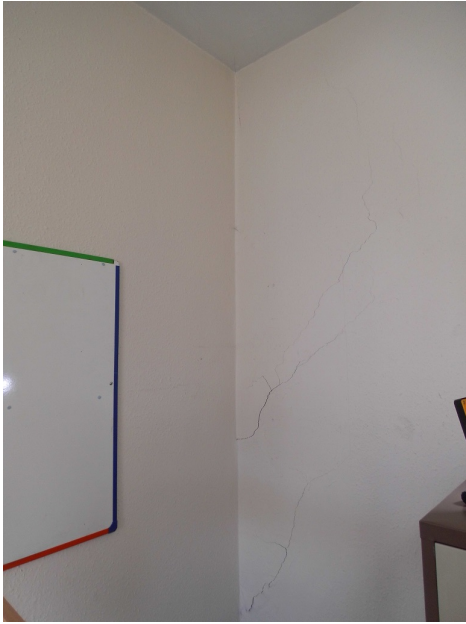
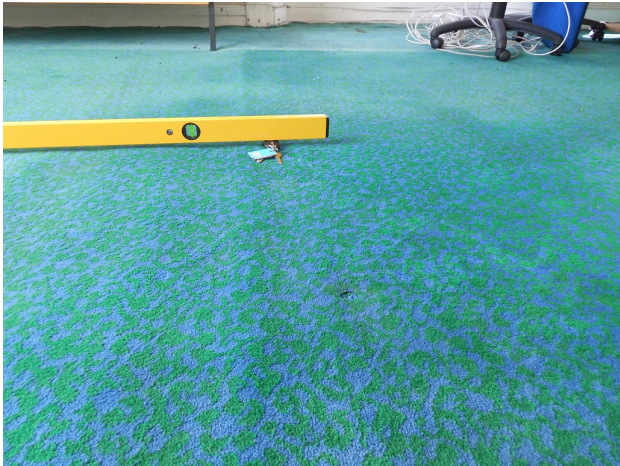
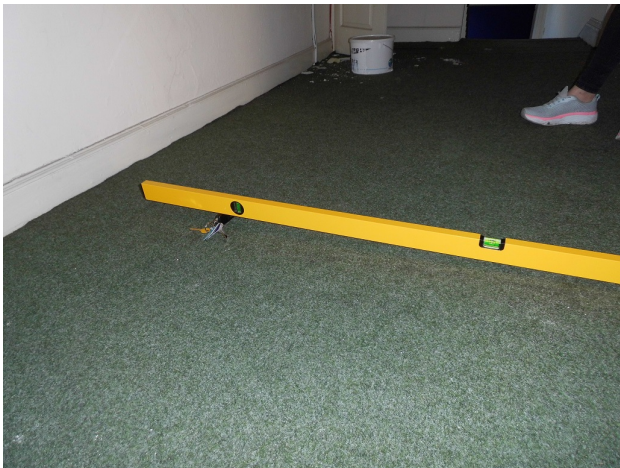
The majority of floors are found to be acceptably level, however, there is significant sloping of floors noted adjacent the gable and rear walls. The slope is estimated at 25-35mm over a 1.8m length at ground floors and 10-15mm at 1<sup>st</sup> floors. There is minor cracking of plaster finishes throughout the property of maximum width estimated at 2-3mm and the majority of the cracking is noted throughout the rear half of the property and most frequent at the rear extension adjacent removed walls. Internal beams are noted to rooms to the rear of the property adjacent the gable wall, which line through with external vertical cracking and brickwork colour differential, and this is indicative of original rear walls being removed to allow a rear extension to the property.

- The internal ground floors adjacent the movement show significant slope, and flooring should be removed to check joist bearings remain adequately seated, and the floors relevelled as far as practicable. The 1<sup>st</sup> floors adjacent the movement slope less severely and these floors may have been recently relevelled for commercial use.
