# **Preliminary Bat Roost Assessment**

**29 Whitburn Road, Cleadon**

**November 2024**

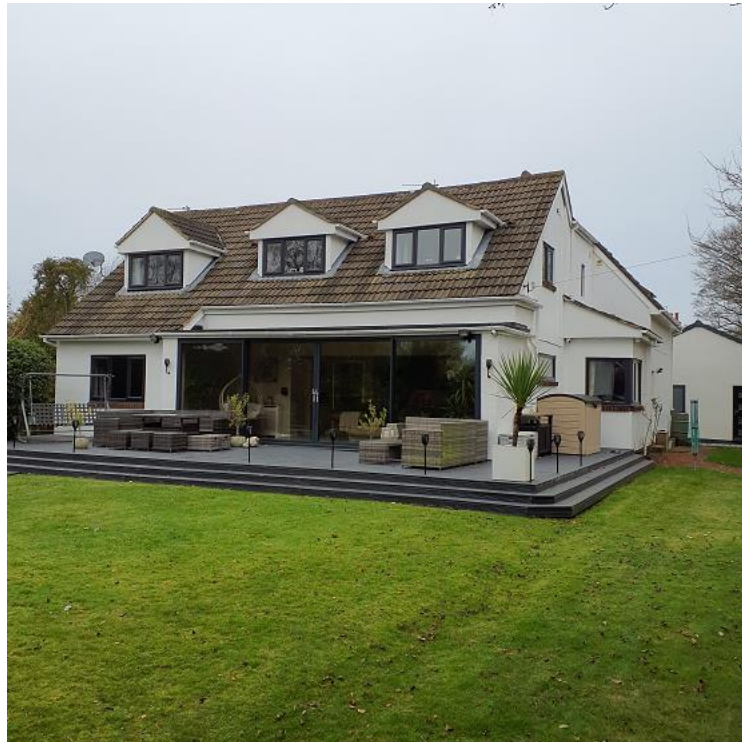
The building proposed for development is a large, detached, brick cavity-wall dormer bungalow (Photos 1-4, Appendix A). The building has an L-shaped ground plan with east, west, north and south facing roof pitches. The steeply pitched and gabled roof is finished in concrete Roman tiling, and has uPVC boxing at the eaves. Three pitch-roofed dormers are present on the south-facing roof pitch (Photo 1) and two Velux windows on the east-facing pitch (Photo 2), both at the rear of the building. At the front of the building there is a single dormer on the west-facing pitch and three Velux windows on the north-facing pitch (Photo 3). A small ground floor annex with a shallow-pitched roof is present below the east-facing gable (Photo 2), and a flat roofed patio door unit is present on the south aspect, opening onto an area of PVC decking (Photo 1). Exterior walls are rendered except below the damp proof course.

Photo 1. Building viewed from the SE.

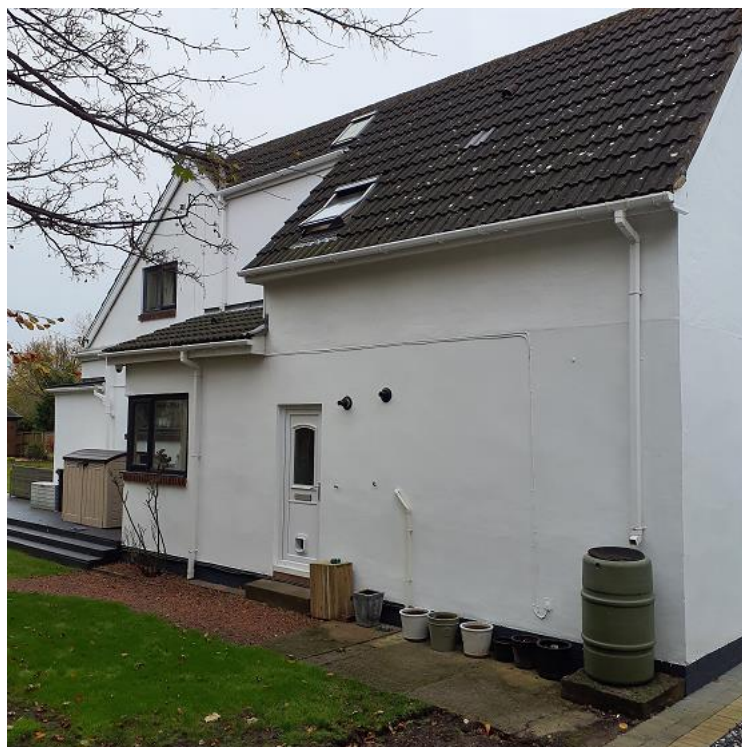
Photo 2. Building viewed from the NE

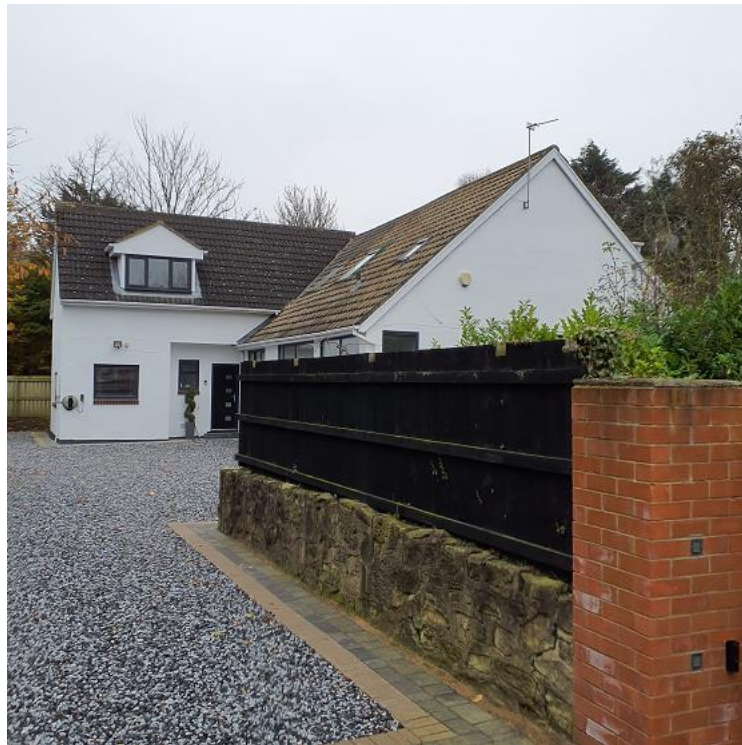
Photo 3. Building viewed from the NW.

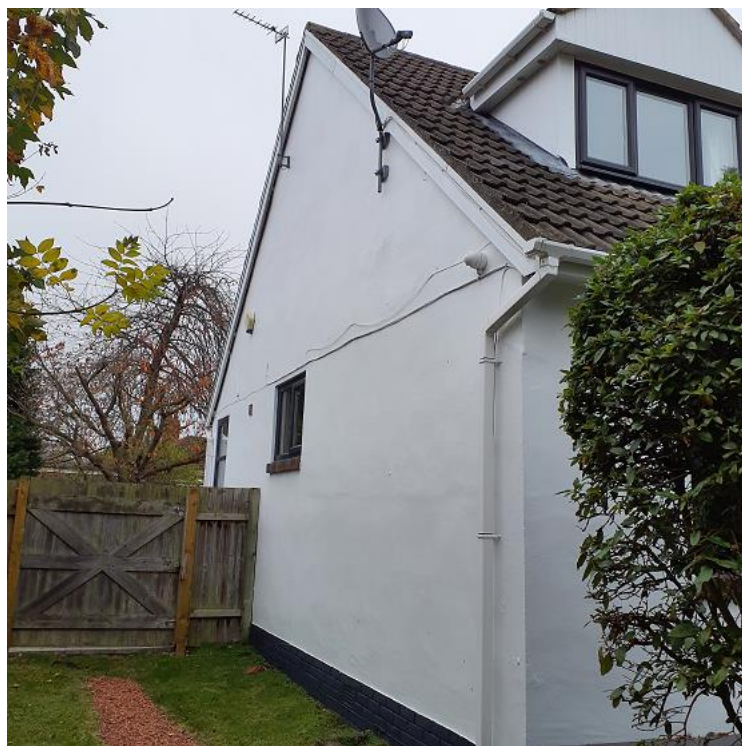
Photo 4. Building viewed from the SW.

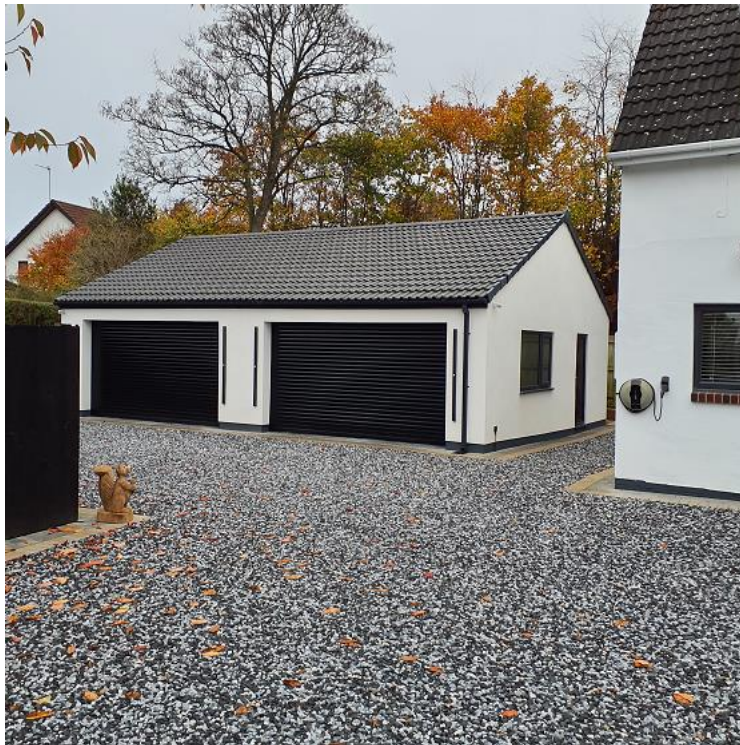
Two further structures are present within the curtilage of the property. Immediately to the north is a double garage with a shallow-pitched roof of similar overall design to the main building (Photo 5). A large PVC shed is also present ca. 50 m to the south of the main building at the far end of an elongate lawned rear garden.

Photo 5. Garage viewed from the SW.

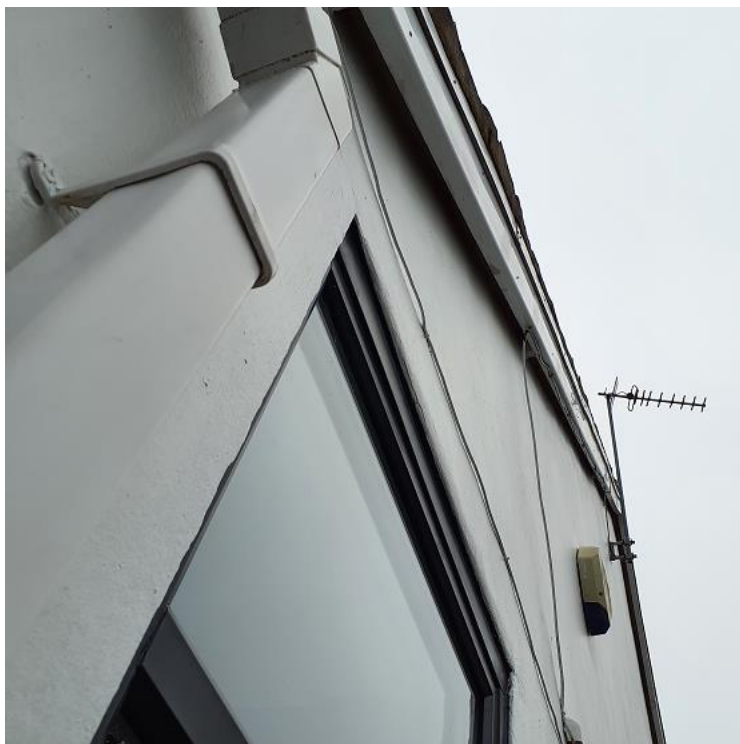
The buildings on the site are in excellent condition overall. No displacement of roofing tiles is visible, and mortar bedding is intact at the verges with the exception of slight decay on the rear dormers. Soffits are sealed to the wall render throughout, and though gaps are present behind barge boards, these are wide and shallow (Photo 6).

Photo 6. Wide/shallow gap behind barge board on west-facing gable.

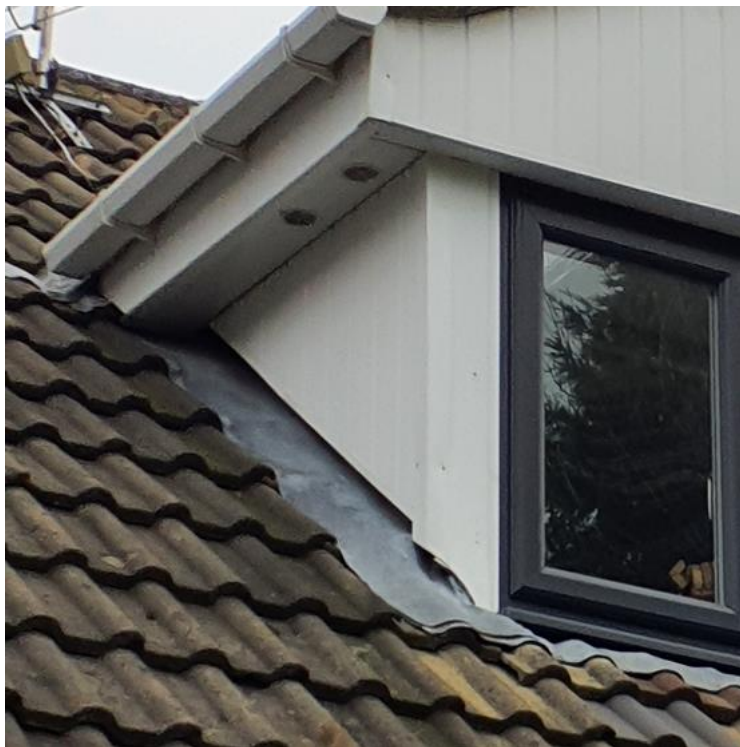
PVC cladding is present above the ground-floor annex on the east-facing aspect, and on the dormers, where there is a suggestion of a gap at the bottom edge of the cladding in some cases (Photo 7). Lead flashing around the base of the dormers also shows gaps between the ridges of the Roman tiling (Photo 8). A gap is also present behind the fascia above the rear patio door unit (Photo 9).

Photo 7. Possible gap behind cladding.

For the property under development, the greatest risk of bat presence occurs around the dormer windows. Prior to demolition, therefore, the cladding and lead flashing on and around the dormers should be carefully removed by hand, checking for the presence of bats on the underside or the covered surface.

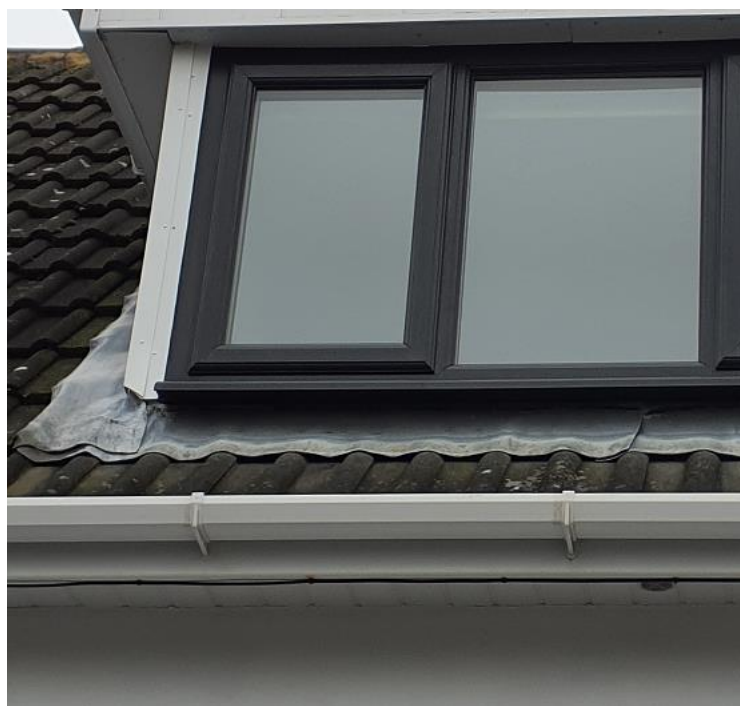
Photo 8. Gaps below lead flashing.

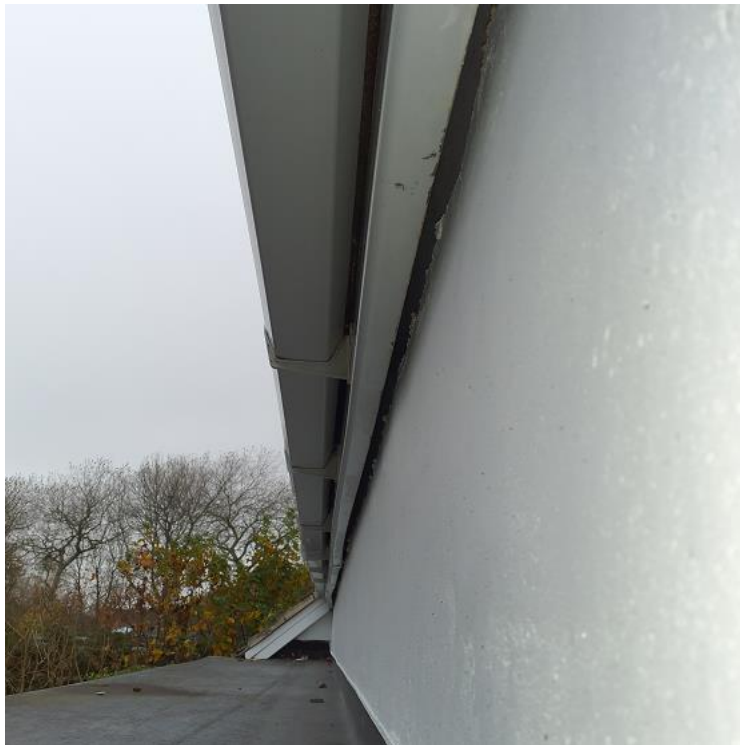
Photo 9. Gap behind fascia above the rear patio door unit.

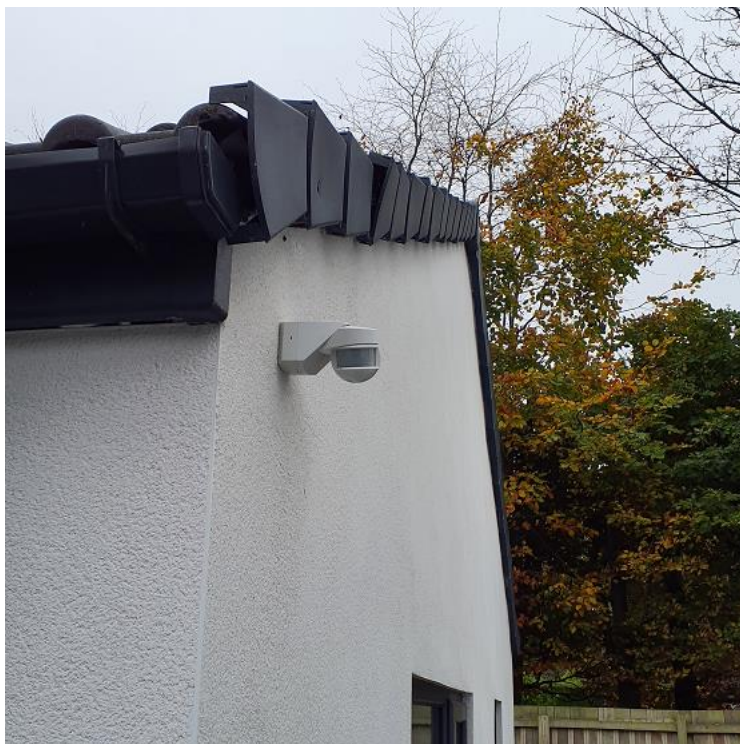
The garage is newly constructed and in generally good condition, except for some displaced dry verge units (Photo 10) a fascia that is slightly dislodged at one end (Photo 11). No void is present within the garage, which has open truss rafters and is lined with breathable membrane (Photo 12).

Photo 10. Displaced dry verge units on the garage.

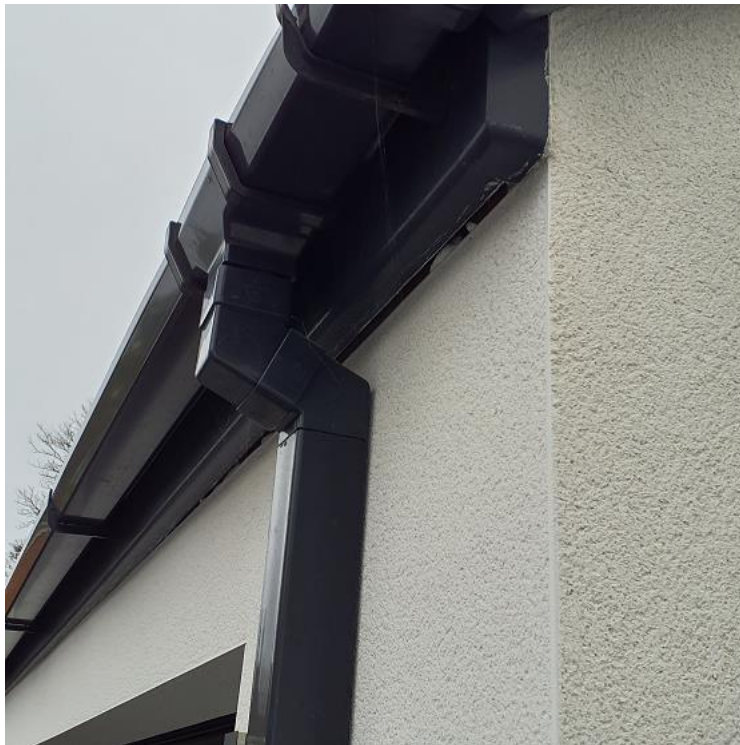
Photo 11. Detached fascia on the garage.

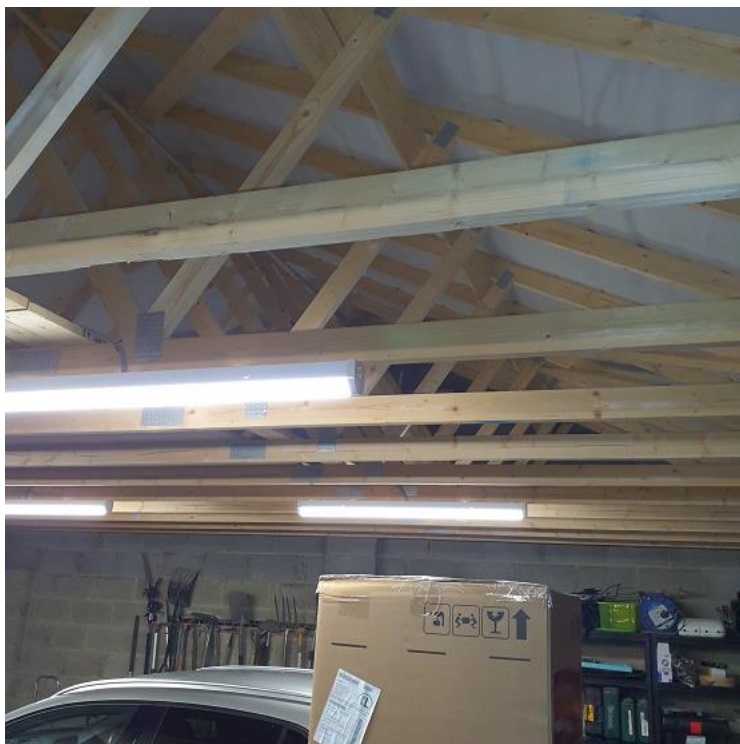
Photo 12. Underside of the garage roof.

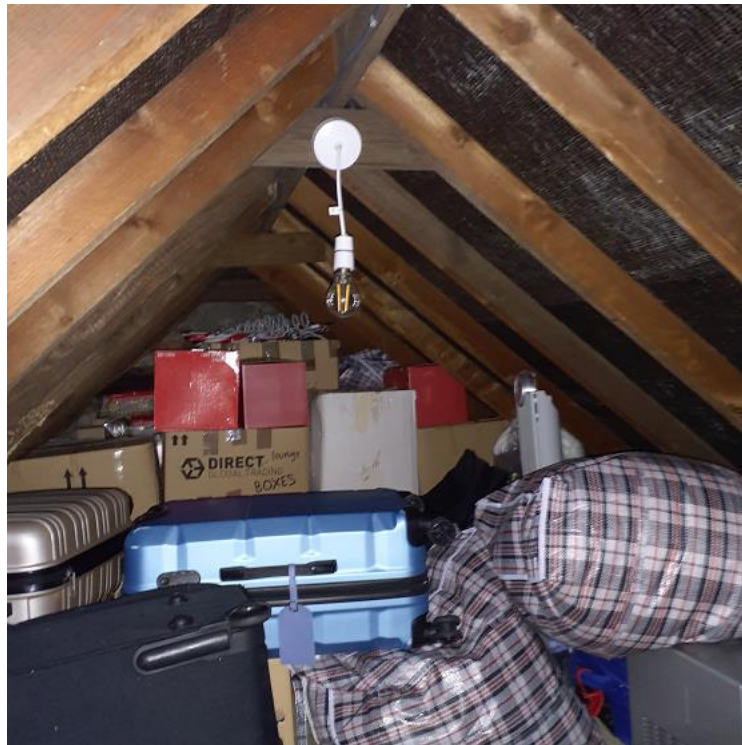
A narrow void is present below the E-W oriented roof ridge, which is fully boarded and has a bitumen lining, and contains numerous storage items (Photo 13). This is torn in places, especially at the junction with the roof of the N-S wing of the building, where some light is visible from the exterior (Photo 14). Only slight cobwebbing is present at the roof ridge, but there is some penetration of plant debris from the exterior, especially near the roof junction.

Photo 13. Main roof void.

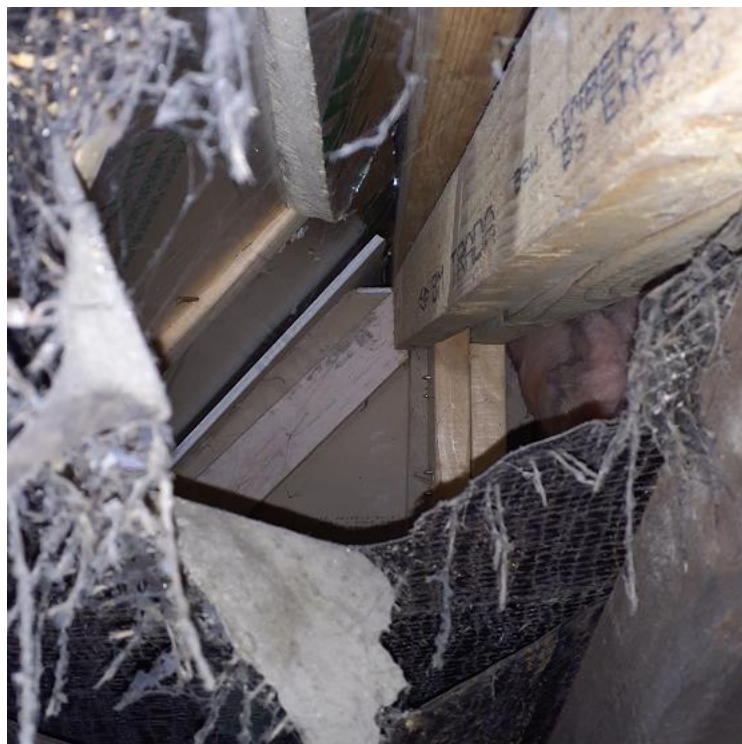
Photo 14. Torn roof lining and light penetration.
