# Arboricultural Consultancy for Lloyds Bank

| Insured | Mrs Lynda Harkus | Address | 1 AVONDALE TERRACE, WEST BOLDON EAST, BOLDON, TYNE AND WEAR, NE36 0PS | | |
| ES Ref | SA-253575 | Consultant | Nigel Chopping | Contact No. | 0330 380 1036 |
| Report Date | 23/08/2023 | | | | |

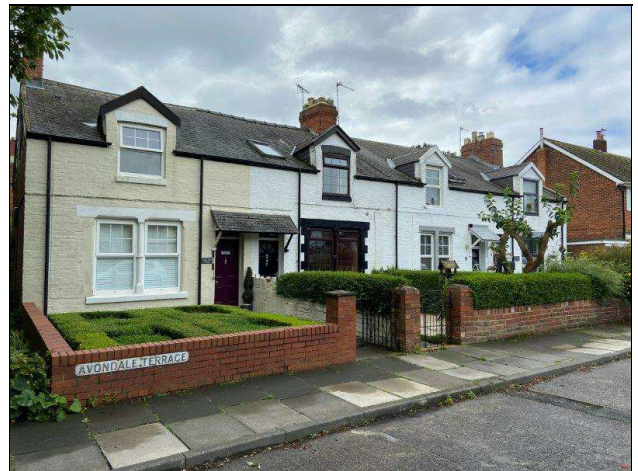
Insured property front with S1 H1 and H2

| Tree No. | Species | Age Cat | Approx. Height (m) | Distance to Building (m) * | Ownership | Action | Requirement |
|---|---|---|---|---|---|---|---|
| H1 | Privet | 1 | 1.2 | 1.6 | A - Third Party | Action to avoid future risk | Maintain at broadly current dimensions by way of regular pruning. |
| H2 | Privet | 1 | 0.4 | 1.1 | C - Insured | Action to avoid future risk | Maintain at broadly current dimensions by way of regular pruning. |
| S1 | Lilac | 1 | 2.5 | 9 | A - Third Party | No action | No works. |
