# Arboricultural Consultancy for Lloyds Bank

| Insured | Mrs Lynda Harkus | Address | 1 AVONDALE TERRACE, WEST BOLDON EAST, BOLDON, TYNE AND WEAR, NE36 0PS | | |
| Client | Subsidence Management Services | Contact | Steven Sargent | Claim No. | IFS-LBG-SUB-23-0108295 |

**Scope of Report:** To survey the property and determine significant vegetation contributing to subsidence damage, make recommendation for remedial action and assess initial mitigation and recovery prospects. The survey does not make an assessment for decay or hazard evaluation.

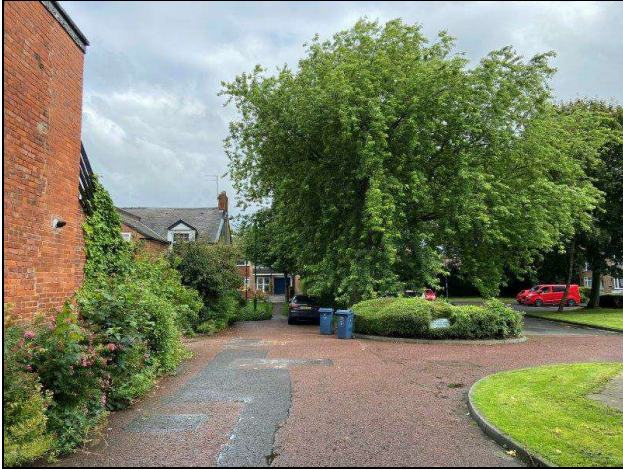
Due to the high probability that T3 and T4 retain conjoined root systems with T5 (Maple (Silver)) and T6 (Maple (Silver)), these trees are also considered significant; it is in our opinion that stability is unlikely to be achieved if works are restricted to T2, T3 and T4 only.

Given the above, we have identified the collective / cohesive influence of T2, T3, T4, T5 & T6 as the primary cause of the subsidence damage.

T6 - Silver Maple

Consequently, we have advocated the complete removal of T2 (Maple (Silver)), T3 (Maple (Silver)), T4 (Maple (Silver)), T5 (Maple (Silver)) and T6 (Maple (Silver)) as it will offer the most certain arboricultural solution likely to restore long-term stability.

| Tree No. | Species | Age Cat | Approx. Height (m) | Distance to Building (m) * | Ownership | Action | Requirement |
|---|---|---|---|---|---|---|---|
| T6 | Maple (Silver) | 1 | 15 | 8.6 | F - Commercial Third Party | Remove | Remove close to ground level and manage stump to inhibit regrowth. |

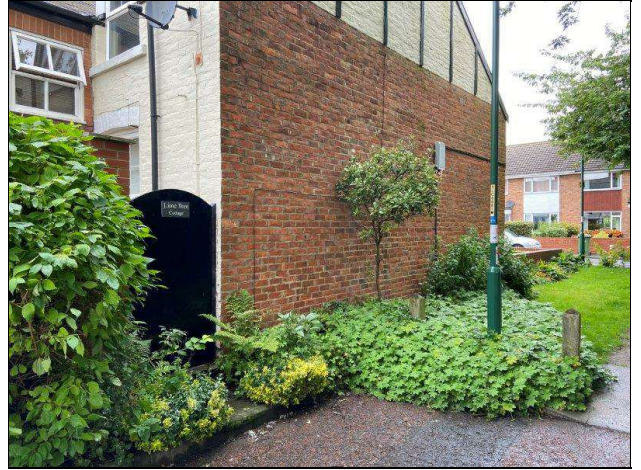
SG1 - Mixed Shrub Group

| Tree No. | Species | Age Cat | Approx. Height (m) | Distance to Building (m) * | Ownership | Action | Requirement |
|---|---|---|---|---|---|---|---|
| SG1 | Mixed species shrubs | 1 | 2 | 0.3 | D - Unknown | Action to avoid future risk | Maintain at broadly current dimensions by way of regular pruning. |

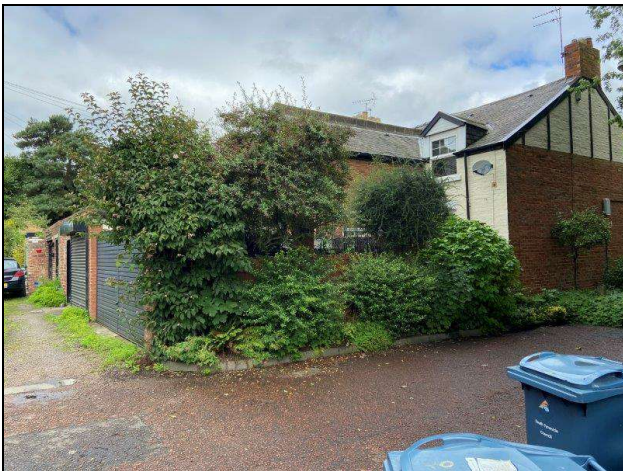
SG2 - Mixed Shrub Group

| Tree No. | Species | Age Cat | Approx. Height (m) | Distance to Building (m) * | Ownership | Action | Requirement |
|---|---|---|---|---|---|---|---|
| SG2 | Mixed species shrubs | 1 | 2.5 | 2 | D - Unknown | Action to avoid future risk | Maintain at broadly current dimensions by way of regular pruning. |

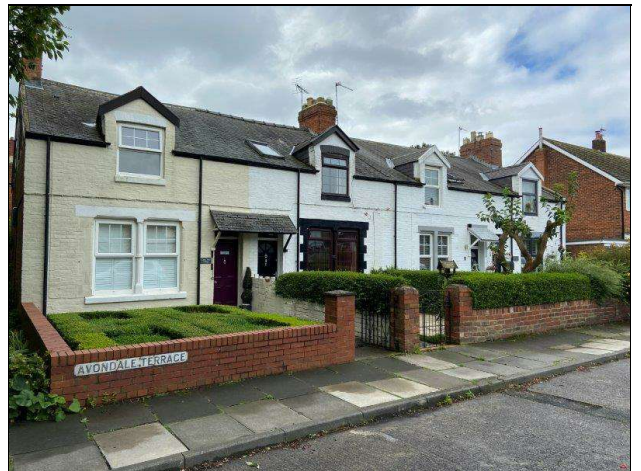
Insured property front with S1 H1 and H2

| Tree No. | Species | Age Cat | Approx. Height (m) | Distance to Building (m) * | Ownership | Action | Requirement |
|---|---|---|---|---|---|---|---|
| H1 | Privet | 1 | 1.2 | 1.6 | A - Third Party | Action to avoid future risk | Maintain at broadly current dimensions by way of regular pruning. |
| H2 | Privet | 1 | 0.4 | 1.1 | C - Insured | Action to avoid future risk | Maintain at broadly current dimensions by way of regular pruning. |
| S1 | Lilac | 1 | 2.5 | 9 | A - Third Party | No action | No works. |

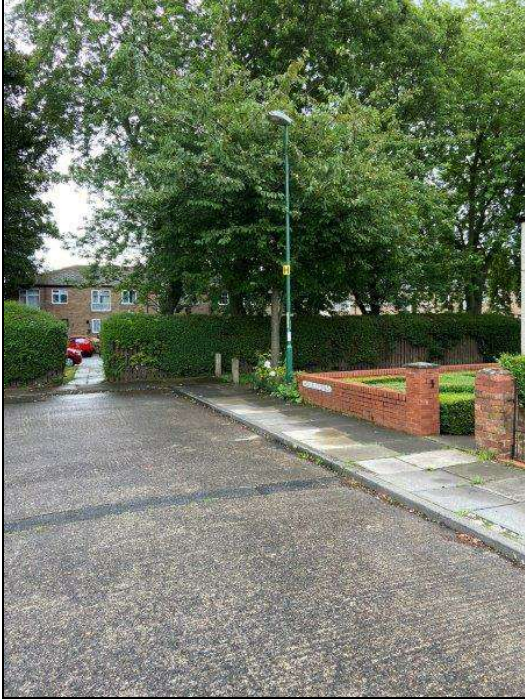
T1 - Cherry

| Tree No. | Species | Age Cat | Approx. Height (m) | Distance to Building (m) * | Ownership | Action | Requirement |
|---|---|---|---|---|---|---|---|
| T1 | Cherry | 1 | 8 | 6.5 | D - Unknown | Action to avoid future risk | Maintain at, or below current dimensions by way of regular pruning. |

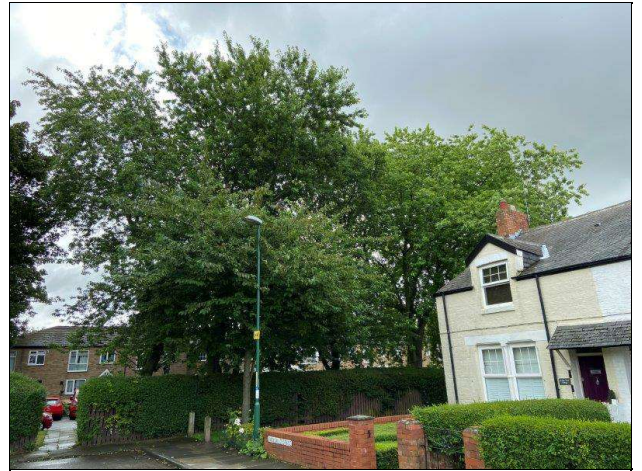
With due regards to species profile, size and proximity, T2 (Maple (Silver)), T3 (Maple (Silver)) and T4 (Maple (Silver)) are considered the dominant features proximate to the focal area(s) of movement and accordingly, where vegetation is confirmed as being causal, we have identified them as the primary cause of the current subsidence damage.

T1 T2 T3 T4 T5 and T6

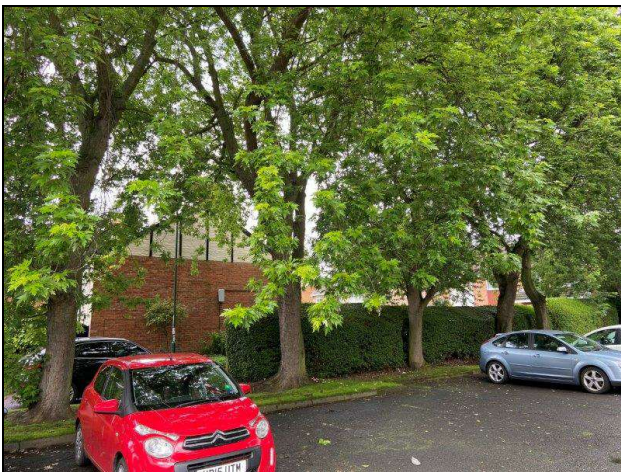
Stems of T2 T3 T4 T5 and T6

| Tree No. | Species | Age Cat | Approx. Height (m) | Distance to Building (m) * | Ownership | Action | Requirement |
|---|---|---|---|---|---|---|---|
| T2 | Maple (Silver) | 1 | 14.5 | 11.6 | F - Commercial Third Party | Remove | Remove close to ground level and manage stump to inhibit regrowth. |
| T3 | Maple (Silver) | 1 | 16 | 9.5 | F - Commercial Third Party | Remove | Remove close to ground level and manage stump to inhibit regrowth. |
| T4 | Maple (Silver) | 1 | 14.5 | 8.9 | F - Commercial Third Party | Remove | Remove close to ground level and manage stump to inhibit regrowth. |
| T5 | Maple (Silver) | 1 | 15 | 8.9 | F - Commercial Third Party | Remove | Remove close to ground level and manage stump to inhibit regrowth. |

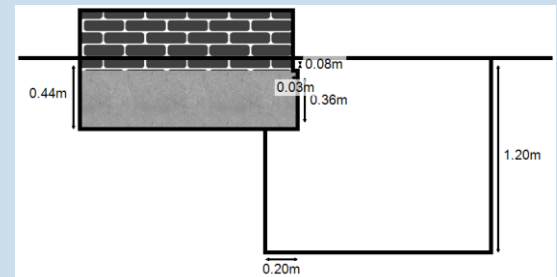
### Foundation Detail

House foundation comprised of brick wall to 80mm bgl, bearing on concrete to 440mm bgl, with a total projection of 30mm from the elevation. Underside of foundation (USF) was exposed to 200mm back from the face of the foundation and probed 200mm back from the face of the foundation.

At 0.44m bgl UNDERSIDE OF HOUSE FOUNDATION in TP/BH1.
