20<sup>th</sup> October 2025

Mr Michael Dickson  
9 Underhill Road  
Cleadow  
Tyne & Wear  
SR6 7RS

Acting on your instructions I have now inspected the trees at the above location.

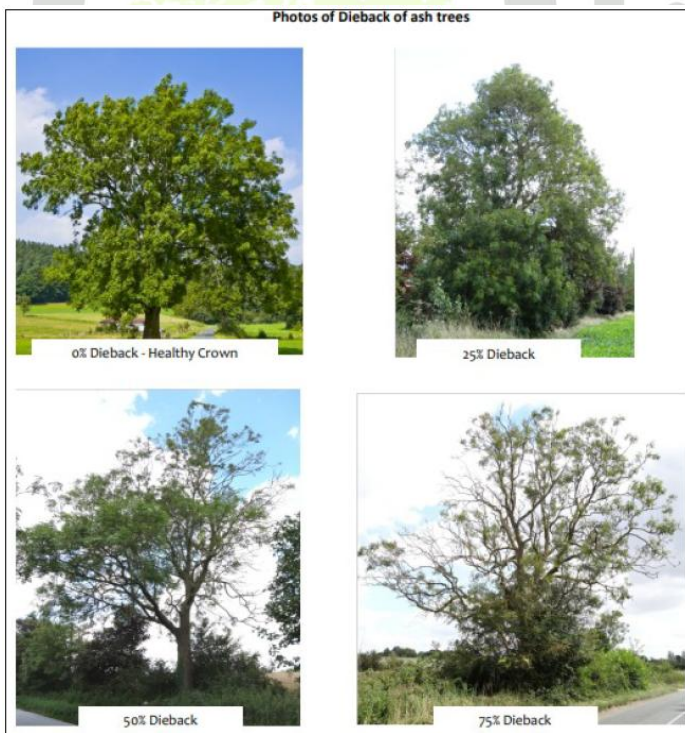
### **Ash Dieback Disease (*Hymenoscyphus fraxineus*)**

Several trees have gone into decline and require removal – notably tree 45 is a large Ash tree which is showing signs of Ash Dieback (see below) and has a crown which spans 3 gardens.

Ash Dieback is a fungal disease formally known as *Chalara fraxinea* which is spread naturally by windborne spores. It has become an endemic in the whole of Britain over the last few years and is known to block the water transport system in trees. This causes leaf loss, lesions in the branches and then as the name suggest the die back of the trees crown. Younger Ash trees are more vulnerable and die quickly once they catch the disease, older trees decline more slowly with the crown gradually dying back further on a yearly basis. This can increase a potential health and safety risk as the pathogen weakens the structural strength of the tree as it dies back, this is specifically important to monitor if the tree is located in a high target area. There is currently no known cure for Ash Die Back.

We recommended that trees are checked for fungus growing on, or around the base in the Autumn. This is generally the time of year most fungus produces fruiting bodies, but the first frost of winter often kills them off so the window to detect this disorder is short. If fungus is noted on or around the base of tree's, please contact our office to arrange a further assessment.
