# Jarrow Town Hall – Photo Schedule

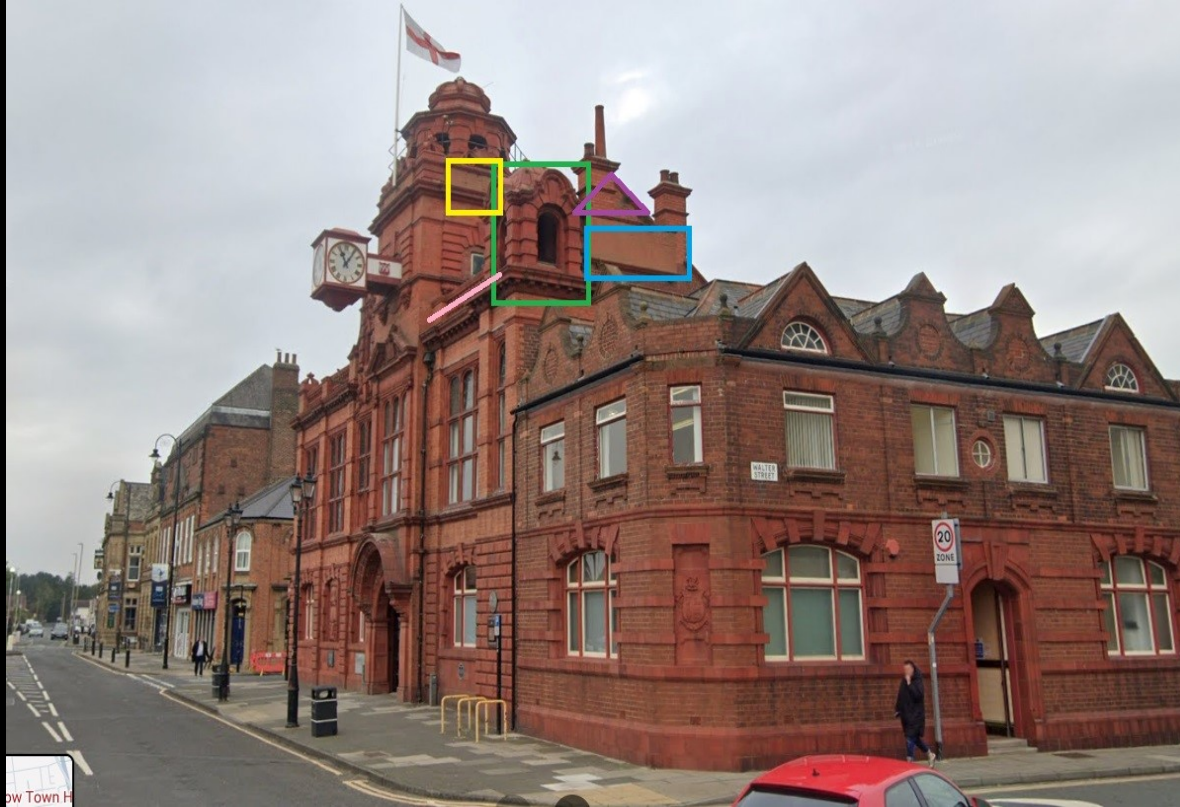
JTH View Mark up 2

- Pink = balustrade / parapet wall with gutter behind
- Green = Small Arch with Parapet behind
- Blue = Parapet wall with failed render
- Yellow = Tower with patched render repair
- Purple = Gable end with patch render repairs

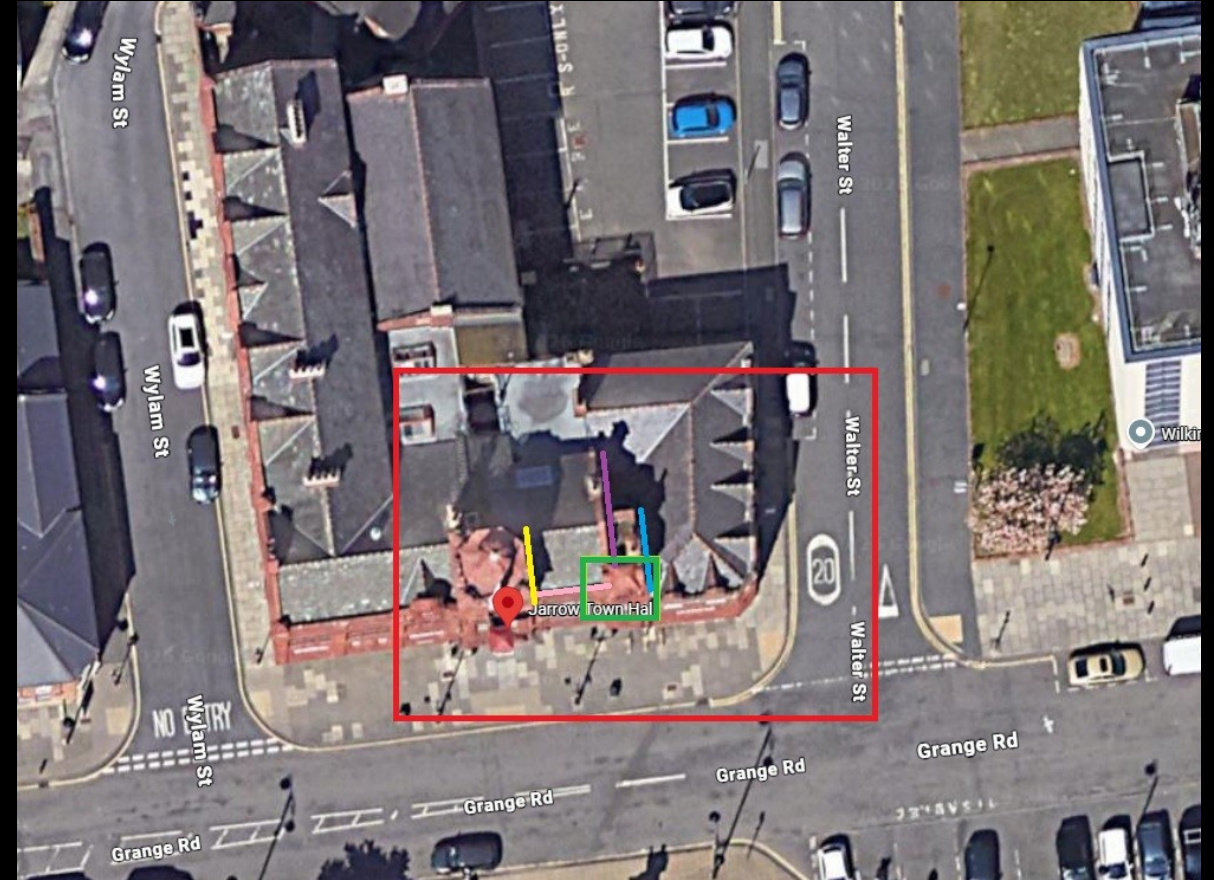
JTH View Mark up 1

- Pink = balustrade / parapet wall with gutter behind
- Green = Small Arch with Parapet behind
- Blue = Parapet wall with failed render
- Yellow = Tower with patched render repair
- Purple = Gable end with patch render repairs

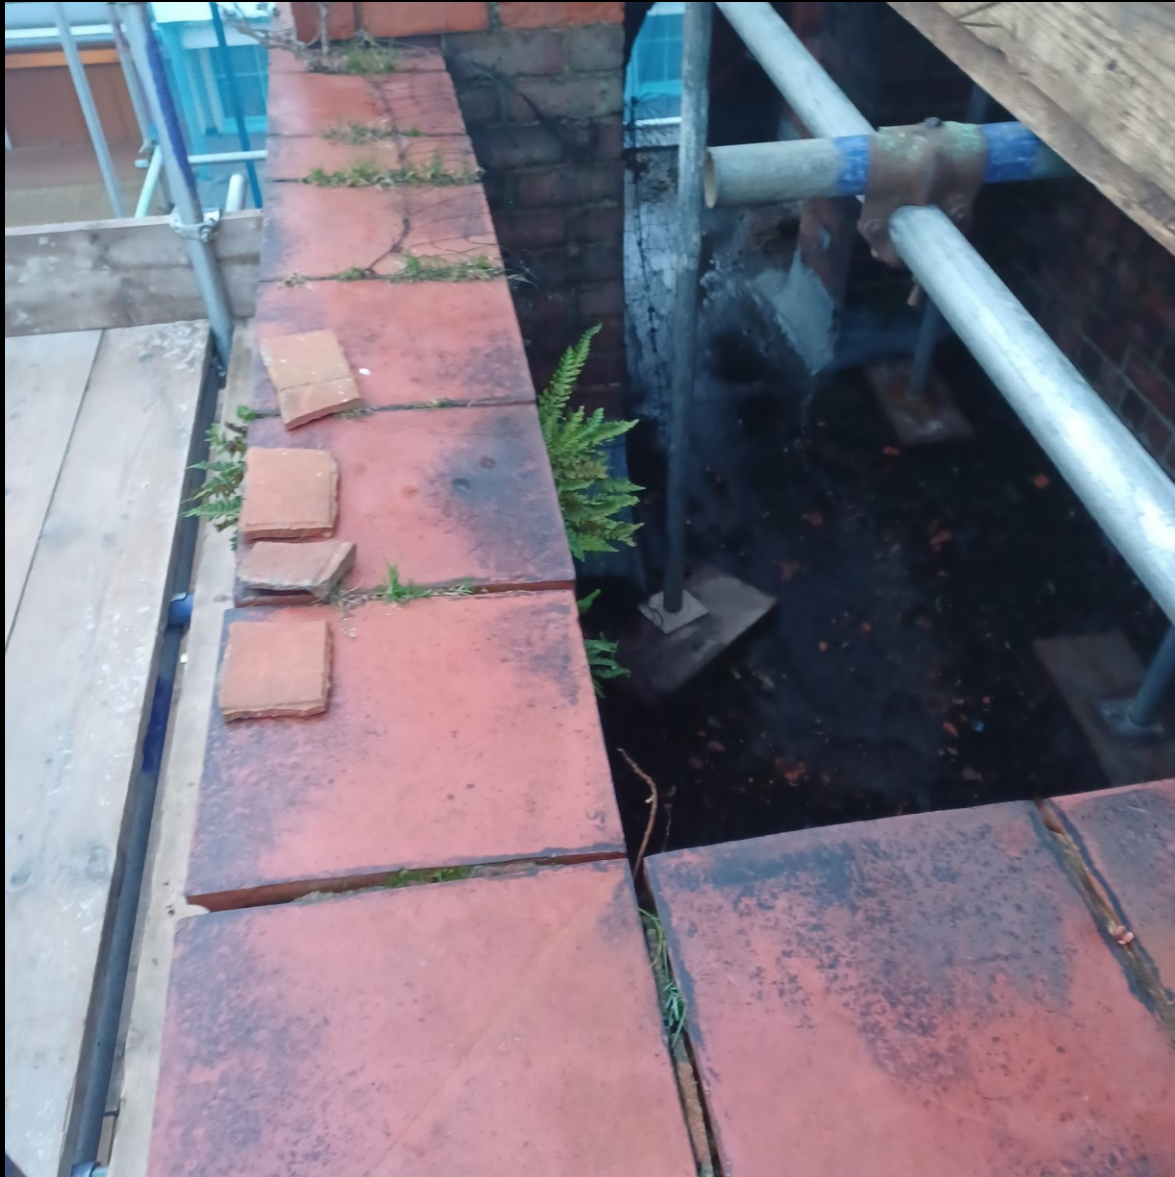
Front Elevation, Parapet wall, with loose capping stones and vegetation in joints

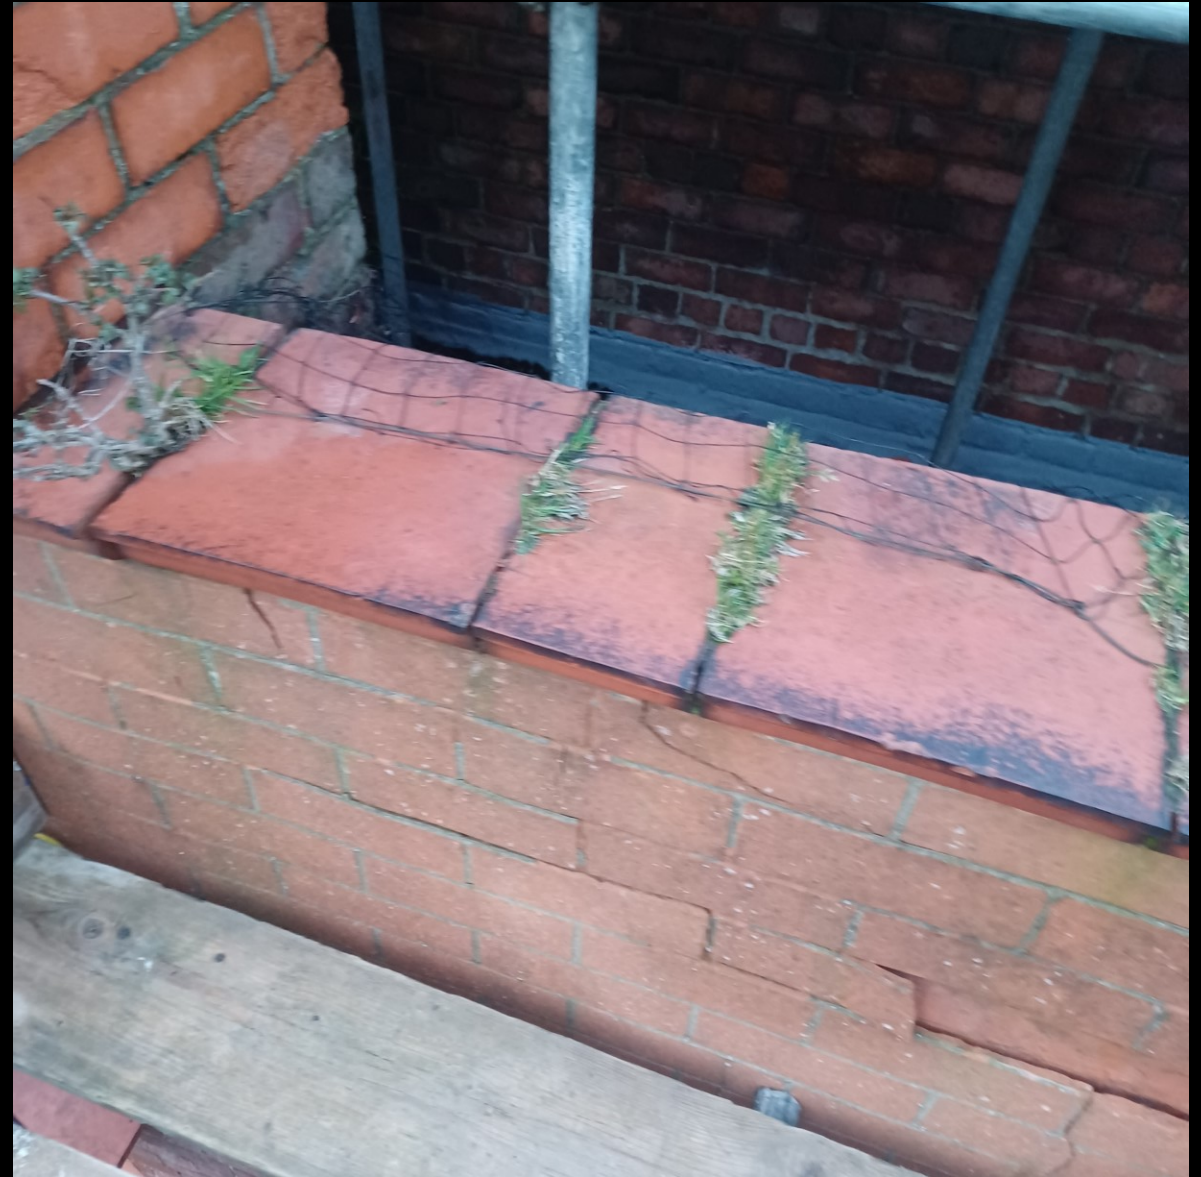
Parapet wall with failed render, loose capping stones and vegetation

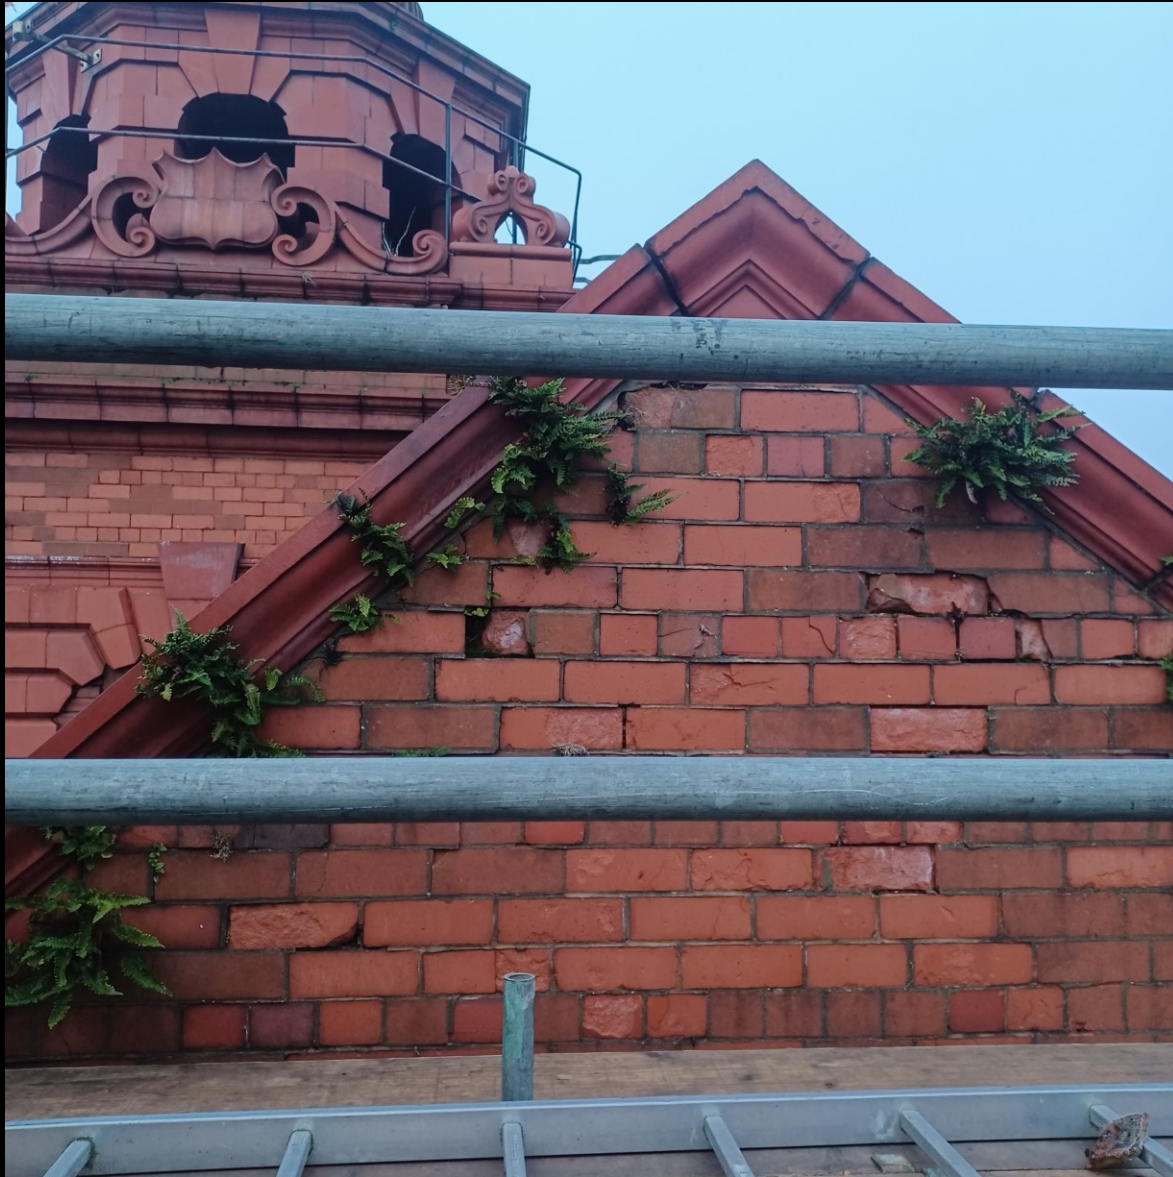
Side Elevation, Gable end wall with partial render repair to brick

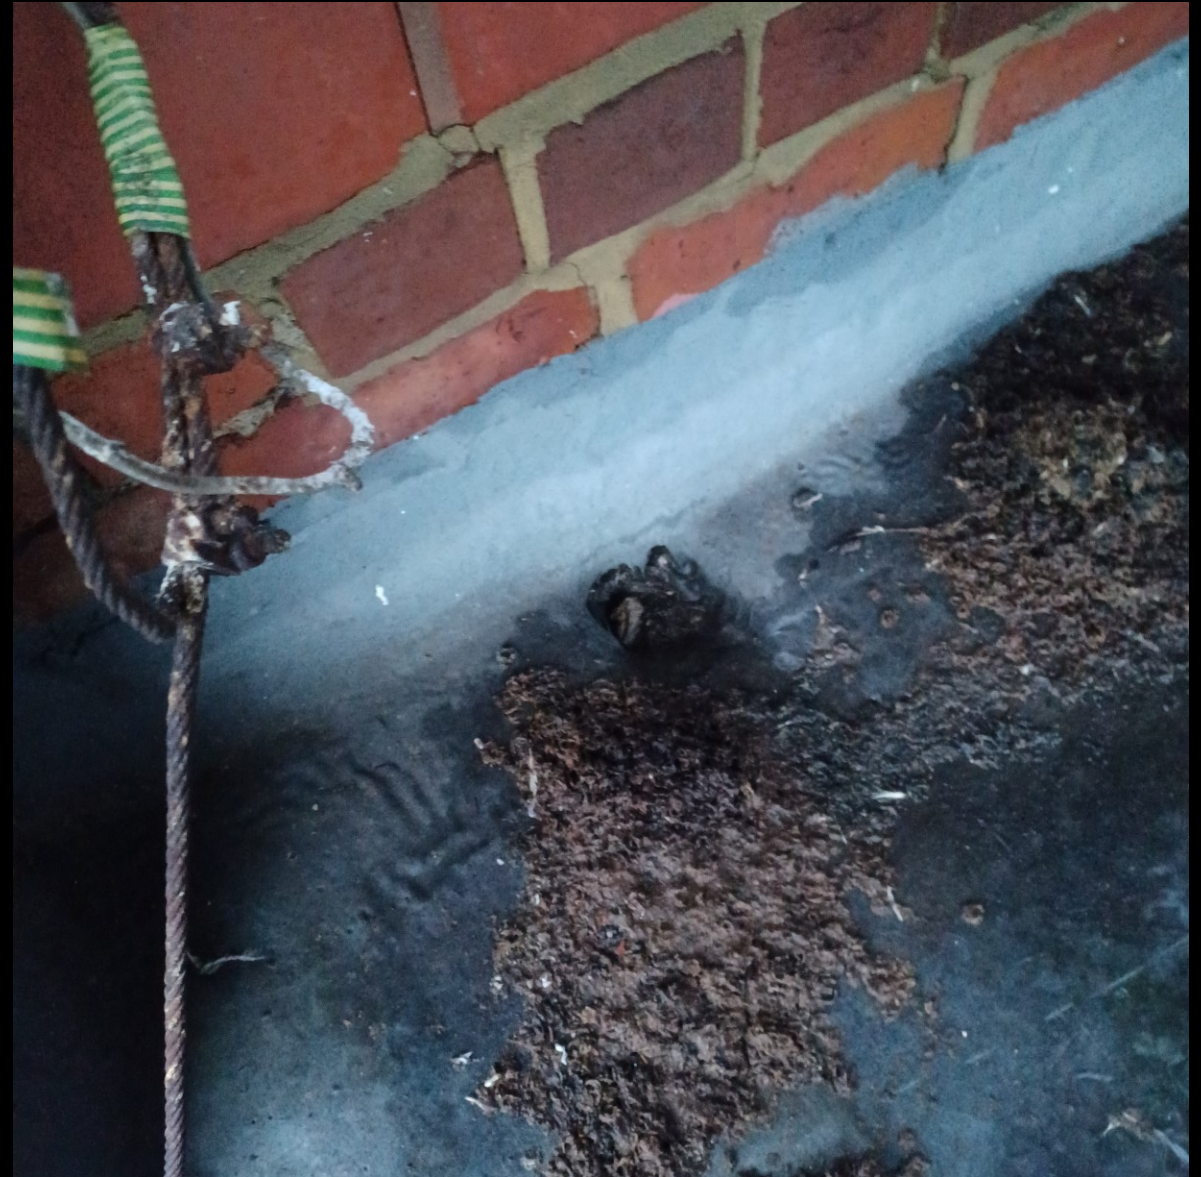
Side Elevation, behind small arch / parapet wall.  
Debris blocking out to rainwater goods

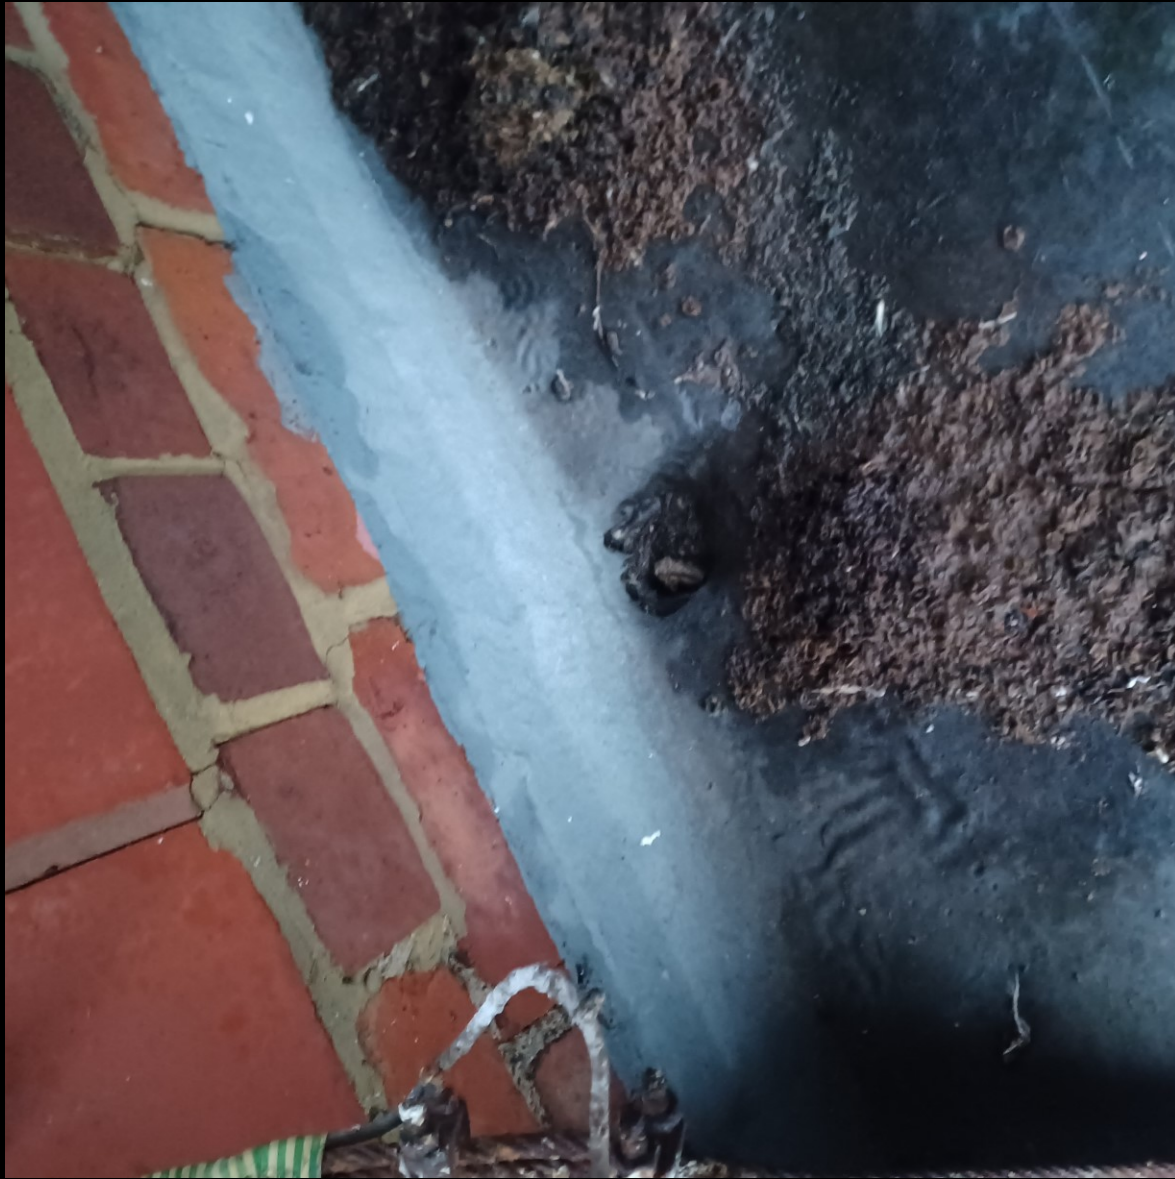
Debris blocking outlet to rainwater good, causing water ingress into building

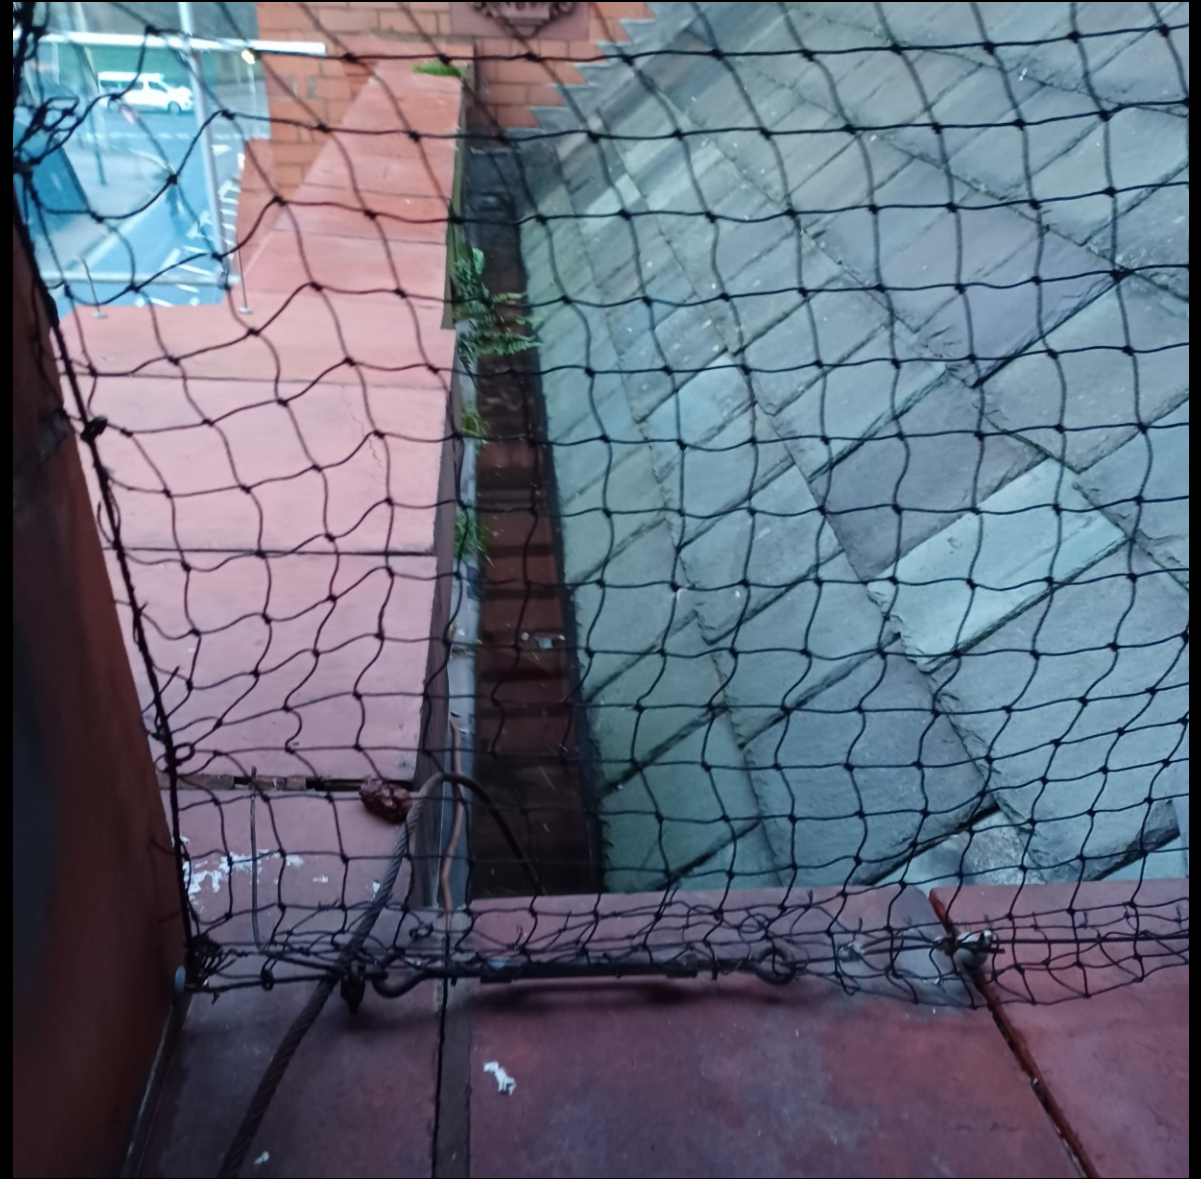
Blocked gutter causing water ingress into building

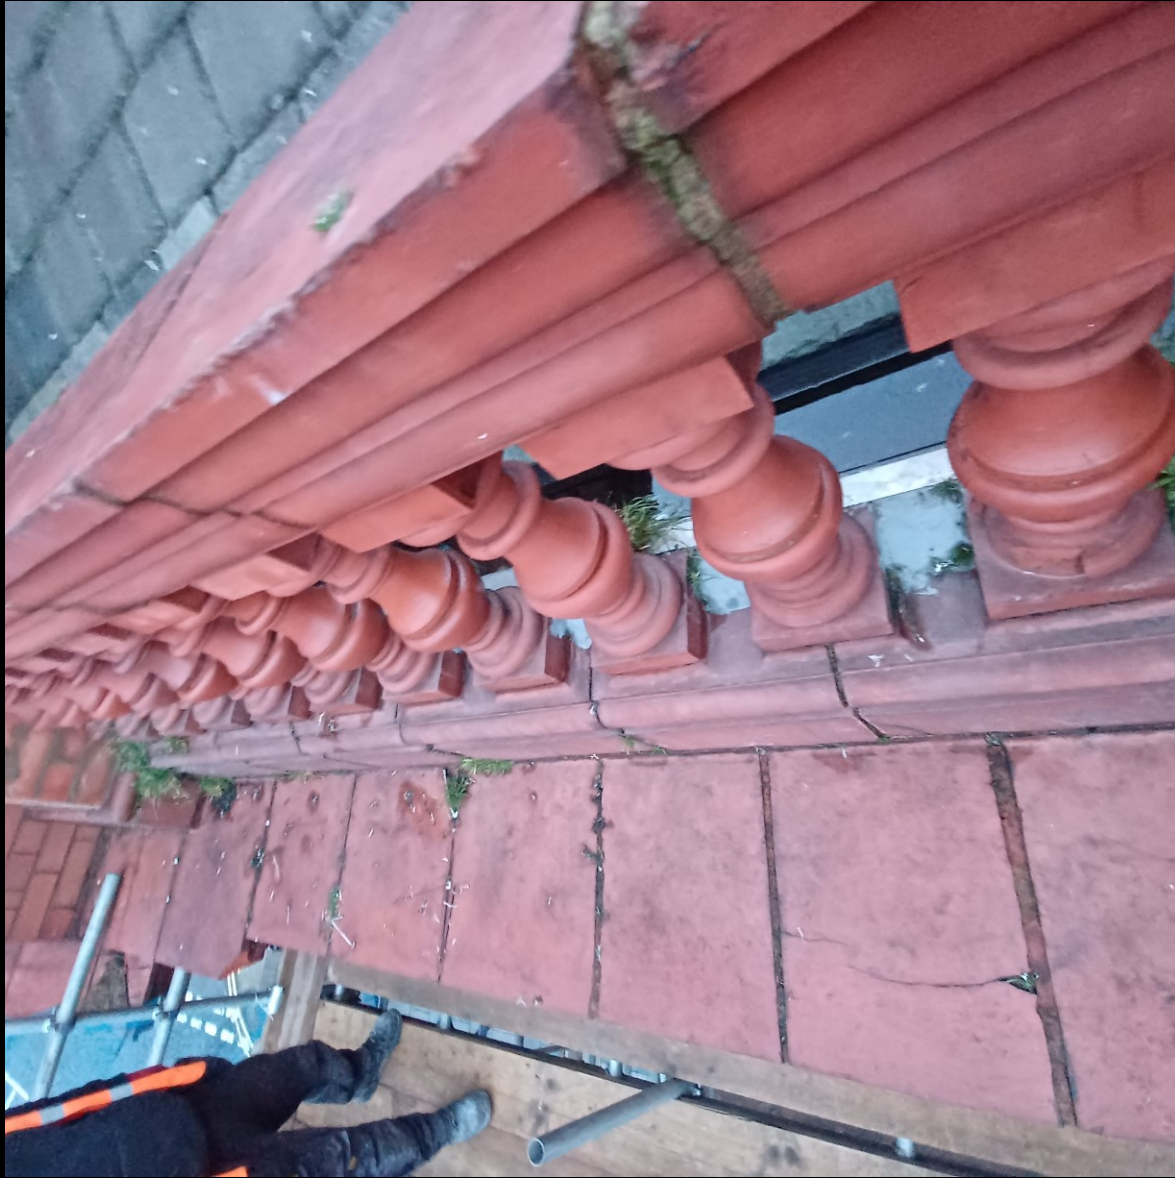
Balustrade / parapet wall with vegetation to joints and blocked gutter

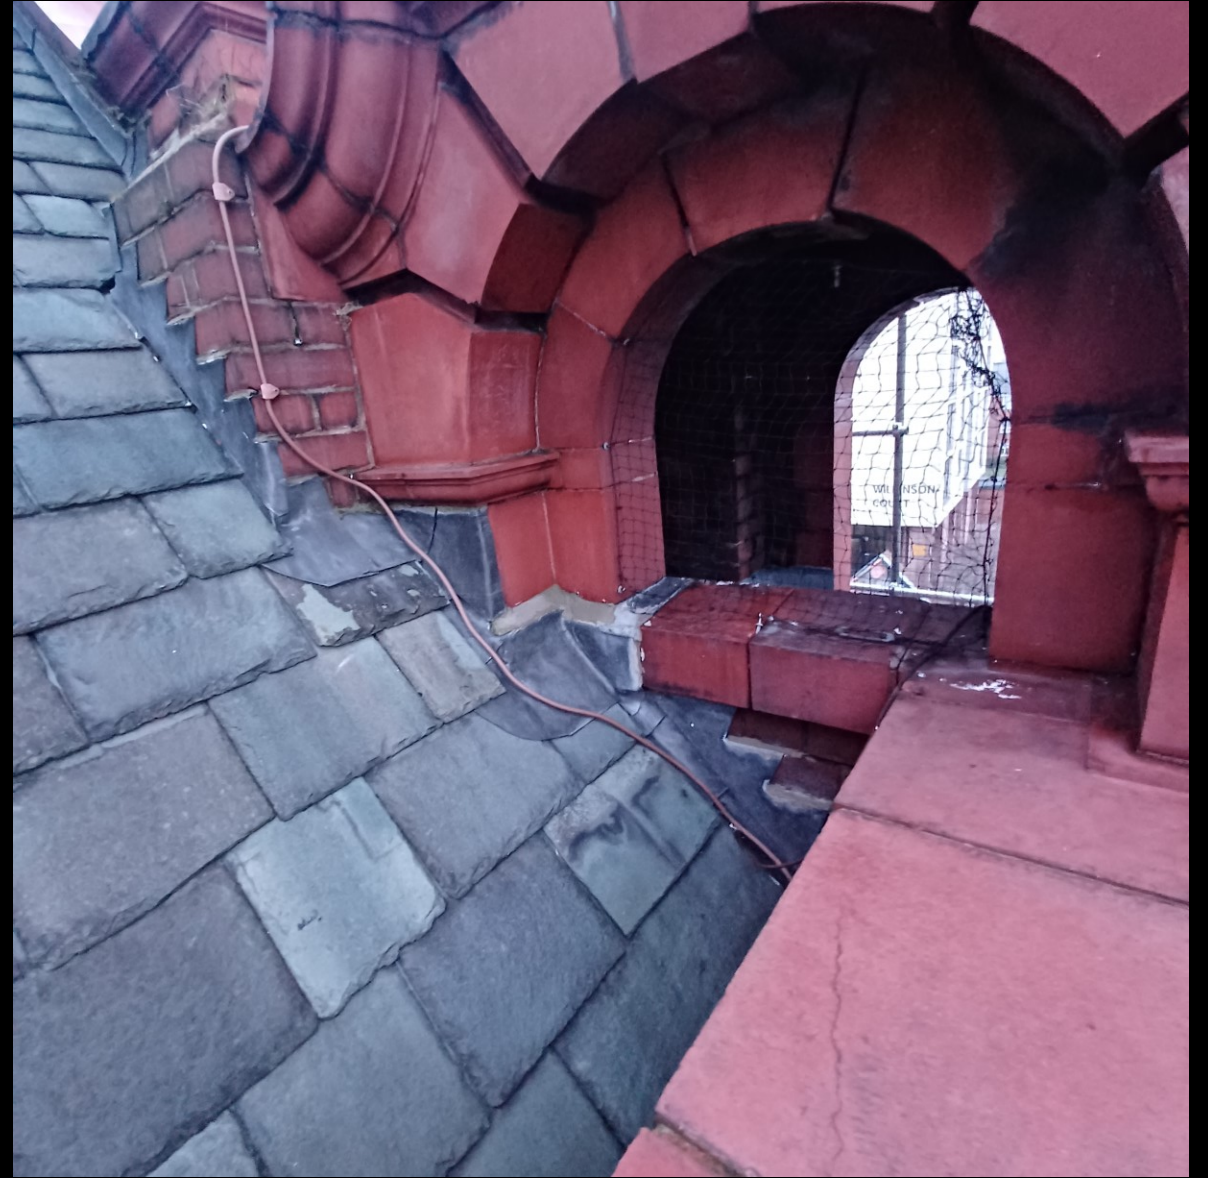
Small decorative arch with vegetation to joints and failed netting

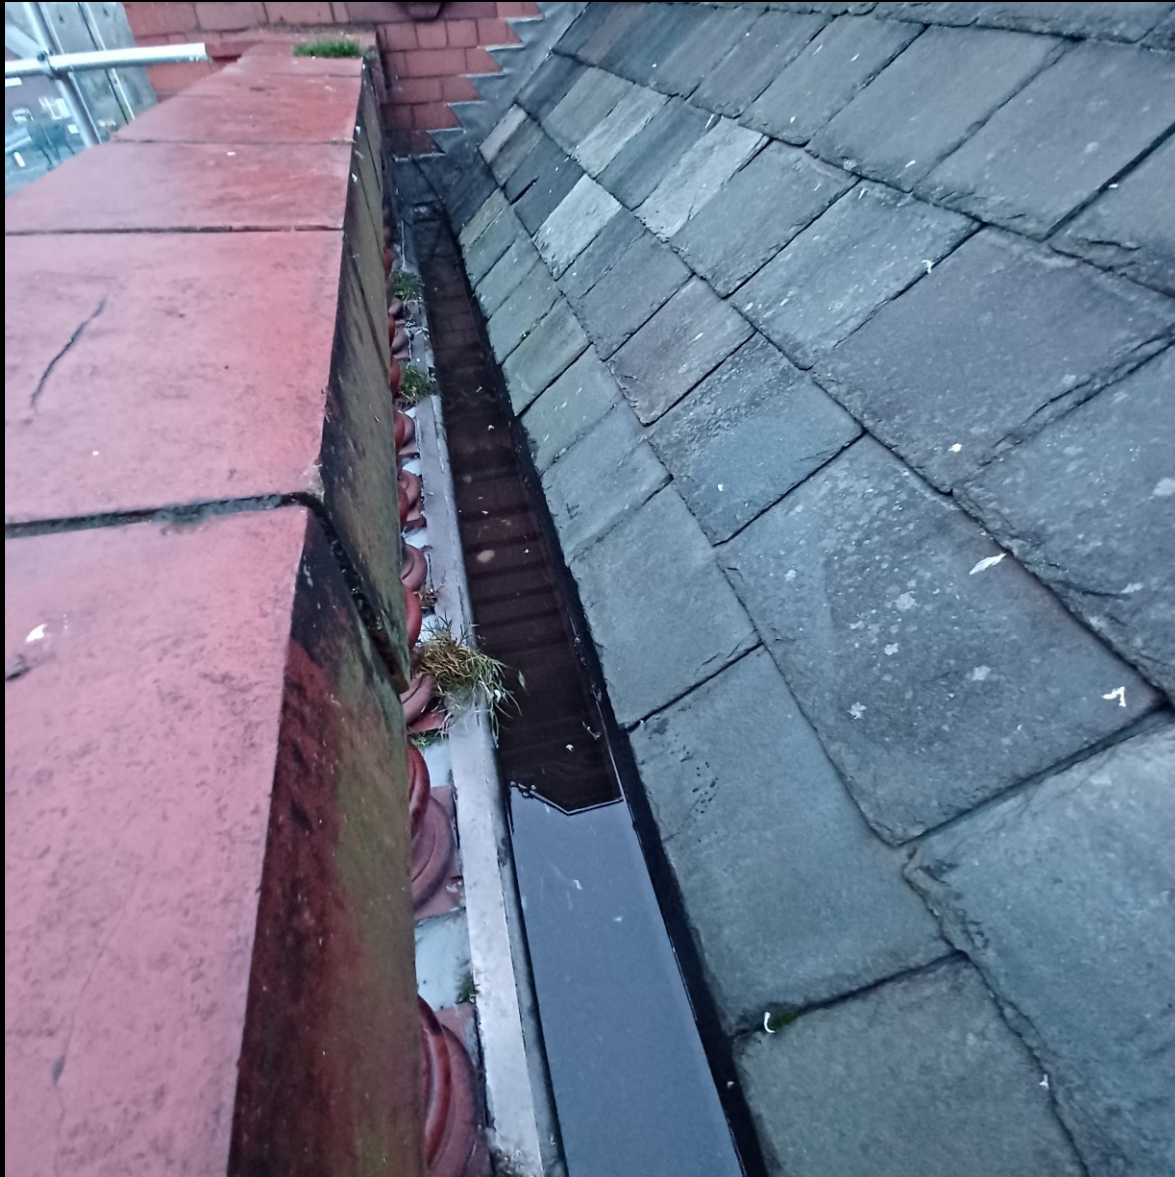
Blocked gutter behind balustrade / parapet wall

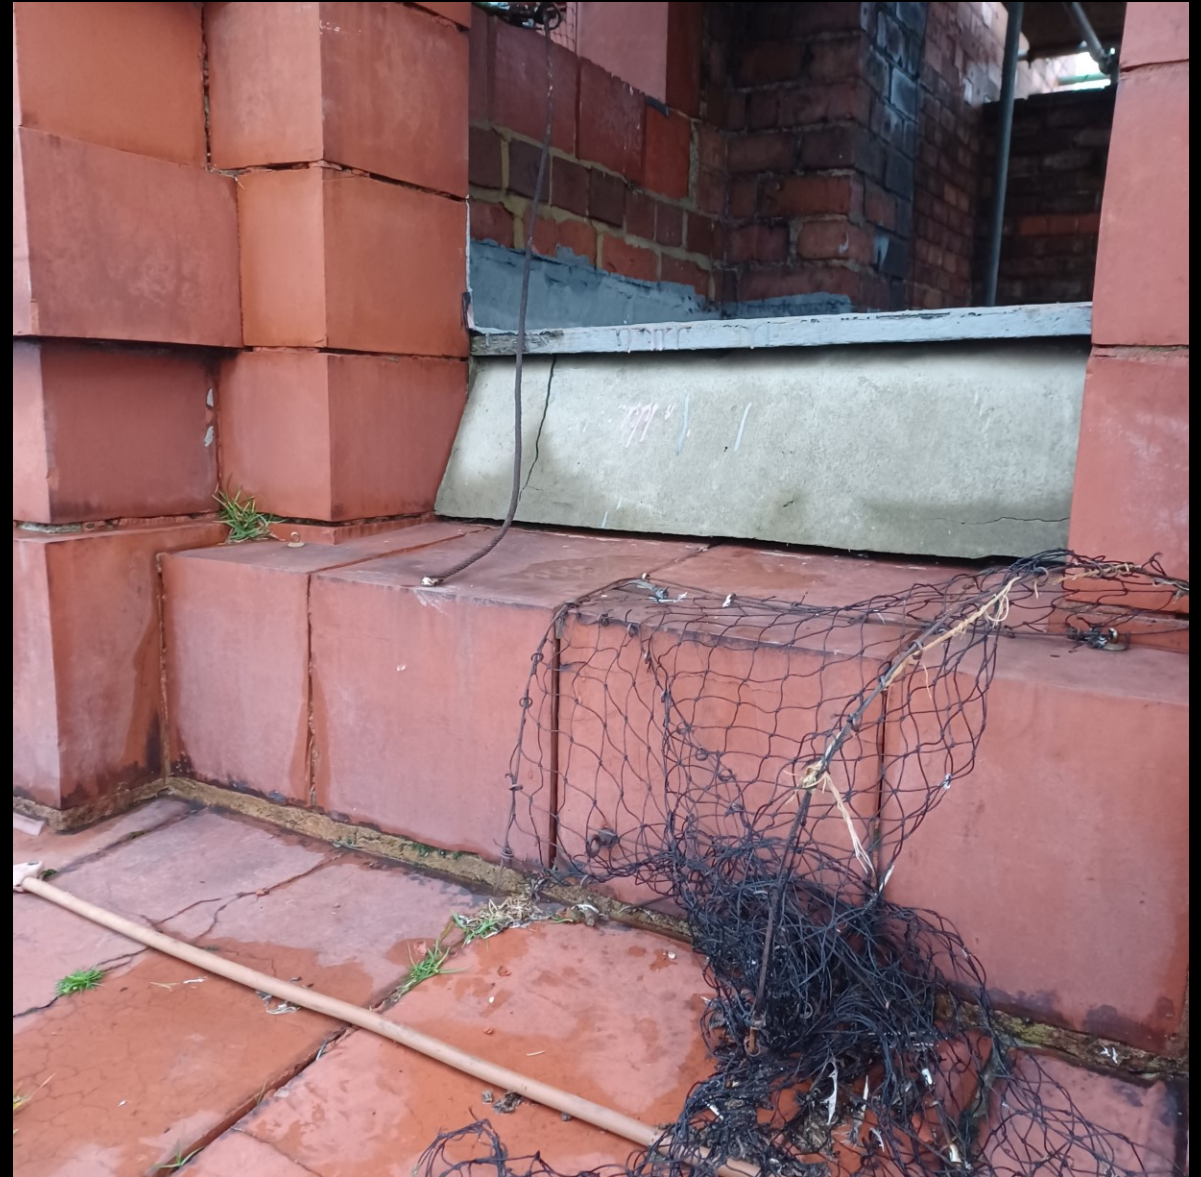
Joints with vegetation and ineffective water diversion inside small arch. Later addition.  
Also note failed netting

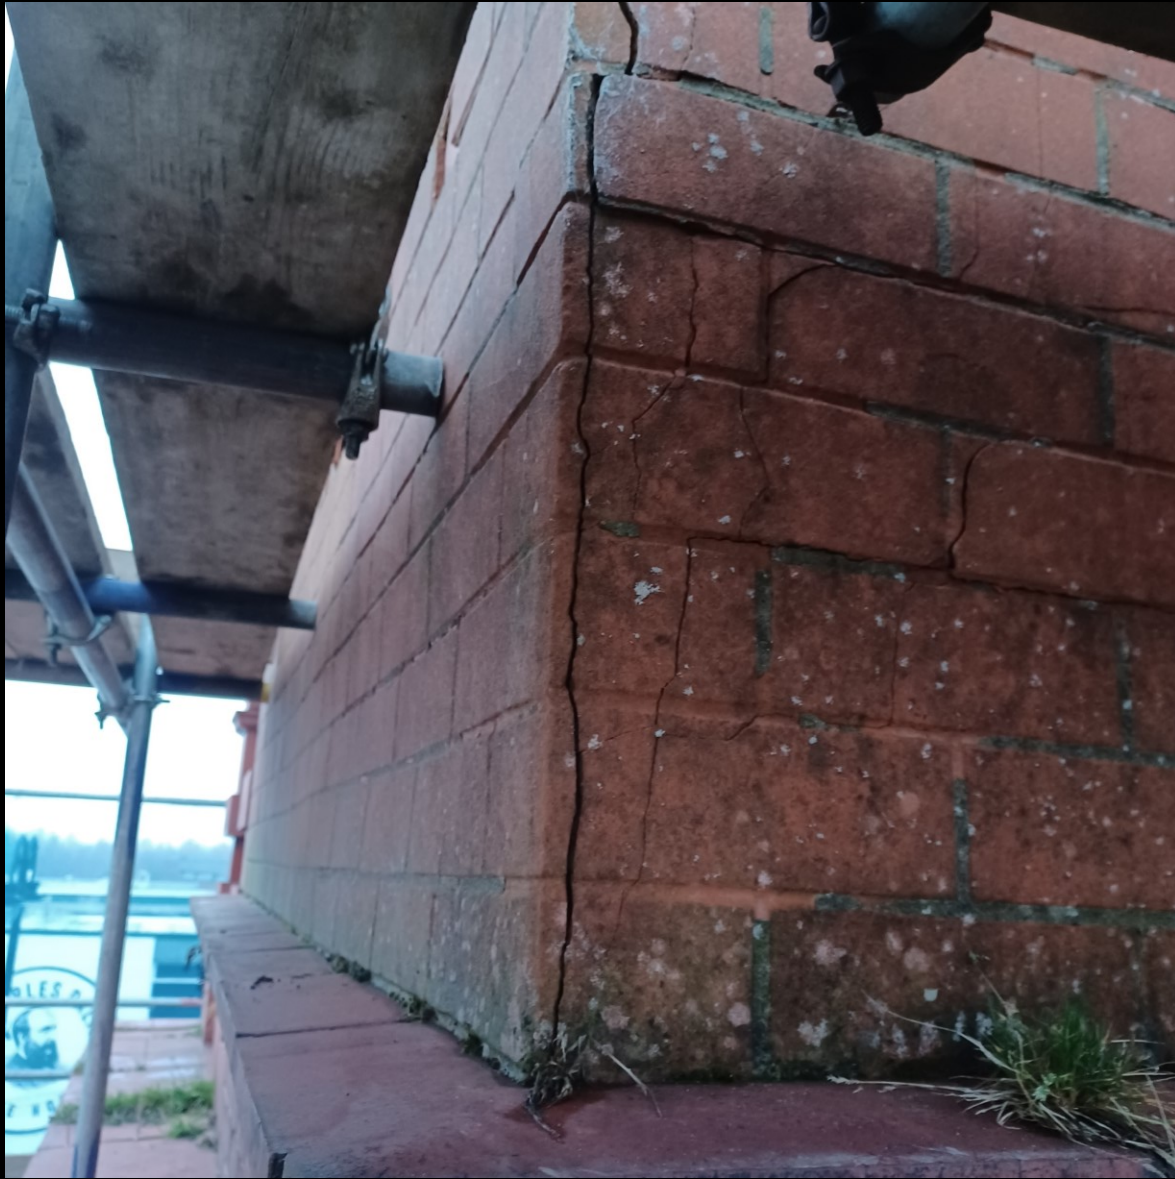
Failed Render to small parapet wall behind small arch. Also note vegetation to joints.

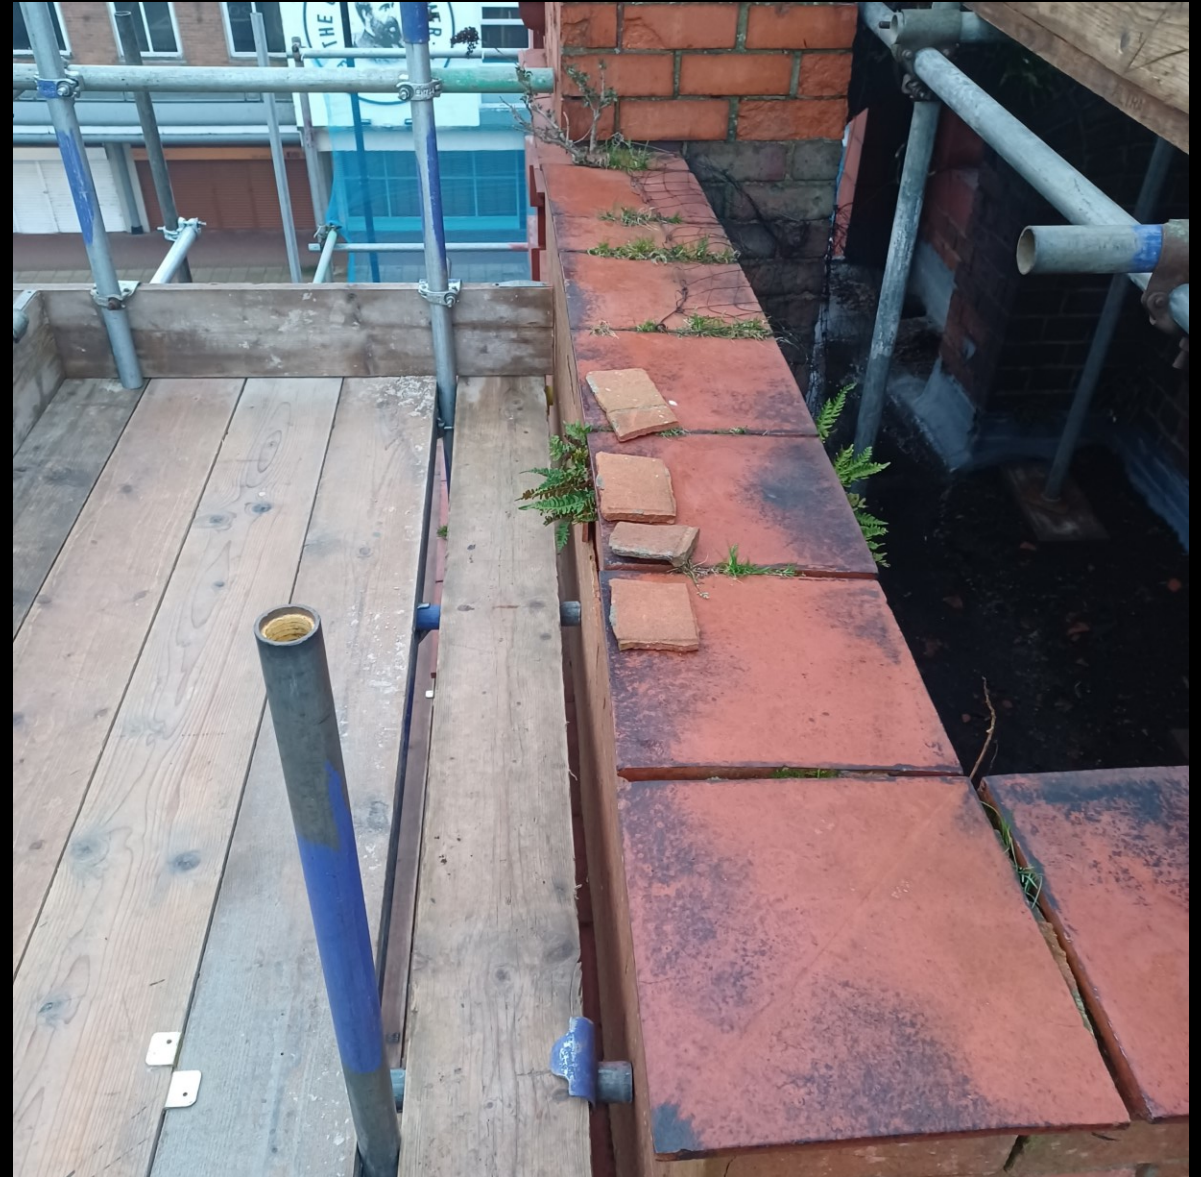
Side elevation, capping to parapet wall, showing failed render

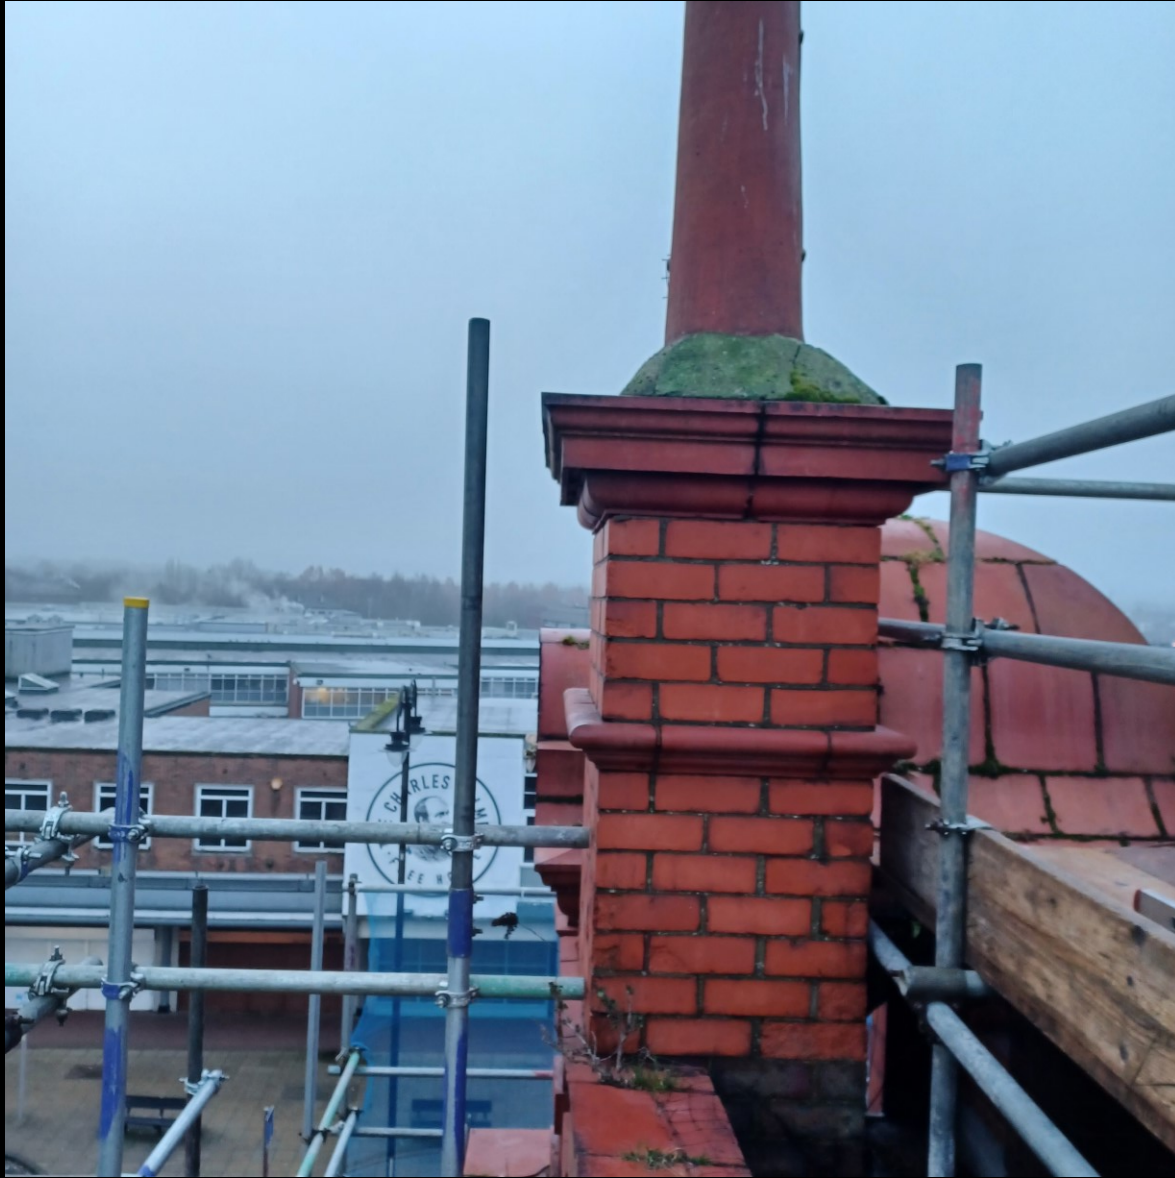
Chimney with failed haunching

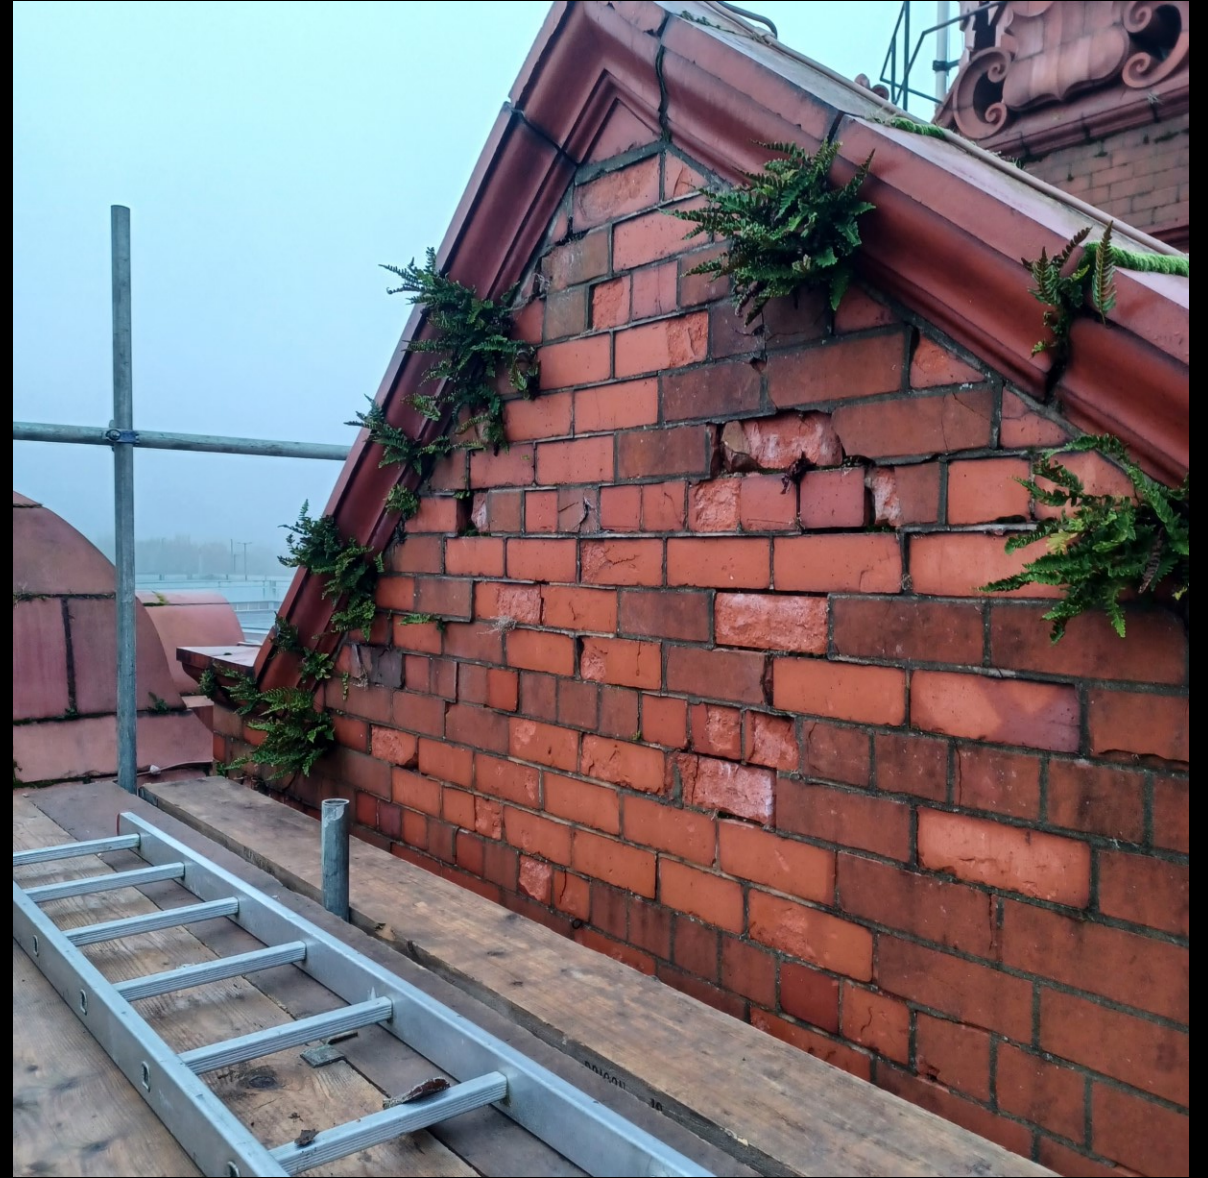
Side elevation with patched failed render and vegetation

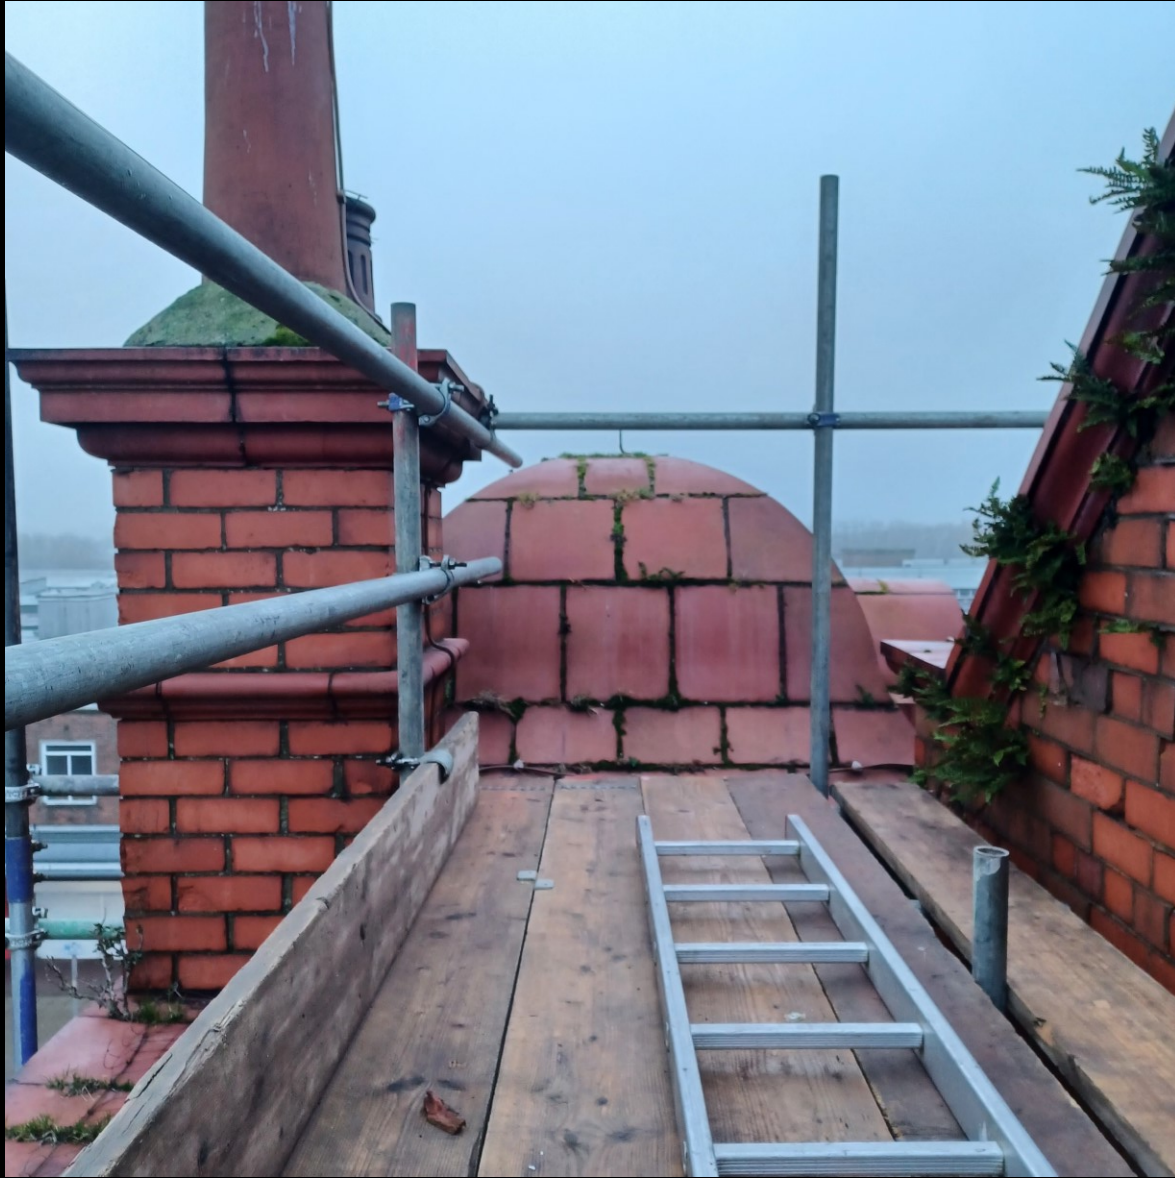
View from rear of small arch, showing vegetation growth in all the failed joints
