# Jarrow Town Hall – Photo Schedule

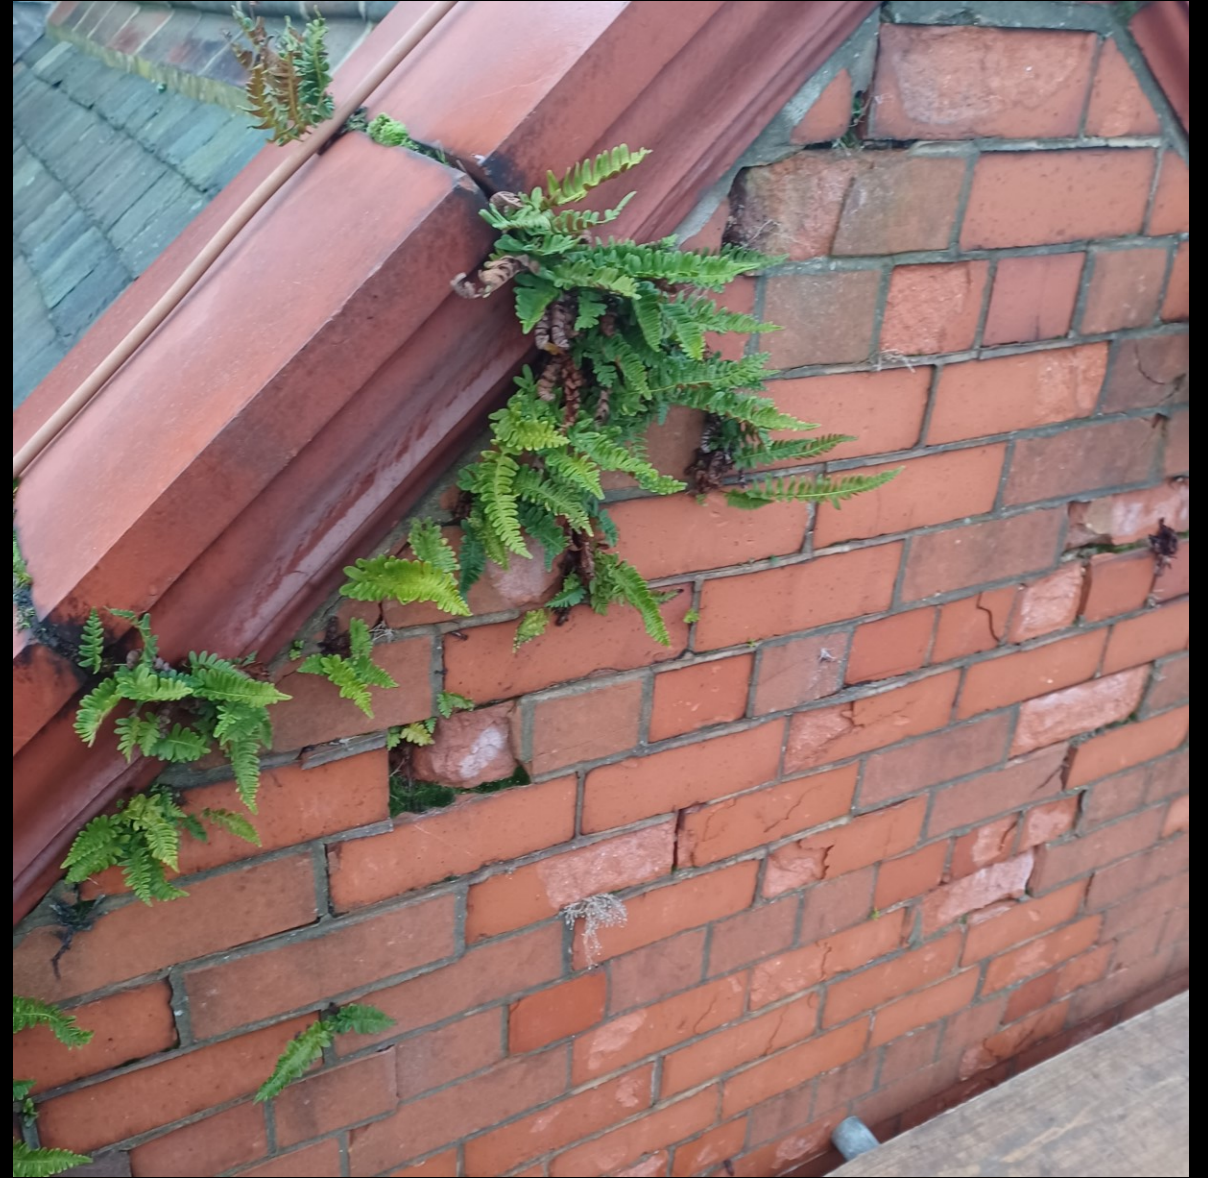
Gable end showing vegetation to failed render

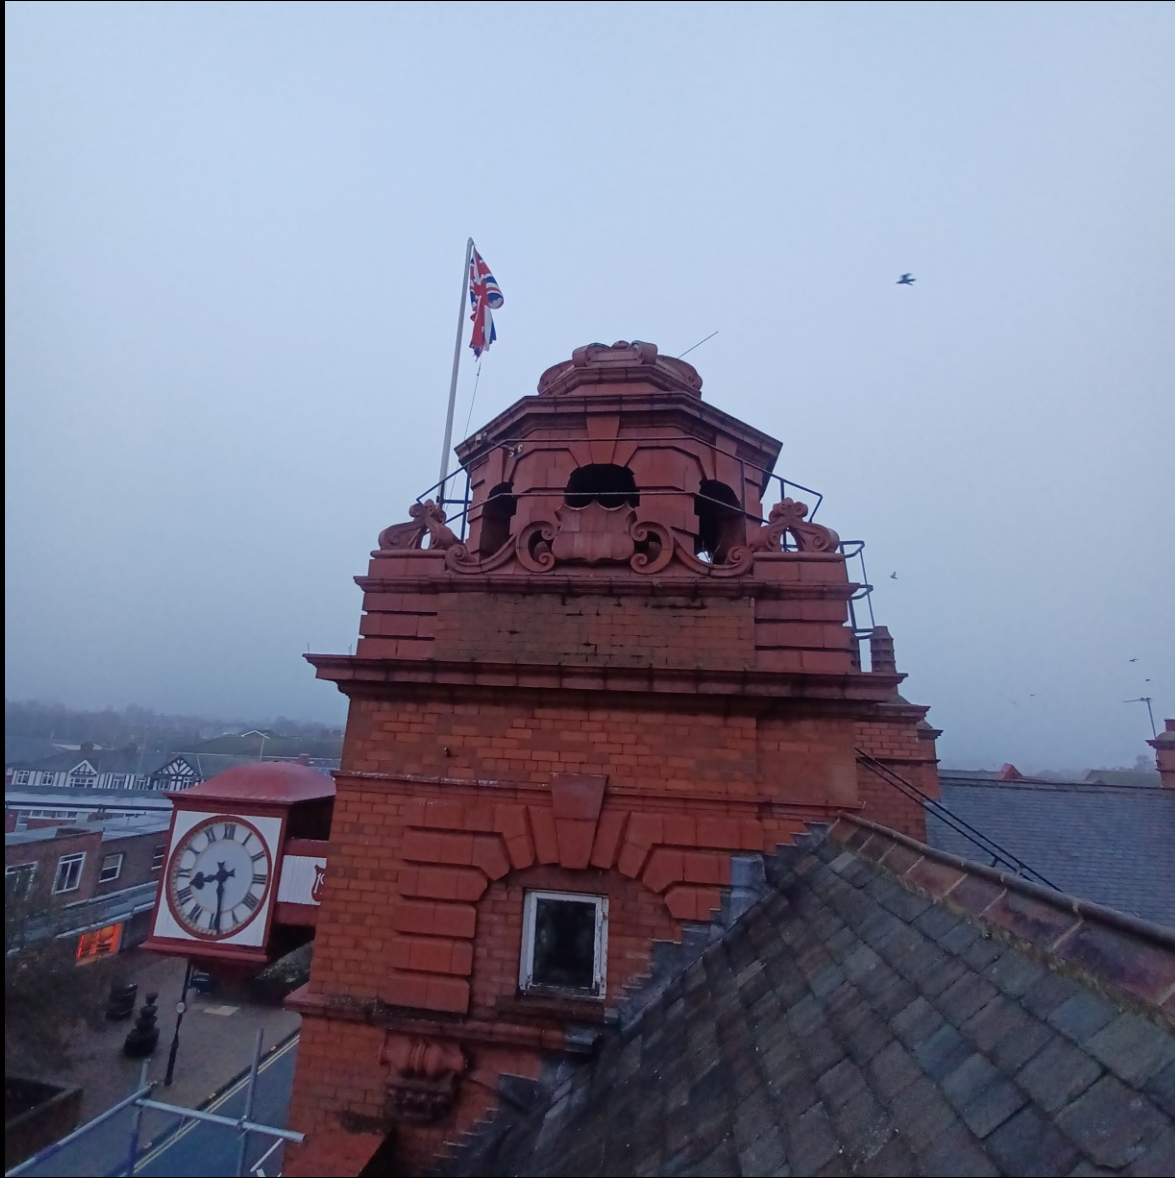
Main Tower with patch render repairs, failed / damaged brick work and vegetation growth to joints

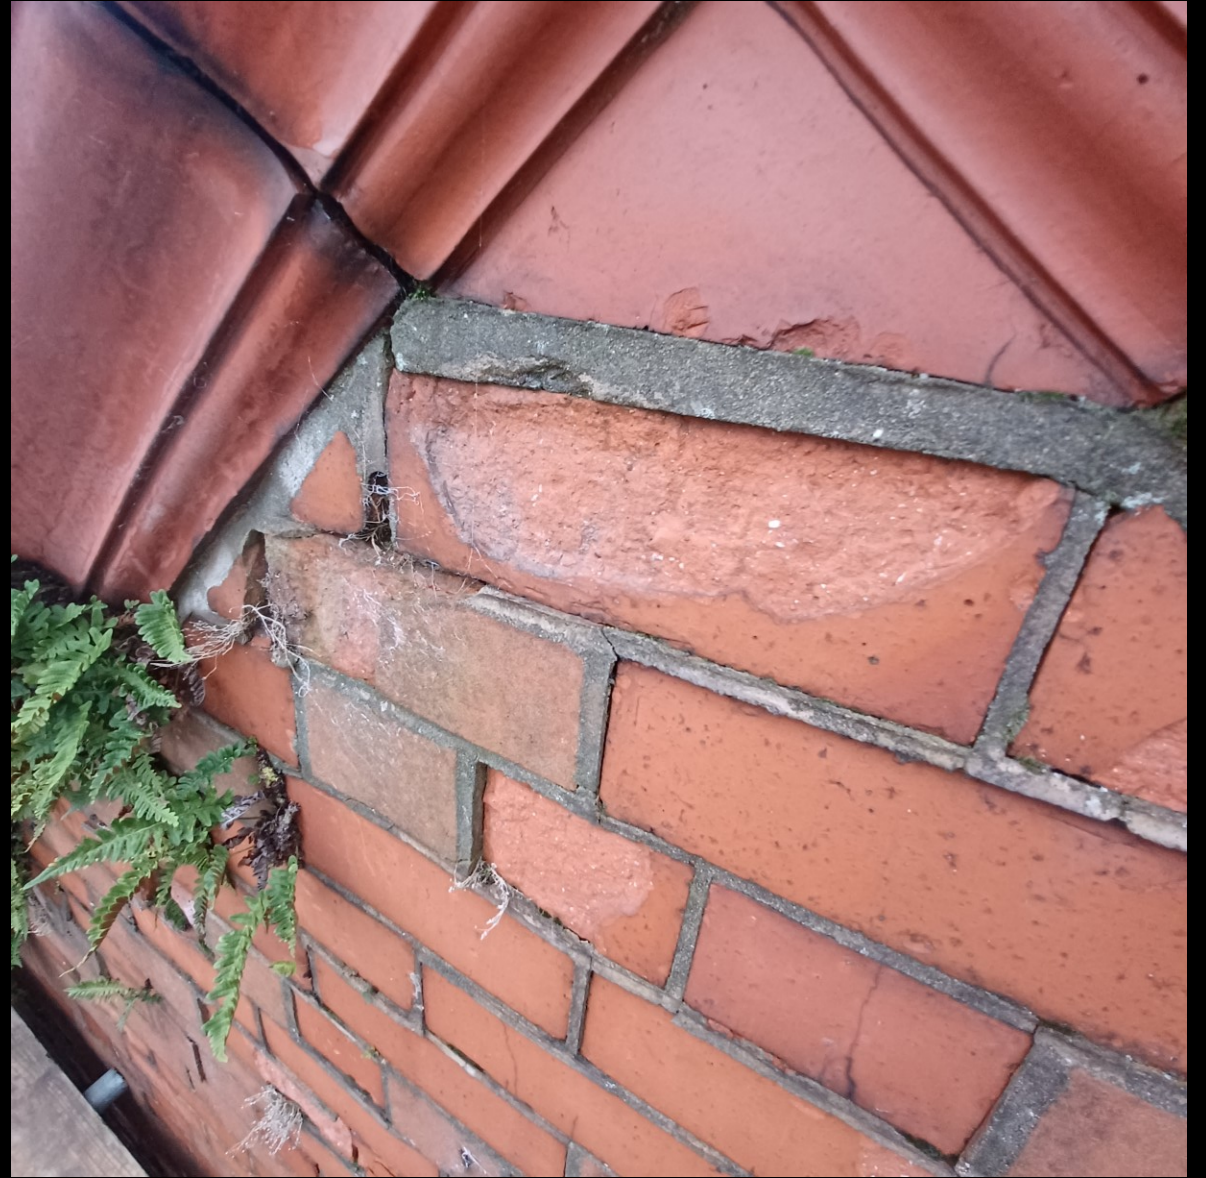
Gable end with vegetation growth and failed render /  
damaged brick work

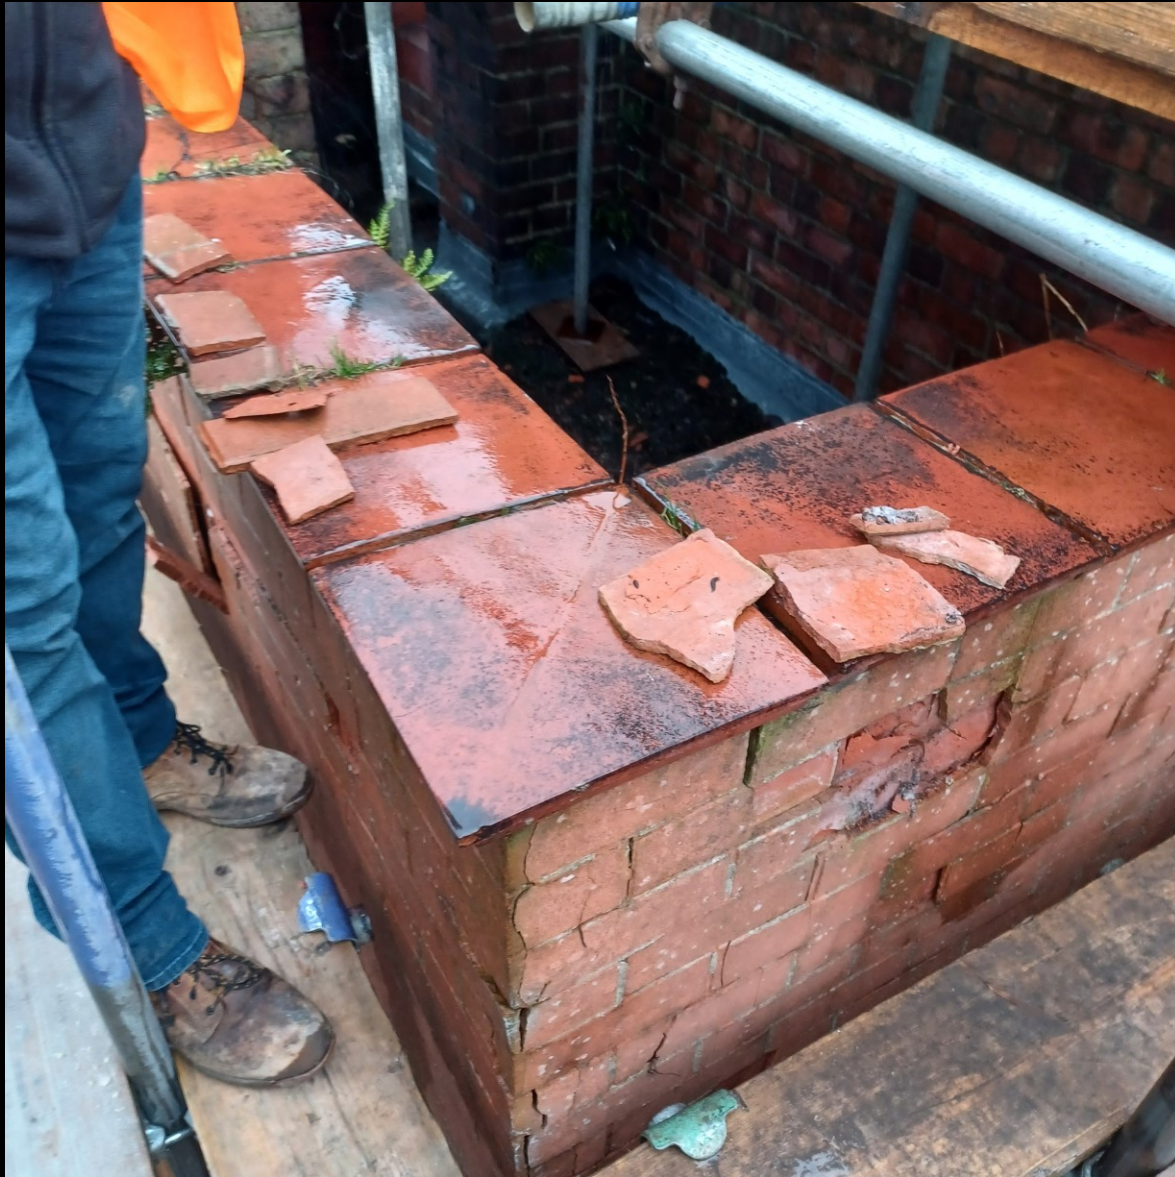
Small Parapet wall showing loose capping and failed render

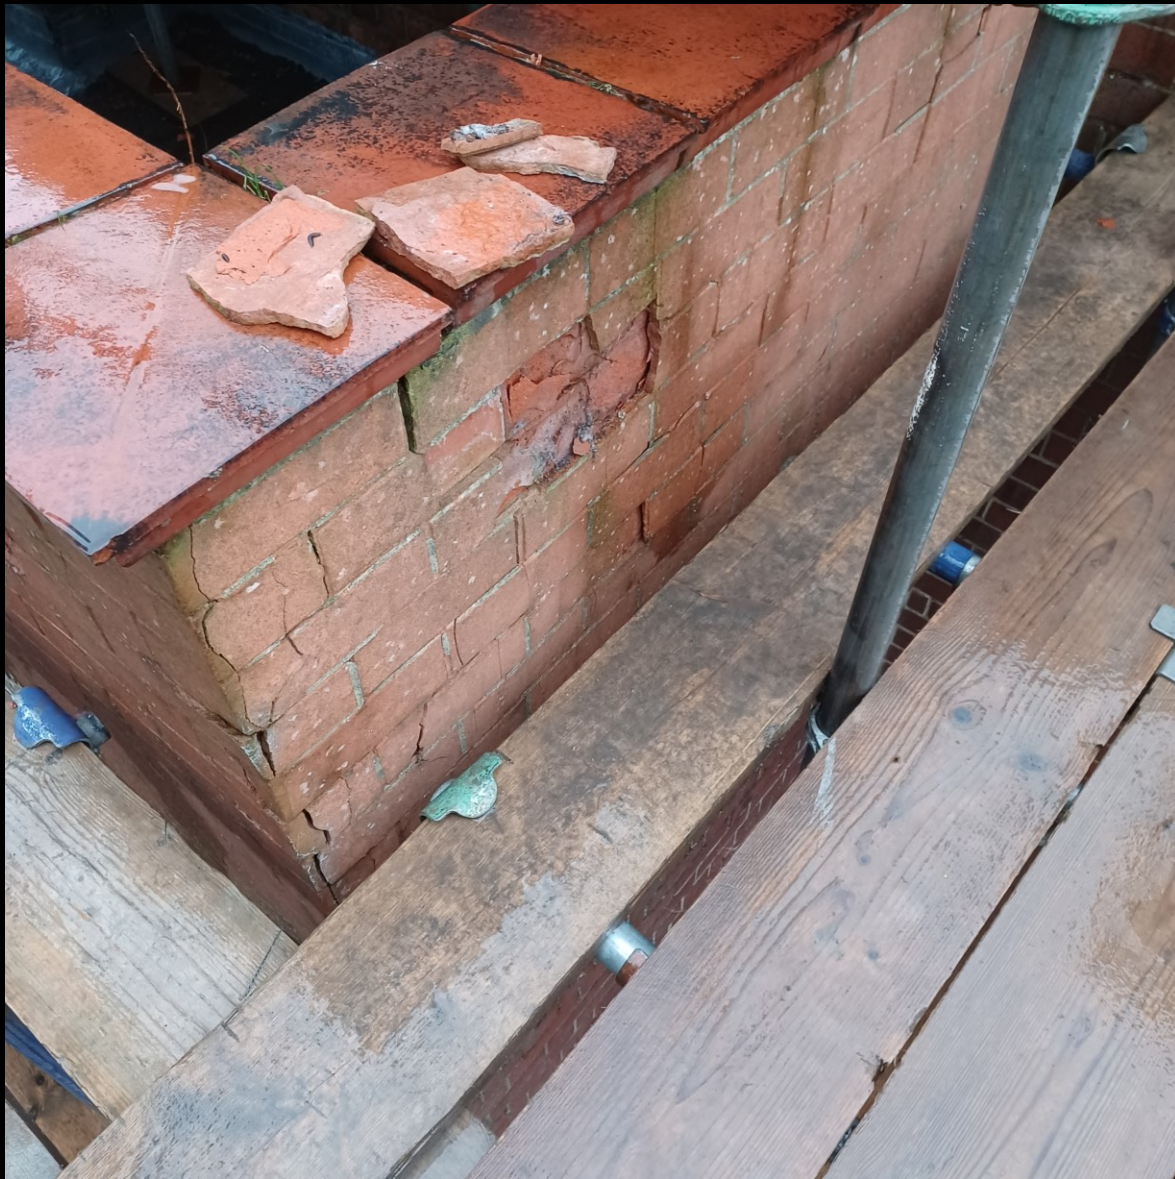
Small Parapet wall showing loose capping and failed render

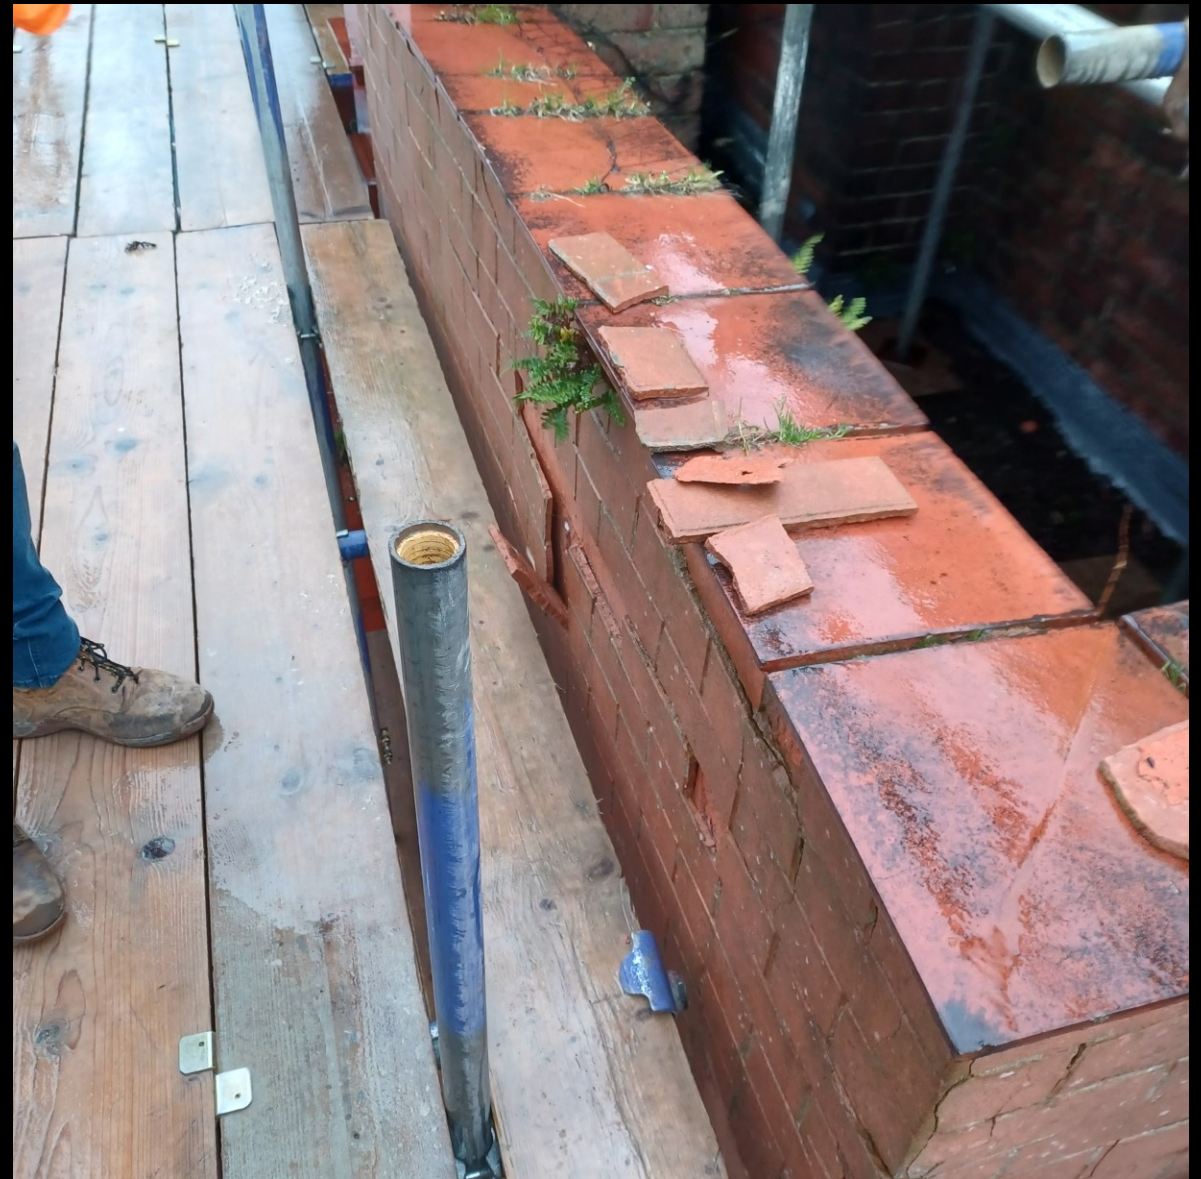
Small Parapet wall showing loose capping and failed render

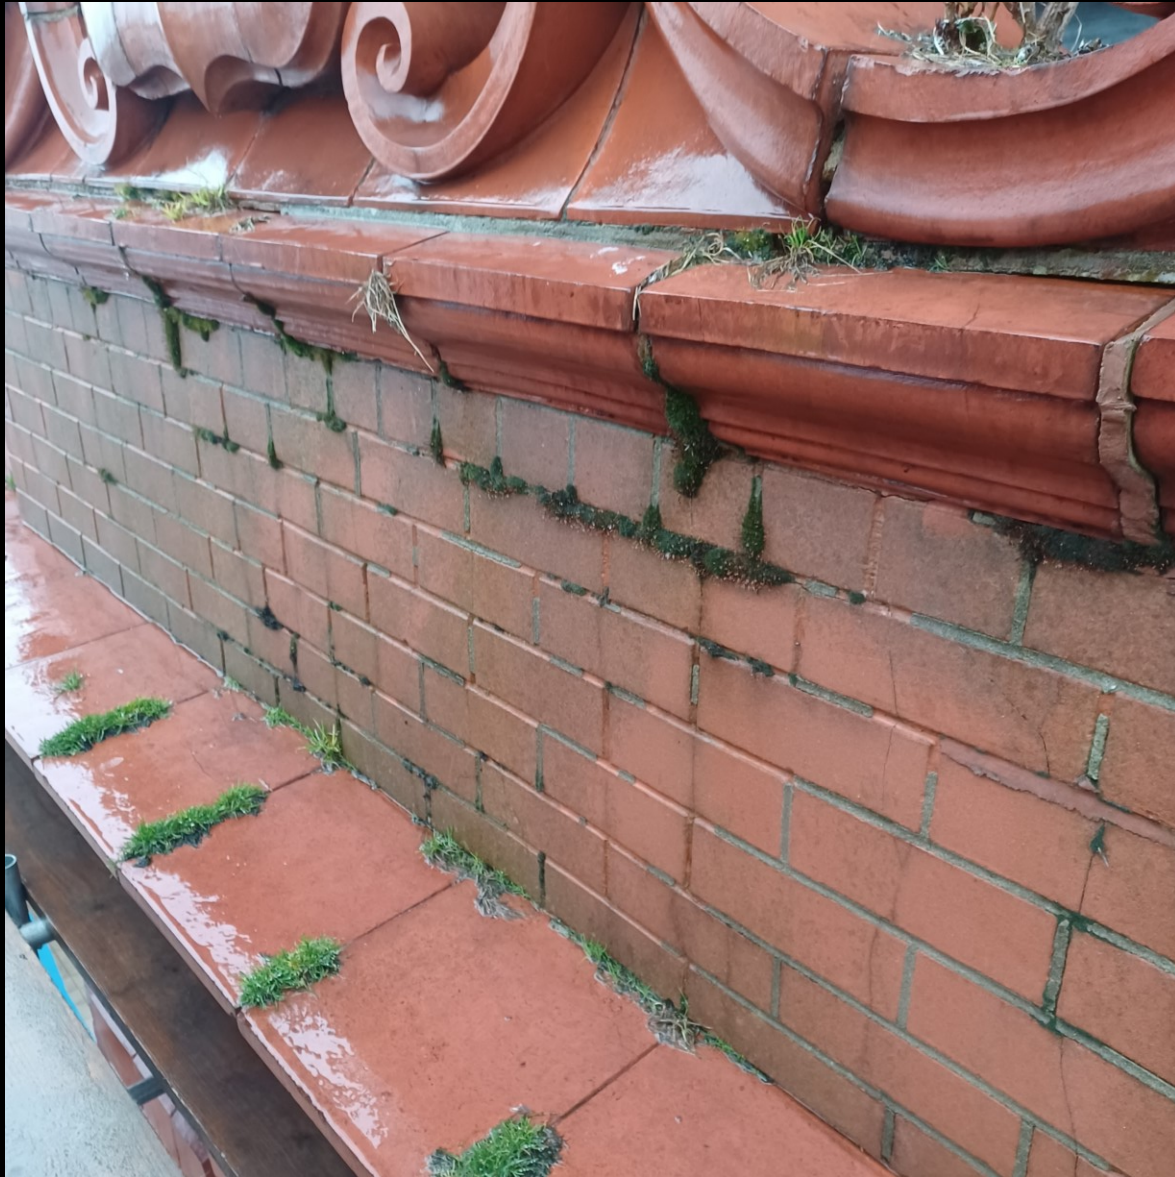
Front Elevation – vegetation growth and gaps to joints
