# PRELIMINARY ARBORICULTURAL REPORT

11 Barns Close, Jarrow NE32 5NY

PRI Ref: 359622

Survey Date: 04-06-2026

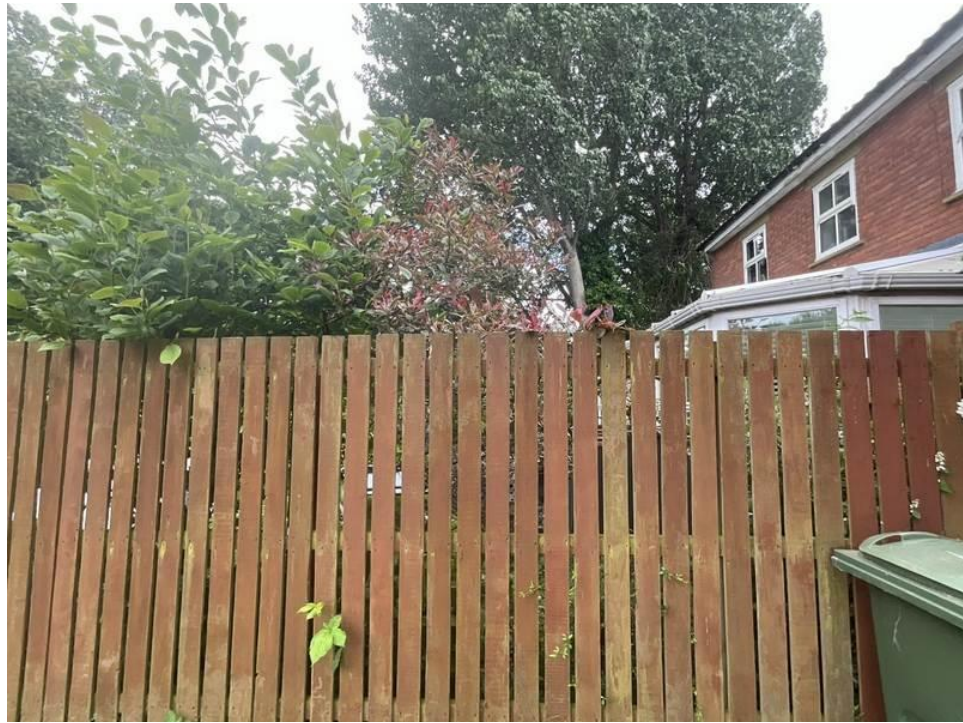
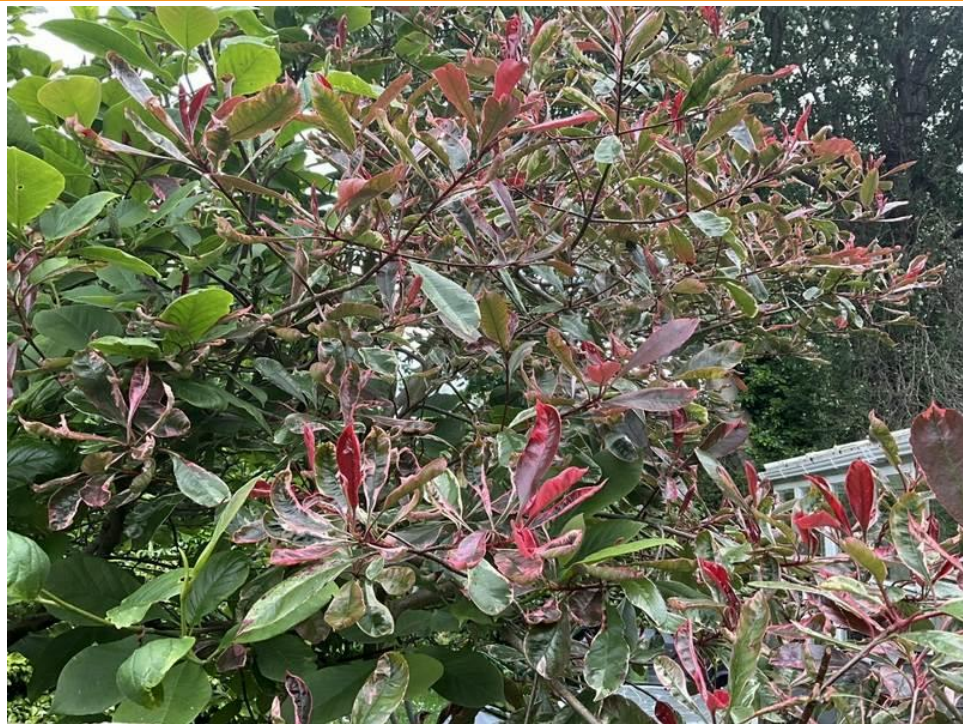
S2 Photinia

| Tree No: | Common Name | Age Class | Condition | Height (m) | Crown Spread (m) | Stem diam. (mm) | No. of Stems | Dist to bldg. (m) | Roots Implicated | Pruning History | Recommendation | Tree Work Constraints | Notes | Owner address | Owner |
|---|---|---|---|---|---|---|---|---|---|---|---|---|---|---|---|
| S2 | Photinia | Semi-Mature | Fair | 2.50 | 1.50 | 50 | 1 | 3.50 | No | No significant past works. | Fell and treat stump with eco plugs (broadleaved). | The third party may be responsible for works. | All measurements estimated due to lack of access. | 12 Barns Close, Jarrow NE32 5NY | P3P |

| Tree No: | Species | Works Required | CA | TPO | Ownership |
|---|---|---|---|---|---|
| S2 | Photinia | Fell and treat stump with eco plugs (broadleaved). | No | No | P3P |

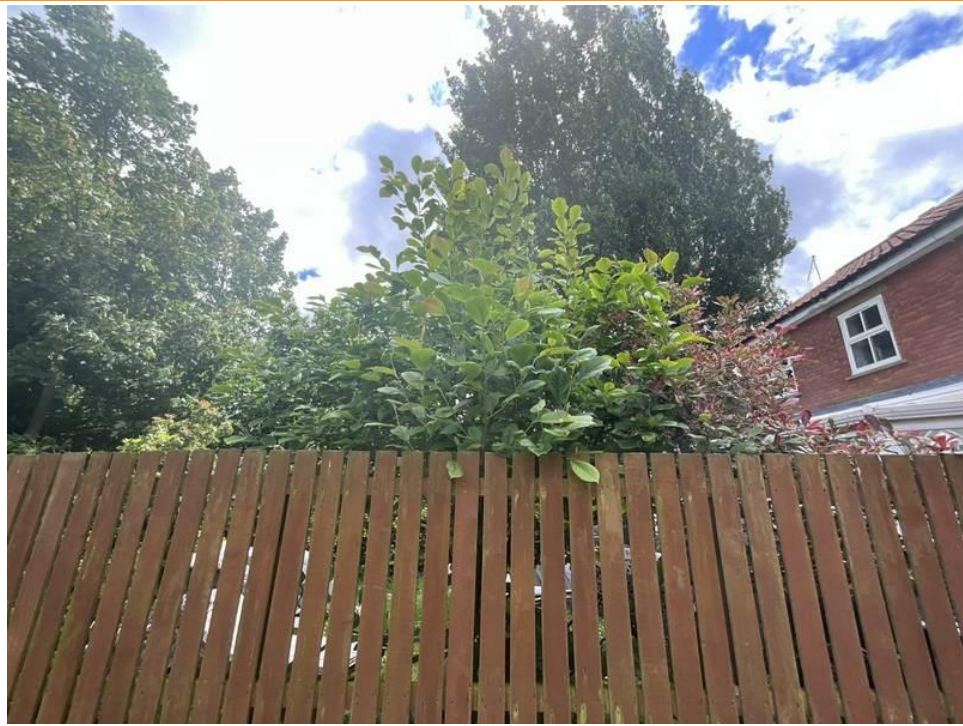
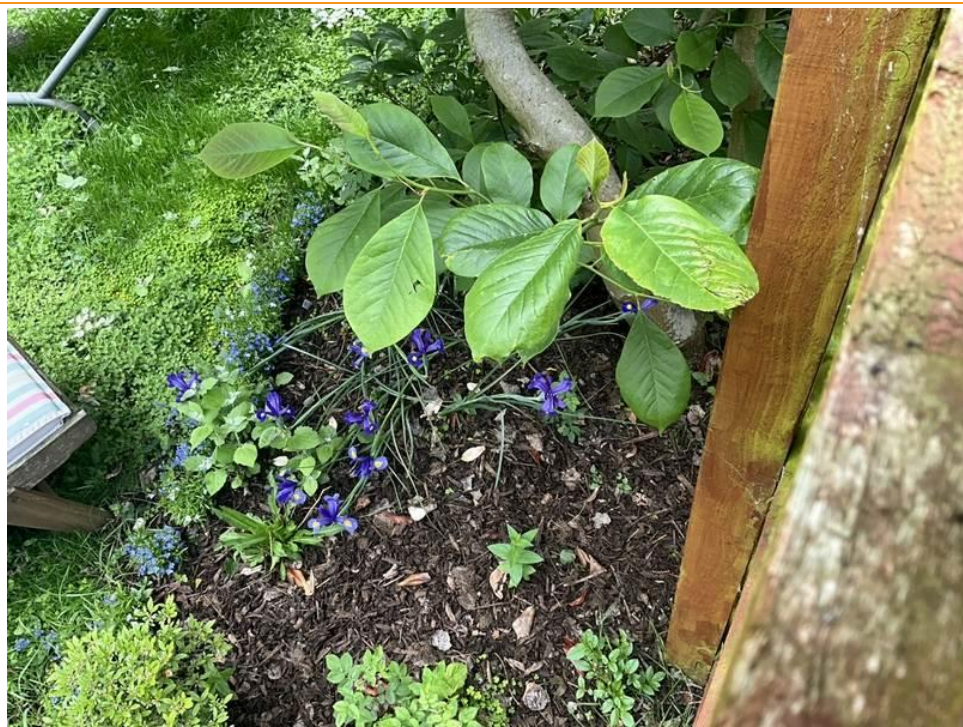
T4 Magnolia

| Tree No: | Common Name | Age Class | Condition | Height (m) | Crown Spread (m) | Stem diam. (mm) | No. of Stems | Dist to bldg. (m) | Roots Implicated | Pruning History | Recommendation | Tree Work Constraints | Notes | Owner address | Owner |
|---|---|---|---|---|---|---|---|---|---|---|---|---|---|---|---|
| T4 | Magnolia | Semi-Mature | Fair | 4.00 | 3.00 | 75 | 1 | 4.20 | Yes | Managed by regular pruning. | Fell and treat stump with eco plugs (broadleaved). | The third party may be responsible for works. | All measurements estimated due to lack of access. | 12 Barns Close, Jarrow NE32 5NY | P3P |

| Tree No: | Species | Works Required | CA | TPO | Ownership |
|---|---|---|---|---|---|
| T4 | Magnolia | Fell and treat stump with eco plugs (broadleaved). | Yes | No | P3P |

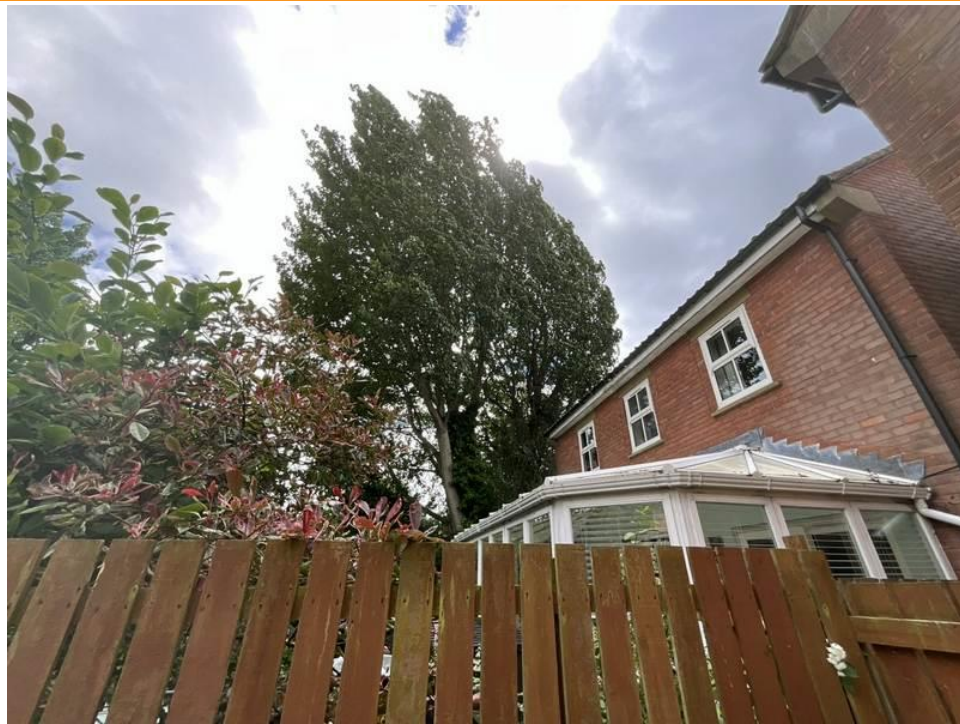
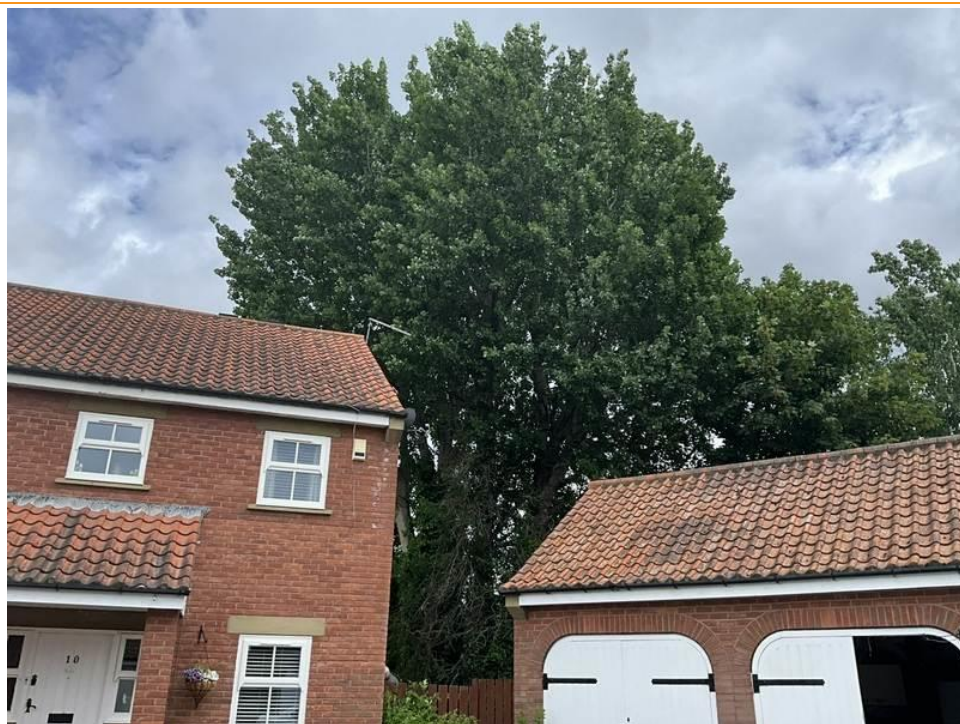
TG2 Poplar

| Tree No: | Common Name | Age Class | Condition | Height (m) | Crown Spread (m) | Stem diam. (mm) | No. of Stems | Dist to bldg. (m) | Roots Implicated | Pruning History | Recommendation | Tree Work Constraints | Notes | Owner address | Owner |
|---|---|---|---|---|---|---|---|---|---|---|---|---|---|---|---|
| TG2 | Poplar | Mature | Fair | 19.00 | 8.00 | 600 | 2 | 15.50 | No | Significant past works. | Fell and grind stump. | The commercial third party may be responsible for works. | All measurements estimated due to lack of access. DBH is an approximate average of the stems. | DLR Search Required | UKN |

| Tree No: | Species | Works Required | CA | TPO | Ownership |
|---|---|---|---|---|---|
| TG2 | Poplar | Fell and grind stump. | Yes | No | UKN |
