**CASTLE**

**16 BARRINGTON STREET  
SOUTH SHIELDS  
TYNE AND WEAR  
NE33 1AN**

**SPECIFIC DEFECT SURVEY**

**FEBRUARY 2026**

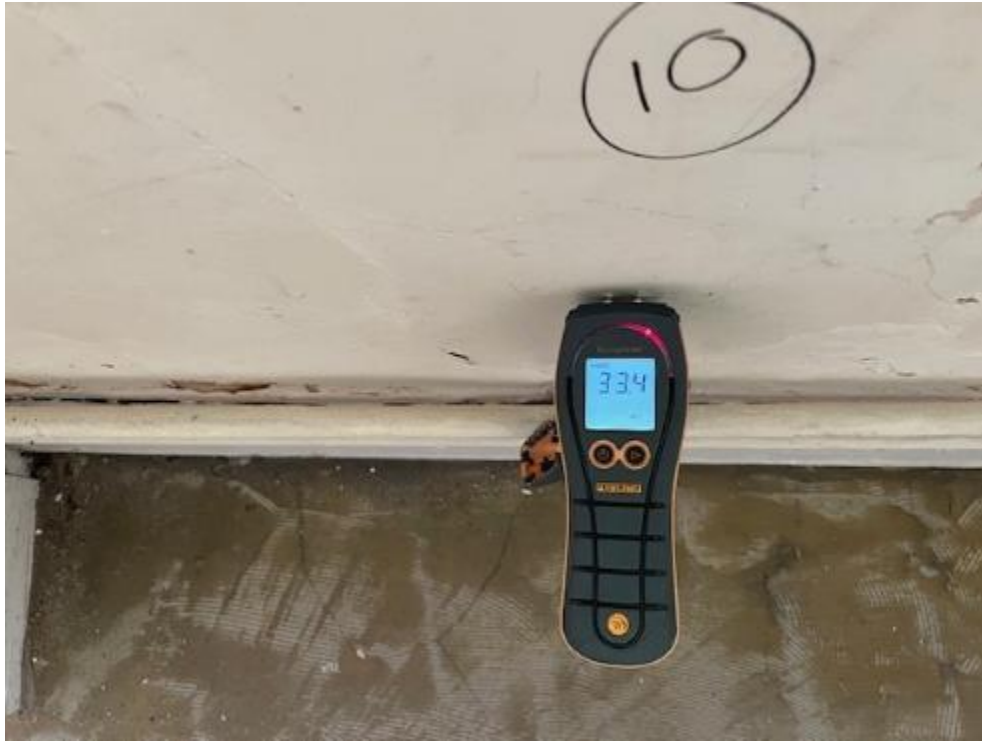
P8 – Store Room 33% m.c

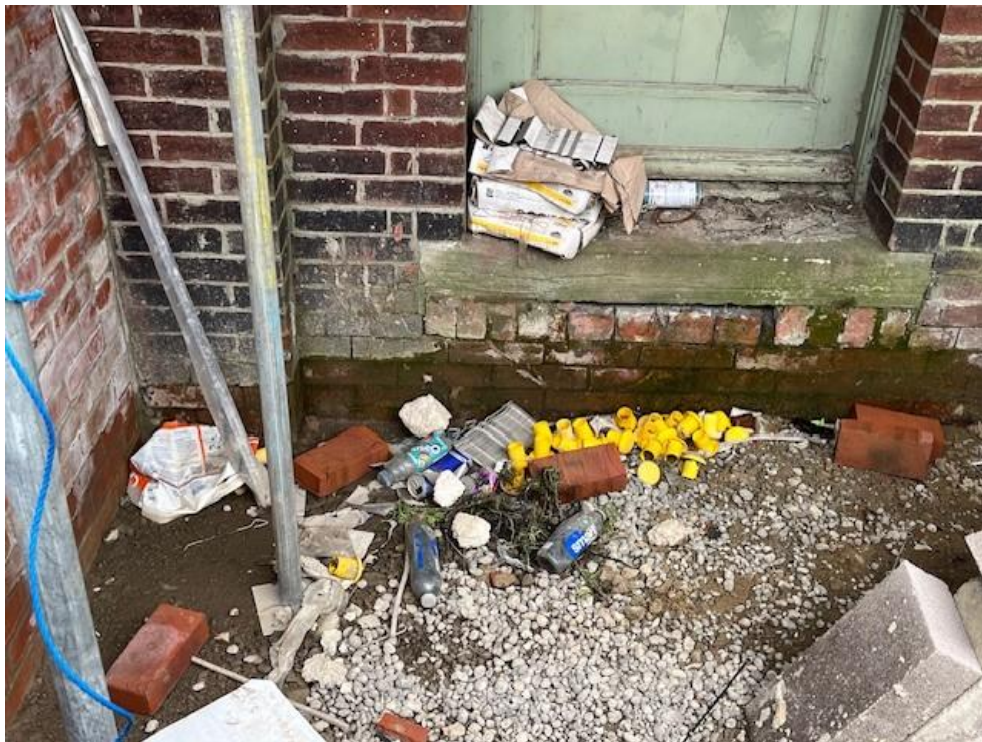
P22 – East Elevation brickwork below door threshold saturated

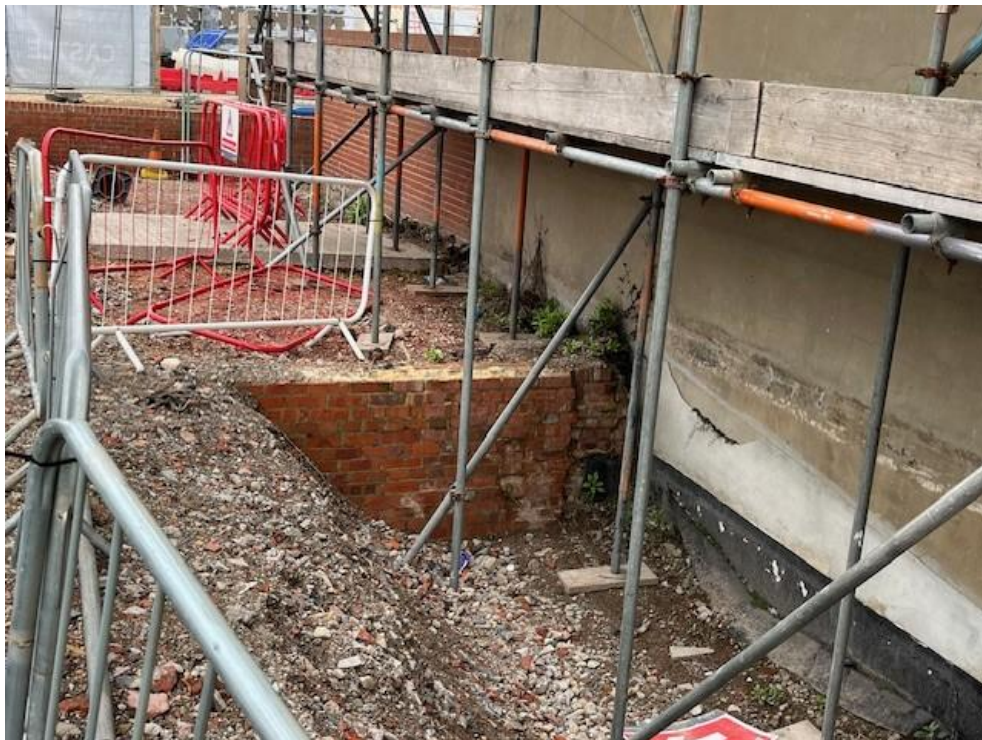
P28 – South Elevation

(**Note:** existing vertical damp membrane used to isolate below ground fill/earth from the external wall and prevent migration of moisture)

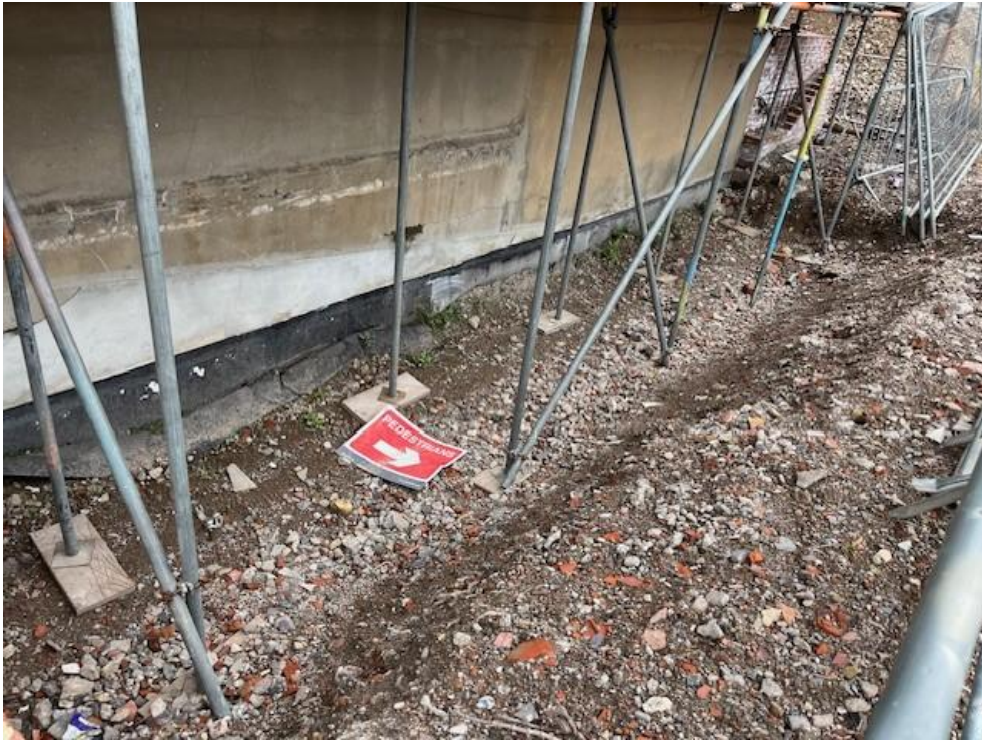
P29 – South Elevation

(**Note:** existing vertical damp membrane to isolate below ground fill/earth from the external wall)

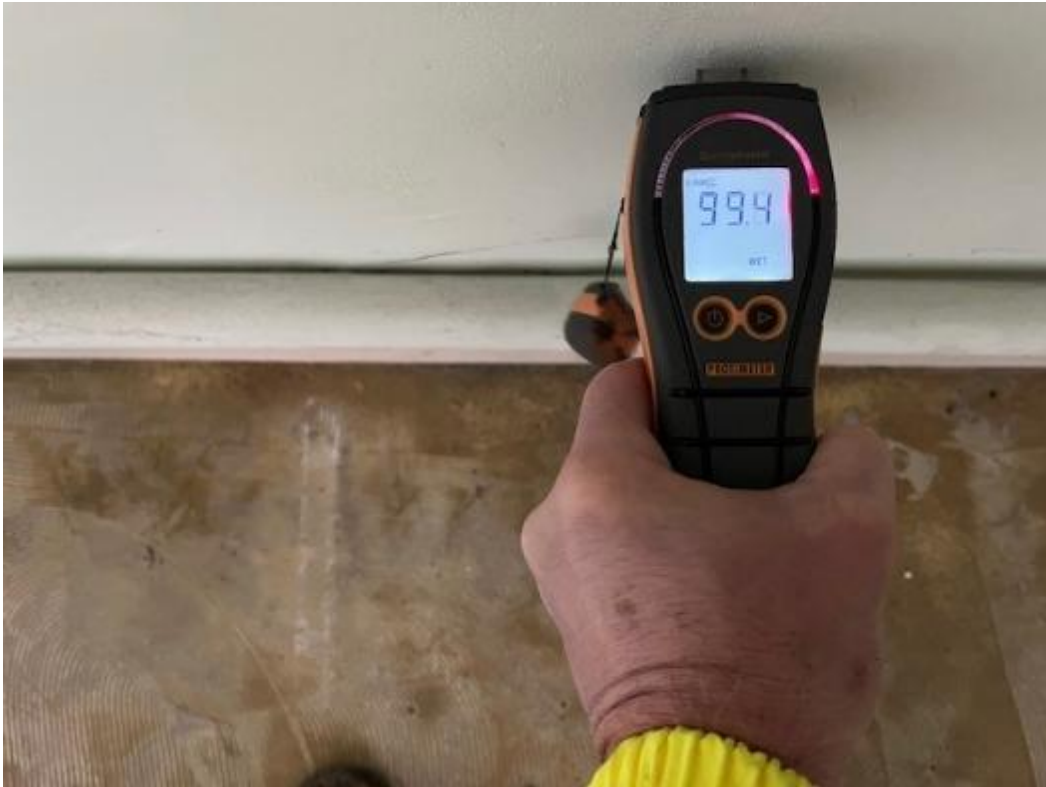
- 2.3.1 Exceptionally high moisture content (saturation level) readings were recorded in the corner of the Director of Estates Room. The exterior yard was inspected and there was significant evidence of ponding with extensive moss and vegetation growth and blocked gullies and inadequate falls to the yard itself which would have contributed to the high readings.

P35 – Director of Estates 99.4% (refer to Photograph P36)

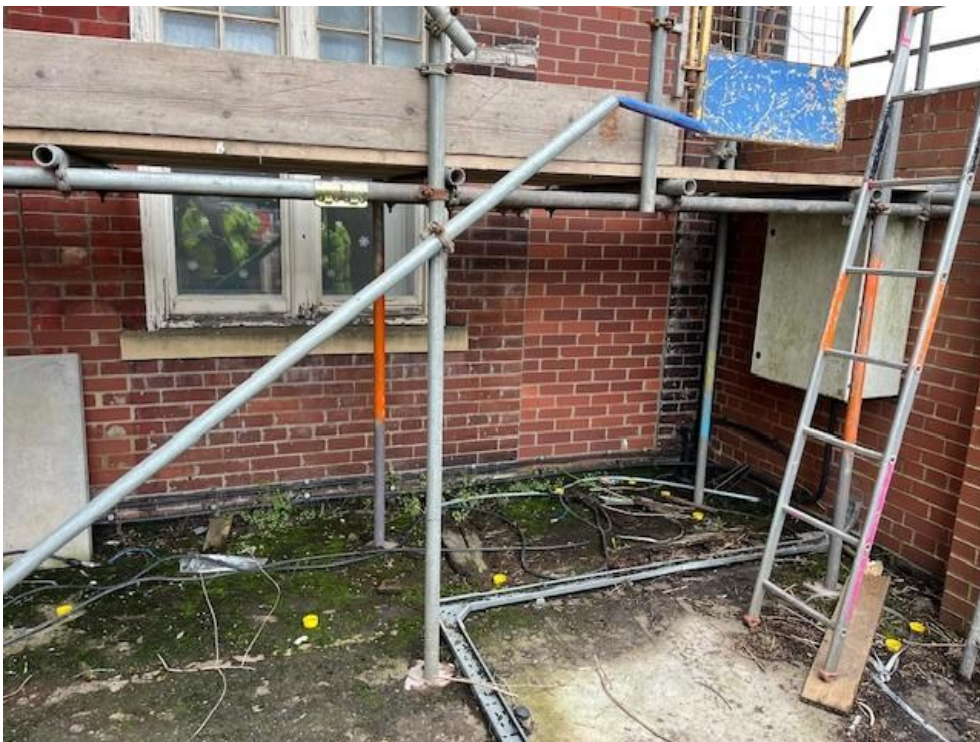
P36 – West Elevation yard – surface water ponding against the external wall of the building

Replacement of the yard wall new gullies and the installation of gravel margin adjacent to the external wall is advised.

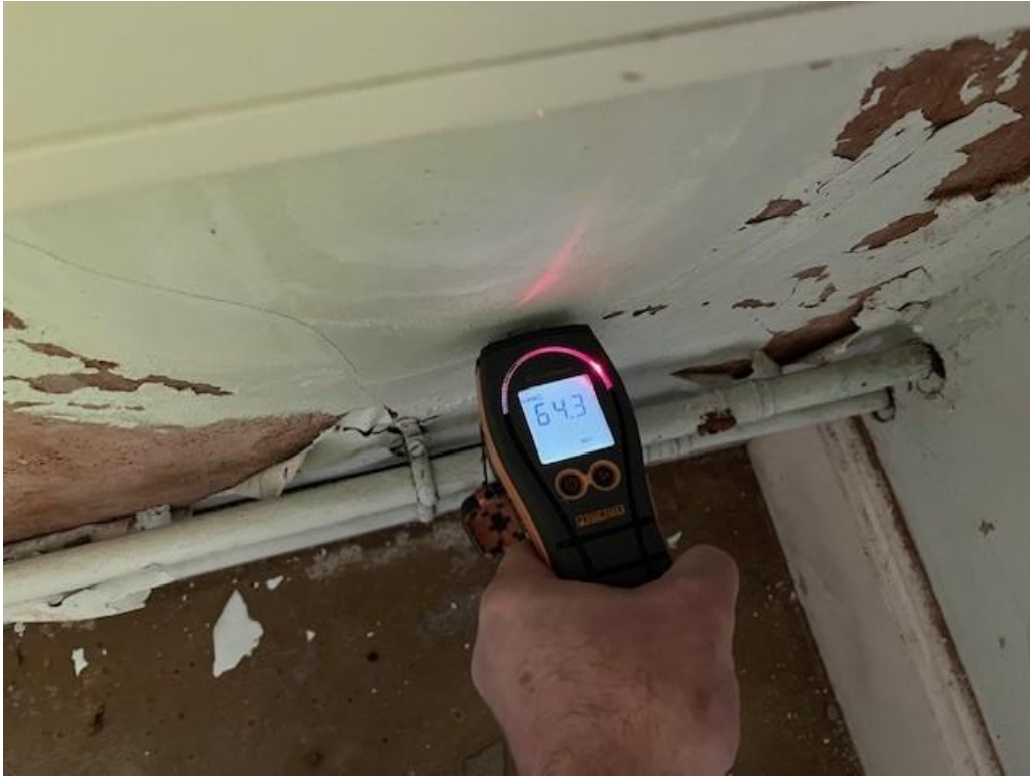
- 2.4.1 The moisture readings up to 64% were recorded within this area and there is significant vegetation growth and ponding within the yard adjoining the external wall of the WC. There is also some buddleia evident which is opening up brickwork joints and further evidence of extensive ponding in the adjoining area.

P45 – Director of Estates 64.3% m.c note damaged paintwork and plaster

- 2.8.3 It is not necessary to replace the plaster generally with slurry tanking however, in isolated areas i.e. the Director of Estates and WC Room where the wall is saturated the lightweight gypsum plaster (hygroscopic) should be cut out and replaced in a breathable lime plaster.

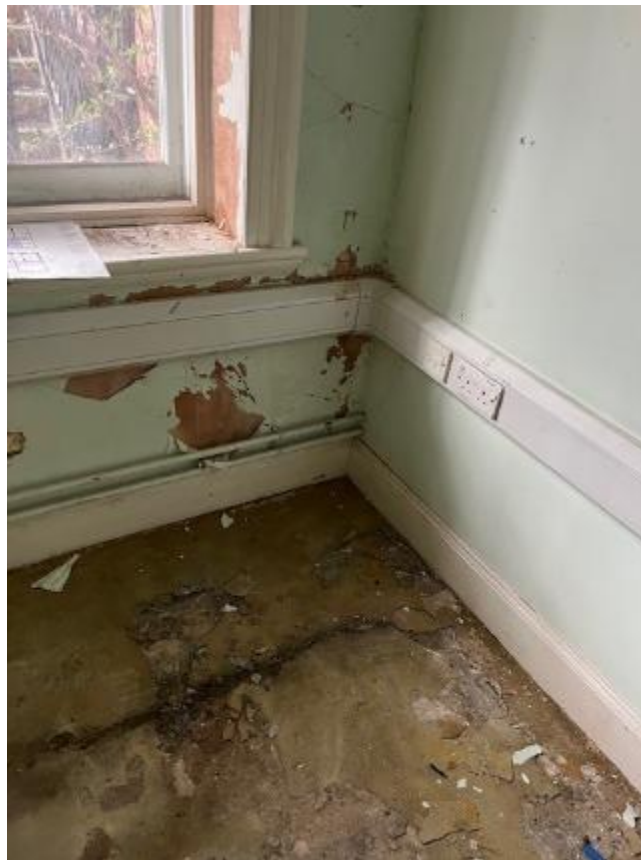
- 2.3.2 It was also noted that the adjoining boundary wall build up against and butting to the corner of the building is potentially forming a bridge which could cause the high moisture levels and dampness at this corner. It is recommended that a vertical damp proof membrane is installed at the interface between the brick boundary wall and the corner of the building and a movement joint installed at this juncture (refer to Photograph P46).

P46 – Visual evidence of flaking paintwork and damp plasterwork

- Replacement of the yard with new gullies and the installation of a gravel margin adjacent to the external wall is advised.
- South West corner: rake out the vertical joint between the boundary wall and external wall of the building and insert a vertical damp proof membrane, a flexcell filler board and polysulphide mastic joint to isolate the boundary wall from the external wall of the building

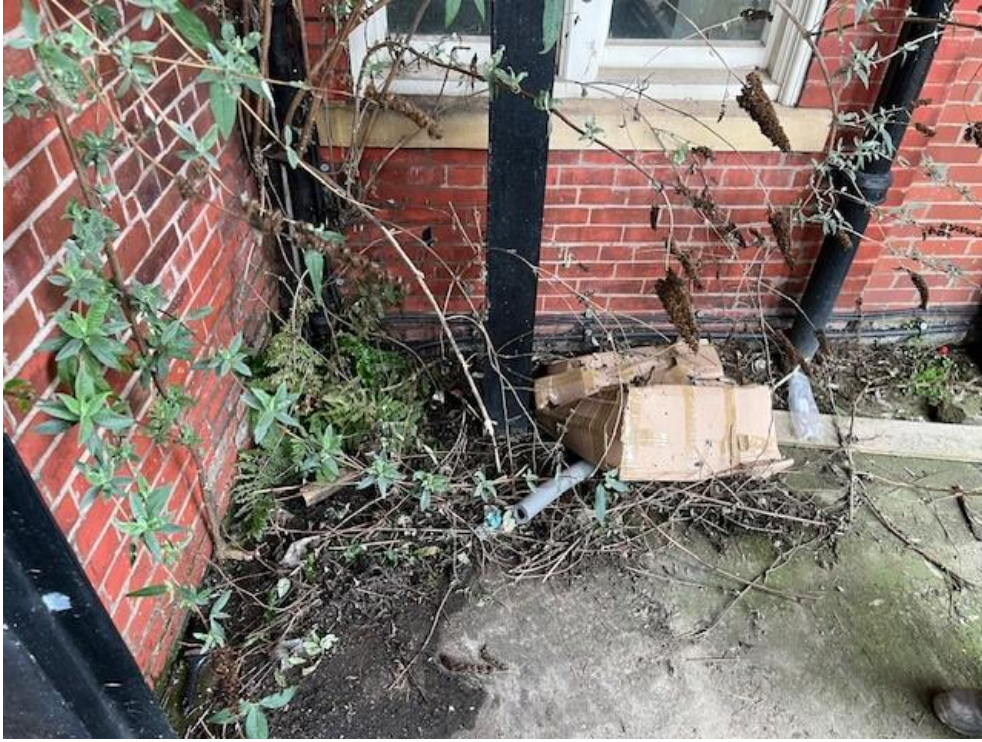
- 2.3.3 Moisture Meter Readings were also recorded on the west facing external wall of the Director of Estates Office and again this faces on to the yard which has flooded and ponded due to inadequate drainage (refer to Photograph P47).

P47 – West Elevation – buddleia growth and blocked gulleys

- Allow for replacement of all defective gullies, rainwater pipes etc to the rear yard
- Allow for replacement/repair of the roof coverings
- Allow for removal of the drylining to the area marked A within Circulation Area 02 to allow the masonry to dry on the completion of the roof remedial works

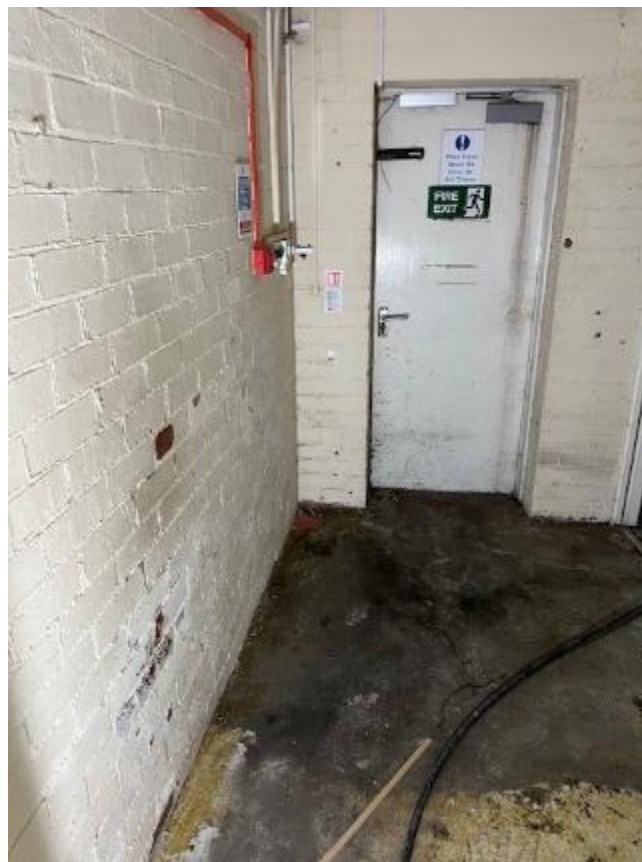
- 2.5.1 Extensive efflorescence is evident to the joints within the painted brickwork. This is caused by the evaporation of salts within the mortar following continuous moisture penetration within the external walls. There is also a flat roof with defective covering above the Circulation space and this is an inferior condition and should be replaced. In brief the high moisture content is a result of penetrating rainwater via the flat roof and also via the external walls of the building itself. Replacement of the roof covering and repointing of the external walls together with remedial work to the drainage of the yard and to the gullies should eliminate the source of the dampness to the external walls to this area.

P50 – Efflorescence on solid brickwork wall caused by penetrating dampness

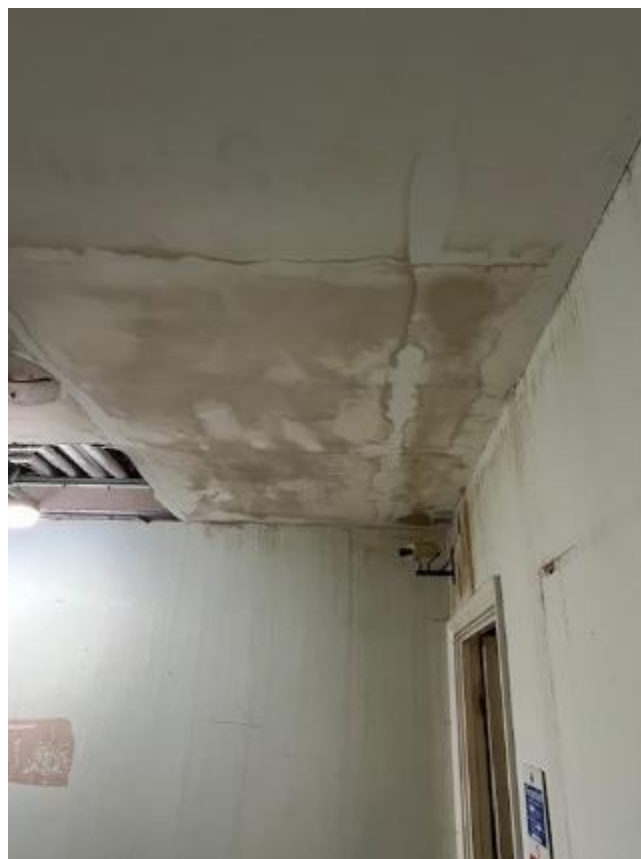
P52 – External wall and ceiling of Circulation Area 2 affected by roof leaks -penetrating dampness from failed rainwater pipes

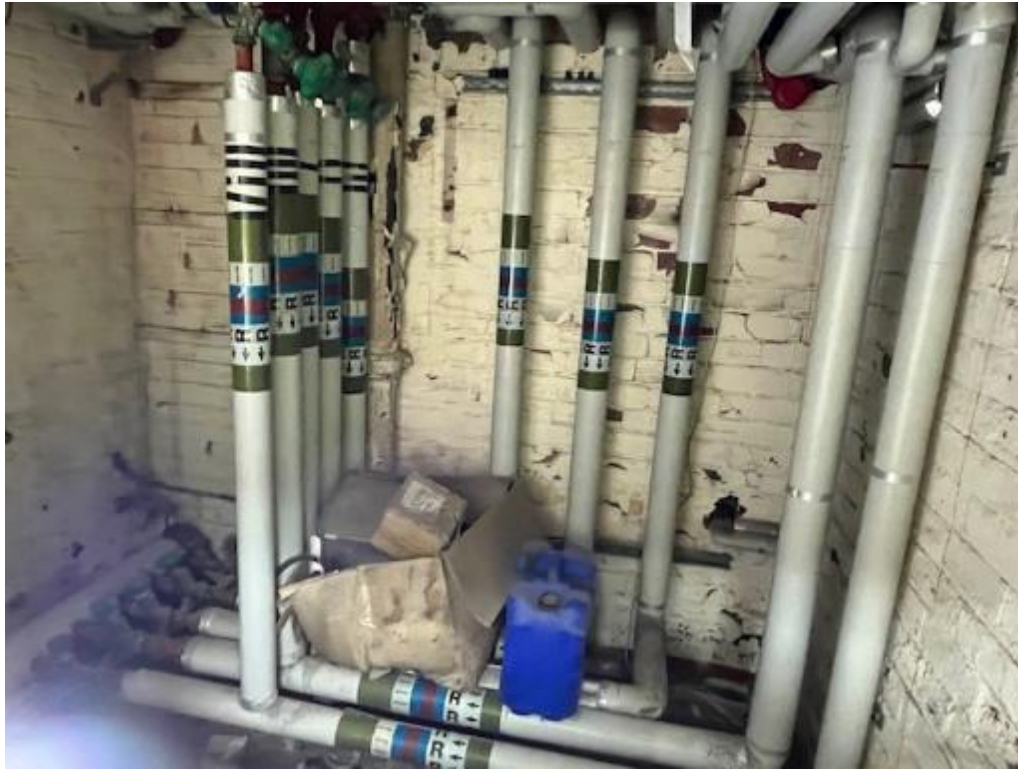
- 2.6.1 The plant room is very similar to that previously described in that the efflorescence within the brickwork is as a consequence of penetrating dampness through the external walls potentially via the chimney. This area has a concrete floor and there is no risk of any timber decay. It has natural ventilation via grilles within the external wall and with the increased heat in the Plant Room and further dehydration of the walls will result and there is no remedial work necessary to the masonry walls in this space.

P53 – Plant and Storage Room 25.7% moisture content due to penetrating dampness

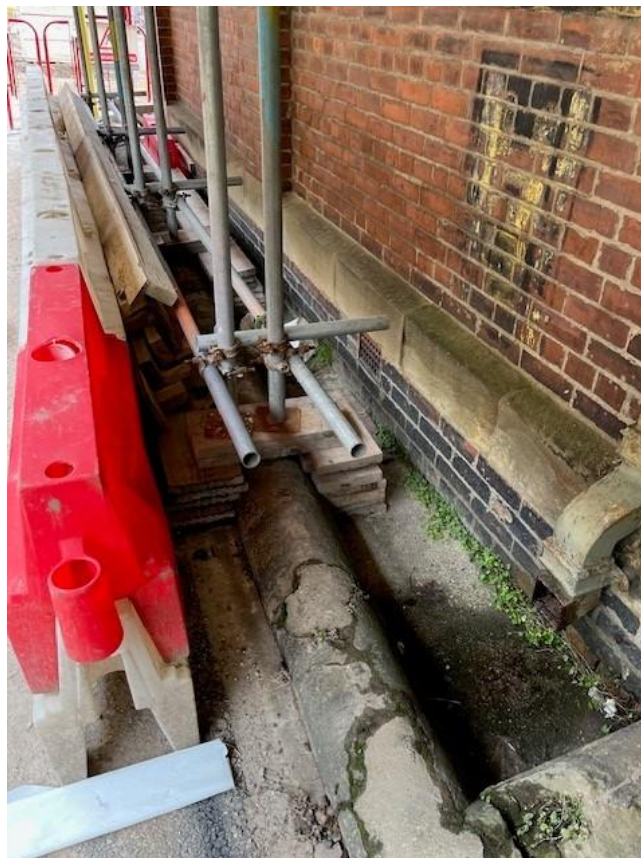
P56 – North Elevation rainwater pipes discharge onto solid concrete contained within a stone plinth course

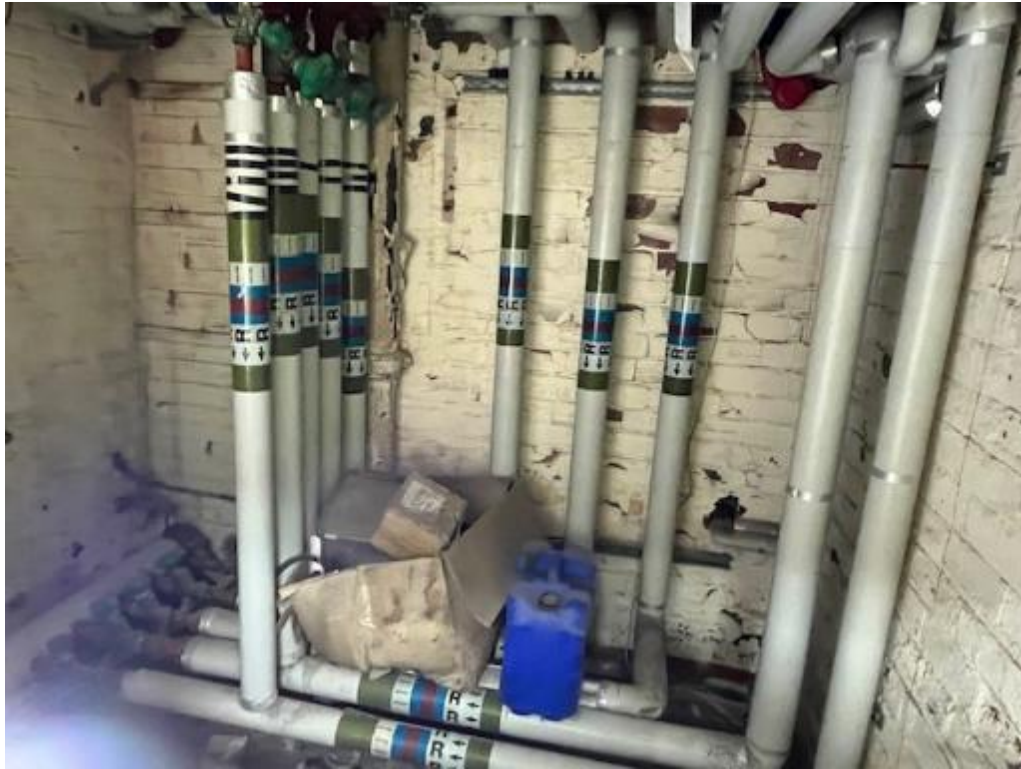
P57 – Plant Room penetrating dampness from front roof

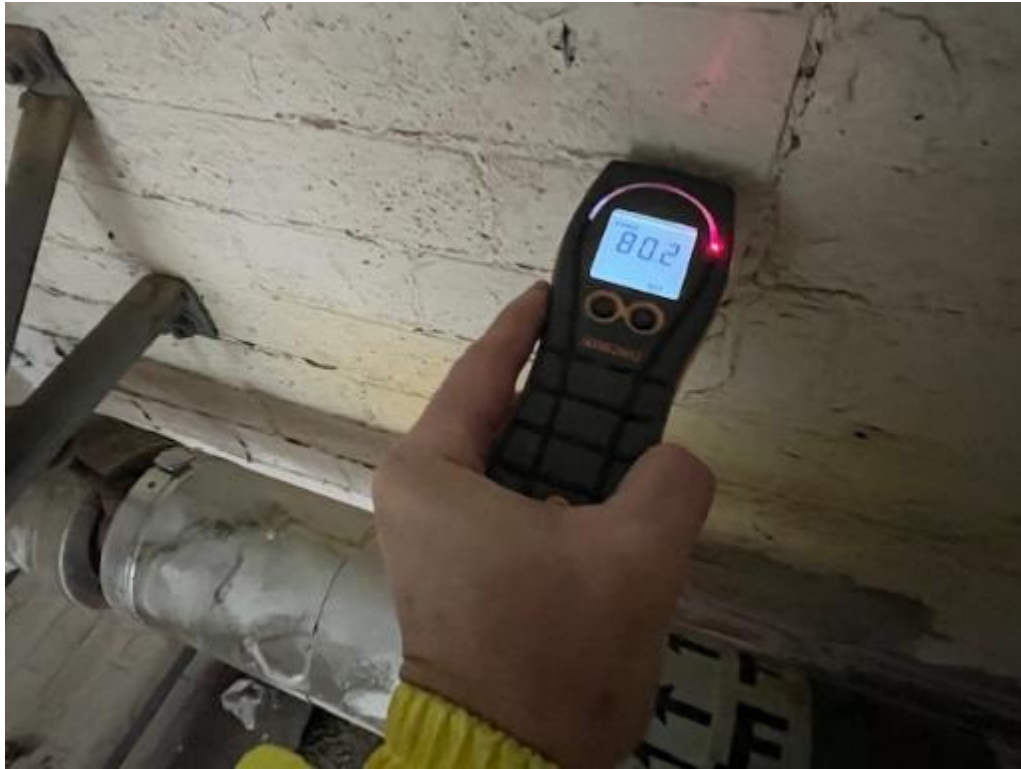
P59 – Plant Room 80% moisture content

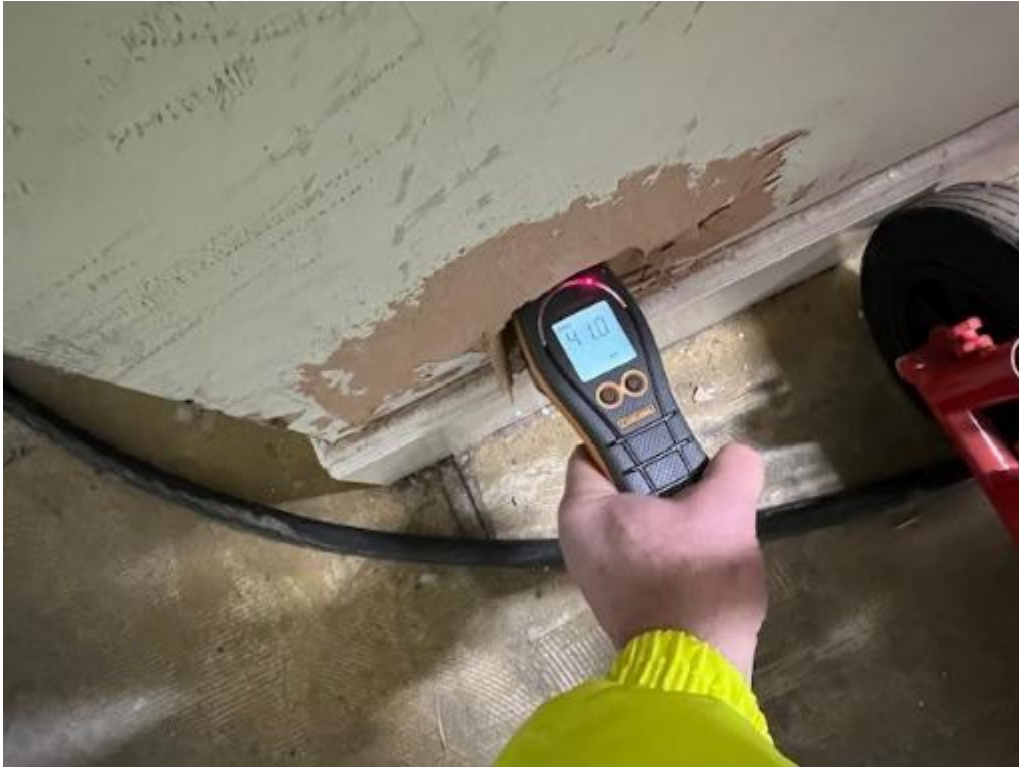
- 2.7.1 This part of the wall identified on the plan has been drylined and would appear to be chimney. The brickwork recorded a very high reading (refer to Photographs P60 and P61). The wall is drylined however water staining is evident on the face of the wall finish and to the rear of the lining. This lining conceals the chimney breast. It is likely there are failures of back gutter flashings and valley gutters and roof coverings at the juncture between the chimney and the pitched roof covering. Upon completion of the remedial works to the roof coverings and abutments it is unlikely that further rainwater penetration will occur. The drylining should be removed to allow the masonry to dry out whilst the roofing works are completed.

P60 – Chimney – 41% moisture content (concealed behind drylining)

- Allow for replacement of all defective gullies, rainwater pipes etc to the rear yard
- Allow for replacement/repair of the roof coverings
- Allow for removal of the drylining to the area marked A within Circulation Area 02 to allow the masonry to dry on the completion of the roof remedial works

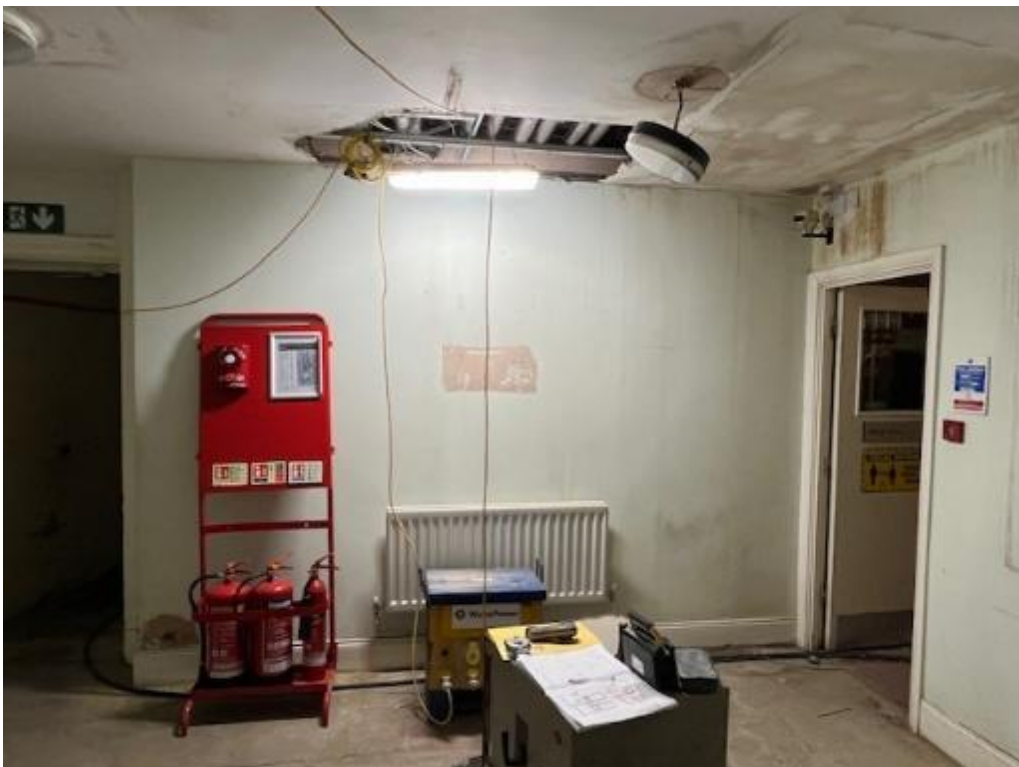
P61 – Chimney – drylined  
(**Note:** damp staining)

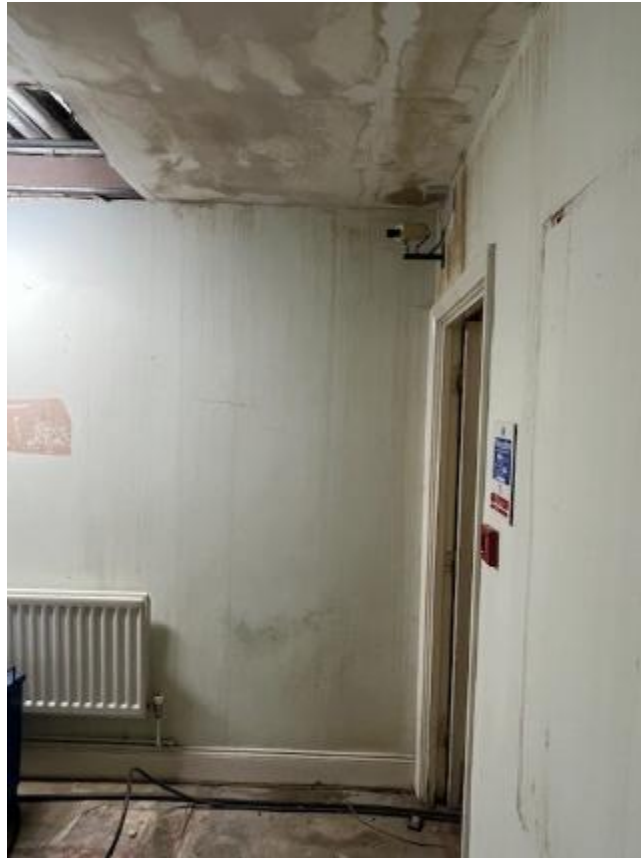
P62 – Chimney/adjacent ceiling penetrating dampness evident

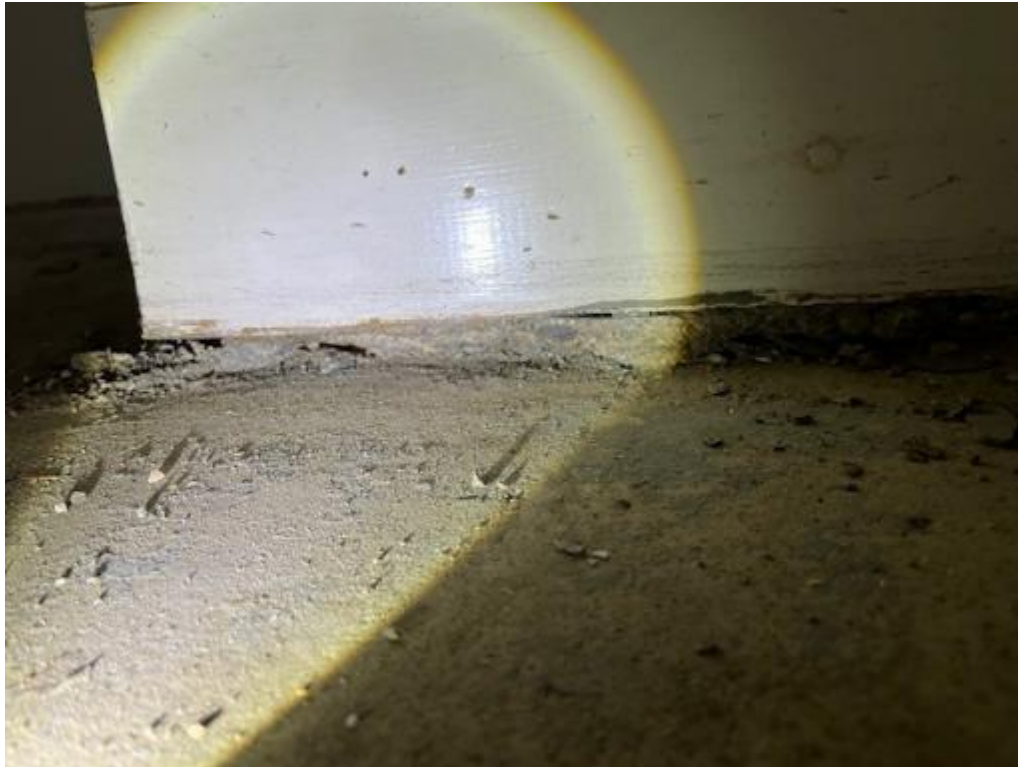
- 2.8.1 The readings taken to these two pillars revealed slightly elevated readings in isolated areas. On the balance of probabilities it is likely that the plaster is in contact with the concrete floor and bridging has resulted in vertical moisture transfer via capillary action to these areas (refer to Photographs P67, P69 and P74).

P74 – Potential bridging caused by migration of moisture via plaster in contact with the floor

- 2.8.2 It is recommended that the skirting is removed and the plaster cut back in isolated areas from the floor and repaired in a renovating breathable lime plaster.
