## Survey Report & Proposal

16 Barrington Street  
South Shields  
NE33 1BB

Date of Report: 12/02/2026

Our Reference: NE16318-UPDATED

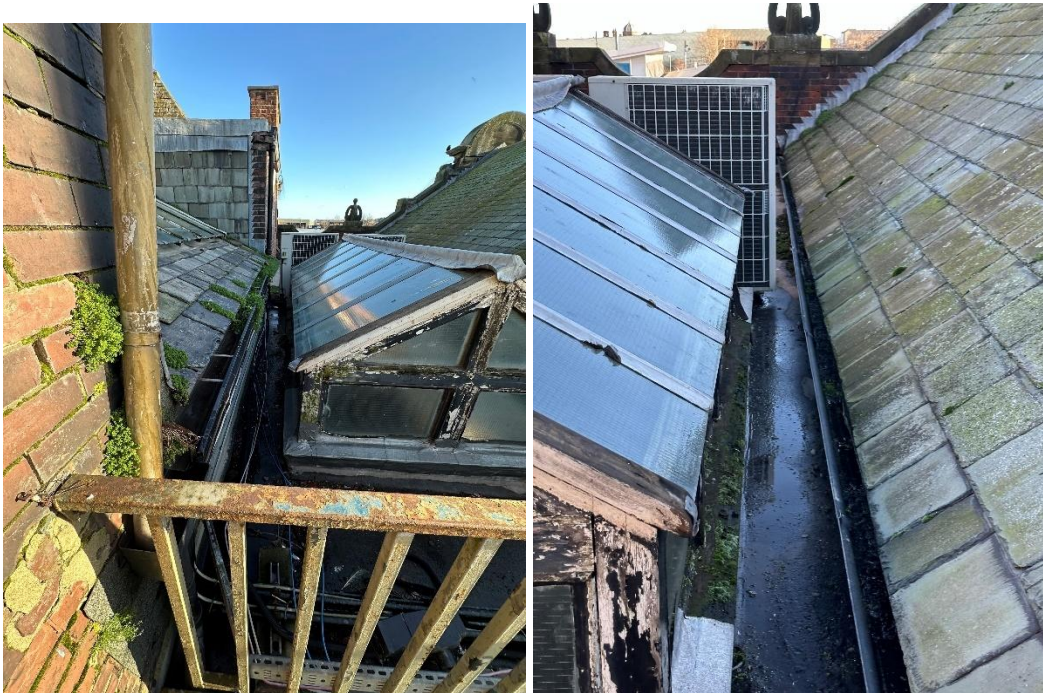
At the time of the survey the lead flashing to main roof were noted to be in poor condition and need of repair or replacement.

Flash banding has been used as a temporary measure to the glass lantern roof and has failed.

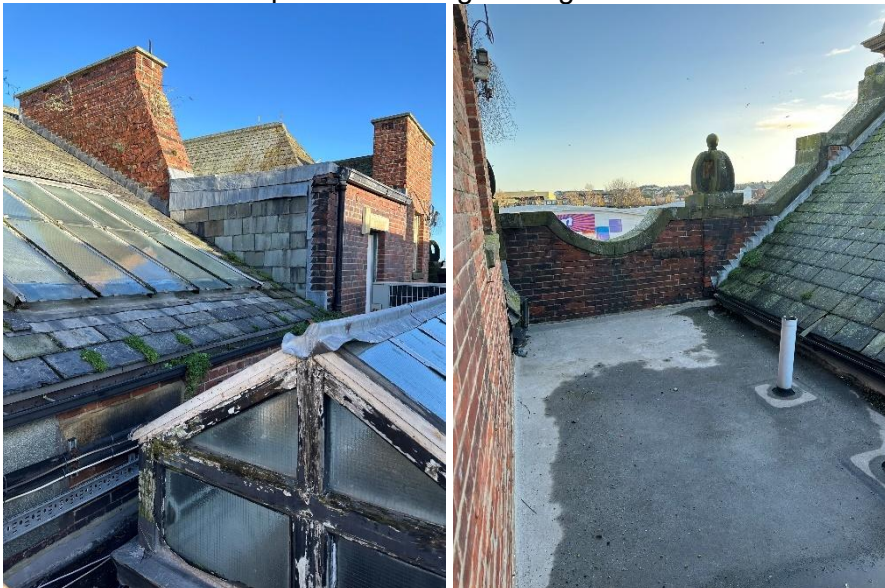
At the time of the inspection missing/dislodged tiles/slates were noted to the front elevation.

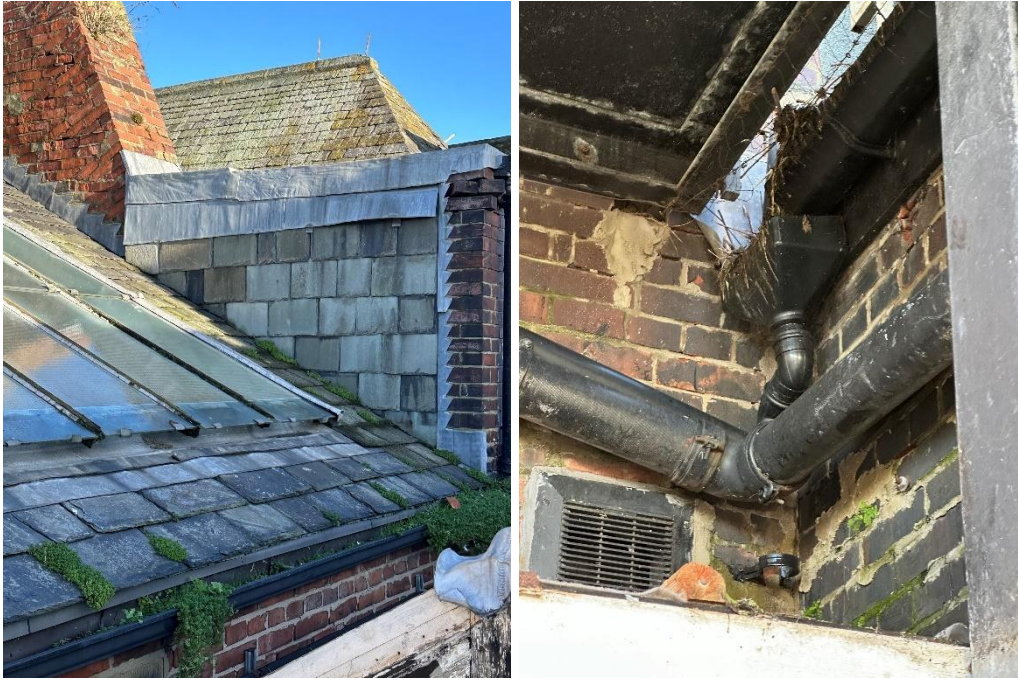
At the time of the inspection broken guttering was noted to all elevations.

Water staining to the gutter joints/masonry on all elevations indicated that they are leaking.

Vegetation growth was noted to be sustained on all elevations / guttering at the time of inspection.

The guttering and downpipes are generally in poor condition and in need of repair or replacement.

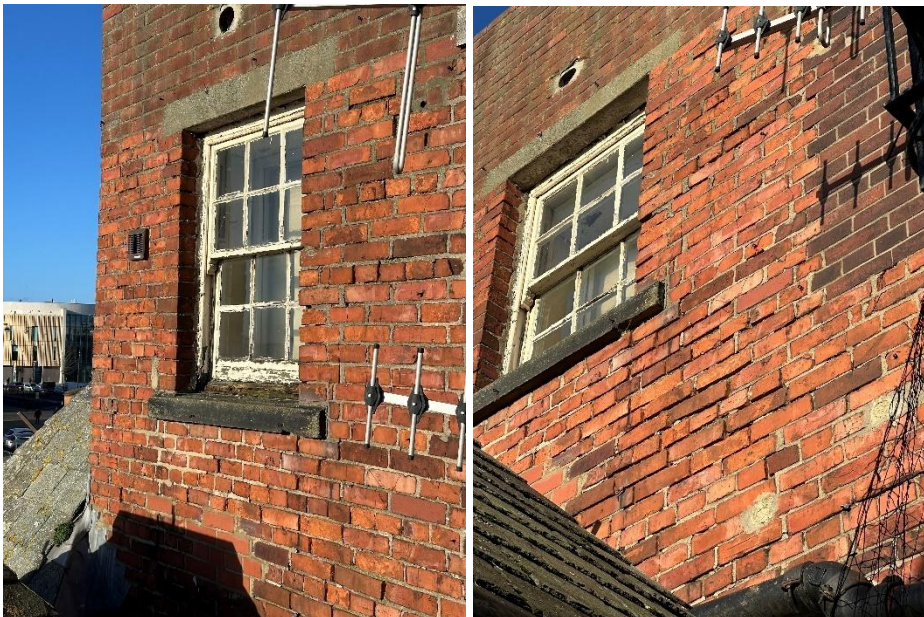
Isolated patches of defective mortar pointing were noted to all elevations.

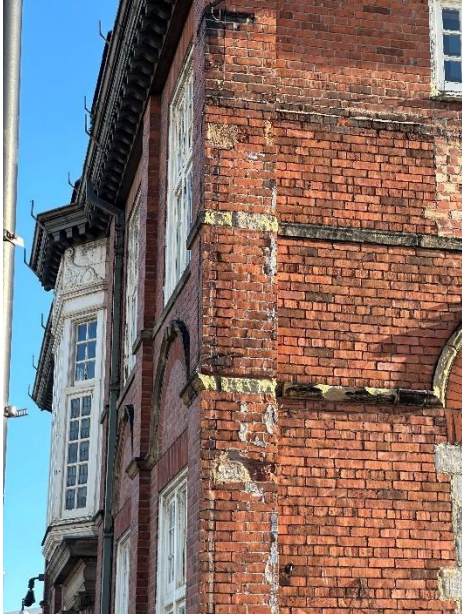
Facing bricks were noted to be spalled at the time of the inspection to the right side and rear elevations.

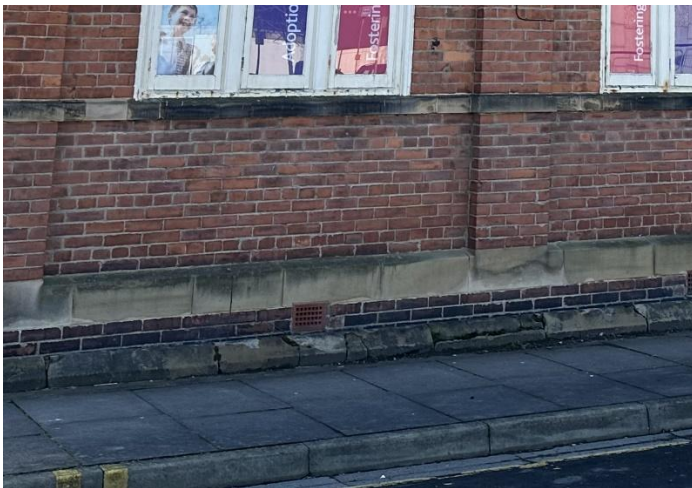
An existing damp proof course could not be established due to a defective concrete plinth at the base of the elevations.

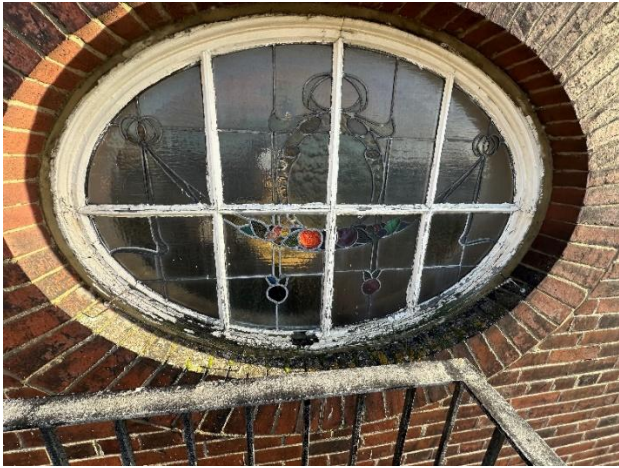
At the time of the inspection flaking and debonding paint was noted to all painted windows and timber external structures to all elevations.

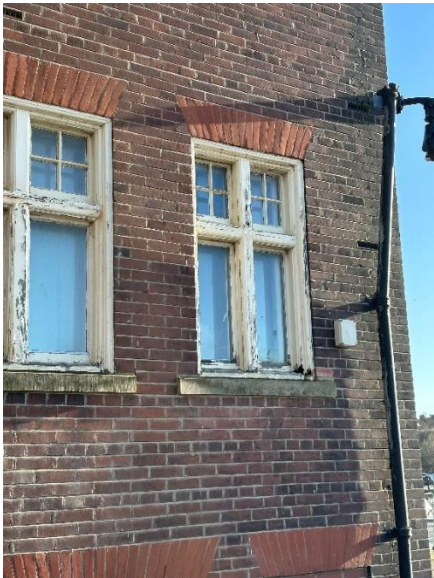
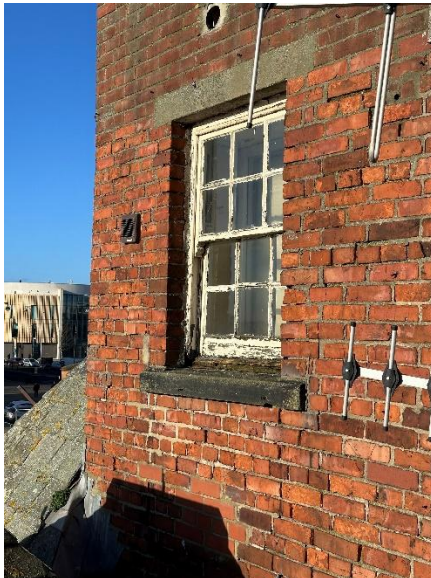
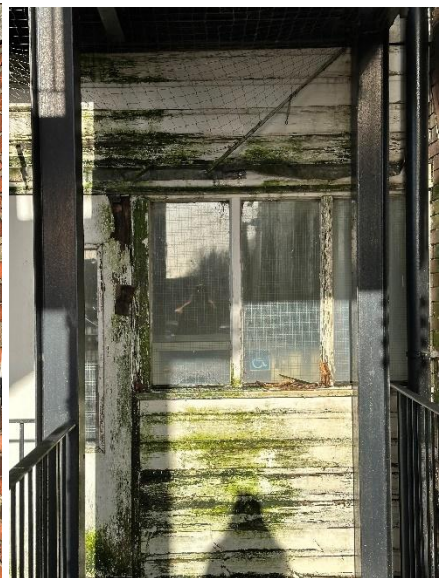
Wet rot decay was noted to all windows and surrounds, all doorways and surroundings to the steel fire exit to the right side and all other elevations at the time of the inspection.

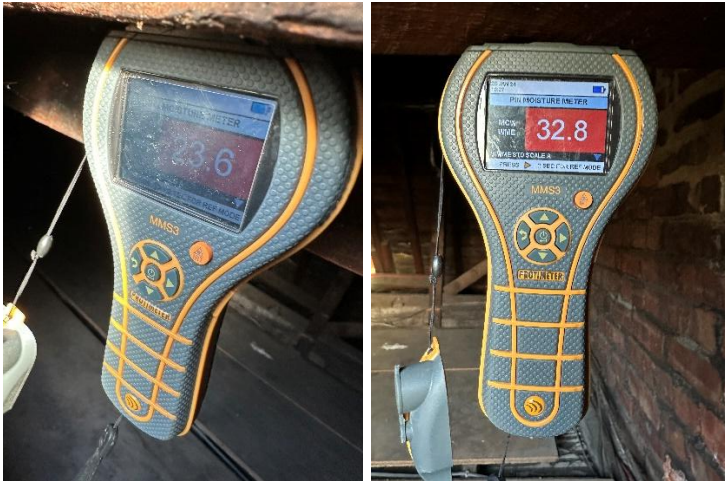
Where inspection was possible, no active infestation was noted to the accessible timbers inspected.

Moisture meter readings taken to the roof timbers are reading between 23.8% to 32.8%, putting the roof void timbers at risk of timber decay and fungus.

Please instruct a reputable roofing contractor to carry out necessary repairs to the roof and ensure watertight upon opening areas up. It may come to light that there is evidence of decay affecting Timbers which we cannot see at this point in time.

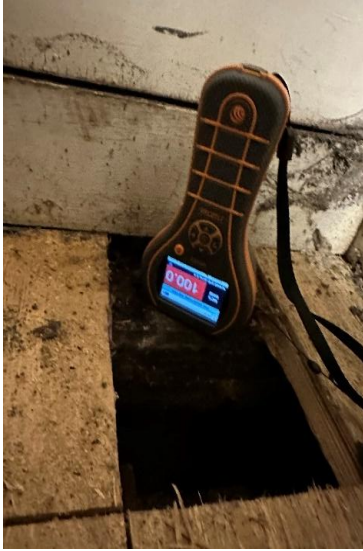
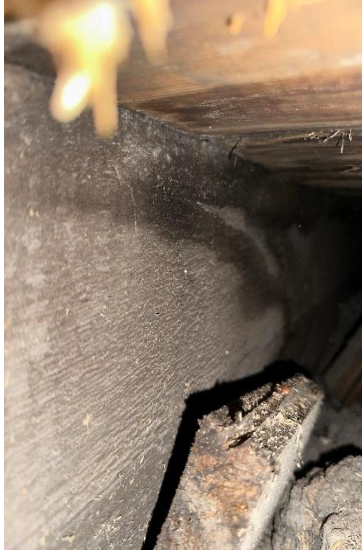
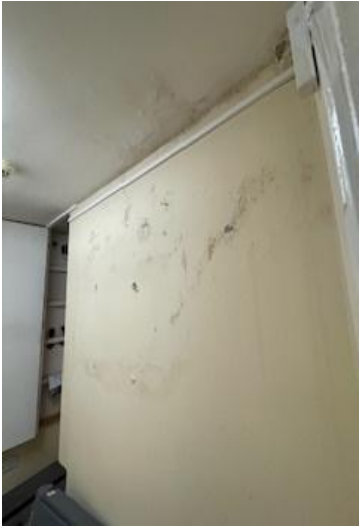
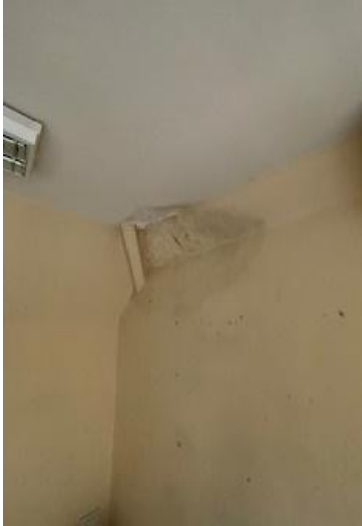
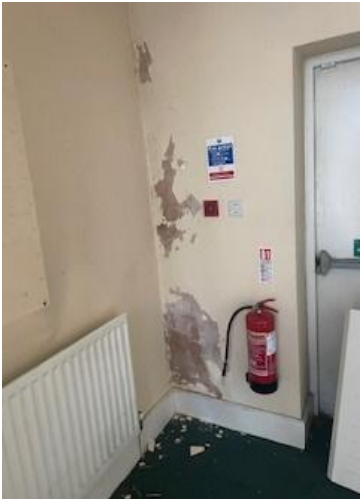
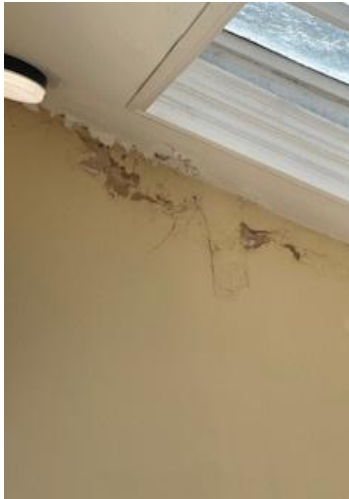
Floor joists and wall plate to the right-side elevation of the building, moisture meter readings taken to this timber by the external exit to the flat roof indicated a moisture reading of 100%. Timber decay was noted, Wet rot decay by Cellar Fungus (*Coniophora puteana*) was noted to the floor joists.

Timber decay was noted to the steel staircase fire exit door and surround.

Water ingress has caused issue with the plaster work and in many areas has become degraded we have highlighted these in green on the attached amended plans.

Client to remove existing floor coverings and boards to expose timber floor joists to areas of noted water ingress, **THIS IS WITHIN THE AREAS WE HAVE HIGHLIGHTED ON THE ADDED PLAN BELOW NOT THE ENTIRITY OF THE RED AREAS ORIGINALLY SHOWN** remove and replace all decayed timbers, ensuring timbers are not in direct contact with masonry. Whilst timbers are exposed Timberwise to apply a **localised** dual fungicidal/ insecticidal

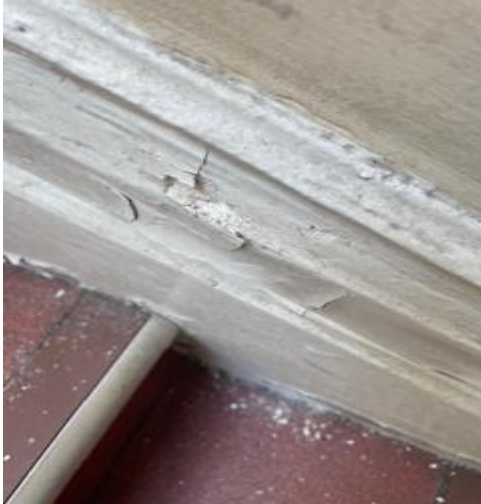
The staircase was noted to be of a stone construction. The string to the stairs is showing signs of peeling paint and there are timber elements off skirting board however it would appear that the majority of the string is of a fibrous plaster nature and will need attention.

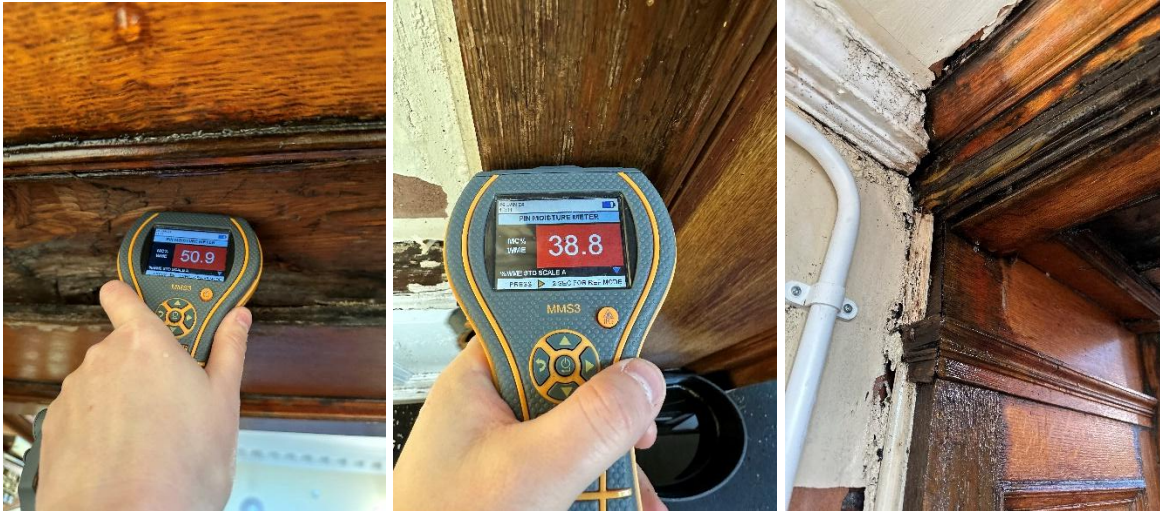
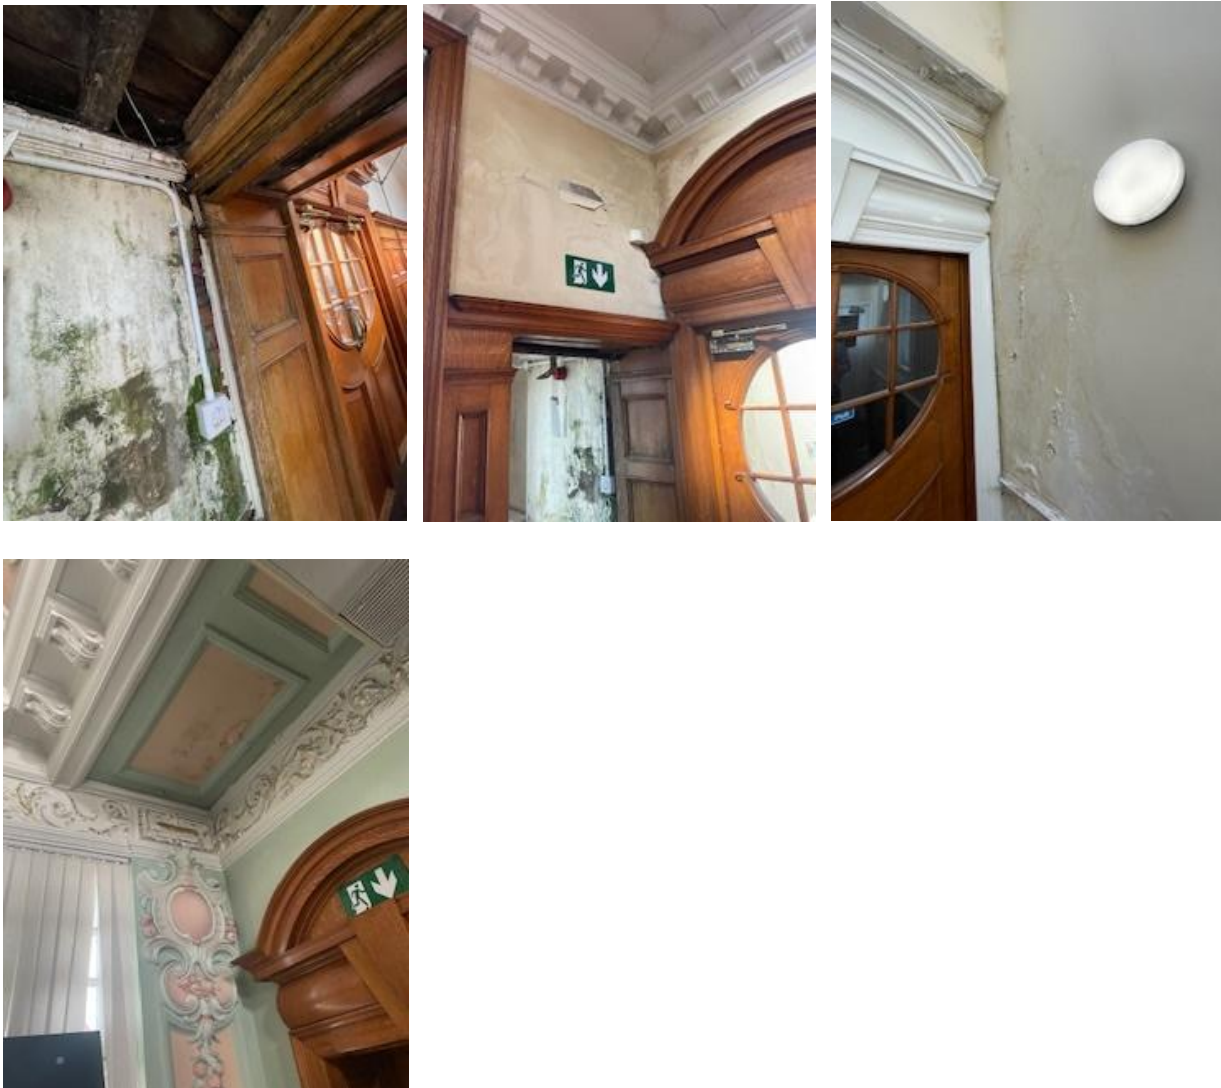
Where inspection was possible, no active infestation was noted to the accessible timbers inspected. Due to failure of the glass lantern roof and flat roof above, water is freely running through the right side of the building, through the first floor and ground floor. Timber decay was noted, between 38.8% and 50.9% moisture meter reading were noted at the time of survey, to the entire floor, and wooden wall panelling, directly below the glass lantern roof, as pictured below. Wet rot decay by Cellar Fungus (*Coniophora puteana*) was noted to these timbers.

This has caused decay to the varnished ornate timber panelling and to the general area of the corridor leading to the rear right room, stripping out and exposure work will be necessary, and we have highlighted this again on the amended sketch plan below. Multiple areas of degraded plaster work are noted and have been highlighted also on the plan. Within the boardroom there is slight sign of water ingress which has caused some damp staining adjacent to the entrance door which may need some attention. Generally there should be no disturbance to the ornate plaster work or indeed the raised computer floor over.

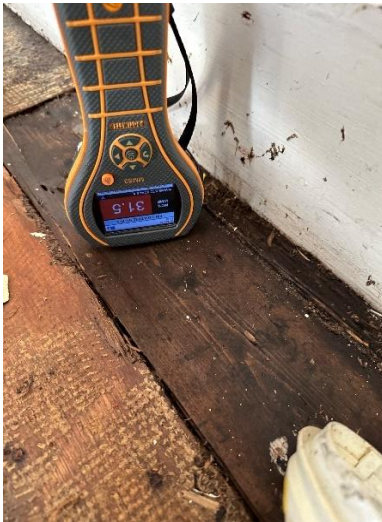
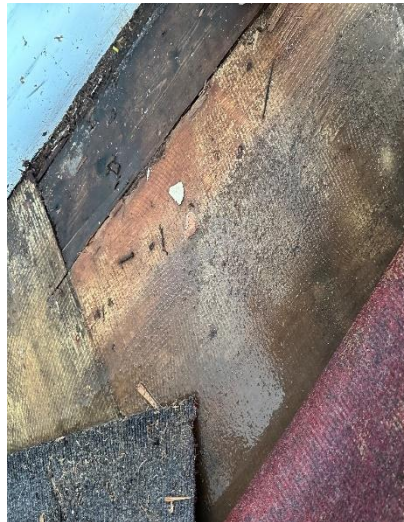
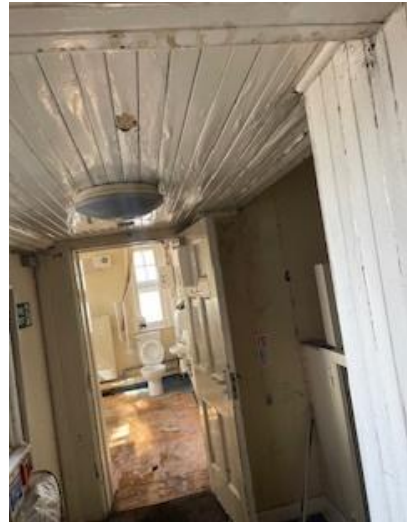
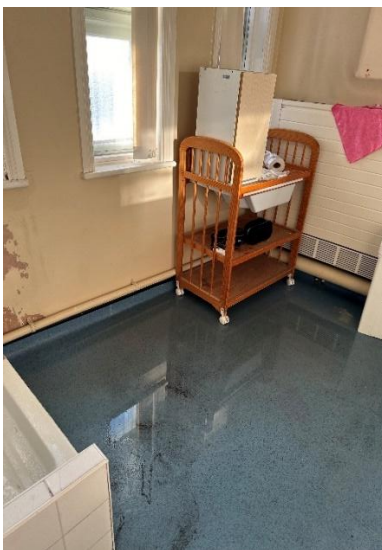
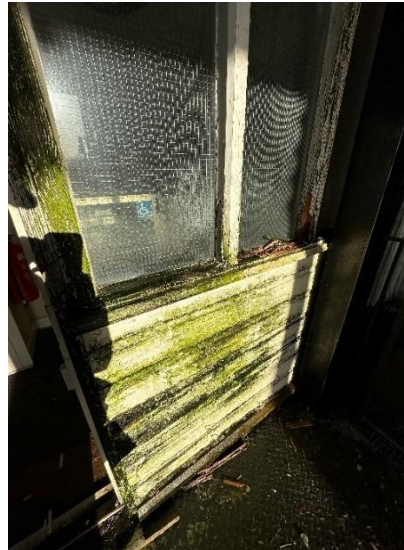
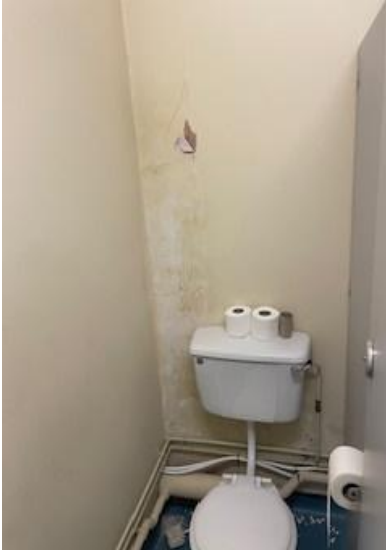
Where inspection was possible, no active infestation was noted to the accessible timbers inspected. Due to failure of the glass lantern roof and flat roof above, water is freely running through the right side of the building, through the first floor and ground floor. Timber decay was noted, between 38.1% and 100% moisture meter reading were noted at the time of survey, to the entire floor, and wooden wall panelling, directly below the glass lantern roof from the first floor, as pictured below. Wet rot decay by Cellar Fungus (*Coniophora puteana*) was noted to these timbers. The entire floor to the right-hand side of the building is flooded and timbers are compromised. Again, there are areas of damp affected plaster work through ongoing water ingress which has degraded the plaster.

***Areas of moisture / decay to timbers within highlighted in red to floor plan above. SEE PLAN BELOW\****

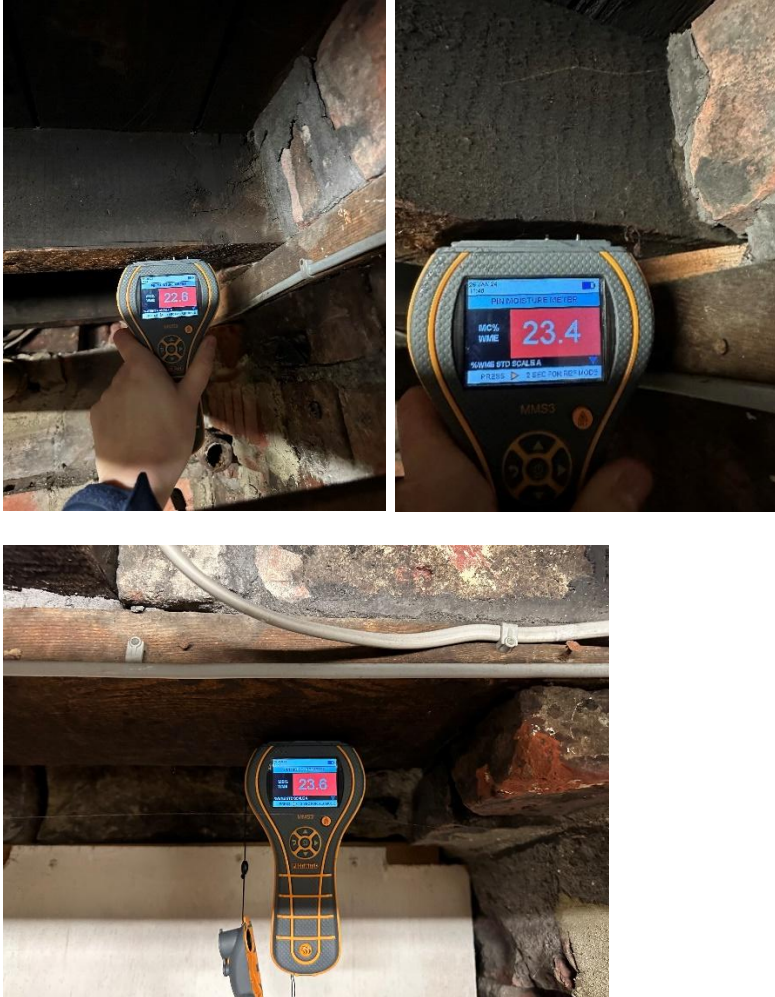
The ground floor is generally constructed of a concrete slab. Suspended timbers to both plant rooms were tested using a handheld moisture meter with readings of 22.6% to 23.4%, and timbers that are in direct contact with masonry we must stress we have seen no obvious signs of infestation or decay to these timbers.

Client to remove existing floor coverings and floor boards to expose timber floor joists to areas of noted water ingress **specific to the areas highlighted on the marked up amended plan below**, remove and replace any decayed timbers, ensuring timbers are not in direct contact with masonry. Whilst timbers are exposed Timberwise to apply a **localised** dual fungicidal/ insecticidal.

Areas of degraded plaster work through water ingress should be removed to expose masonry behind.

Timberwise are to treat the masonry which has been exposed through plaster removal with a masonry biocide sterilisation treatment.

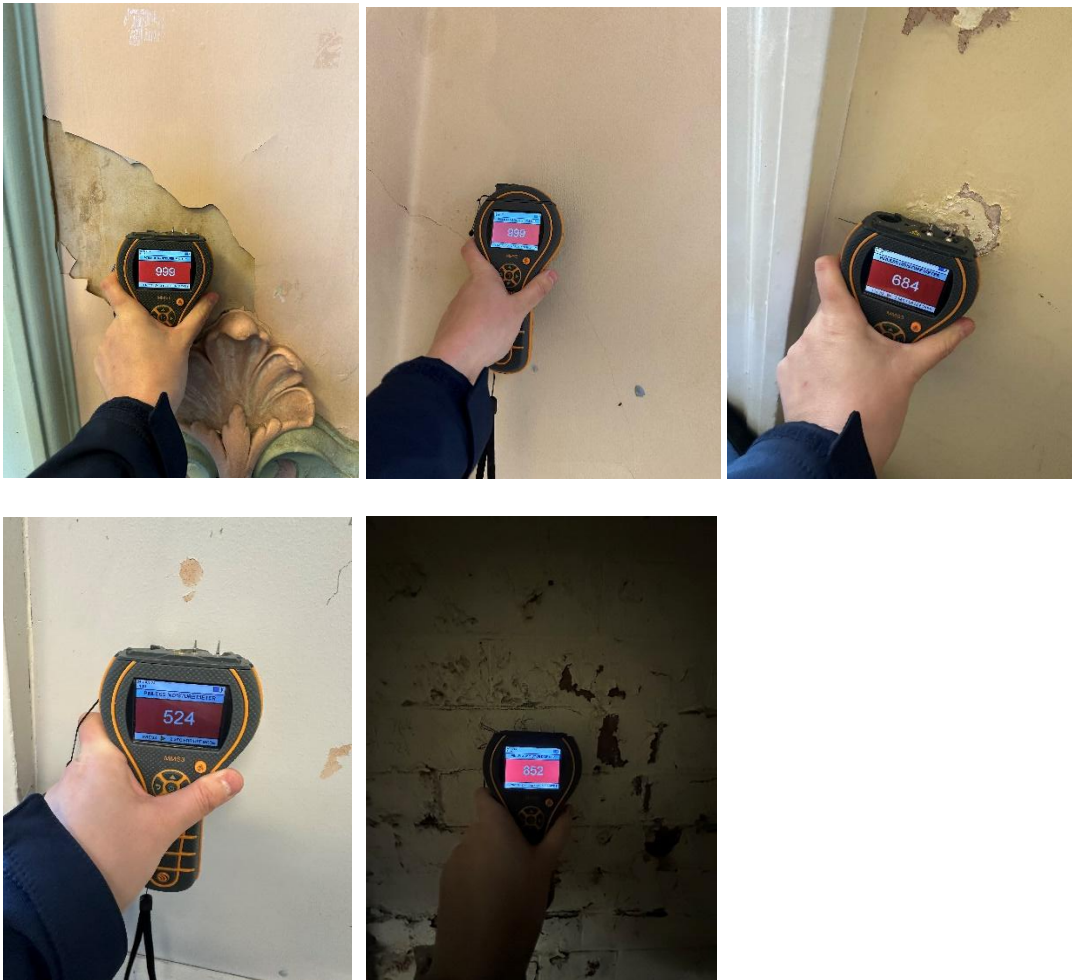
Water stained/visibly damp and defective plaster was noted to the second, first and ground floor as per marked sketches below, this is due to rainwater penetration from the (leaking gutters, defective pointing, flashings, defective roof coverings, defective flashings, spalled brickwork, decayed joinery) identified in our external observations above.

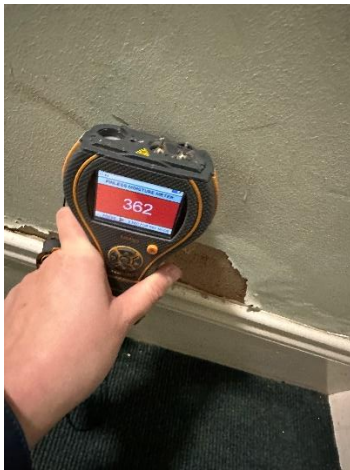
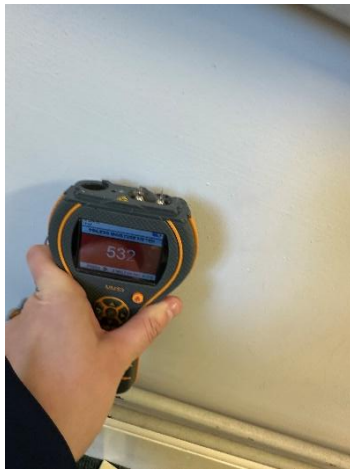
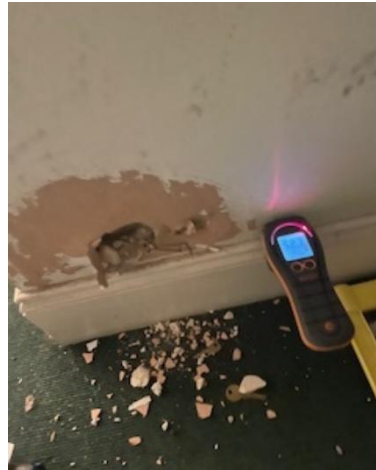
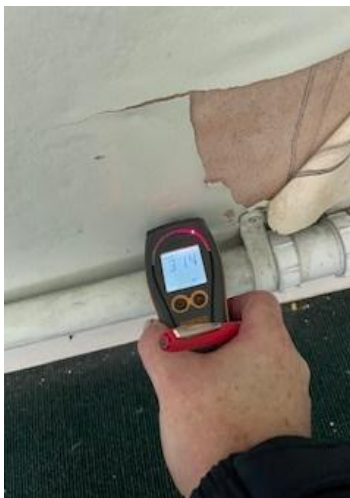
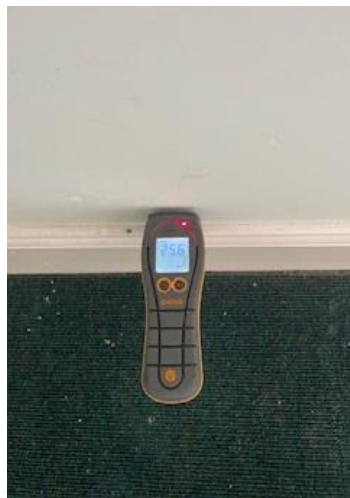
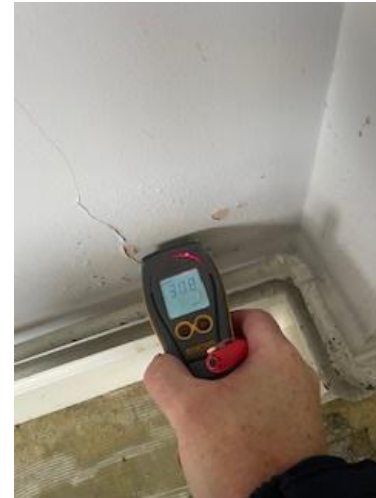
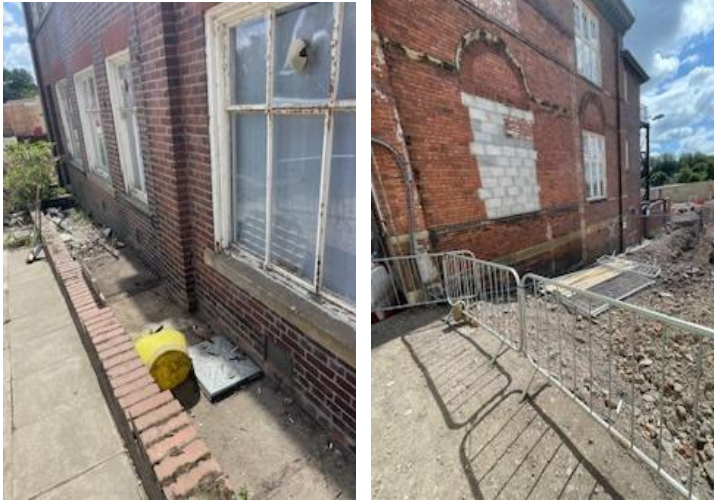
Moisture profiles were plotted on the walls with an electronic conductivity meter, the profiles recorded indicate both an ongoing rising damp issue to the basement/lower ground floor. Conductivity meters are non-destructive and only give an indication of moisture content on masonry but a true reading on timber.

Visible damp, salt contaminated plaster was noted to the areas as noted on the floor plans below.

After consideration of the instrumental readings, soluble salt contamination and other relevant factors, it is assessed that various walls within the property are affected by rising dampness. The installation of an electro osmosis damp proof course is recommended to the areas indicated on the enclosed sketch plan and technical drawings.

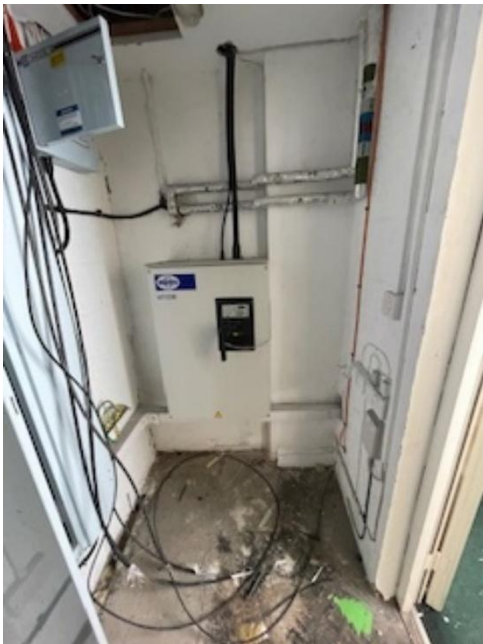
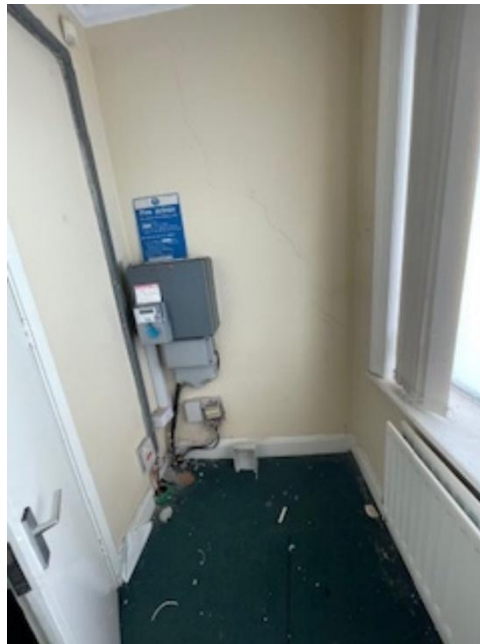
The majority of the lower ground floor / basement walls are above external ground levels with the exception of the left hand elevation we pointed out earlier and shown on photograph above however, within the basement there are walls which may be subject to high levels of earth against though these walls are midsection to the building we are most likely unable to carry out any works due to the restrictions of the electrical plant equipment on the electrical supplies on those walls see photograph below we for the time being have omitted any works to these areas though they are not showing any significant signs of being degraded at this point in time.

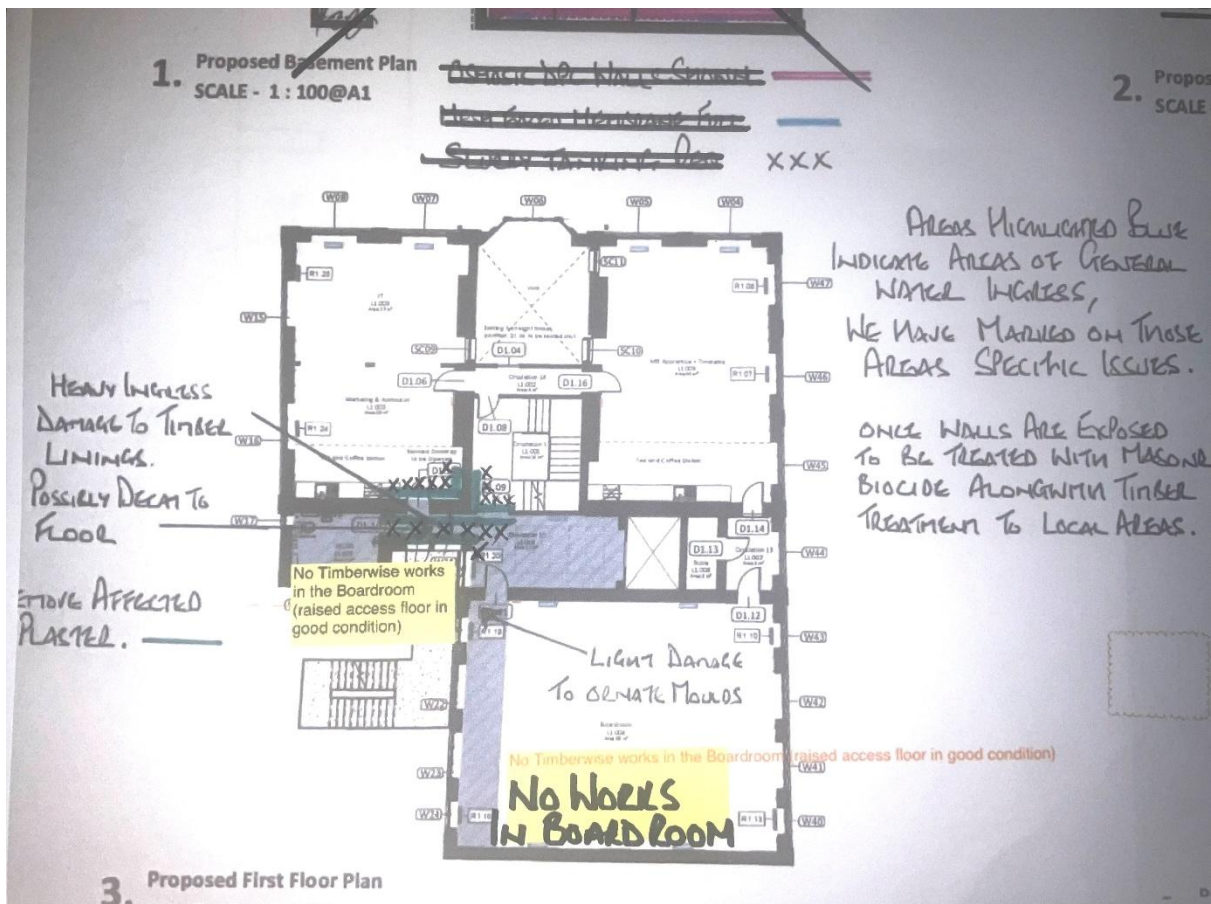
**REVISED BY / ON SITE FEBRUARY 2026**

AREAS HIGHLIGHTED BLUE  
INDICATE AREAS OF GENERAL  
WATER INGRESS,  
WE HAVE MARKED ON THOSE  
AREAS SPECIFIC ISSUES.

ONCE WALLS ARE EXPOSED  
TO BE TREATED WITH MASONRY  
BIOCIDE ALONG WITH TIMBER  
TREATMENT TO LOCAL AREAS.
