# Arboricultural Consultancy for Aviva

| Insured | Mr Robert Whitelaw | Address | 12 West Meadows Road, Sunderland, SR6 7TX | | |
| ES Ref | SA-256073 | Consultant | Nigel Chopping | Contact No. | 0330 380 1036 |
| Report Date | 16/09/2025 | | | | |

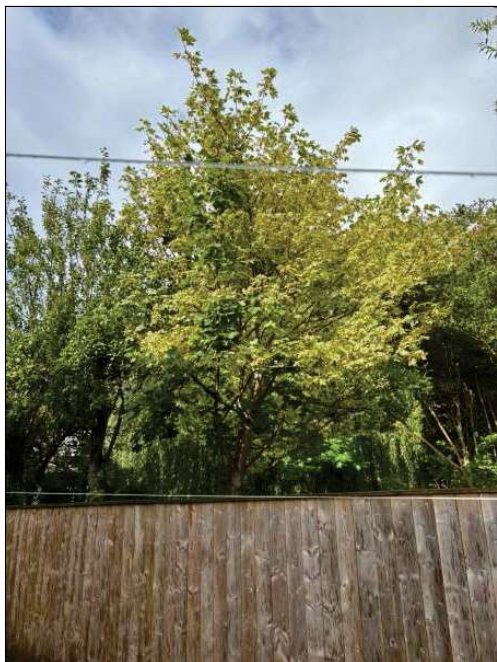
T1 - Maple (Norway)

T1 (Maple (Norway)), TG1 (Mixed species group) and T6 (Willow) cannot be discounted as contributing to the overall level of soil drying proximate to the advised area of damage and are therefore also considered to be exerting a contributory influence, albeit in a secondary capacity when compared to T2.

| Tree No. | Species | Age Cat | Approx. Height (m) | Distance to Building (m) * | Ownership | Action | Requirement |
|---|---|---|---|---|---|---|---|
| T1 | Maple (Norway) | 3 | 5 | 3.8 | A - Third Party<br>6 West Meadows Road | Remove | Remove close to ground level and treat stump(s) to inhibit regrowth. |

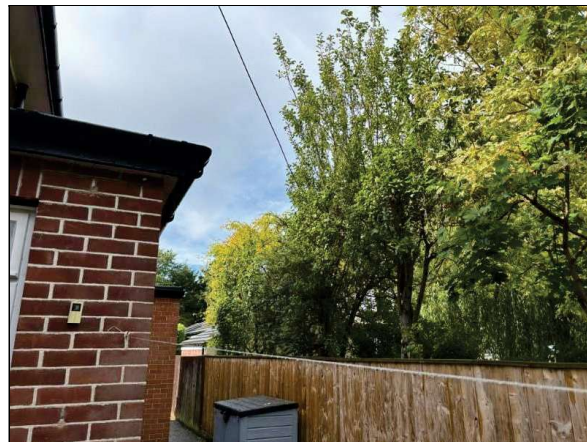
TG1 - Mixed Species Group with Damson trees in fore

| Tree No. | Species | Age Cat | Approx. Height (m) | Distance to Building (m) * | Ownership | Action | Requirement |
|---|---|---|---|---|---|---|---|
| TG1 | Mixed Species Group: includes Laburnum, Prunus, Lonicera and Ceanothus. | 2 | 5 | 1.7 | A - Third Party<br>6 West Meadows Road | Maintain as detailed | Remove Laburnum and Prunus and treat stump to inhibit regrowth. Do not allow remainder to exceed current dimensions by way of regular pruning. |

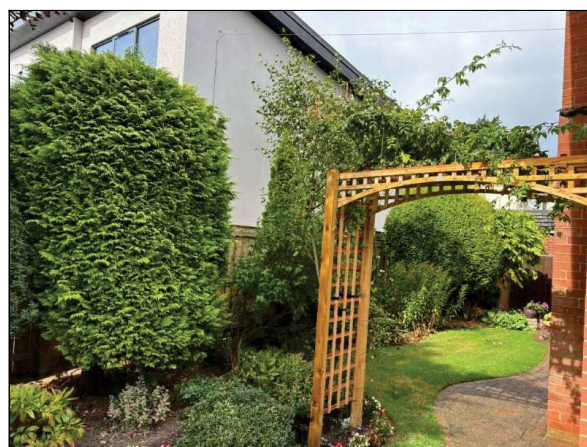
TG2 - Mixed Species Group

| Tree No. | Species | Age Cat | Approx. Height (m) | Distance to Building (m) * | Ownership | Action | Requirement |
|---|---|---|---|---|---|---|---|
| TG2 | Mixed Species Group:<br>includes Cypress,<br>Himalayan Birch, Yew<br>and Fatsia. | 1 | 4.5 | 4 | C - Insured | Action to avoid future risk | Maintain at broadly current dimensions by way of regular pruning. |

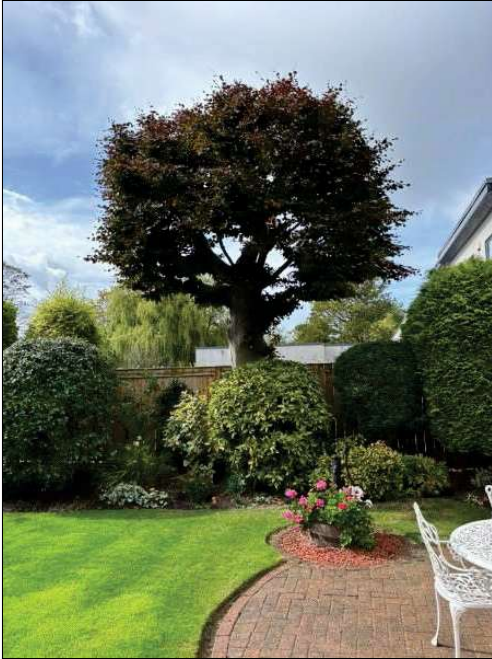
T4 - Beech (Purple)

| Tree No. | Species | Age Cat | Approx. Height (m) | Distance to Building (m) * | Ownership | Action | Requirement |
|---|---|---|---|---|---|---|---|
| T4 | Beech (Copper/Purple) | 2 | 5.5 | 5.7 | C - Insured | Action to avoid future risk | Do not allow to exceed current dimensions by way of regular pruning. |

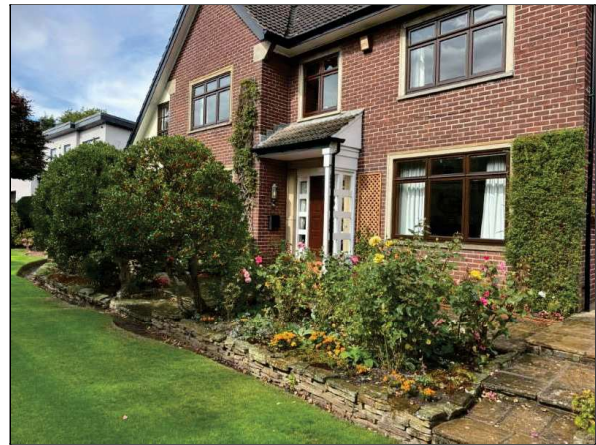
TG3 and CG1

| Tree No. | Species | Age Cat | Approx. Height (m) | Distance to Building (m) * | Ownership | Action | Requirement |
|---|---|---|---|---|---|---|---|
| CG1 | Mixed species climbers:<br>Includes Jasmine,<br>Hydrangea and Clematis. | 1 | 3 | 0.1 | C - Insured | Action to avoid future risk | Maintain at broadly current dimensions by way of regular pruning. |
| TG3 | Holly | 1 | 2.2 | 3.1 | C - Insured | Action to avoid future risk | Maintain at broadly current dimensions by way of regular pruning. |

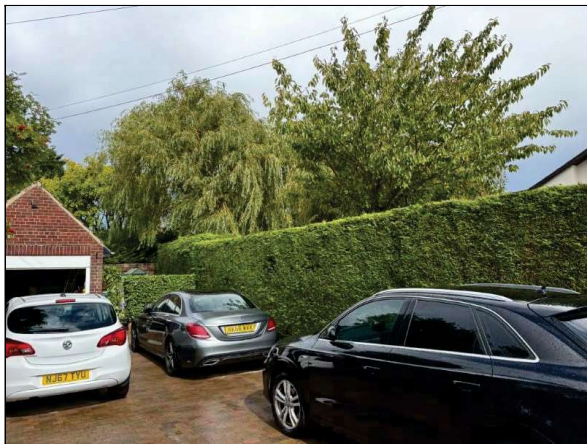
View looking towards H1, TG4 and T5

| Tree No. | Species | Age Cat | Approx. Height (m) | Distance to Building (m) * | Ownership | Action | Requirement |
|---|---|---|---|---|---|---|---|
| H1 | Cypress (Leyland) | 1 | 2.5 | 3.3 | C - Insured | Action to avoid future risk | Maintain at broadly current dimensions by way of regular pruning. |
| T5 | Willow (Weeping) | 3 | 10 | 12 | A - Third Party<br>10 West Meadows Road | Action to avoid future risk | Reduce back to 8m in height (previous pollard points) and maintain at reduced dimensions by way of routine re-pollarding to restrict regrowth below pre-pruning dimensions. |
| TG4 | Mixed Species Group:<br>includes Cherry and<br>Weeping Birch | 1 | 5 | 8 | A - Third Party<br>10 West Meadows Road | Action to avoid future risk | Maintain at broadly current dimensions by way of regular pruning. |
