**Initial Assessment Report**

**Aviva Insurance**

22 August 2025

**Our Reference:** IFS-AVI-SUB-25-0119858

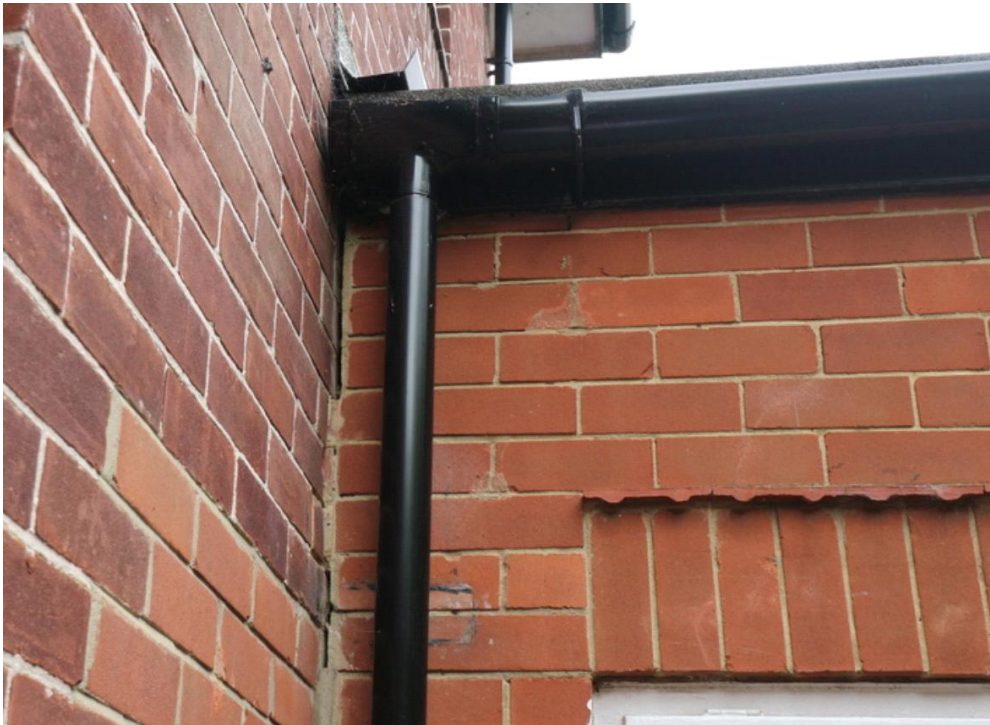
1

- Tapered cracking to the extension and main house abutment measuring roughly 7mm wide.

In this instance, the damage falls into: **Cat 3, 5mm to 15mm - moderate.**

Extension Abutment

The damage is indicative of downward and rotational movement to the single storey bathroom extension, relative to the remainder of the building.

The pattern and type of cracking would suggest that the damage has resulted from subsidence of the site. The most likely cause of subsidence is the shrinkage of underlying soils due to seasonal variations in moisture content. This will have been exacerbated by the moisture extracted by the roots of the vegetation on your neighbour's property.

It is most likely that stability will be regained once the vegetation has been removed or reduced. Once stability has been regained, we will agree how to settle your claim. It is possible that further damage may develop while mitigation is being arranged.

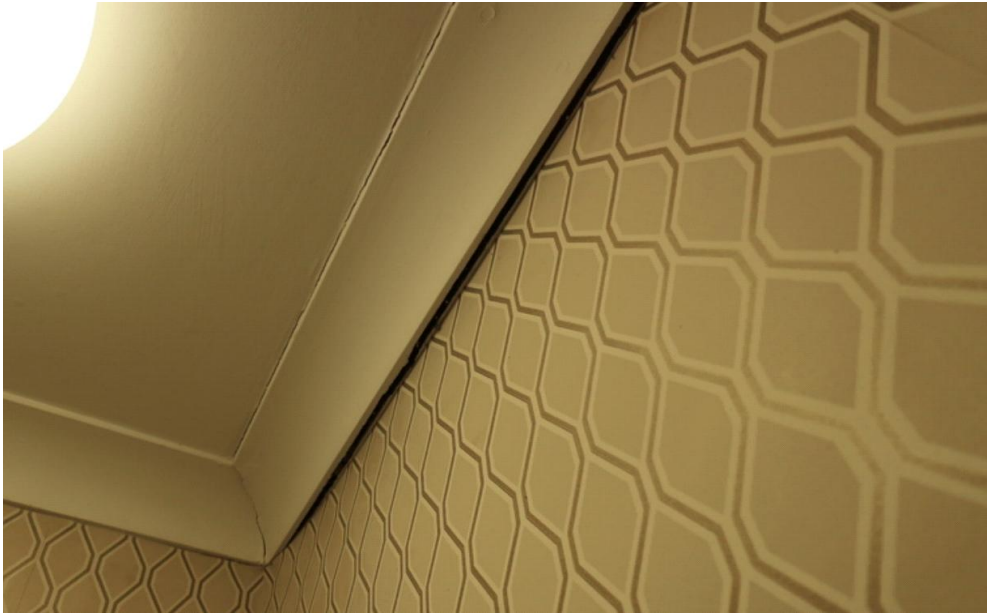
2

- Horizontal cracking between the coving and ceiling joint measuring approx. 2-3mm wide.
- Cracking to the wall and coving measuring 3mm wide.
- The wall appears to have dropped slightly.

Damage to the Bathroom

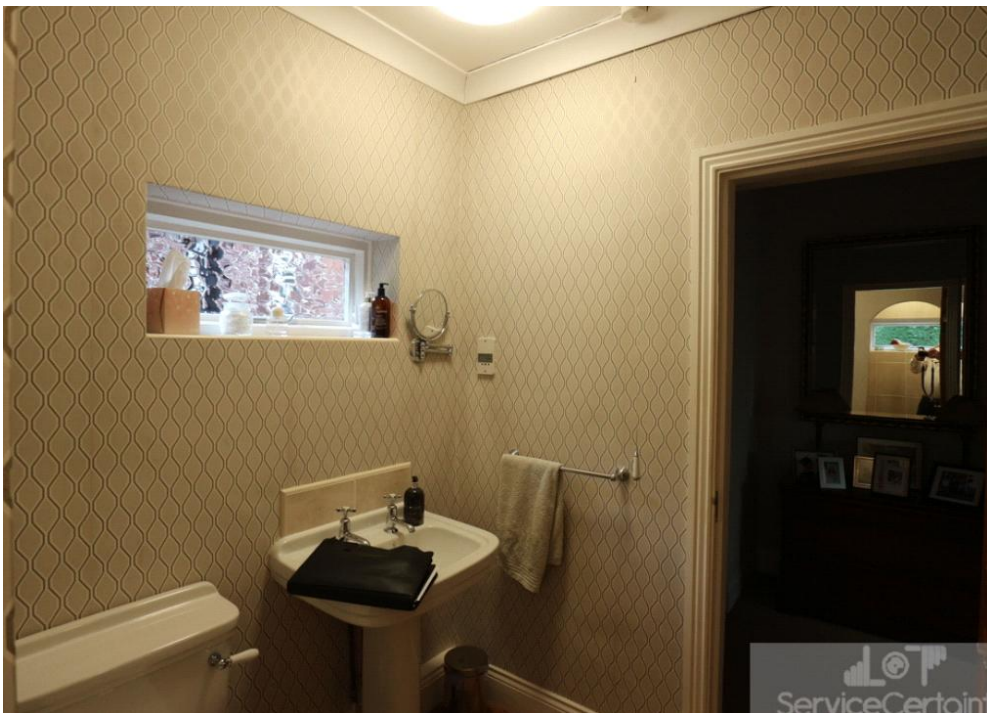
3

Area of damage
