**Rose Lodge,  
Hospital Drive,  
Hebburn,  
Tyne and Wear,  
NE31 2TH**

## **Health and Condition Tree Report**

| <b>Report Reference</b> | 0016408 |

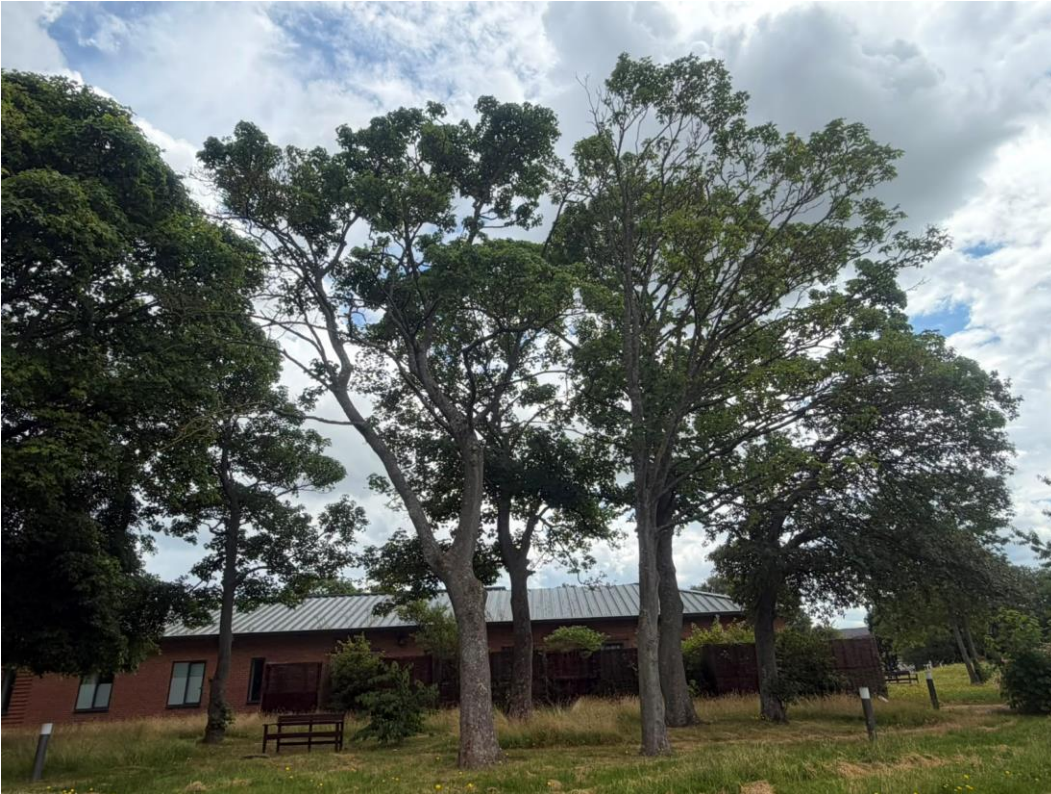
- 3.4.1.8 T17, T18 and T37 are sycamore trees showing signs of physiological stress with sparse upper crowns and moderate deadwood formation. Deadwood removal and annual re-survey of physiological condition are recommended.
- 3.4.1.9 Low priority ivy management recommendations relate to T7, T9 and T40 where dense ivy colonisation prevents inspection of the lower stems, bases and/or principal junctions.
- 3.4.1.10 Refer to Appendix 2 Data Schedule for specific recommendations.

**Image 1:** Looking east to T17 and T18 showing some dieback and physiological stress.

| Ref | Species | Num. Stems | Height (m) | DBH (cm) | Crown Radius (m) | Life Stage | Life Expectancy | Condition | Survey Notes | Recommendation | Priority |
|---|---|---|---|---|---|---|---|---|---|---|---|
| T17 | Sycamore | 1 | 15 | 40 | 6 | M | 10+ | F | Mature sycamore with signs of dieback and a sparse upper crown; moderate deadwood formation throughout crown | Remove deadwood in excess of 2.5 cm diameter; re-survey physiological condition annually | L |
| T18 | Sycamore | 1 | 15 | 35 | 6 | M | 10+ | F | Mature sycamore with signs of dieback and a sparse upper crown; moderate deadwood formation throughout crown | Remove deadwood in excess of 2.5 cm diameter; re-survey physiological condition annually | L |

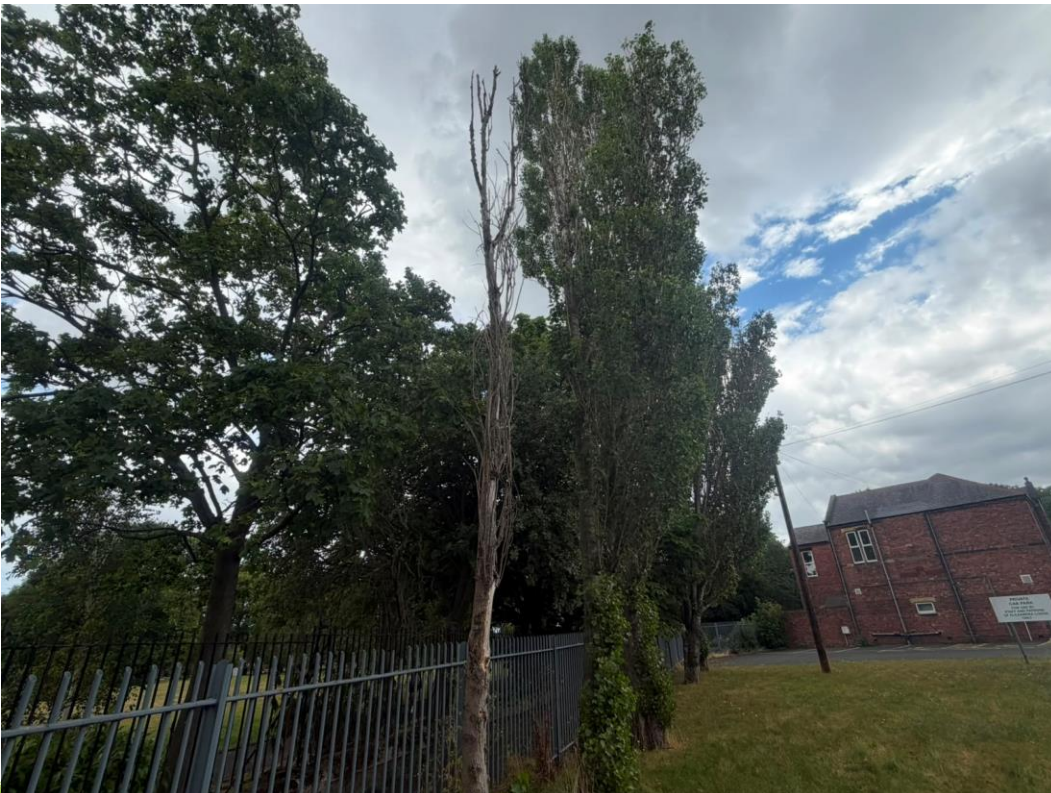
**Image 2:** Looking north to G1 with a single dead poplar tree and poplar tree with dead wooding recommendations behind.

- 3.4.1.6 Low priority recommendations primarily relate to deadwood removal, ivy severance to allow inspection, crown raising for access, removal of one failed rowan and targeted pruning/management of the goat willow T29 and Lombardy poplar group G1.
