**Bat Risk Assessment Survey of:**

17 Charlton Grove  
Cleaton  
SR6 7QR

**Report Ref:** Pascoe\_CharltonGrove\_Bat1.1

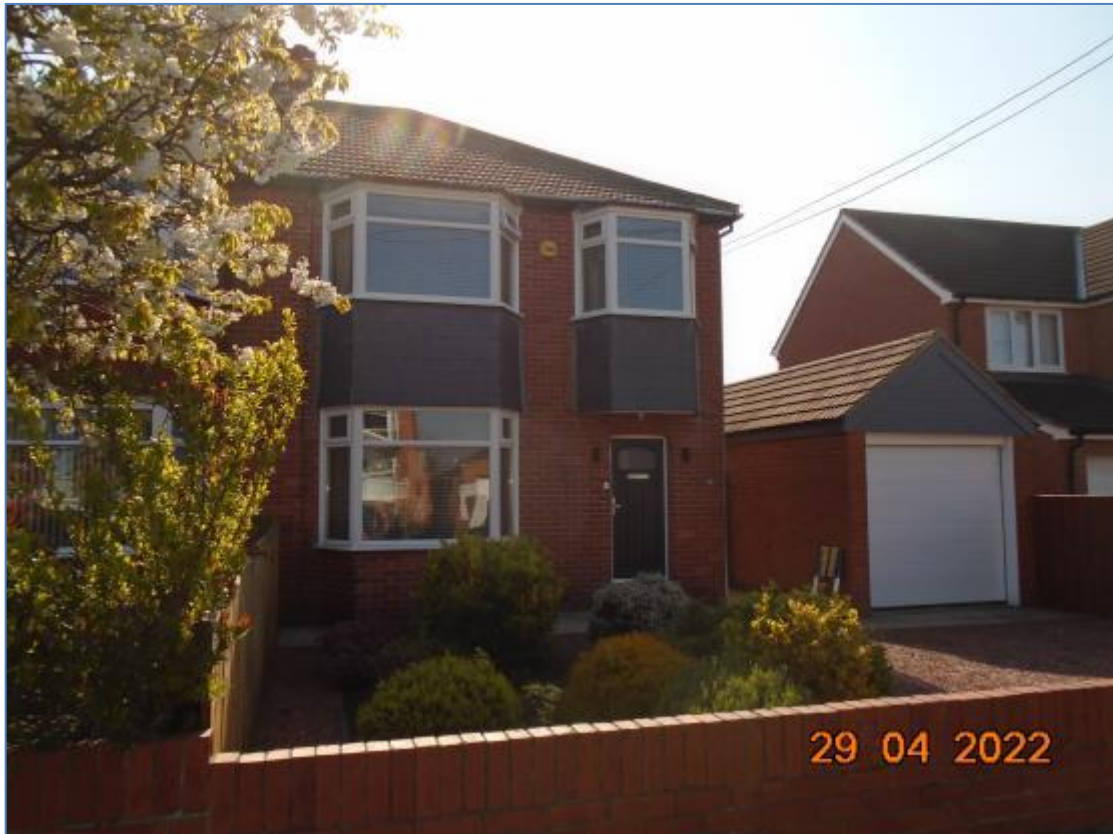
**Photograph 1 – Front (north-west) elevation of the property.**

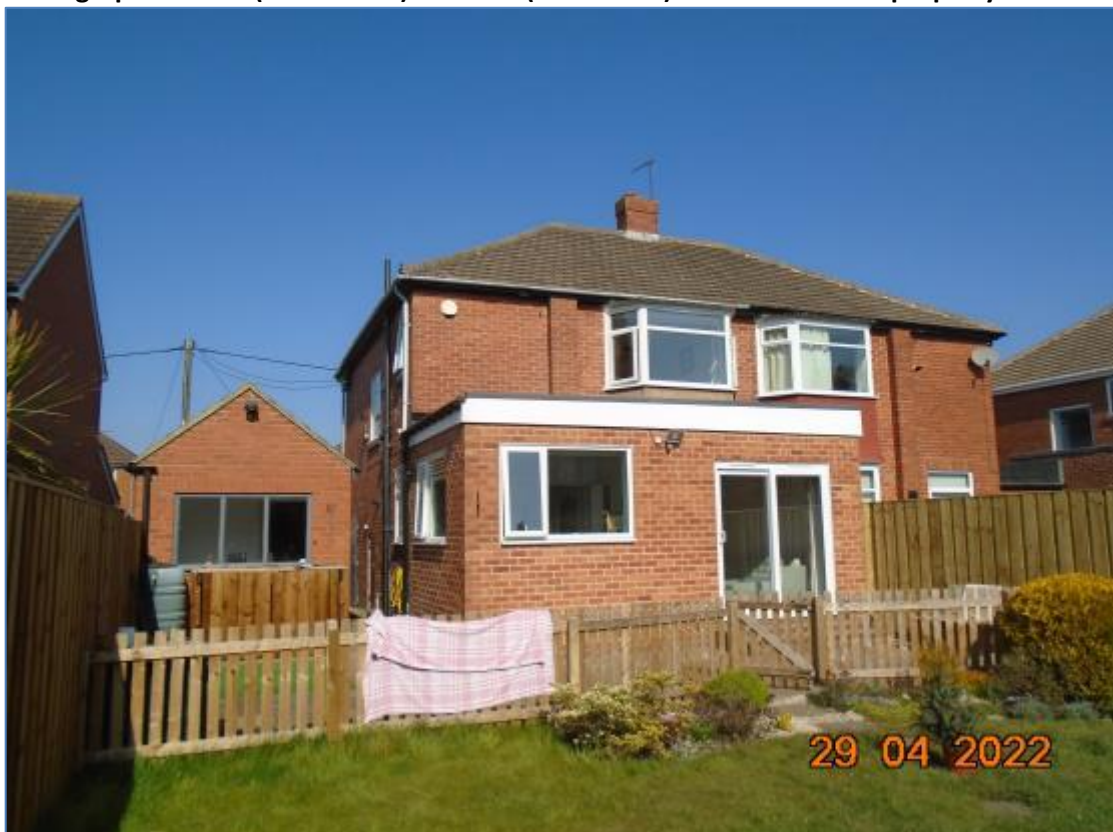
**Photograph 2 – Side (south-west) and rear (south-east) elevations of the property.**

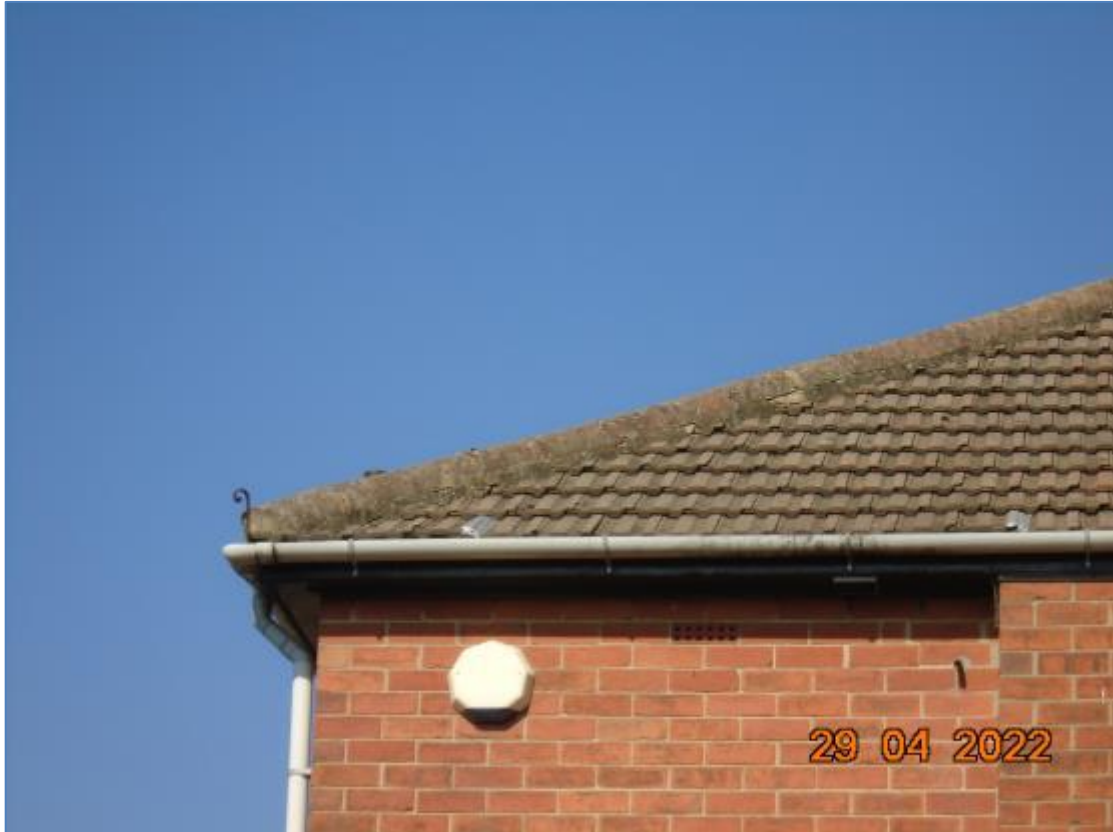
**Photograph 3 – Shallow gaps under the rear elevation roof tiles.**

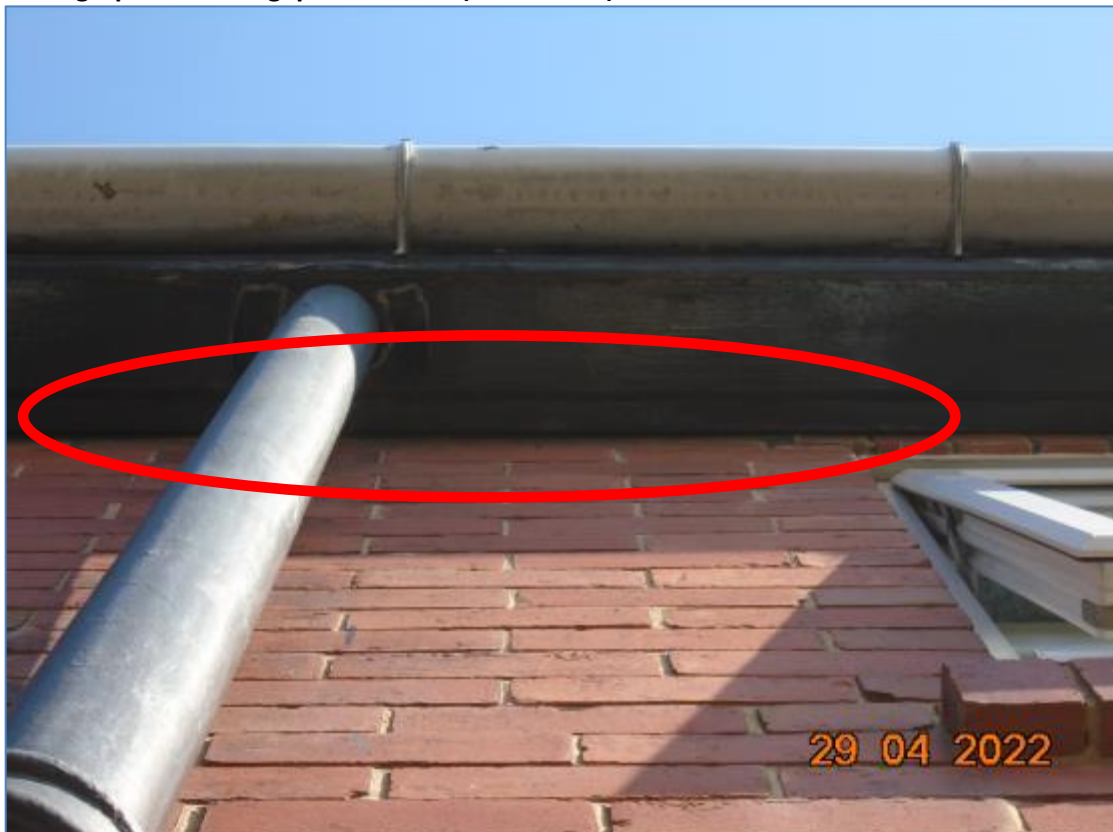
**Photograph 4 – Soffit gap on the side (south-west) elevation.**

4.2.3 No evidence of use by roosting bats was found during the internal/external inspection survey, however several potential bat access points were identified behind the soffit on the side elevation of the main dwelling. Under current industry guidance (Collins, 2016), the property has been assessed as having a low potential risk of supporting roosting bats.

- The supervising ecologist will be present while the fascia board and soffit on the side elevation of dwelling are removed slowly and carefully by hand

- The ecologist will then undertake a check of the exposed surfaces for signs of roosting bats, prior to the works proceeding
- In the unlikely event of evidence of bats, such as droppings etc. being noted, the works will stop and the crevice will be considered a roost. Where possible the area will be reconstructed on a like-for-like basis to ensure the continued ecological functionality of the roost and therefore compliance with current wildlife legislation

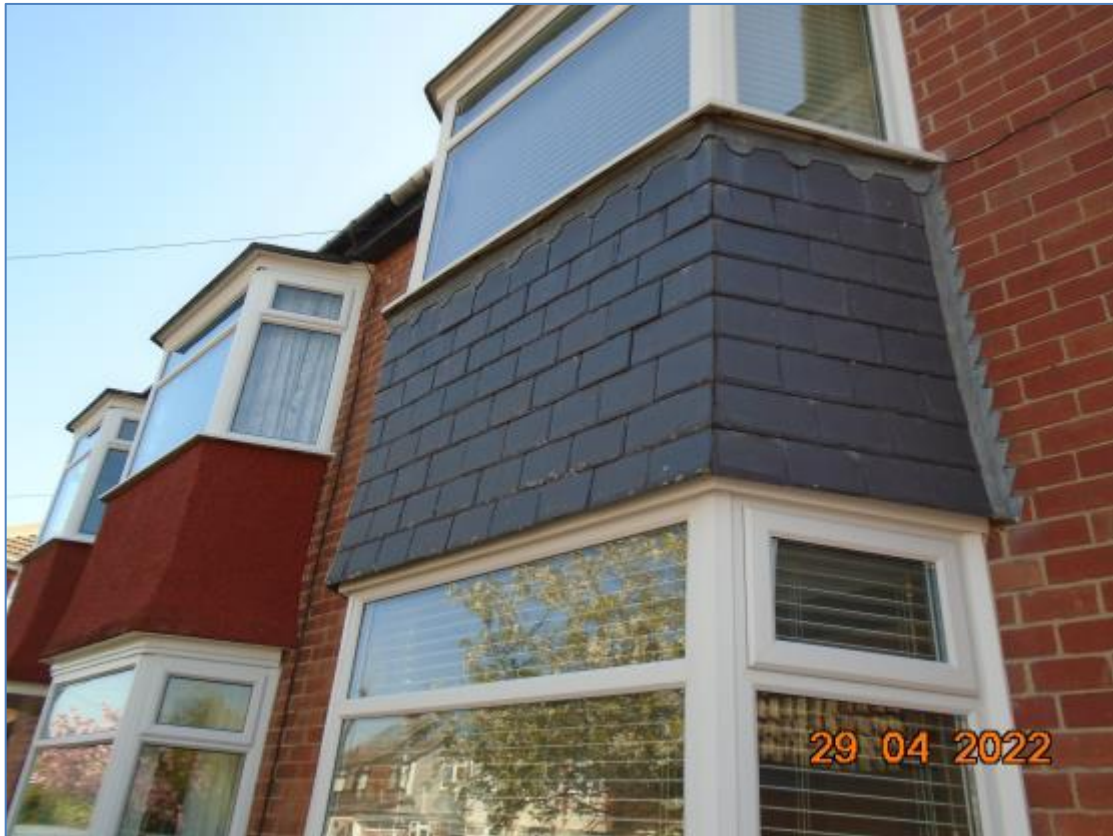
**Photograph 5 – Close fitting slate hanging tiles on the front elevation.**

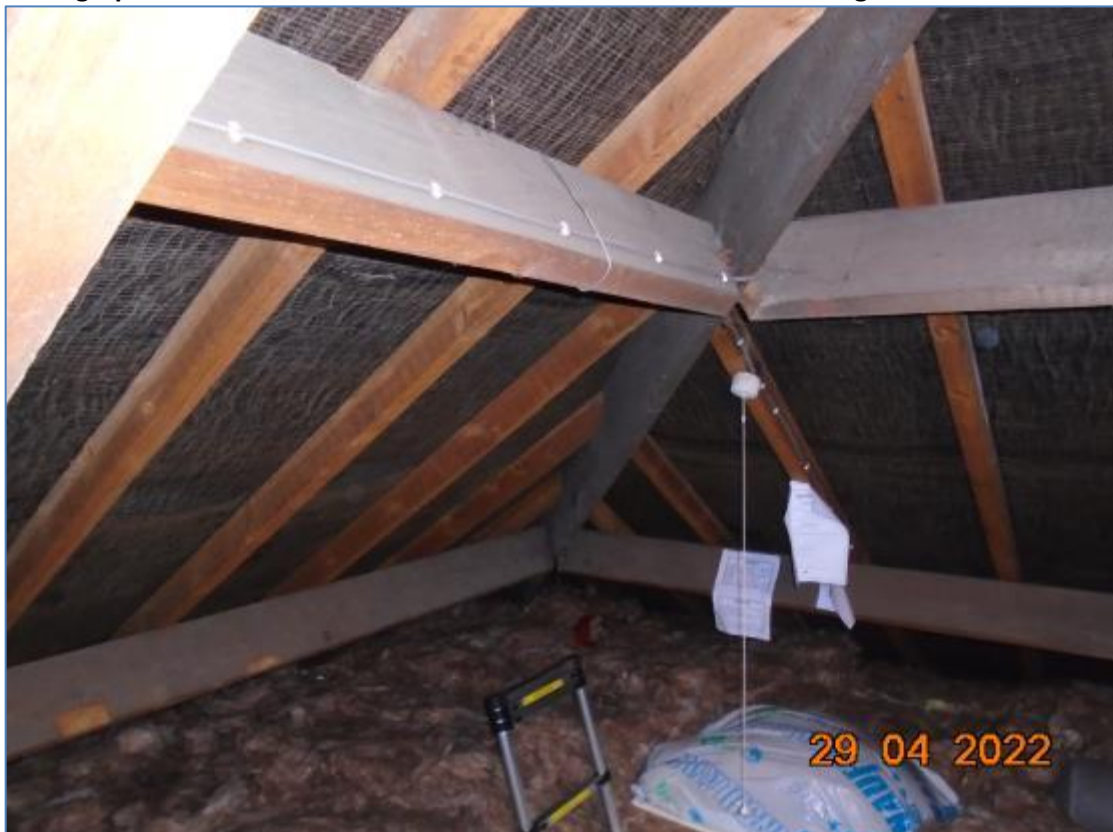
- 3.4.2 Internally a roof void is present in the main dwelling (Photograph 6). The roof timbers are heavily cobwebbed and intact felt membrane is present as a lining to the roof tiles. Clean fibreglass insulation and loft boards are present over the joists.

**Photograph 6 – Internal view of the roof structure of the main dwelling.**

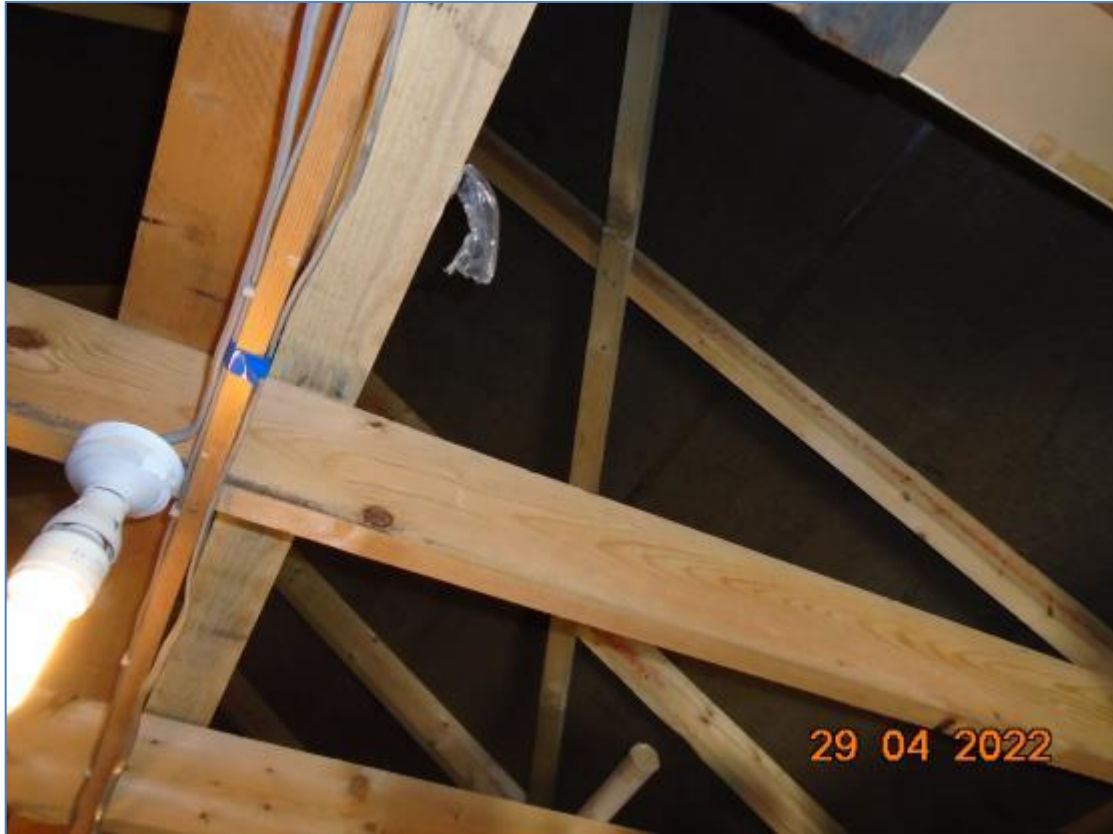
- 3.4.3 The detached garage is constructed of single skin brick with a pitched concrete tile roof. The pitched roof is in good condition with no mortar gaps, missing, broken or raised tiles noted. The brickwork is also in good condition with no mortar gaps noted. A close fitting wooden fascia board is present on both side elevations. Internally no roof void is present, therefore the roof timbers and intact felt membrane could be inspected with a torch from ground level (Photograph 7).

**Photograph 7 – Internal view of the roof structure of the detached garage.**
