**Hebburn Extra Care**  
**Hebburn**  
**ARBORICULTURAL IMPACT ASSESSMENT**  
**July 2025 (v1.8)**

Biodiverse Consulting

## Arboricultural Impact Assessment

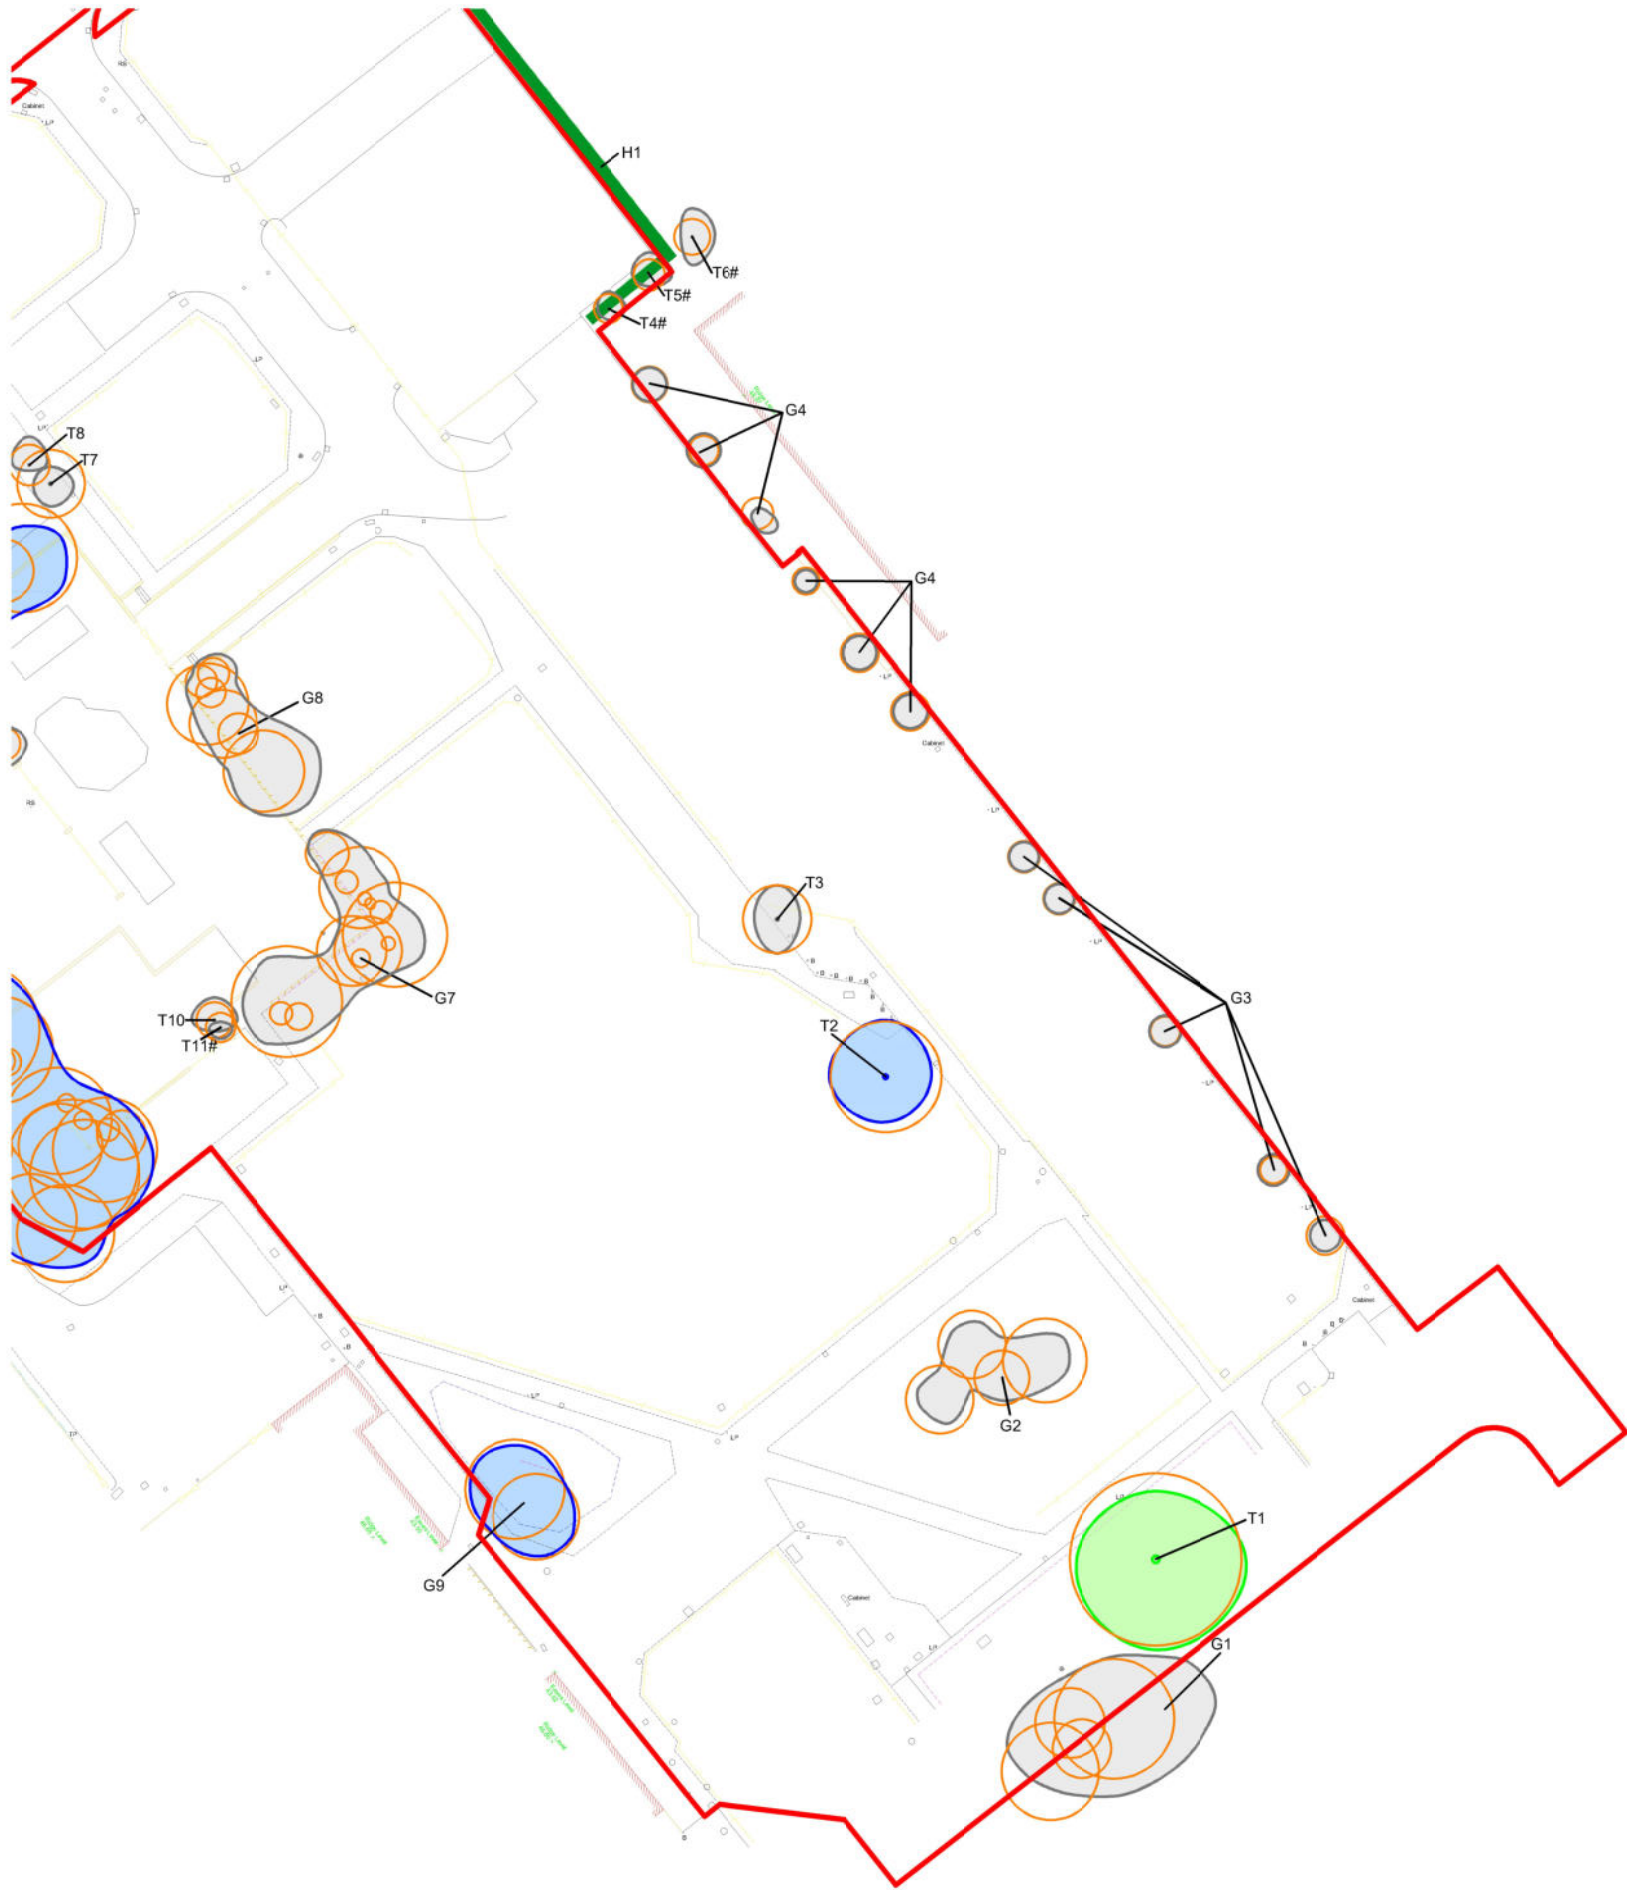
| Drawing 1: Tree Constraints Plan | | |

Trees on site are primarily category C individually due to age, size or condition. Some features such as group G5 and G6 are noted as category B, primarily due to their collective quality.

Tree T1 is noted adjacent to the site and is a mature specimen, although historic branch and limb failures have been noted, it still provides good amenity and is a prominent feature in the landscape.

Unfortunately, due to the recent demolition, extensive root damage and soil compaction has been noted amongst features G7 as well as T2. The retention of these features is questionable due to the extents of the impacts, further investigation is advised.

A single category U specimen was noted, a standing dead whitebeam T9, which is unretainable in its current location adjacent to a road.

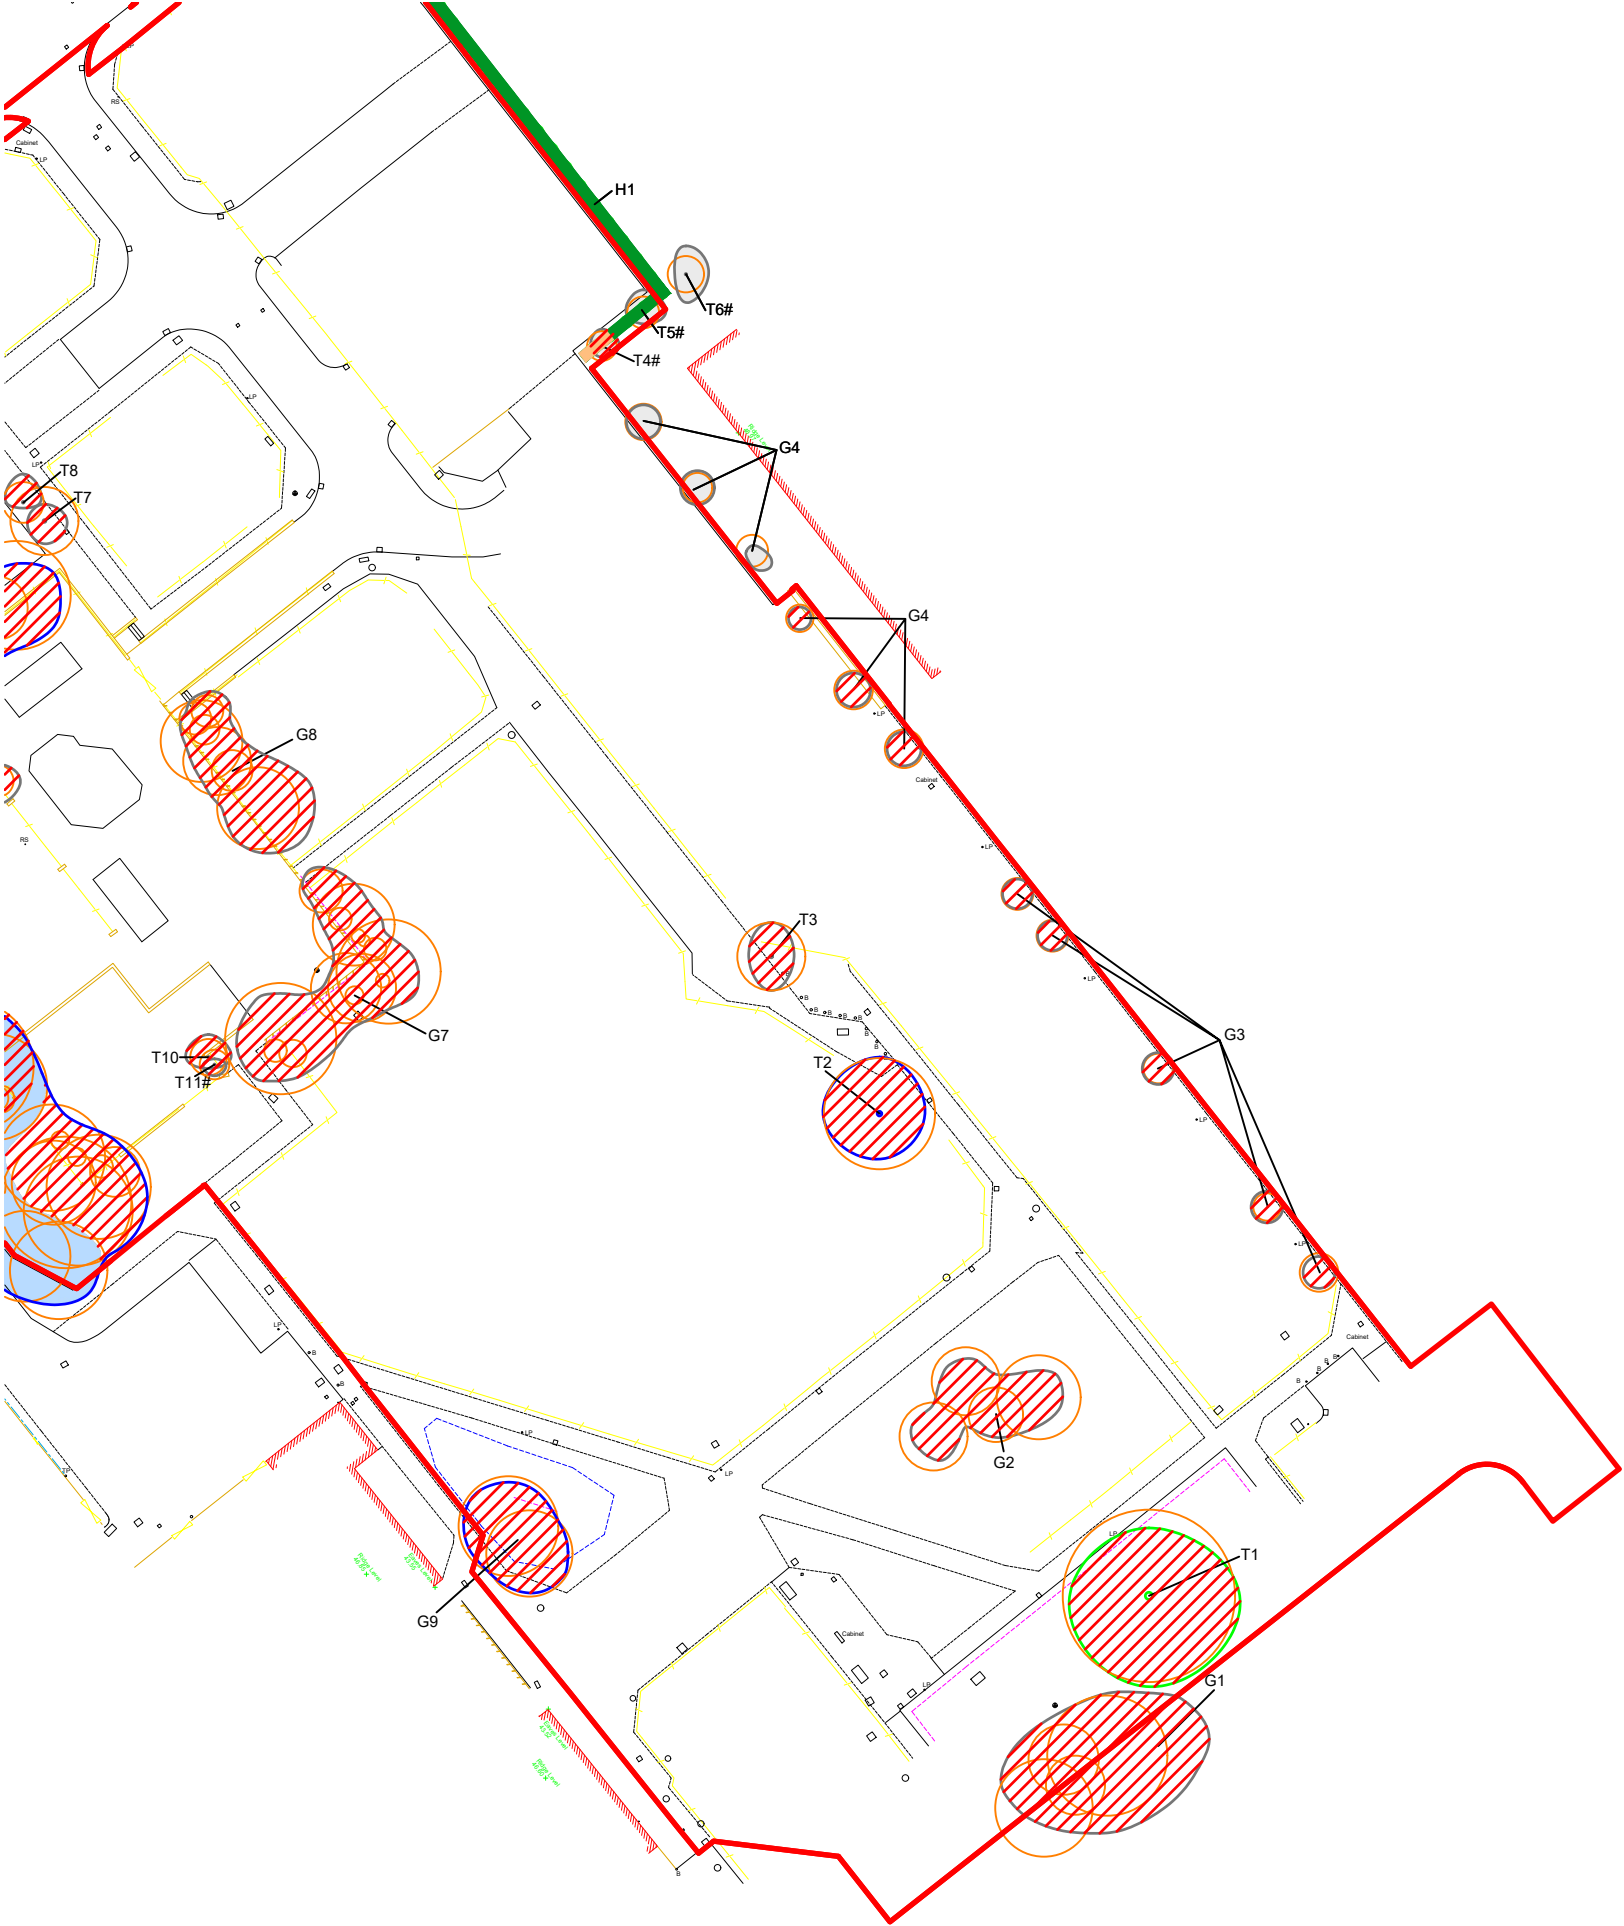
Tree T9, noted as category U, will be removed due to being dead.

Tree T1, a category A specimen to the South of the site, has been noted for removal in the updated proposals alongside a single specimen from tree group G1 due to level changes.

Tree group G9 will require removal due to soil level changes and foundations for a boundary retaining wall.

Tree T2 is noted to be removed due to ground level changes.

Tree group G1 is noted for removal for a temporary footpath.
