| <b>Title:</b> | <b>BS:5837 Tree Survey, Arboricultural Impact Assessment (AIA), Arboricultural Method Statement (AMS) &amp; Tree Protection Plan (TPP)</b> |
| <b>Client:</b> | <b>Fokhrul Islam</b> |
| <b>Site:</b> | <b>Marsden Cottage, South Shields, NE34 7AD</b> |
| <b>Date:</b> | <b>23 September 2025</b> |

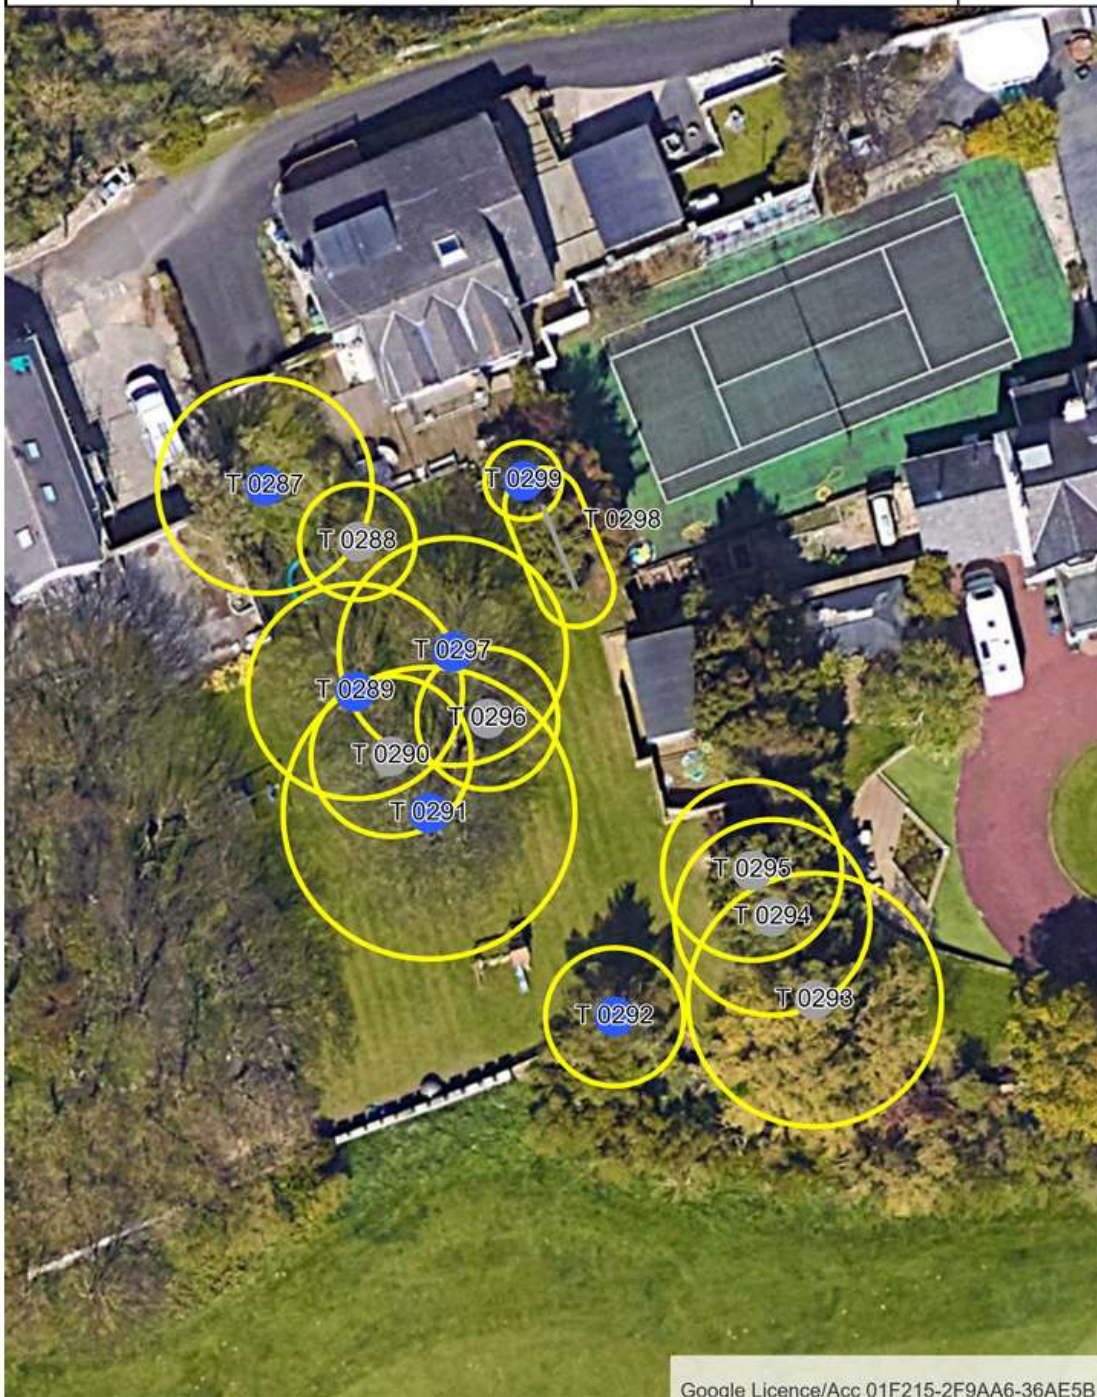
#### 7.4 Existing Site Map Tree Root Protection Areas (RPA Plan)

Yellow Circles = Position Of RPA

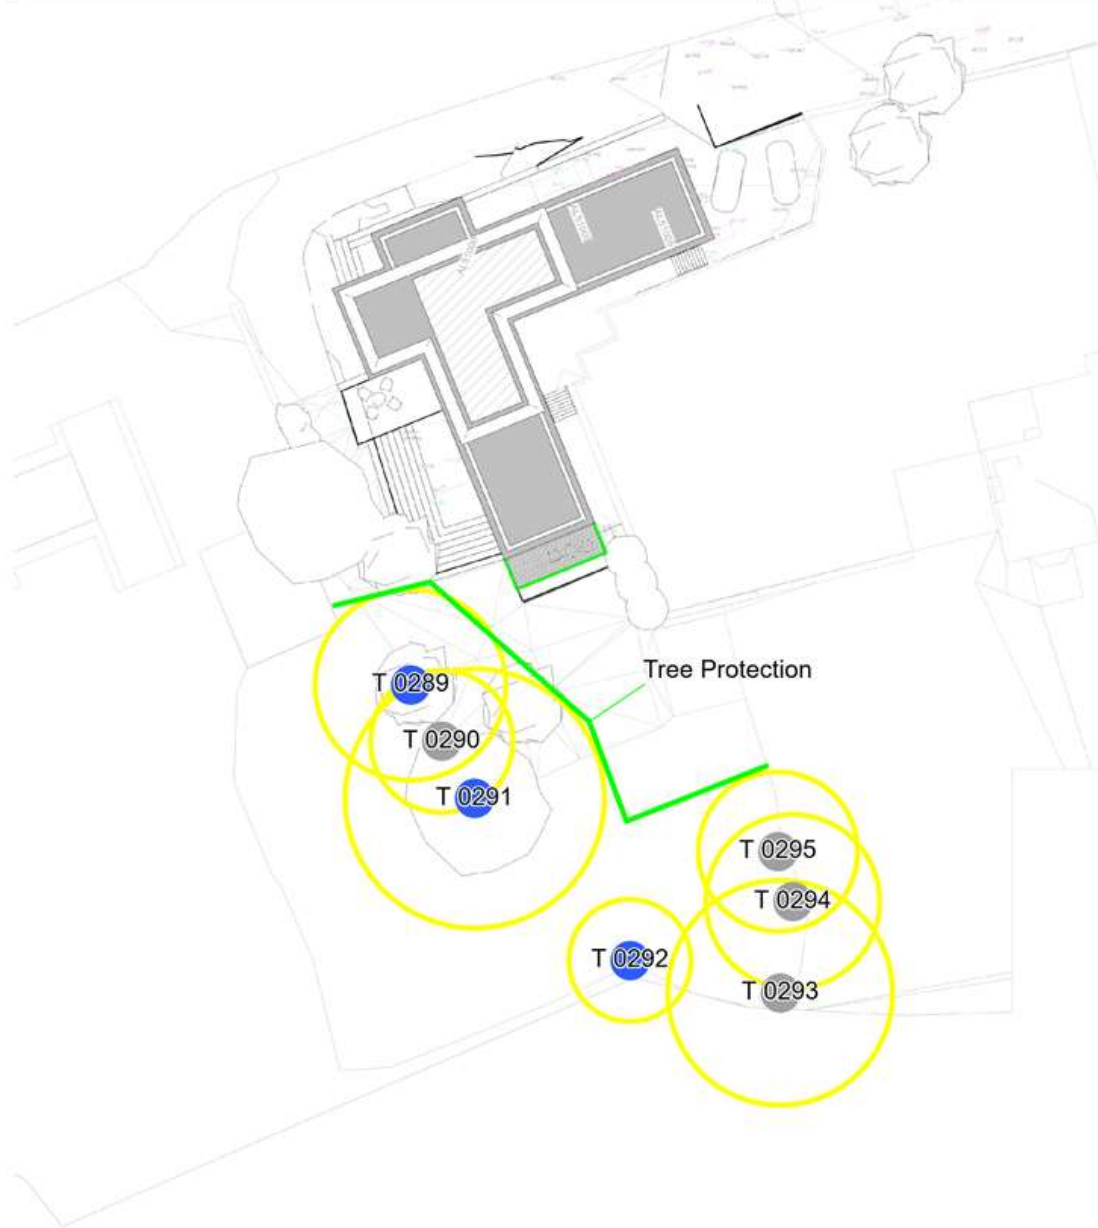
## 7.5 Tree Protection Plan

Green Line = Required Position Of Tree Protection Fence

**Solution:** Install tree protection fencing in the location given in the Tree Protection Plan (appendix 7.5) to the following specification.

| <b>3. Installation of tree protection fencing.</b> | Install tree protection fencing as per appendix 7.6 in the location as given in appendix 7.5 Tree Protection Plan. | Site visit to assess suitability and position of tree protection fencing. |
