| PROJECT TITLE | 11 Beach Road, |
| SITE ADDRESS | South Shields, |
| DRAWING TITLE | Existing Second Floor & Roof Plan |
| DRAWING NO. | 351-1 |

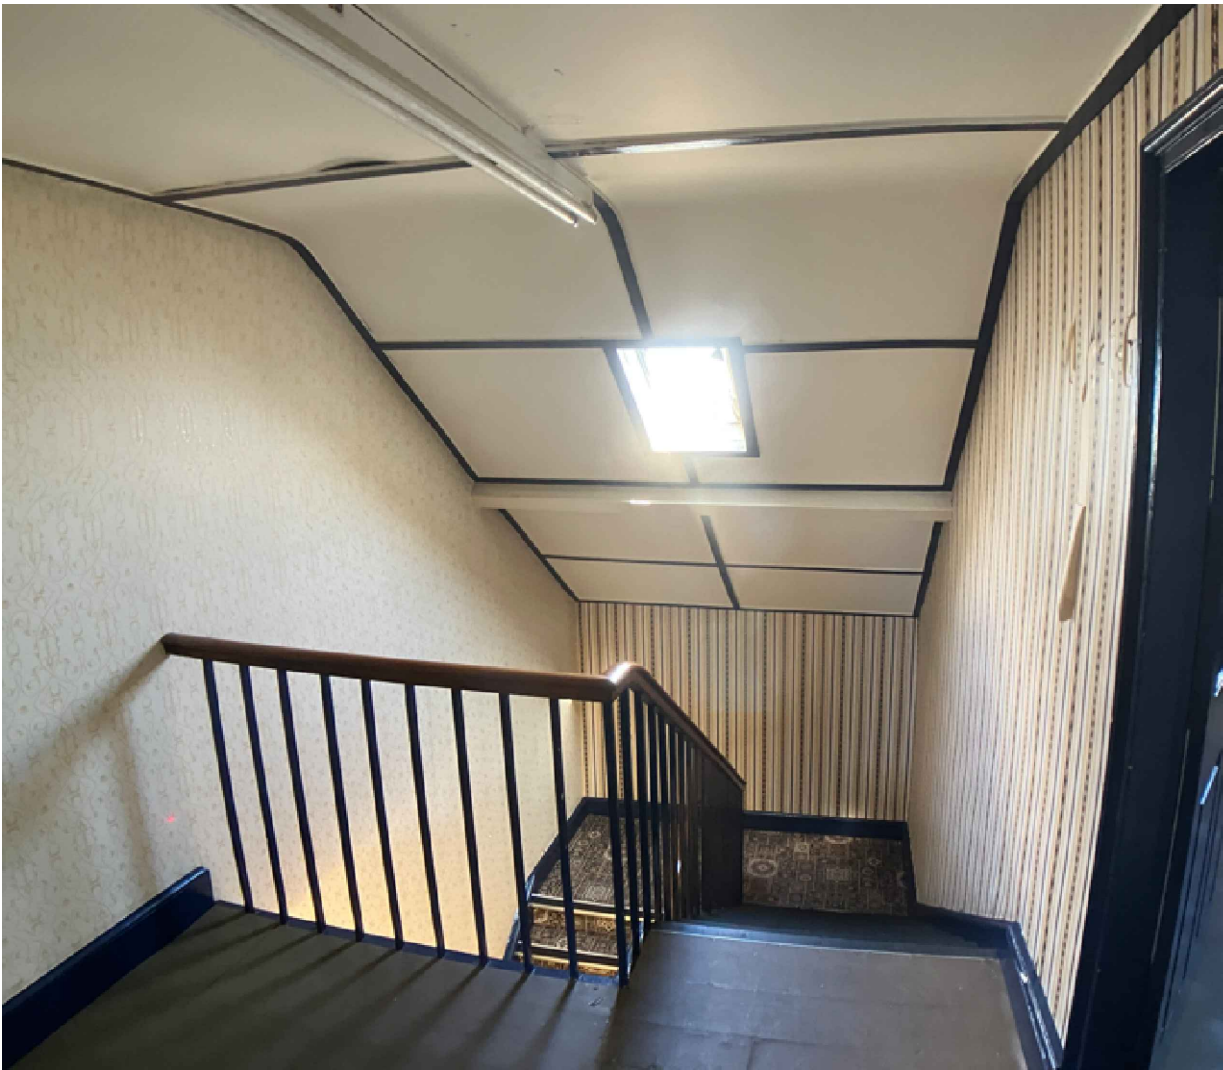
View of existing roof light from second floor landing

The existing timber roof light is of poor quality and is prone to leaking. The roof light features a timber surround internally corresponding with the existing ceiling detail.
