**AN ARCHAEOLOGICAL EVALUATION:
MARKET SQUARE, SOUTH SHIELDS,
TYNE AND WEAR**

**AN ARCHAEOLOGICAL EVALUATION:
MARKET SQUARE, SOUTH SHIELDS, TYNE AND WEAR
EVALUATION REPORT**

**An Archaeological Evaluation:
Market Square, South Shields, Tyne and Wear**

February 2015

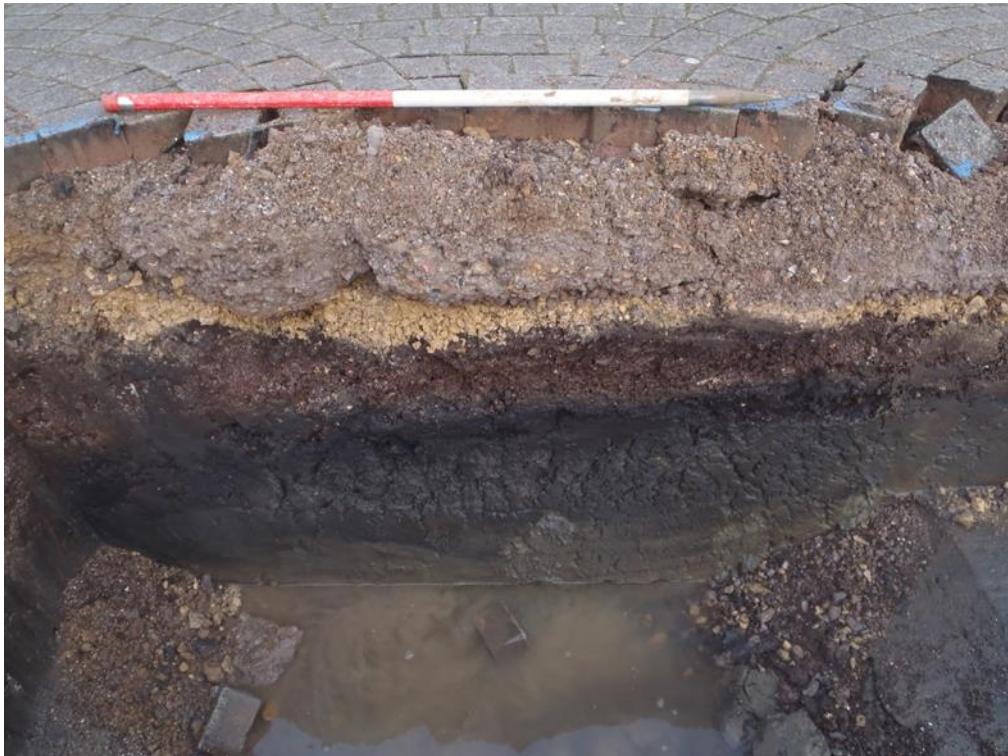
TRENCH 1	Figure 2	Plate 1	
Trench Alignment: NE-SW	Length: 17.50m	Depth: 1.74m	
Deposit	Context No.	Average Depth (m)	
		Section 1	Section 5
Paving	[100]	0.08m	0.08m
Concrete	[101]	0.16m	0.16m
Made Ground	[105]	0.14m	0.14m
Made Ground	[106]	0.10m	0.14m
Made Ground	[107]	0.28m	0.46m
Made Ground	[103]	0.20m	-
Made Ground	[104]	0.40m+	0.64m+
Made Ground	[113]	-	0.28m+
Summary			
Trench 1 was located in the north-eastern corner of the Market Place.			
No archaeological features or deposits of significance were encountered in the trench. The natural geology could not be reached due to the significant amount of made ground present throughout the trench.			
Deposits of made ground were excavated to a maximum thickness of 1.50m. Natural geology was not present at this depth.			
Modern intrusions, including modern services, were present in the trench.

Plate 2. Trench 1, Section 1 (south-east facing section), looking north-west (*scale 2m*)

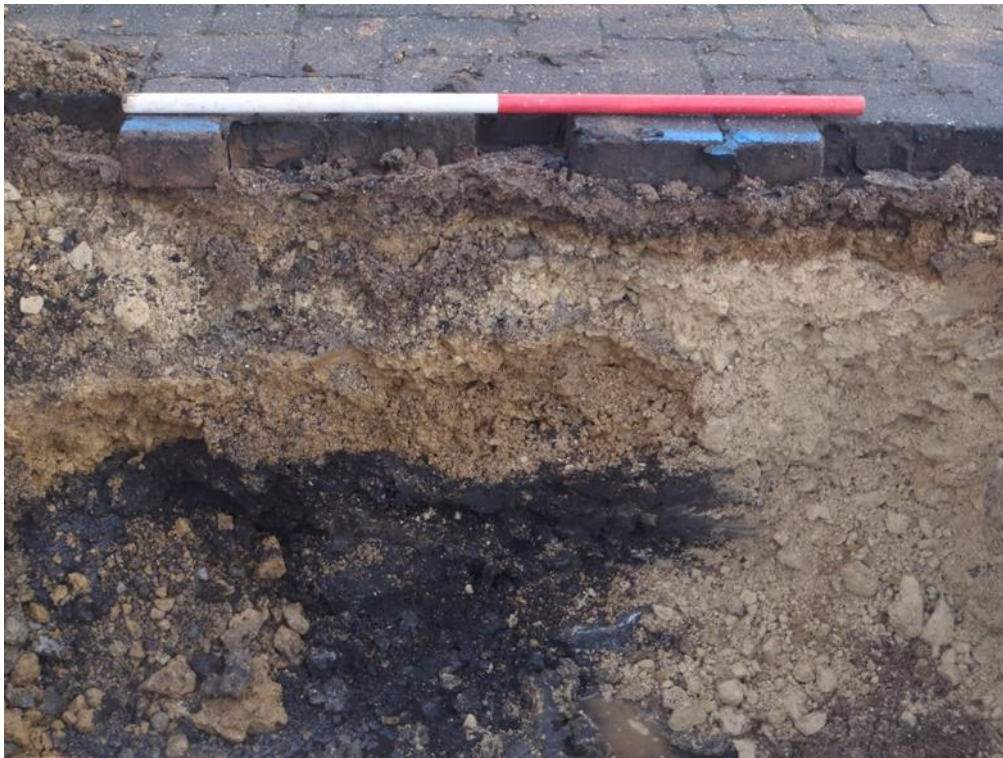
5.3.2 A cut for a modern electricity cable [112] (Plate 4) heavily truncated areas of Trench 3.

TRENCH 3	Figure 2		Plate 4
Trench Alignment: NW–SE	Length: 2m ²	Depth: 0.88m	
Deposit	Context No.	Average Depth (m)	
		Section 3	
Paving	[100]	0.08m	
Concrete	[101]	0.12m	
Made Ground	[102]	0.18m	
Made Ground	[107]	0.24m	
Made Ground	[110]	0.18m+	
Summary			
Trench 3 was located in the south-west corner of the Market Place.			
No archaeological features or deposits of significance were encountered in the trench.			
A modern electricity cable crossed the trench; as such a maximum depth of 0.88m could be reached. Natural geology was not identified at this depth.

Plate 4. Trench 3, showing electricity cable trench [112], looking north-east (scale 1m)
