# CHURCH LANE WHITBURN

## ARCHAEOLOGICAL ASSESSMENT

MAY 2014

Archaeological Assessment

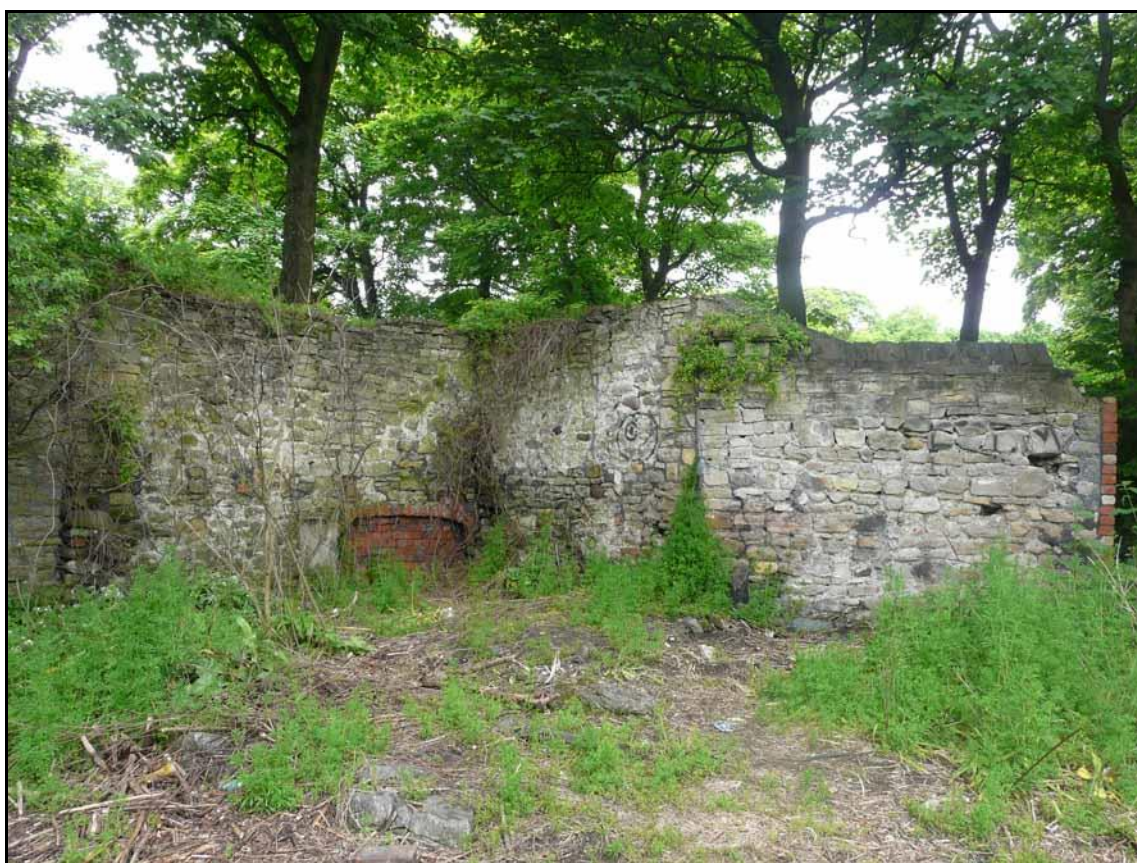
***Frontispiece:*** Multi-phase walls forming the north-west corner of the south part of the assessment site on the east side of Whitburn Rectory.

*It is also recommended that the remainder of the internal east-west wall, as well as the east and north-west walls of the south part of the site and the line of pillars in the north part of the site should be retained and conserved as part of site re-development.*

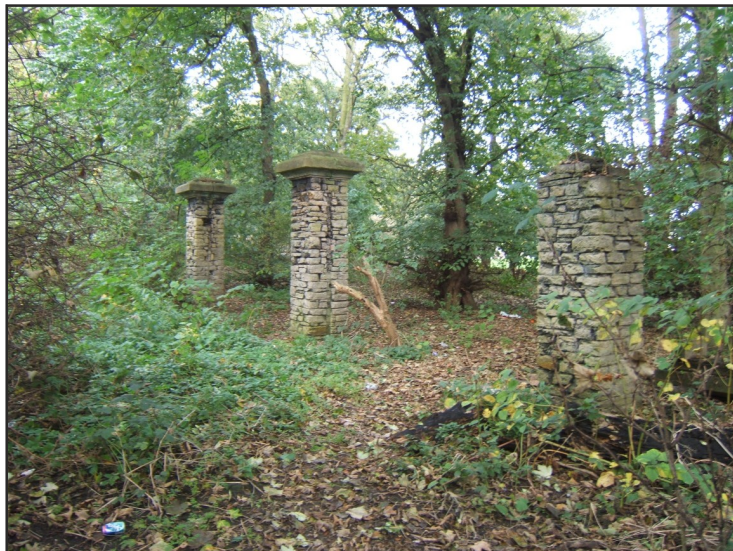
*Illus. 20: Three of six columns in woodland formerly part of Whitburn Hall grounds, in the north part of the assessment site.*

- ❖ *The line of pillars in the north part of the site should be retained and conserved as part of site re-development.*
- ❖ *Based on the preceding desk-top assessment it is recommended that a considered evaluation of the archaeological potential of the site should be made in order to develop an appropriate mitigation strategy.*

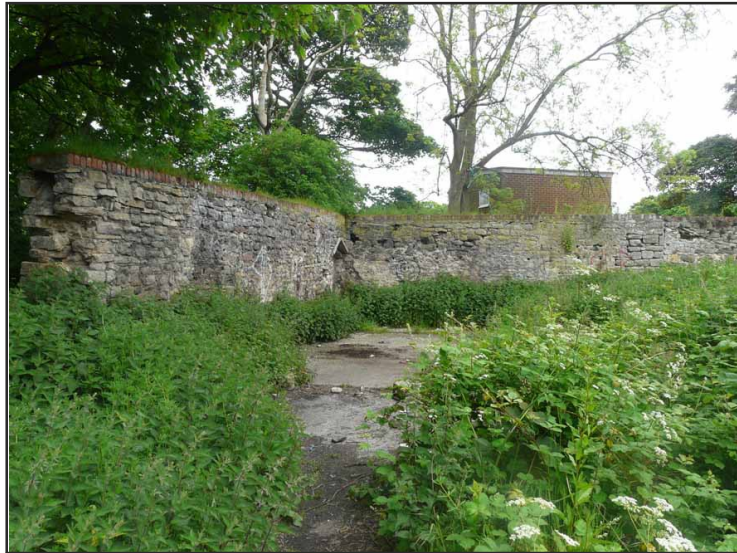
*Illus. 22: The surviving north wall of Whitburn Tithe Barn (left), forming an east-west dividing wall within the assessment site with possibly-contemporary east site boundary wall to right of view.*

- ❖ *The evaluation of the tithe barn and any remains found in association with it will be enhanced by producing a record of the visible upstanding part of the building; this should be achieved by means of photography and measured sketch drawing to show significant features and phasing.*

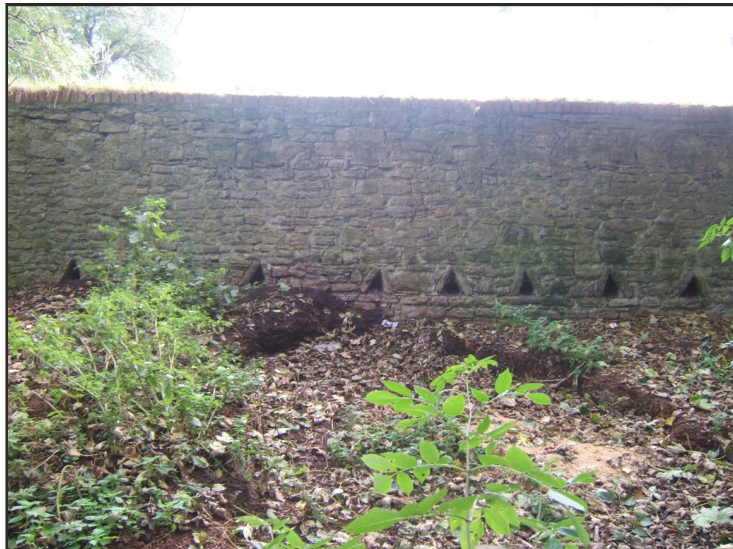
*Illus. 23: The surviving north wall of Whitburn Tithe Barn viewed from the north side.*

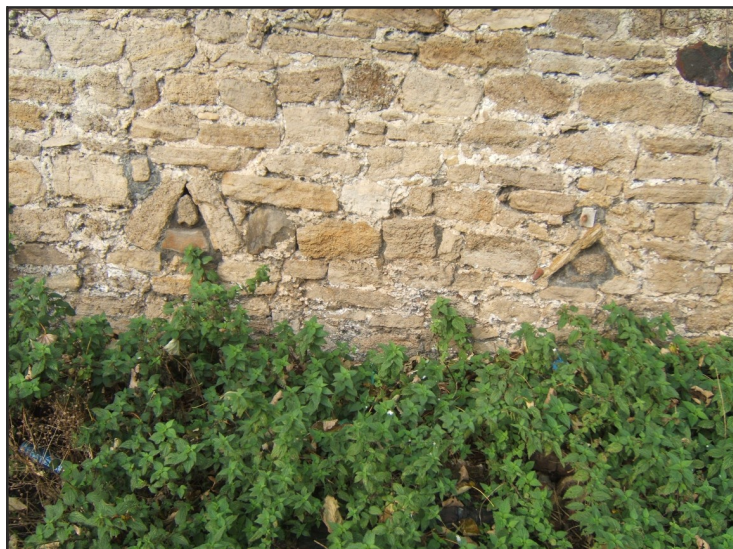
*Probably not Anglo Saxon, despite its appearance, rather a utilitarian use of available slabs (possibly cross slabs). The form appears to relate to the triangular vents, like those in the remains of the barn at Ryton - they are present in several other County Durham barns as well, now generally thought to be late medieval on the basis of dendro-dating. The barn had kerb principal trusses, a typical Durham C15/16 form.*

*Illus. 24: Vents in the surviving north wall of Whitburn Tithe Barn, south-facing elevation.*

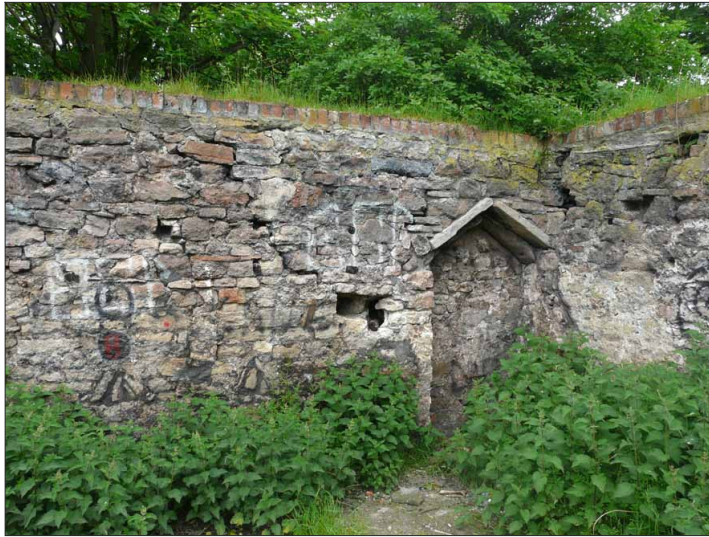
Peter Ryder, Historic buildings specialist, comments as follows on the small blocked doorway at the end of the northern boundary wall - Wall 5 (above):

*Illus. 25: Blocked door at the east end of the north wall of the former tithe barn.*

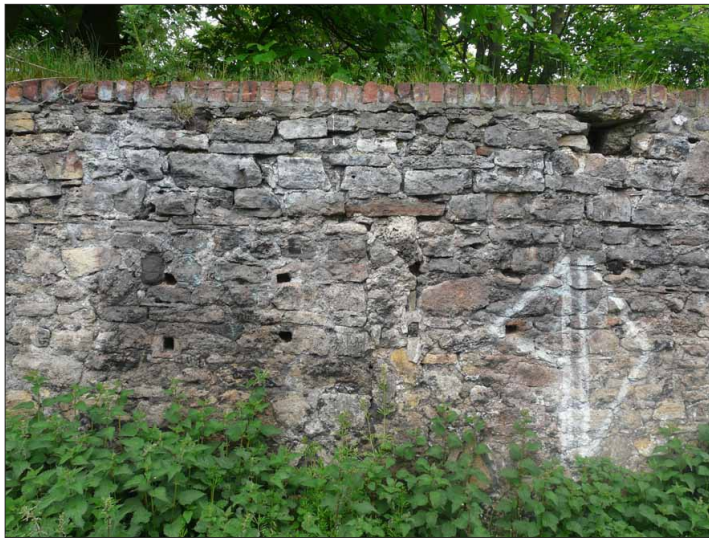
*Illus. 26: View from the south of a blocked doorway at the east end of the tithe barn north wall.*

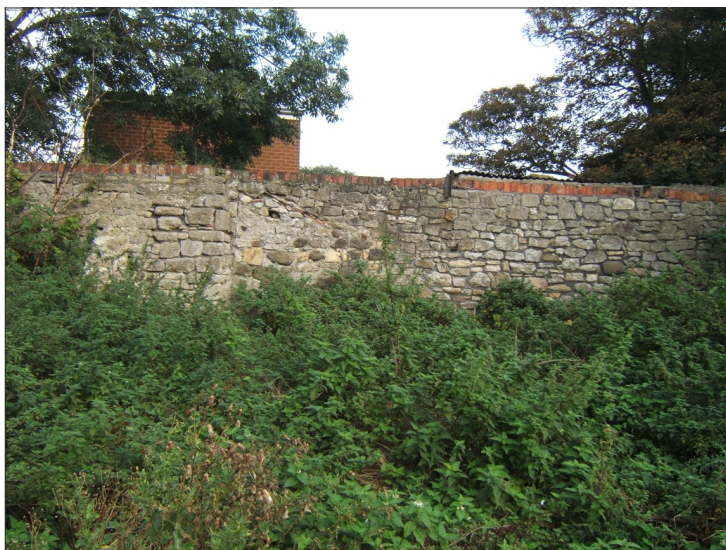
*Illus, 27: Part of the east wall of the assessment site (note former roof line in central section).*

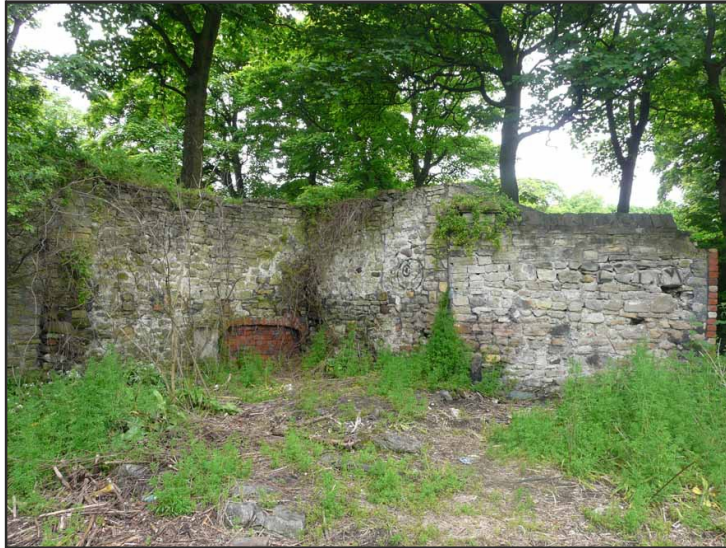
*Illus. 28: Blocked door at the east end of the north wall of the former tithe barn.*

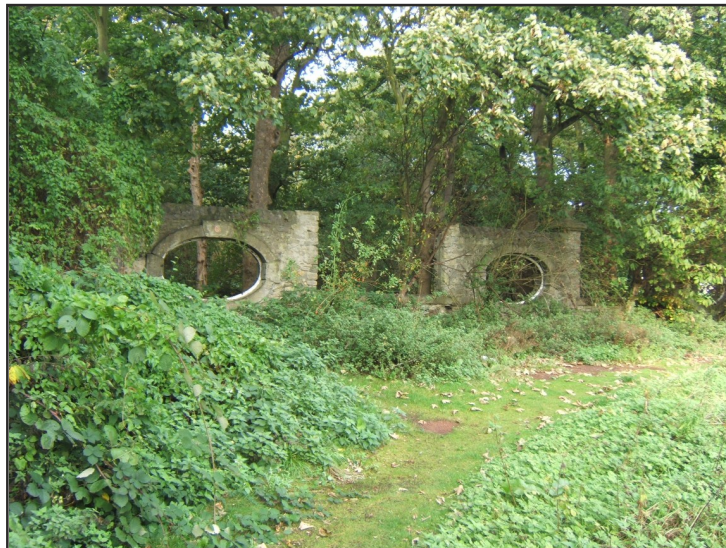
*Illus. 29: West part of the east-west wall within the assessment site - showing oval openings constructed around 1900 (photographed prior to the collapse of the near-side opening).*

It is proposed to build a large residential property on or close to the site of the former Church Lane House, retaining the present site boundary walls as well as the dividing wall between north and south parts of the site, which will be rebuilt in places where it has recently fallen into decay.

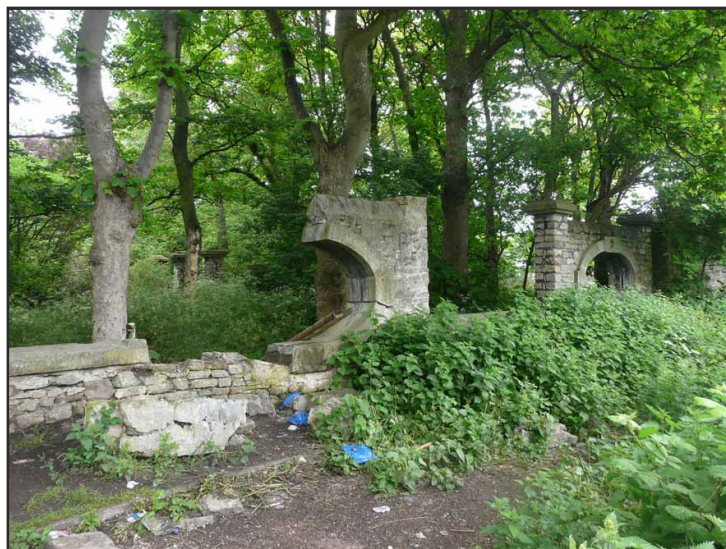
*Illus. 30: West part of the east-west wall showing deterioration caused by partial collapse since 2006.*
