REPORT ON BUILDING RECORDING & PHOTOGRAPHIC SURVEY

**SUNNISIDE FARM,
SUNNISIDE LANE,
CLEADON,
SOUTH TYNESIDE
NE34 8DY**

**Fitzarchitects Ltd
24-26 Norfolk Street,
Sunderland
SR1 1EE**

Date: June 2007

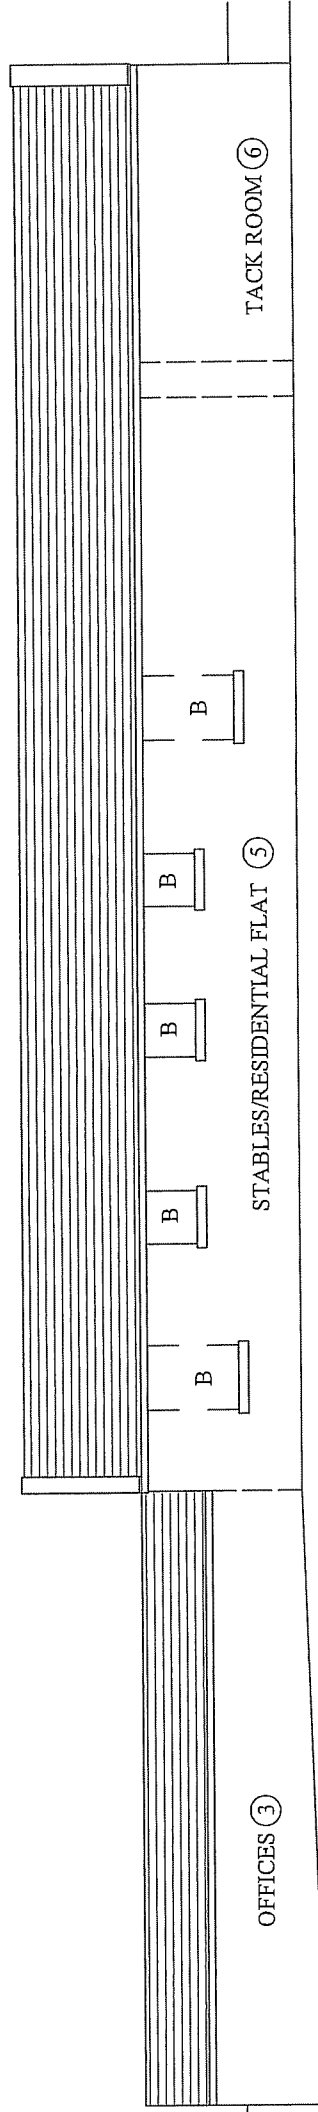
FIG A2.2
EAST ELEVATION OF EAST RANGE

6.3.1 Description: The former farm buildings which form part of the east range and are aligned N-S. These have been converted to offices and are currently in use as such. Only the shell and the roof (much repaired) of the agricultural buildings survive. The walls are of random coursed Permian magnesian limestone with the occasional boulder of Triassic (?) New Red Sandstone (NRS). The roof is of welsh slate. The rear wall of the offices shows no evidence of blocked doors or windows. (A3.5)

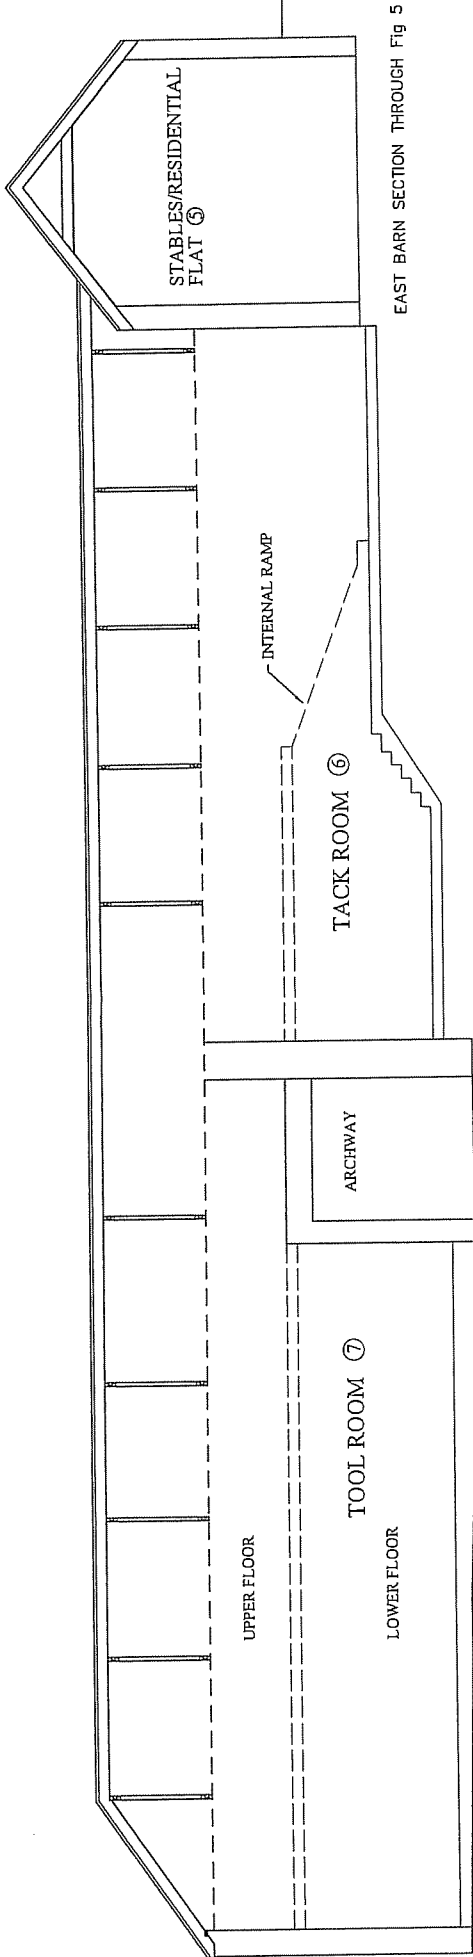
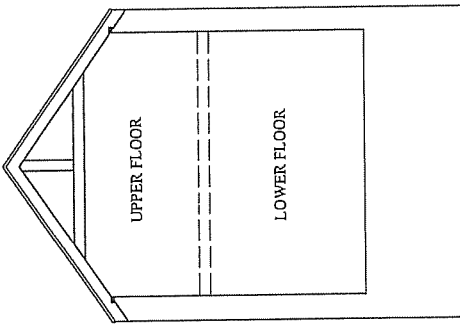
FIG 2.9
SECTION N-S THROUGH TOOL ROOM 7

- 6.7.4 As with building (6), this building has been gutted and the interior rebuilt. It has a recently replaced roof timber roof construction in a modified 'Crown' post style. (A2.8, A2.9)

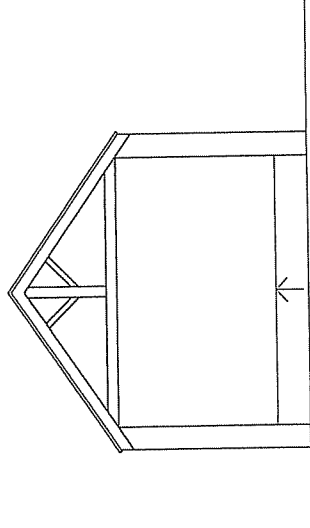
FIG 2.10
SECTION N-S THROUGH TACK ROOM 6

- 6.6.4 The interior of this building has been gutted for its current purpose, the roof timbers have been recently replaced (last 20 years?). The current form is similar to a 'King' post type construction (A2.10)

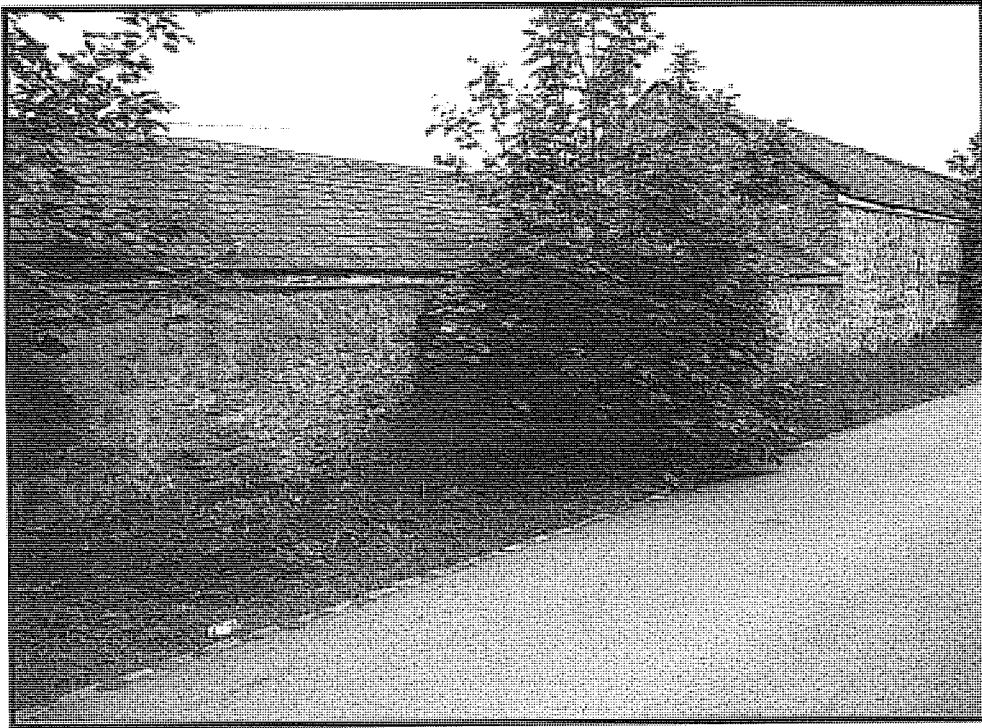
A3.5 : View NNW of east elevation of east range of farm (Scale 3m)

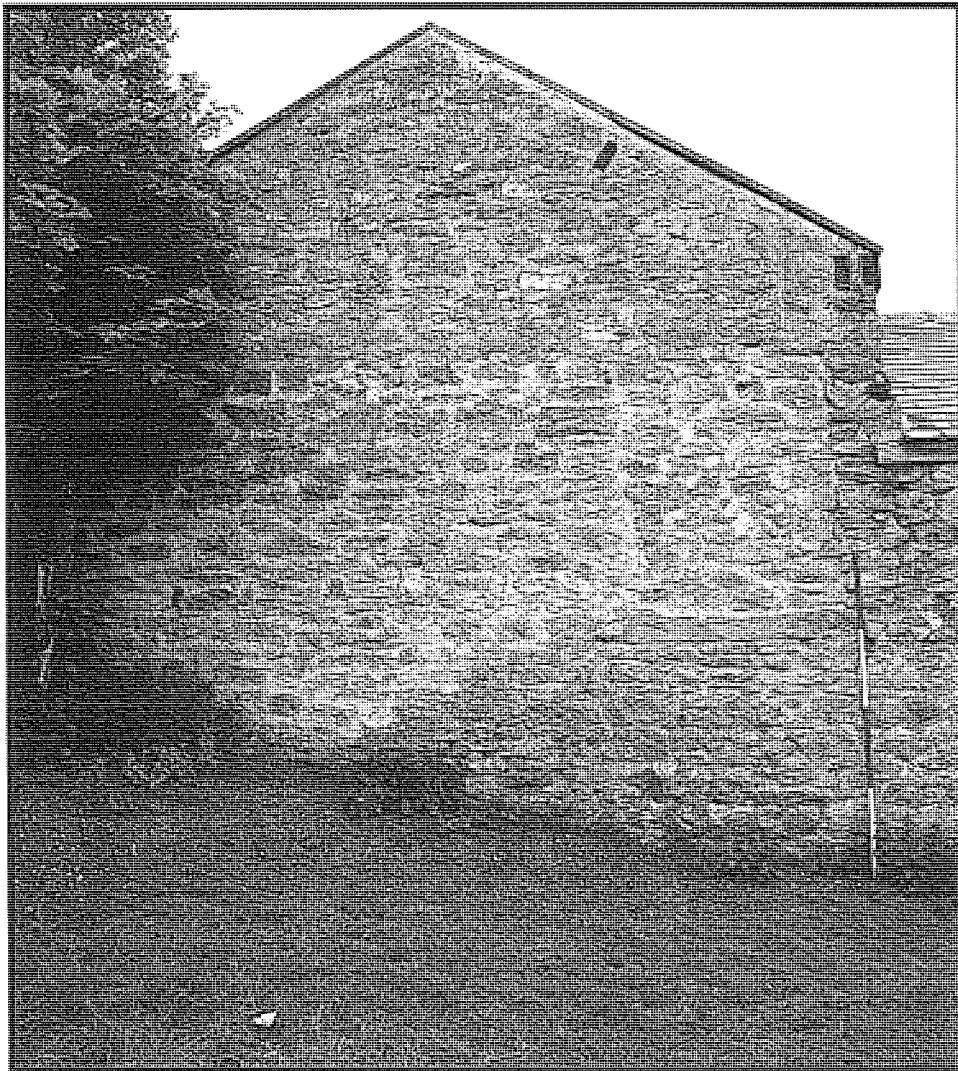
**A3.7 : North elevation of east range of farm showing blocked doorway
and stairway scar (Scale 2m)**

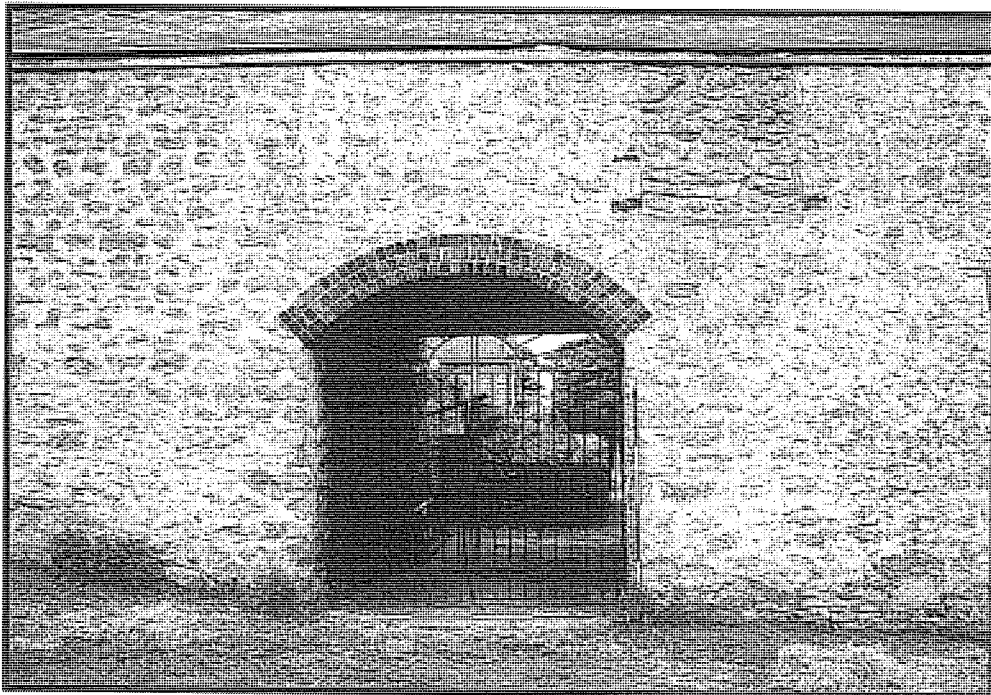
A3.9 : Detail of archway on north facing elevation (Scales 2m)

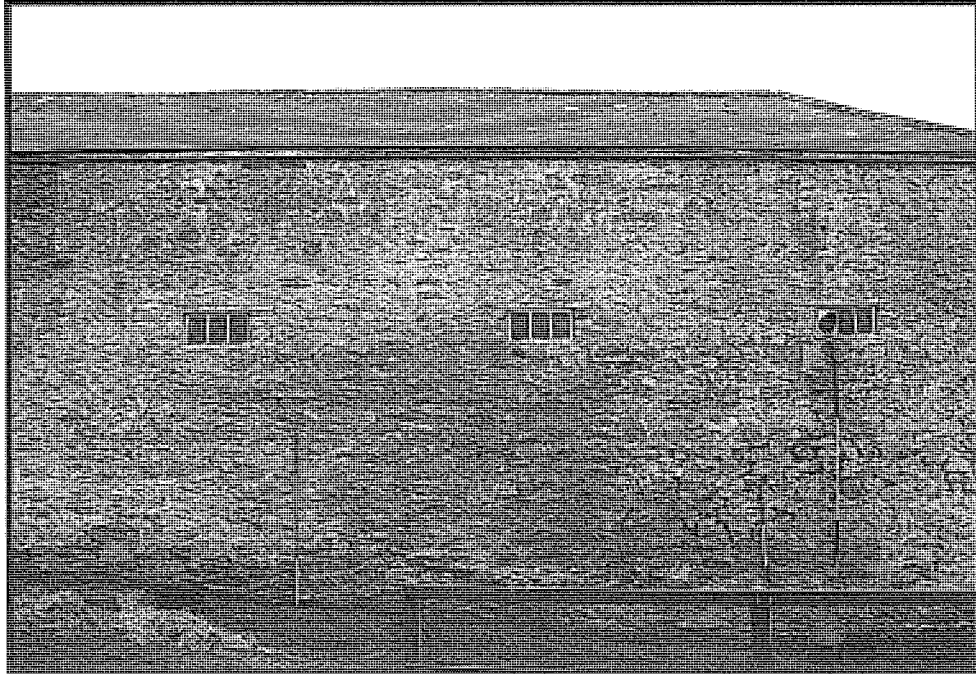
Plate 3.10 : Detail of windows on north facing elevation (Scales 2m)

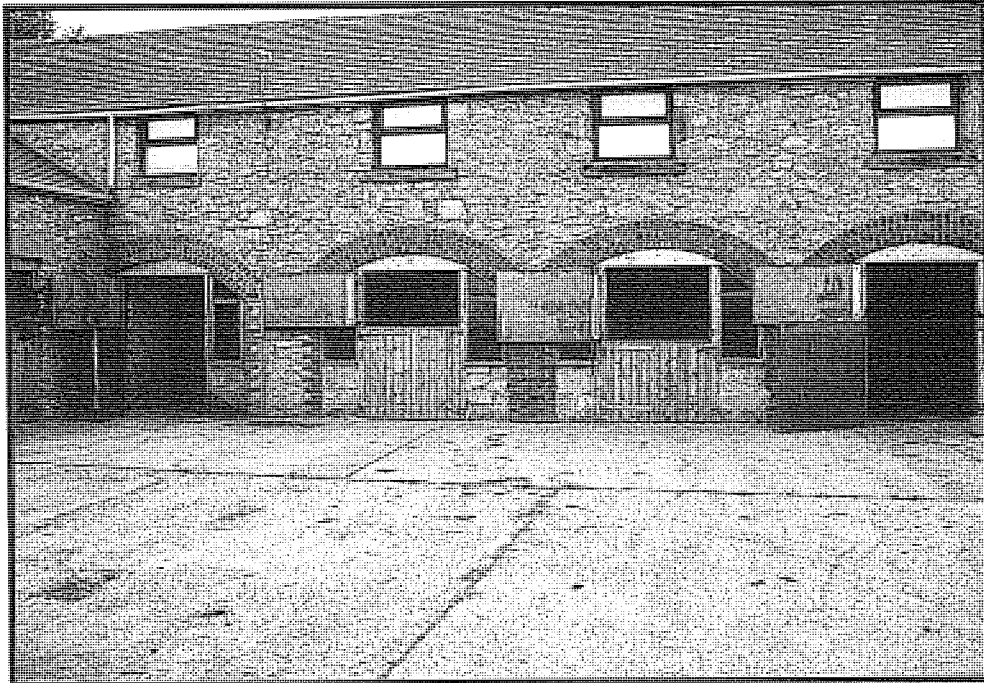
- 6.5.2 The stone walls are of recently repointed random coursed Permian magnesian limestone. The gabled roof is of welsh slate.
- 6.5.3 The west face of the structure, facing the stable yard is pierced at the upper floor level by five new windows associated with the residential flat above the stables. These seem to be replacements for wooden shuttered window that are depicted in the early aerial photograph of the building.

- 6.5.4 Interpretation: The stable entrances on the ground floor below the windows, at least in three instances are replacing archway entrances for what would have been accommodation for farm traffic/carts etc. The new stone blocking infill and wooden doors of the stables can clearly be seen on the recent aerial photograph. On the original aerial photograph there only three entrances and it can be observed that new stable and their associated entrances have been inserted on either side of the older archways. There has been an attempt with the new stable entrances to imitate the earlier entrances.

A3.16 : Stable block (5) from the west, Scales 2m

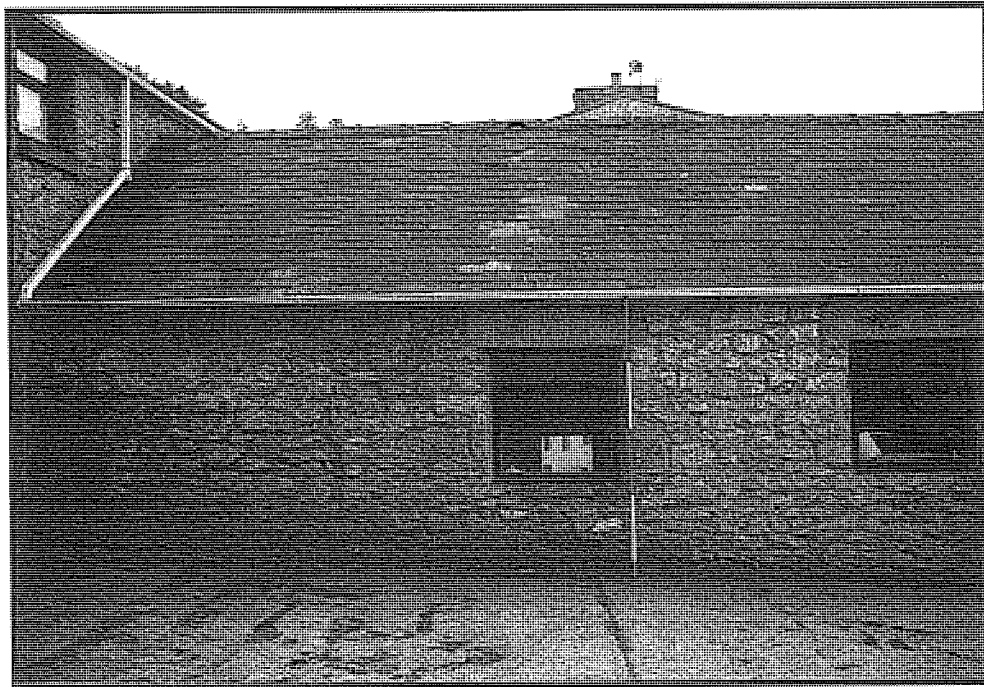
window frames. The ventilation slits appear contemporary with the original structure. The current entrance to the garage is located on the west end of the building and replaces an earlier smaller doorway. The walls of the structure are recently repointed randomly coursed magnesian limestone with occasional NRS boulder. The corners have been strengthened using quoins. The roof is of welsh slate

A3.17 : Detail of north elevation of garage/store (4), Scale 2m
