An Archaeological Evaluation on land adjacent to Lukes Lane, Monkton, South Tyneside

ARS Ltd Report No. 2013/49

June 2013

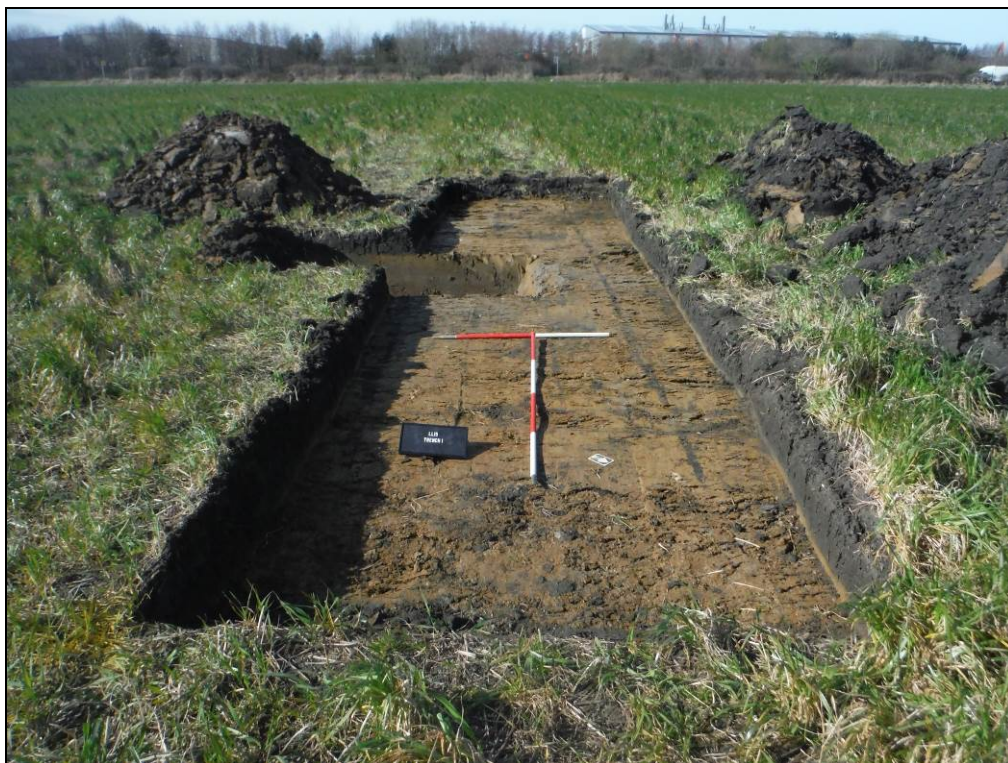
6.1 Trench 1 was located in the lower field towards the south and measured 10 x 2m. The trench was excavated through black silty loam ploughsoil (001) which had a depth of 0.25m. Beneath this was natural orange clay with mottled grey patches (002) which continued beyond the limits of excavation. The upper horizon of the natural clay had been affected by ploughing so this was removed in order to improve visibility.

6.2 Aerial photographs and geophysical survey had identified a linear, possibly a WW2 anti-glider trench, running at right angles through the centre of Trench 1. However this was not discovered during excavation. There was a slight change in the colour of the natural clay where it became mottled with grey patches in the centre of the trench. A sondage was excavated from the centre of the trench towards the south in to the natural, encompassing the discoloured area to establish whether or not there was a cut. The mottled grey material continued and there was no evidence of a cut or of any fill material.

Figure 3. Trench 1, looking west. Scales = 1m + 2m.

7.2 Trench 1 did not encounter any archaeological finds or features. A grey mottled area of clay was noted in the centre of the trench. It is possible that this represented the base of a linear feature or water-staining from moisture within such a feature. Alternatively, it could have represented the base of an ephemeral, ploughed out hedge line or field boundary, although no cut could be discerned.

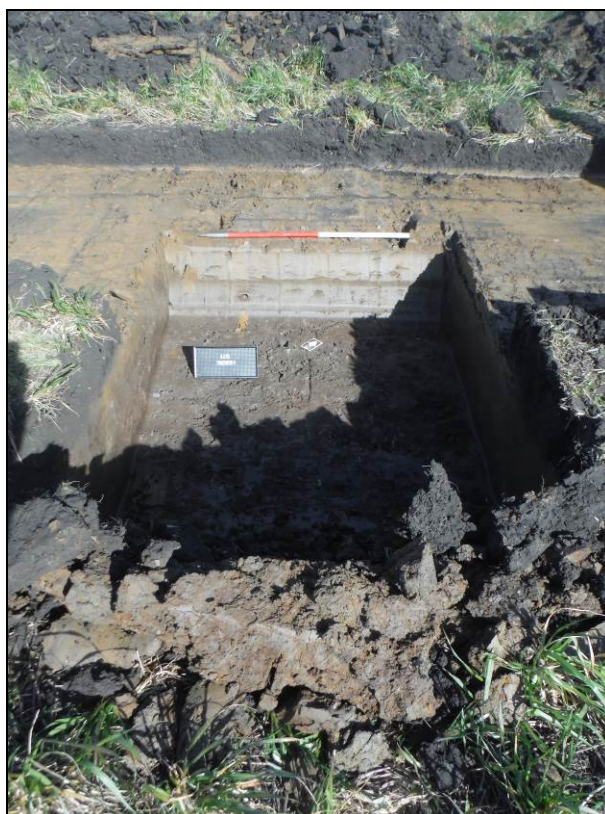
Figure 4. The sondage in Trench 1, looking north west. Scale = 1m.

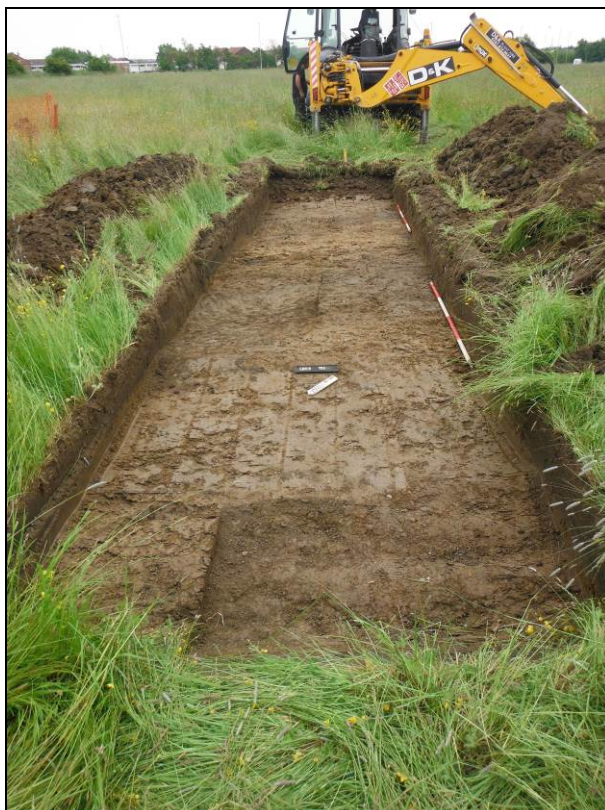
6.3 Trench 2 was excavated in the northern portion of the site, immediately adjacent to the dismantled Bowes Railway and Campbell Park Road. The trench measured 10m x 2m and was orientated North-west by South-east.

6.4 The evaluation trench was cut through topsoil and turf (201), which had a maximum depth of 0.27 metres. This layer sat directly on top of the natural clay (207), which was a yellowish brown colour.

Figure 5. Trench 2 looking south east. Scales = 2 x 2m.

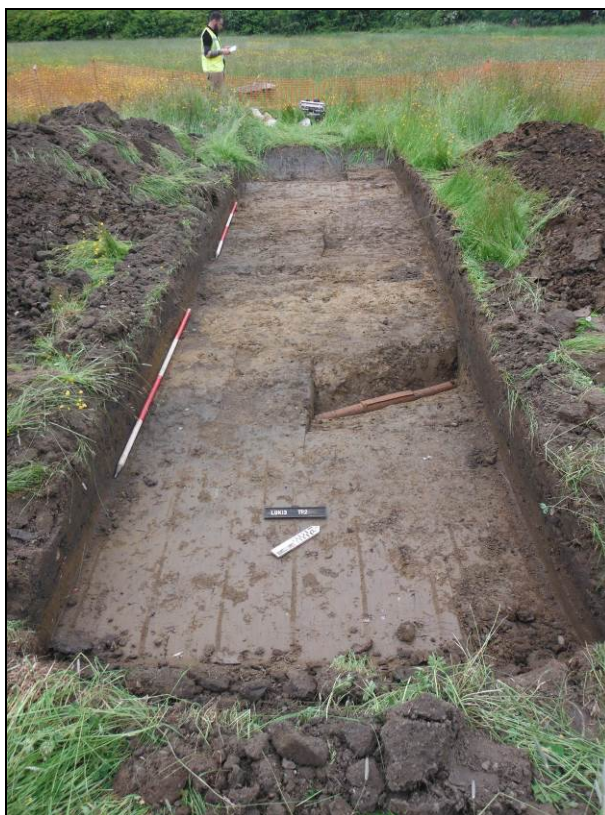
6.5 Located at a distance of 2.5 metres south of the northern extent of the trench was a very shallow possible drainage ditch/field boundary (203), which had a maximum depth of 0.1 metres and was approximately 1.1 metres in width, orientated roughly east to west. This feature contained one fill (202), which was mid grey silty clay material (Figure 5). Contained in this fill were 3 fragments of clay pipe stem, porcelain and a relatively small fragment of pottery, suggesting a 19th century date.

6.6 Located at a distance of 2.6 metres north of the southern extent of the trench was a small field drain (206), which had a steep sided cut (205). The field drain was composed of 0.37m sections, which were 0.22 metres in diameter. Three sections of the field drain are evident, with the middle section inverted (Figure 4). The fill of the field drain cut (204) was 0.28 metres in depth and was composed of a yellowish grey silty clay.

Figure 6. North-east aspect showing exposed field drain (206) and drainage ditch/field boundary (203). Scale = 2 x 2m.

7.1 Trench 2 successfully demonstrated the nature and extent of the two parallel linear features which were highlighted by the geophysical survey in the northern area of the development site. The most northern of these two linear features is a wide but very shallow and truncated field boundary or drainage ditch (203), which runs on an northeast-southwest orientation and contained clay pipe and Victorian pottery, which suggests a date in the 19th Century. The southern feature is a Victorian/Edwardian field drain (206), constructed during the late 19th to early 20th Century, comprised of 0.37 metre sections, which have a flat bottom and sub-circular rounded upper section. Both features were cut through the topsoil layer (201) and into the natural clay (207).

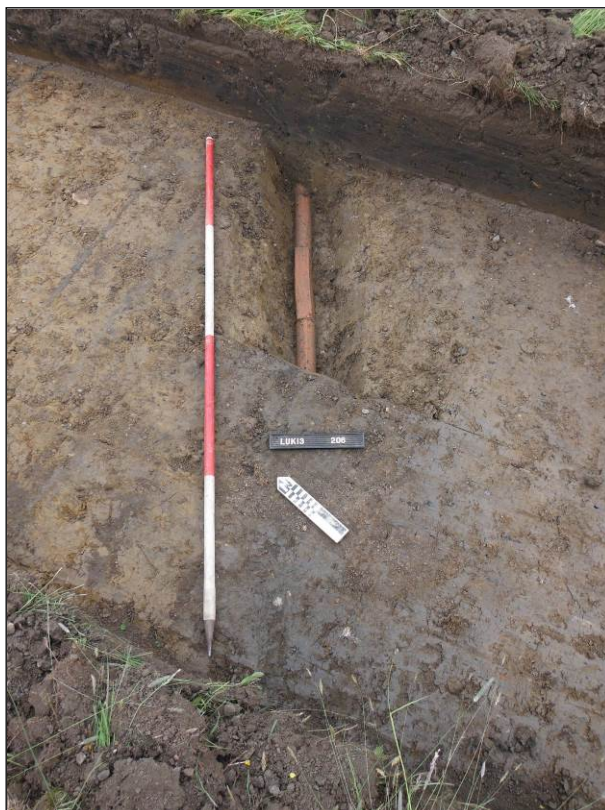
Figure 7. Field drain (206), showing inverted middle drain section.

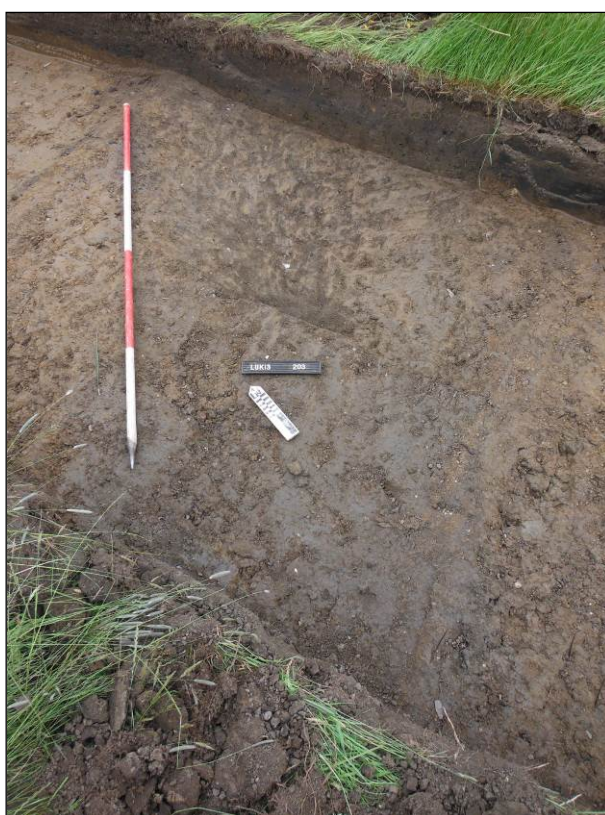
Figure 8. Boundary/drainage ditch (203)
