GROUND INVESTIGATION REPORT

COLEMANS CATERERS LIMITED / BDN LIMITED

PROPOSED REFURBISHMENT AND EXTENSION

GANDHI'S TEMPLE

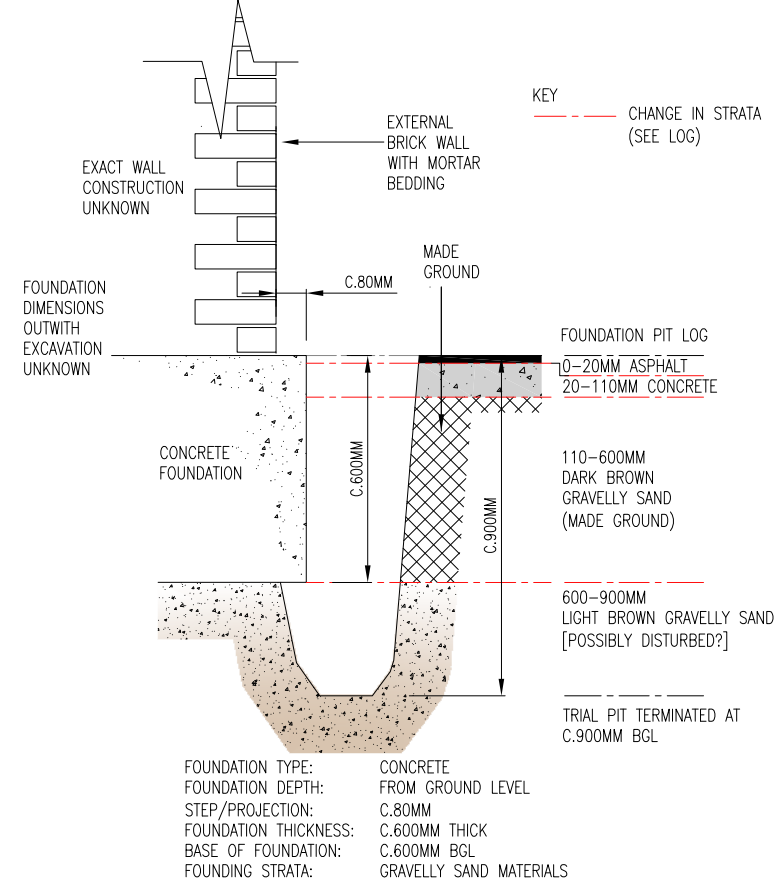
TRIAL PIT CROSS SECTION - TP1

FOUNDATION TYPE: CONCRETE
 FOUNDATION DEPTH: FROM GROUND LEVEL
 STEP/PROJECTION: C.80MM
 FOUNDATION THICKNESS: C.600MM THICK
 BASE OF FOUNDATION: C.600MM BGL
 FOUNDING STRATA: GRAVELLY SAND MATERIALS

When taking into account the difference in ground levels between the 2 no. trial pit positions (c.0.80m), the basal foundations levels were very similar.

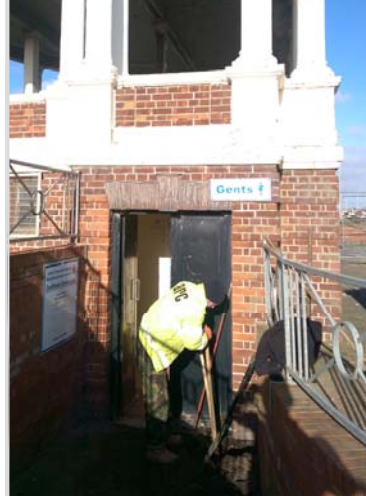
VIEW: EXCAVATION AREA OF TP1 (LOWER LEVEL)

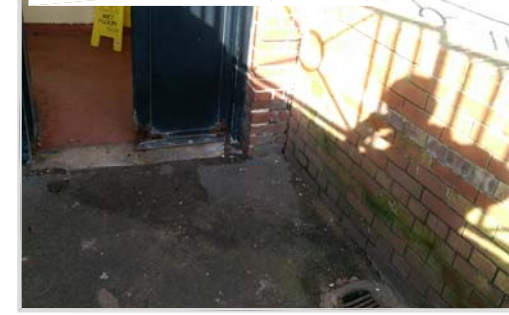
VIEW: EXCAVATION AREA OF TP1 (LOWER LEVEL)

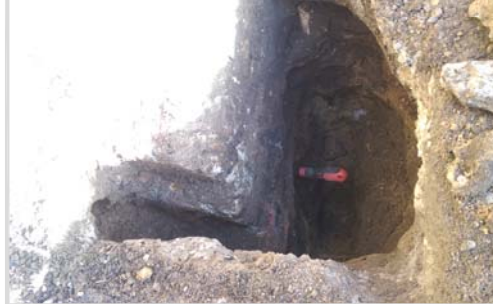
VIEW: EXPOSED CONCRETE FOUNDATION FROM GROUND LEVEL

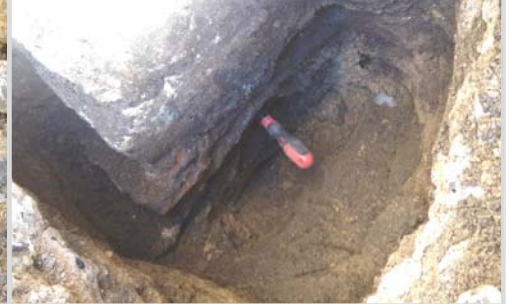
VIEW: SCREWDRIVER PLACED AT BASE OF FOUNDATION

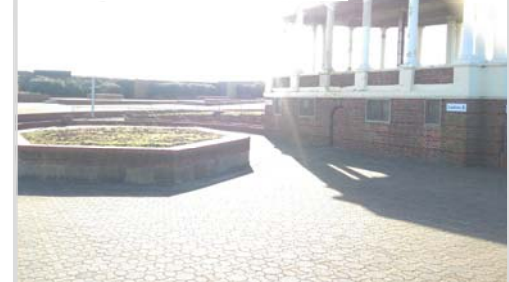
VIEW: VIEW ALONG EASTERN ELEVATION OF BUILDING AND POSITION OF TRIAL PIT TP2

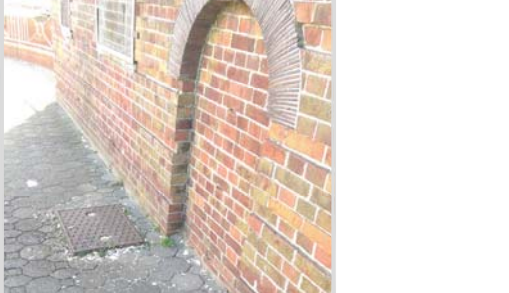
VIEW: POSITION OF TRIAL PIT TP2 (UPPER LEVEL)

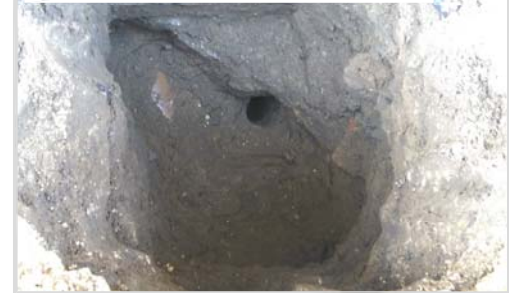
VIEW: EXPOSED UPPER LIMITS OF FOUNDATION AND LOCAL SERVICE RUNS

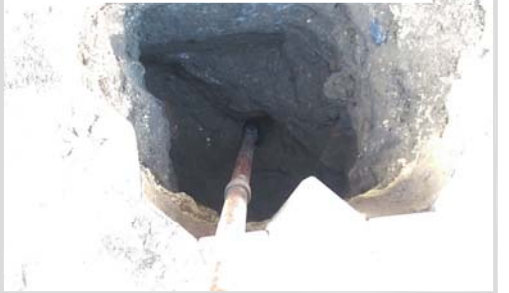
VIEW: PROBING WORKS TO DETERMINE THE BASE OF THE CONCRETE FOUNDATION AT THE UPPER LEVEL

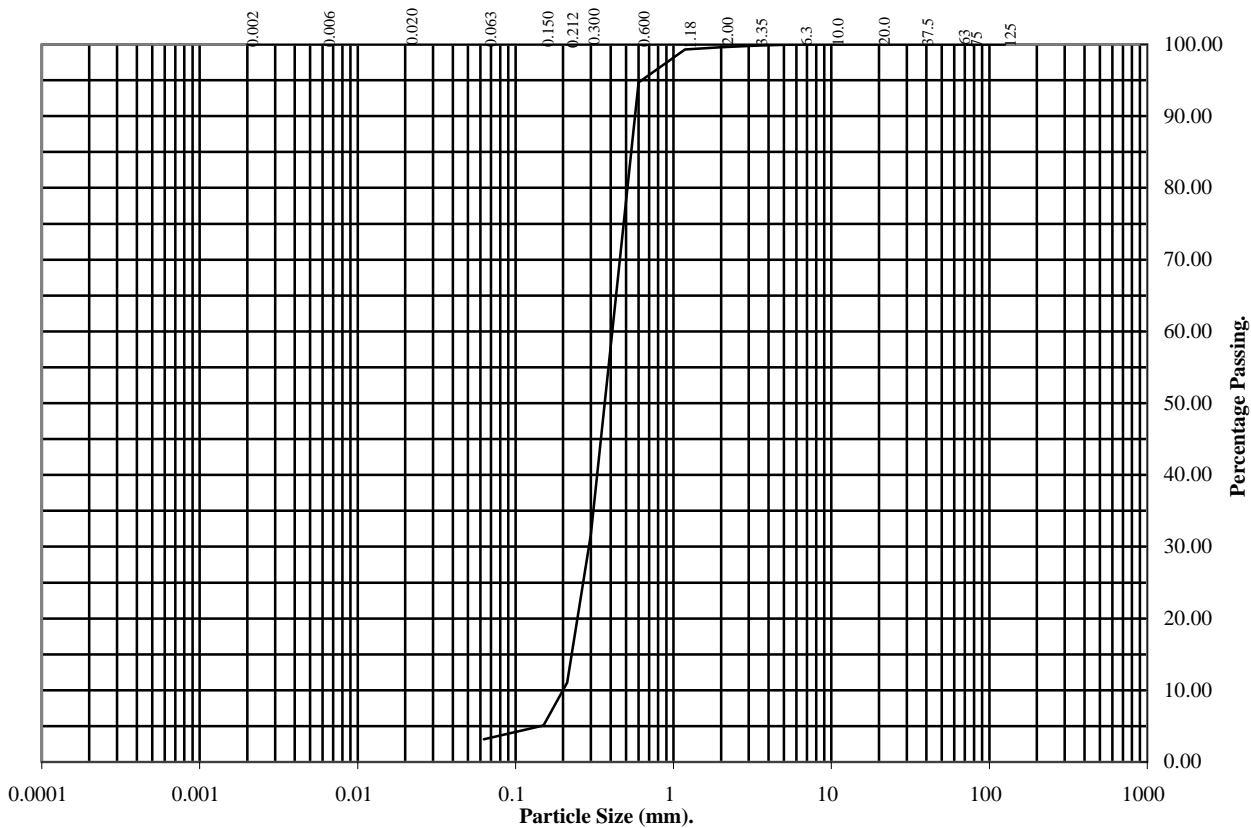
BS Test Sieve	Percentage Passing
125	100
75	100
63	100
37.5	100
20	100
10	100
6.3	100
3.35	100
2	100
1.18	99
0.6	95
0.3	32
0.212	11
0.15	5
0.063	3

Soil Fraction	Total Percentage
Cobbles	0
Gravel	0
Sand	97
Silt / Clay	3

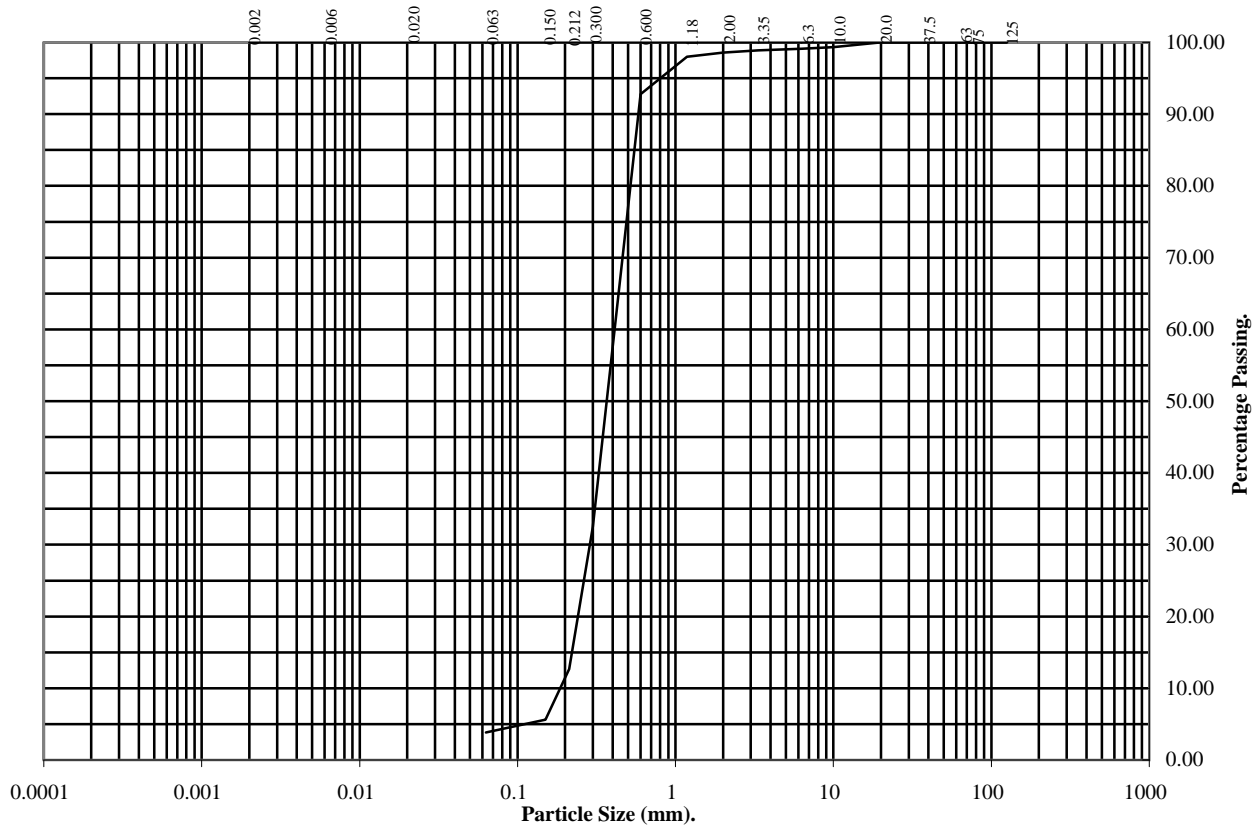
BS Test Sieve	Percentage Passing
125	100
75	100
63	100
37.5	100
20	100
10	99
6.3	99
3.35	99
2	99
1.18	98
0.6	93
0.3	33
0.212	13
0.15	6
0.063	4

Soil Fraction	Total Percentage
Cobbles	0
Gravel	1
Sand	95
Silt / Clay	4

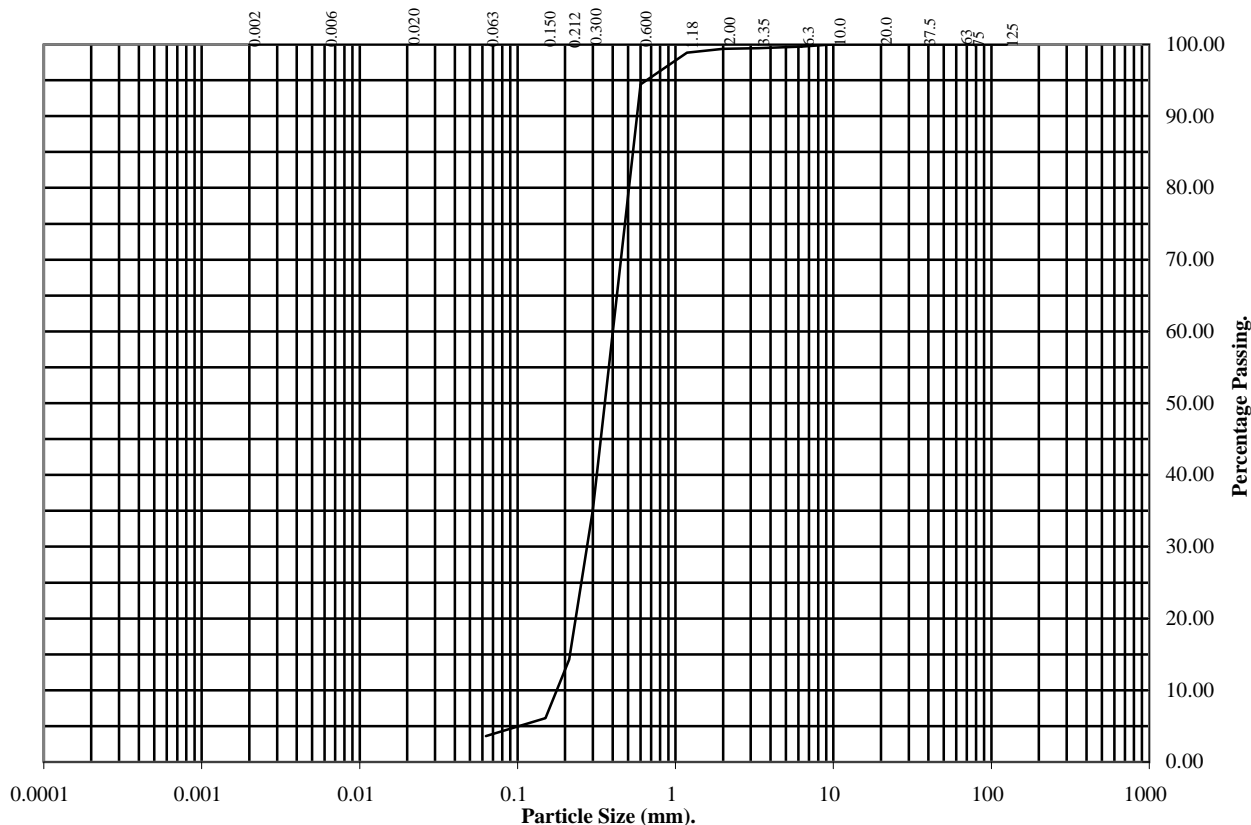
BS Test Sieve	Percentage Passing
125	100
75	100
63	100
37.5	100
20	100
10	100
6.3	100
3.35	99
2	99
1.18	99
0.6	94
0.3	35
0.212	14
0.15	6
0.063	4

Soil Fraction	Total Percentage
Cobbles	0
Gravel	1
Sand	95
Silt / Clay	4

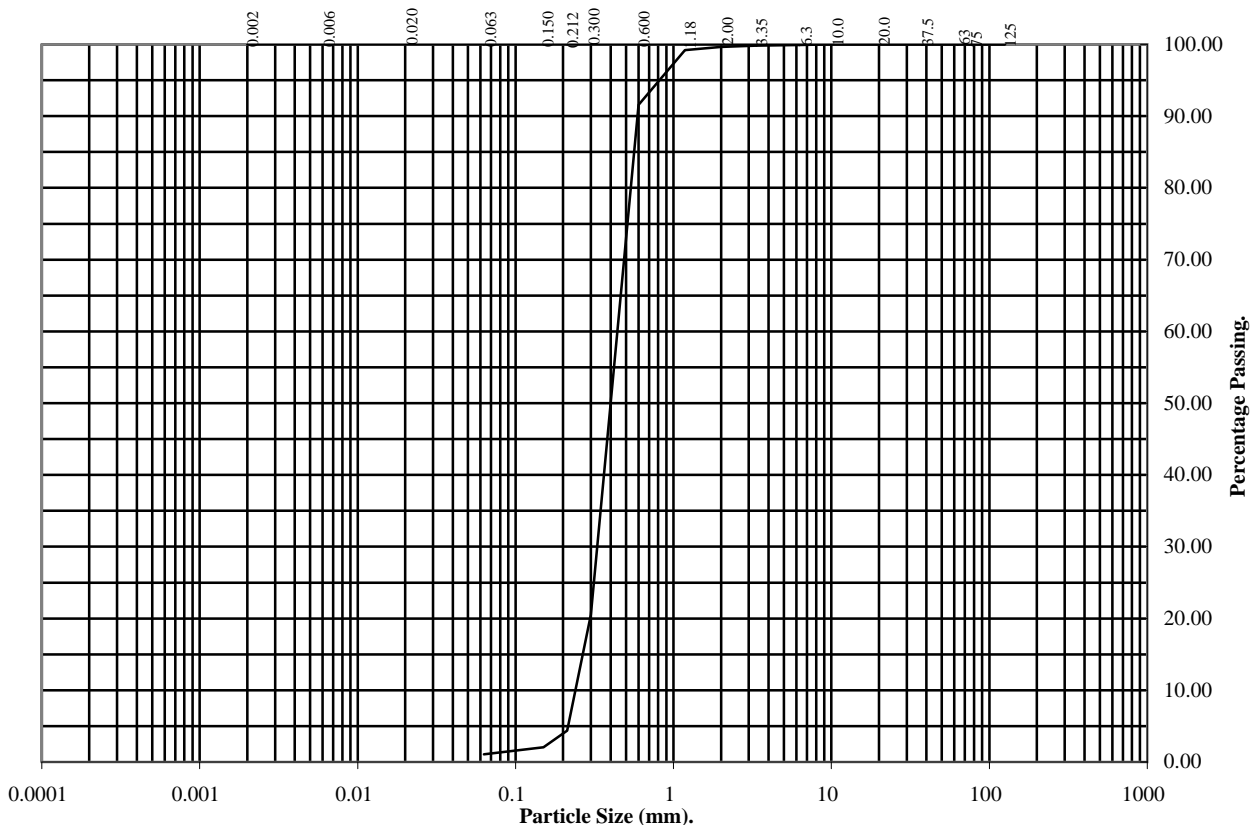
BS Test Sieve	Percentage Passing
125	100
75	100
63	100
37.5	100
20	100
10	100
6.3	100
3.35	100
2	100
1.18	99
0.6	92
0.3	21
0.212	4
0.15	2
0.063	1

Soil Fraction	Total Percentage
Cobbles	0
Gravel	0
Sand	99
Silt / Clay	1

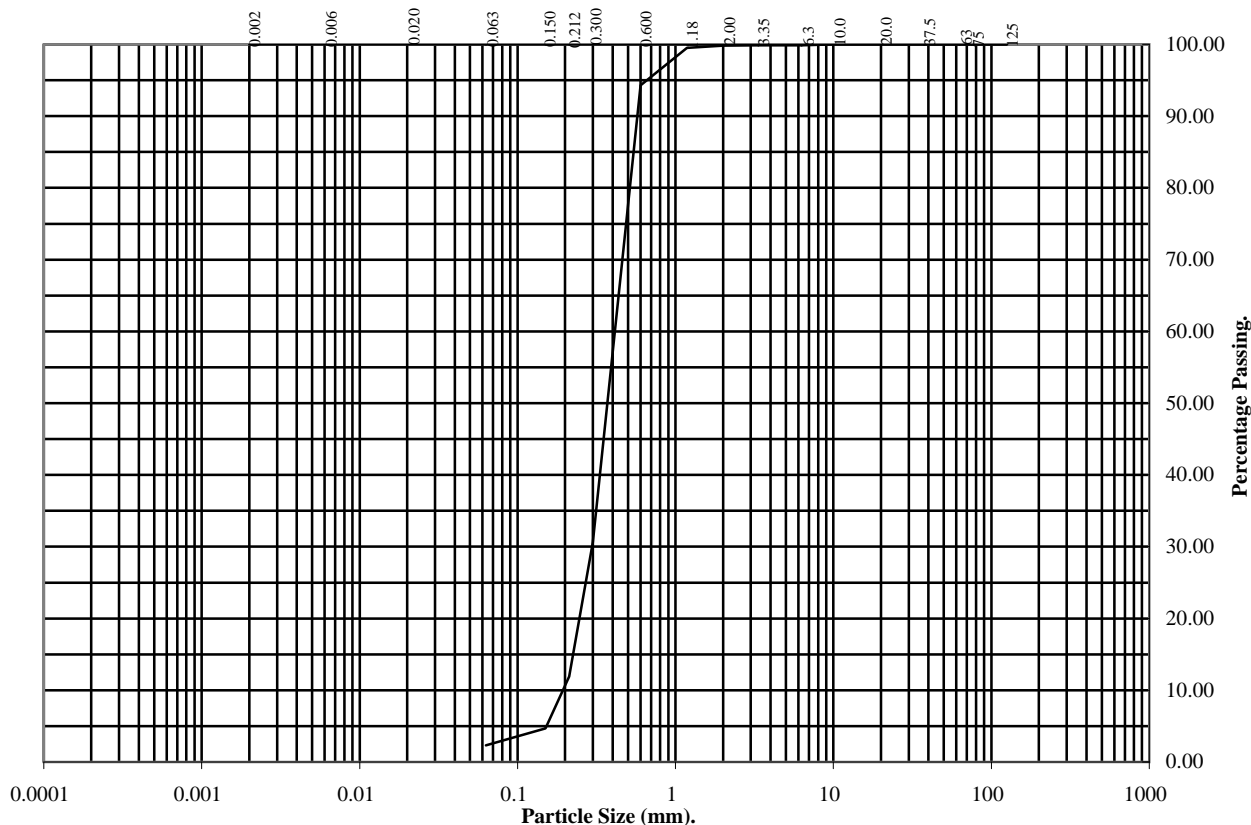
BS Test Sieve	Percentage Passing
125	100
75	100
63	100
37.5	100
20	100
10	100
6.3	100
3.35	100
2	100
1.18	99
0.6	94
0.3	31
0.212	12
0.15	5
0.063	2

Soil Fraction	Total Percentage
Cobbles	0
Gravel	0
Sand	98
Silt / Clay	2

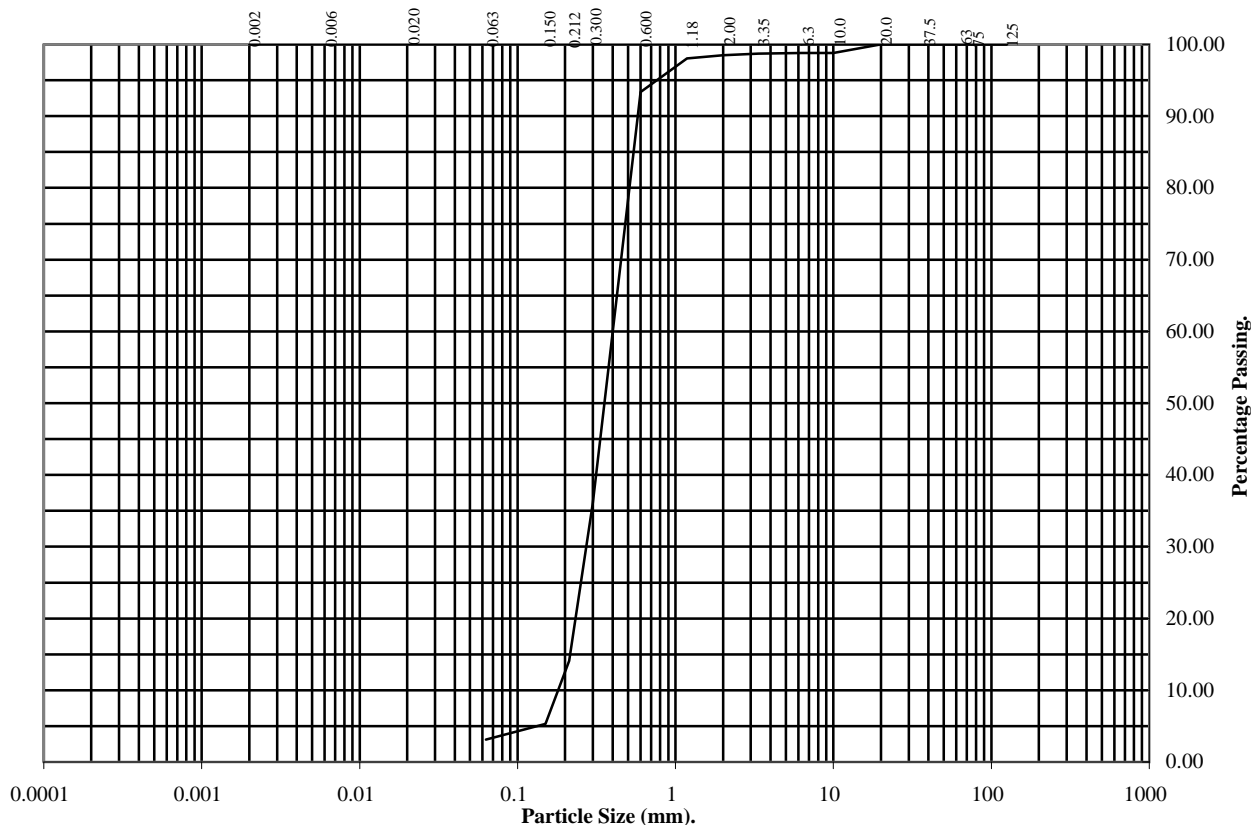
BS Test Sieve	Percentage Passing
125	100
75	100
63	100
37.5	100
20	100
10	99
6.3	99
3.35	99
2	98
1.18	98
0.6	93
0.3	36
0.212	14
0.15	5
0.063	3

Soil Fraction	Total Percentage
Cobbles	0
Gravel	2
Sand	95
Silt / Clay	3

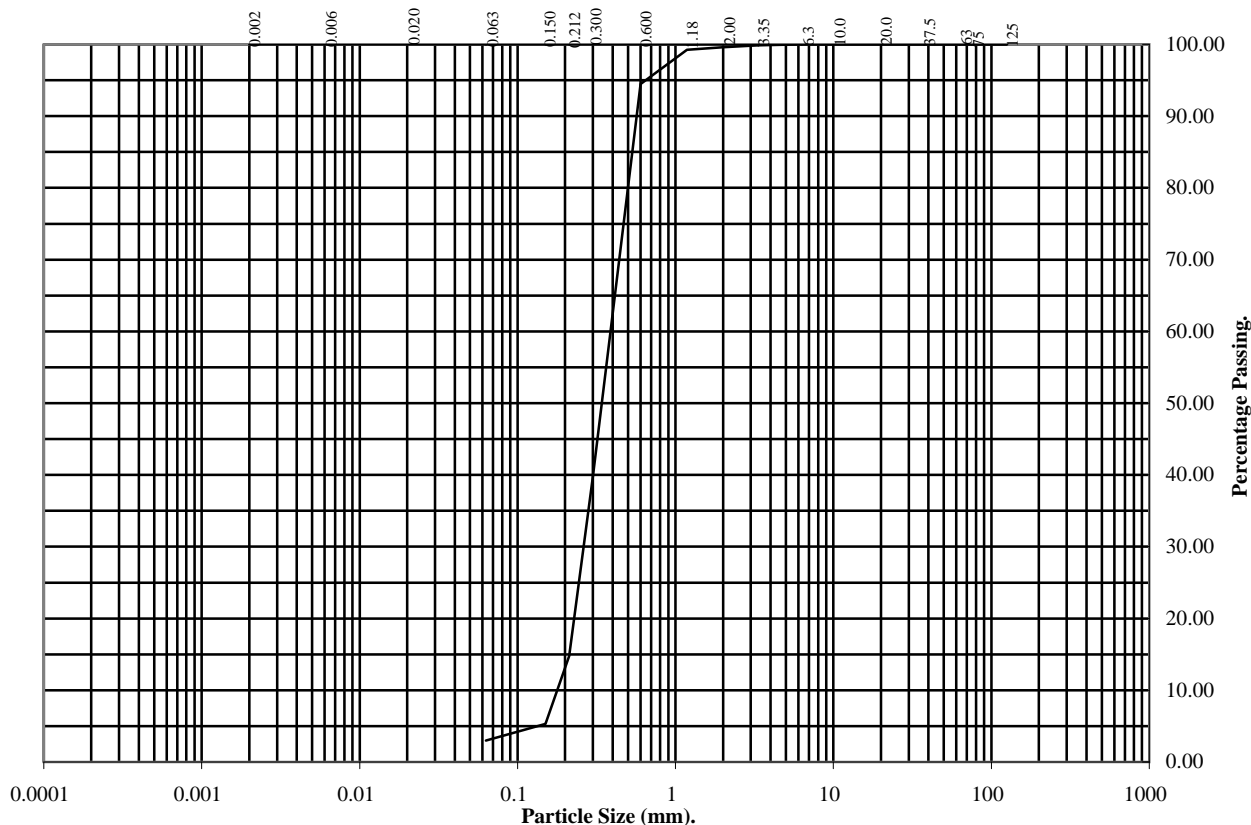
BS Test Sieve	Percentage Passing
125	100
75	100
63	100
37.5	100
20	100
10	100
6.3	100
3.35	100
2	100
1.18	99
0.6	94
0.3	40
0.212	15
0.15	5
0.063	3

Soil Fraction	Total Percentage
Cobbles	0
Gravel	0
Sand	97
Silt / Clay	3

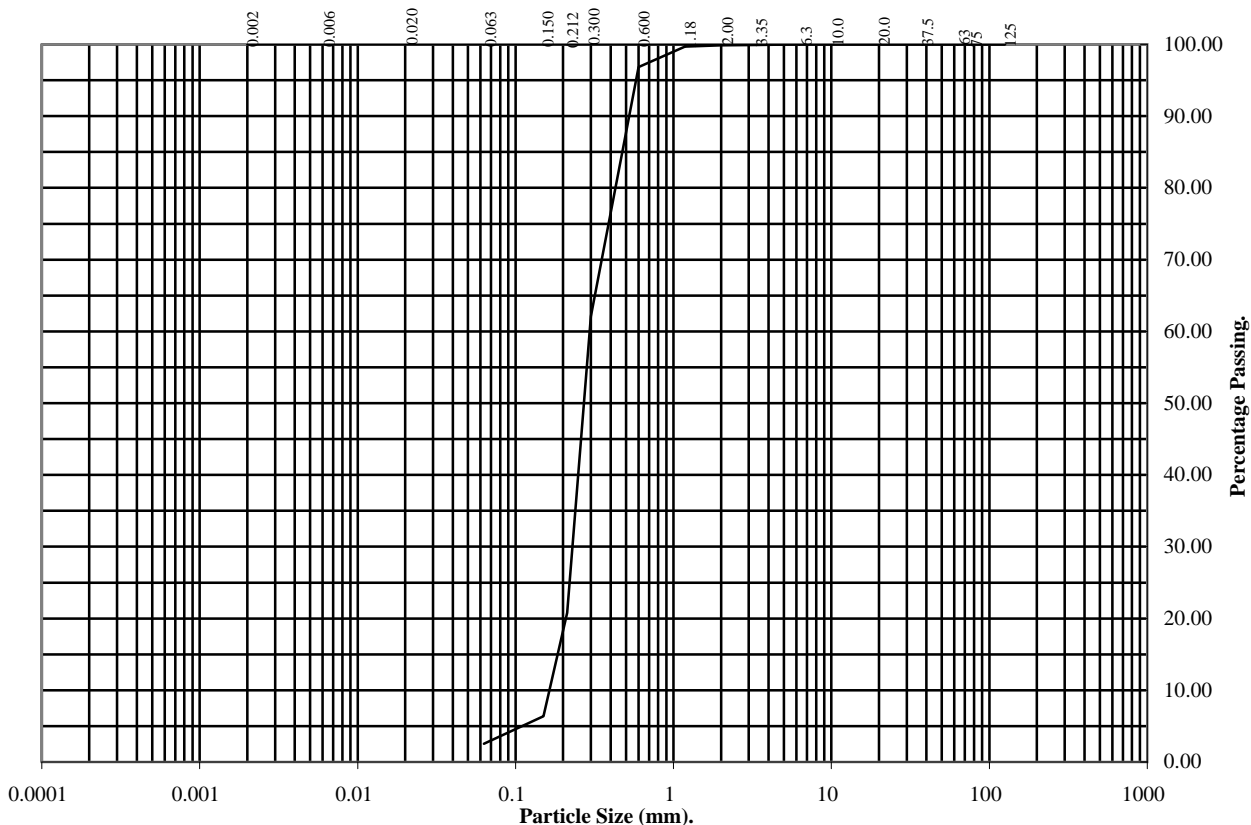
BS Test Sieve	Percentage Passing
125	100
75	100
63	100
37.5	100
20	100
10	100
6.3	100
3.35	100
2	100
1.18	100
0.6	97
0.3	62
0.212	21
0.15	6
0.063	3

Soil Fraction	Total Percentage
Cobbles	0
Gravel	0
Sand	97
Silt / Clay	3
