ARBORICULTURAL REPORT

to BS 5837:2012 at:

***Proposed Transport Interchange
South Shields
Tyne & Wear***

Prepared For:
Nexus, Muse Developments Ltd and South Tyneside Council

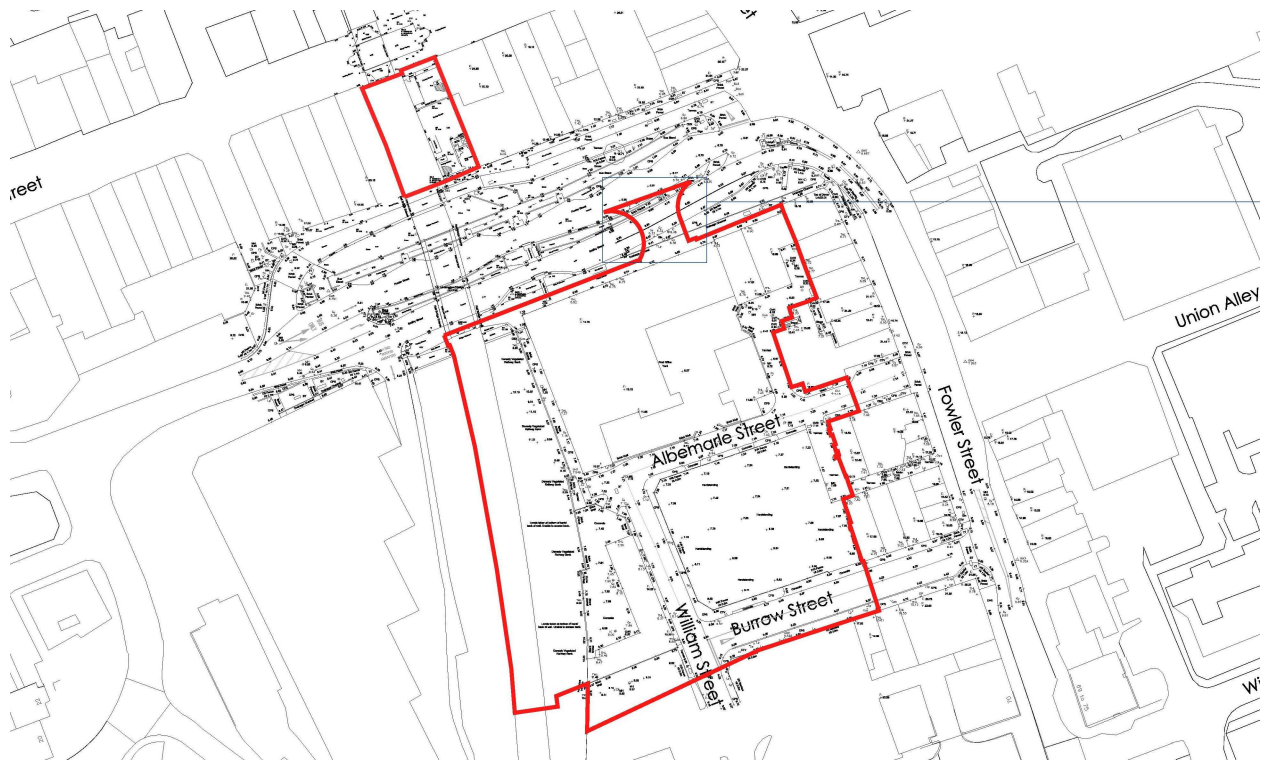
2.1.2 The tree survey was limited to the areas within the red lines, shown in the drawing below:

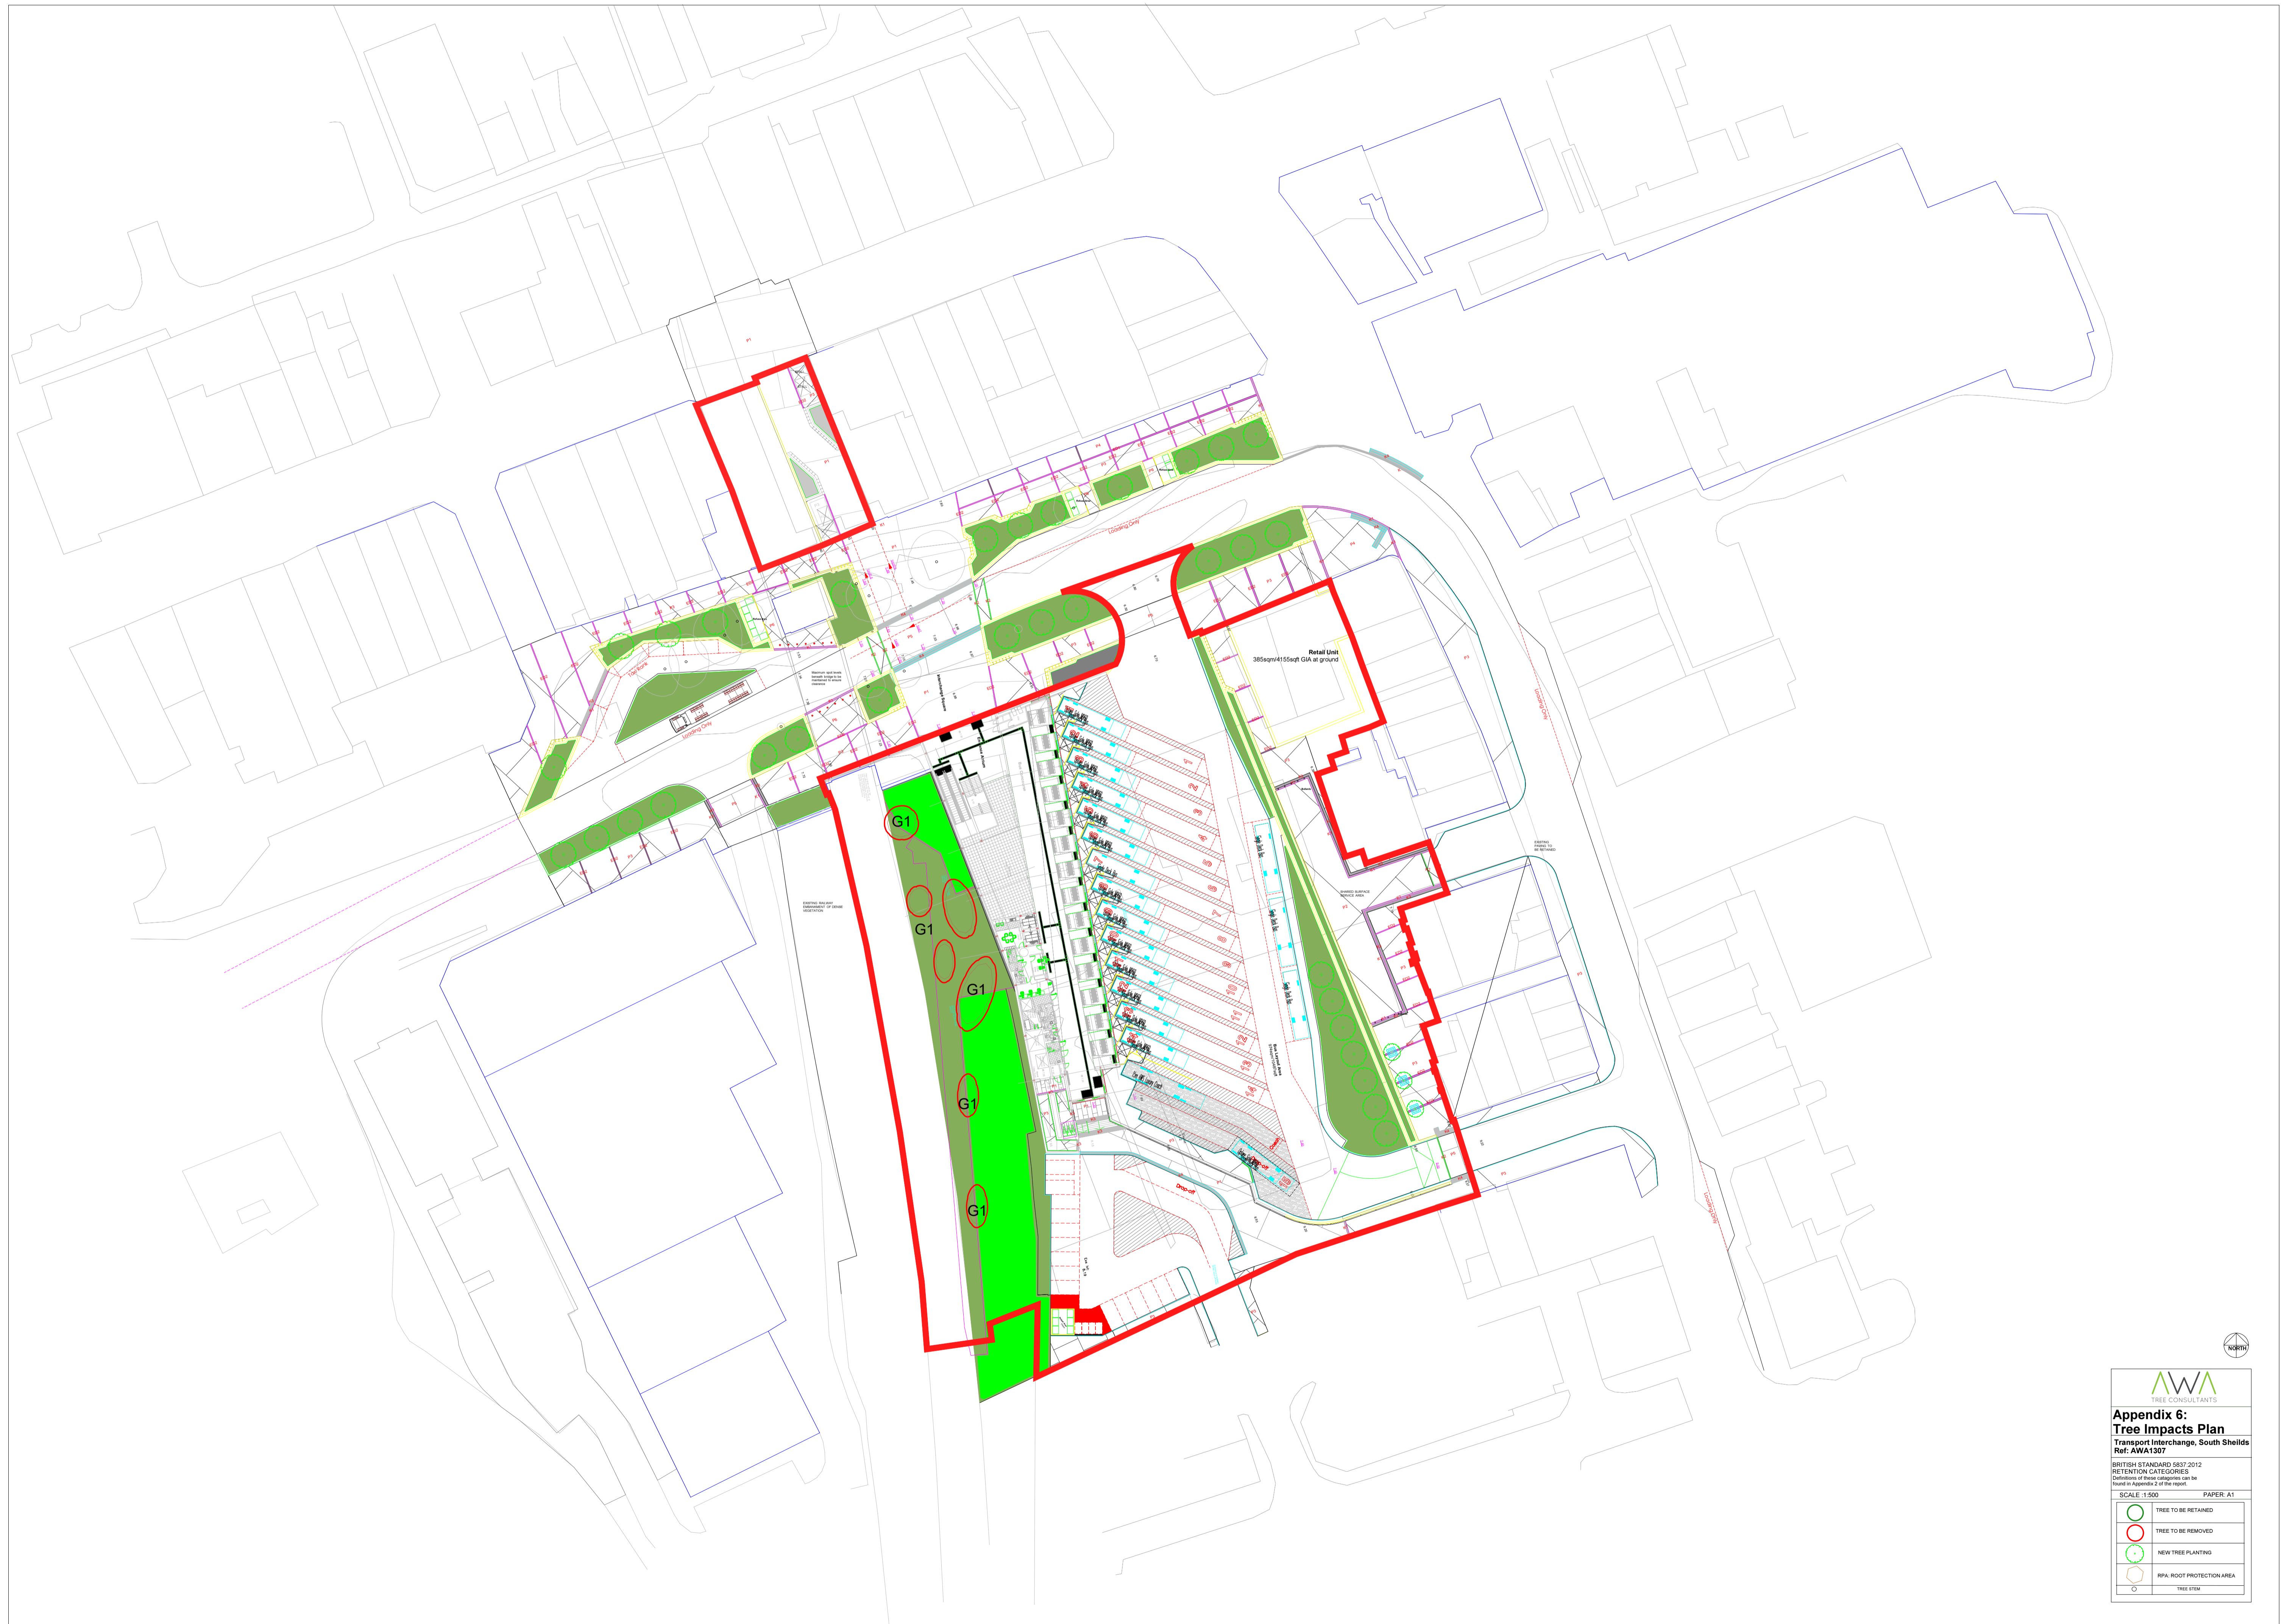
Appendix 6:
Tree Impacts Plan
 Transport Interchange, South Shields
 Ref: AWA1307

- 3.3.2 The development proposals have been provided by my client and inform the Tree Impacts Plan at Appendix 6.
- 3.3.3 The new development will require the removal of G1. Due to the low value and limited prospects of trees and shrubs within G1, the development provides the opportunity to replace them with better quality trees and shrubs elsewhere within the application site boundaries.
- 3.3.4 The new development includes extensive new tree planting of semi-mature trees that will mitigate the removal of G1. In the longer term, as the new trees become established, they will provide greater visual amenity and more robust tree cover than is currently provided by the existing surveyed vegetation.
