ARBORICULTURAL REPORT

to BS 5837:2012 at:
Outline Masterplan Site
South Shields
Tyne & Wear

Prepared For:
Muse Developments Ltd and South Tyneside Council

June 2015

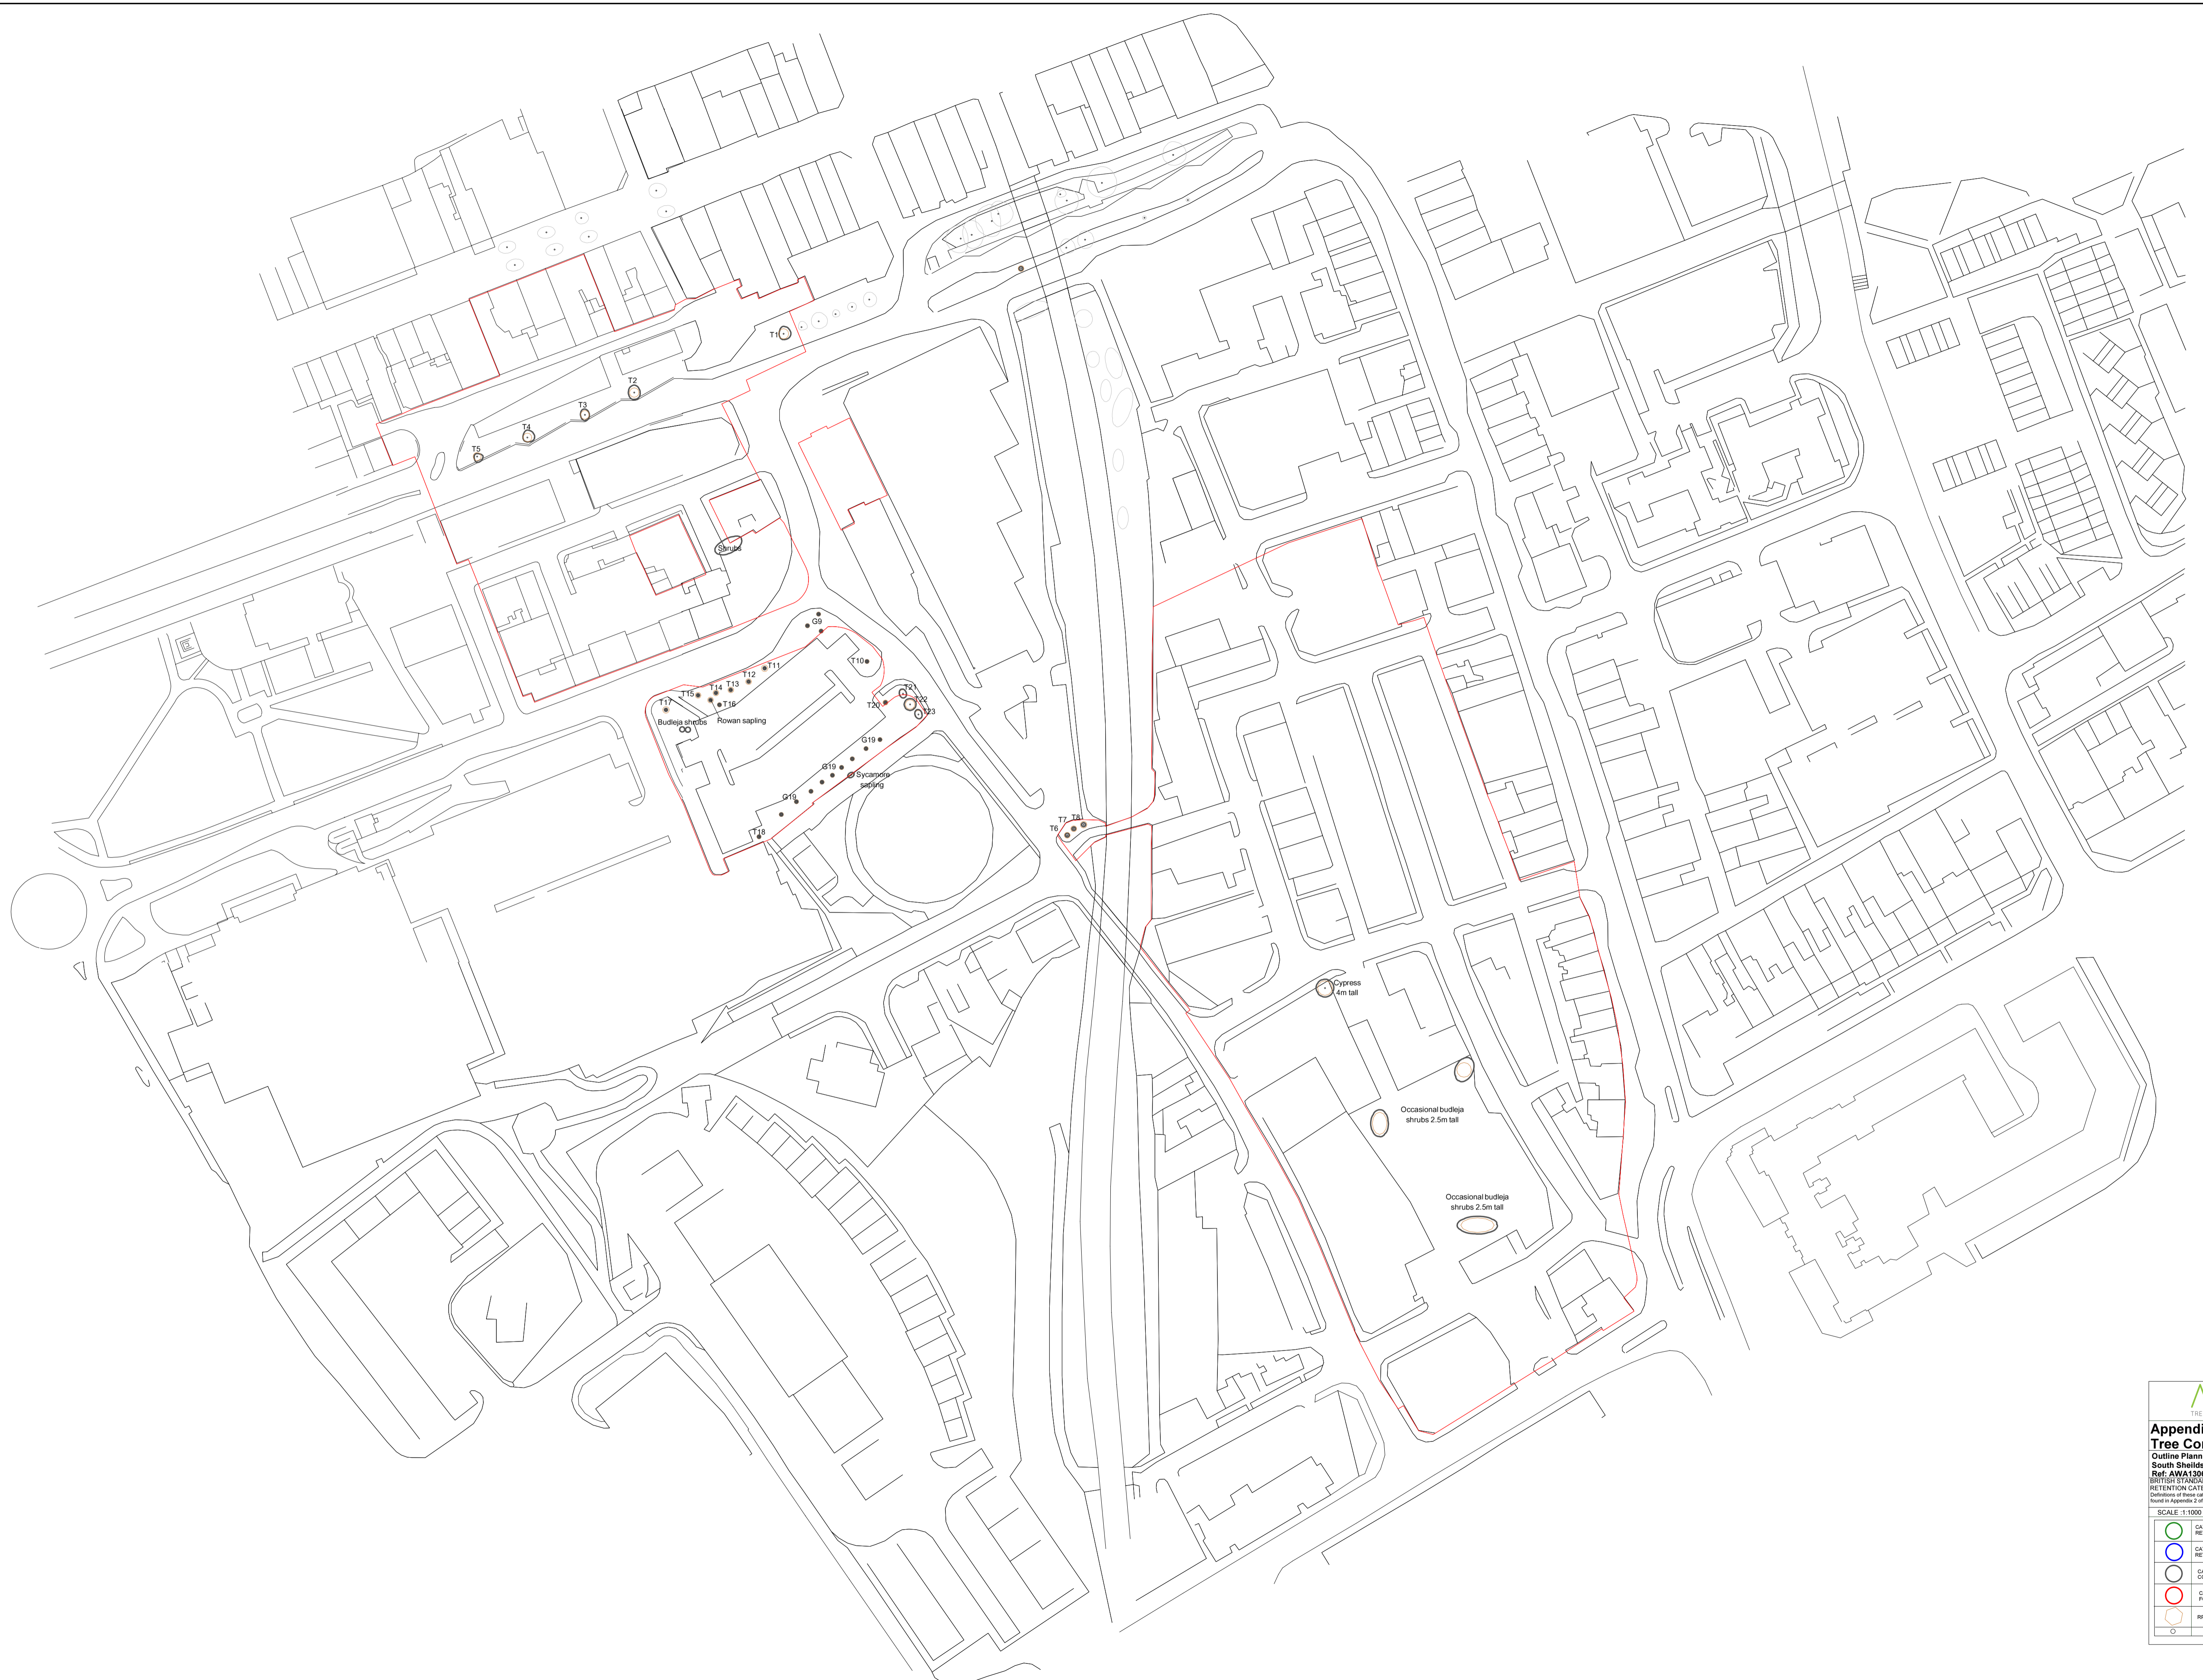
**Appendix 5:
Tree Constraints Plan**
Outline Planning Application,
South Shields
Ref: AWA1306

- 3.2.1 The tree survey revealed 23 items of vegetation, consisting of 21 individual trees and 2 groups of trees.
- 3.2.2 All of the surveyed vegetation is low value, retention category 'C' (explanatory details regarding the retention categories are included within Appendix 3).
- 3.2.3 The surveyed trees are largely comprised of very recently established tree planting as part of soft landscaping for the car park site or roadside planting, and low value shrubs that have recently established on unmanaged land.
- 3.2.4 Collectively the young planted trees provide some limited landscape value to the surrounding area, yet individually they are lower value trees.
- 3.2.5 Occasional small trees and shrubs have been detailed on the attached tree plan but were not surveyed in detail.

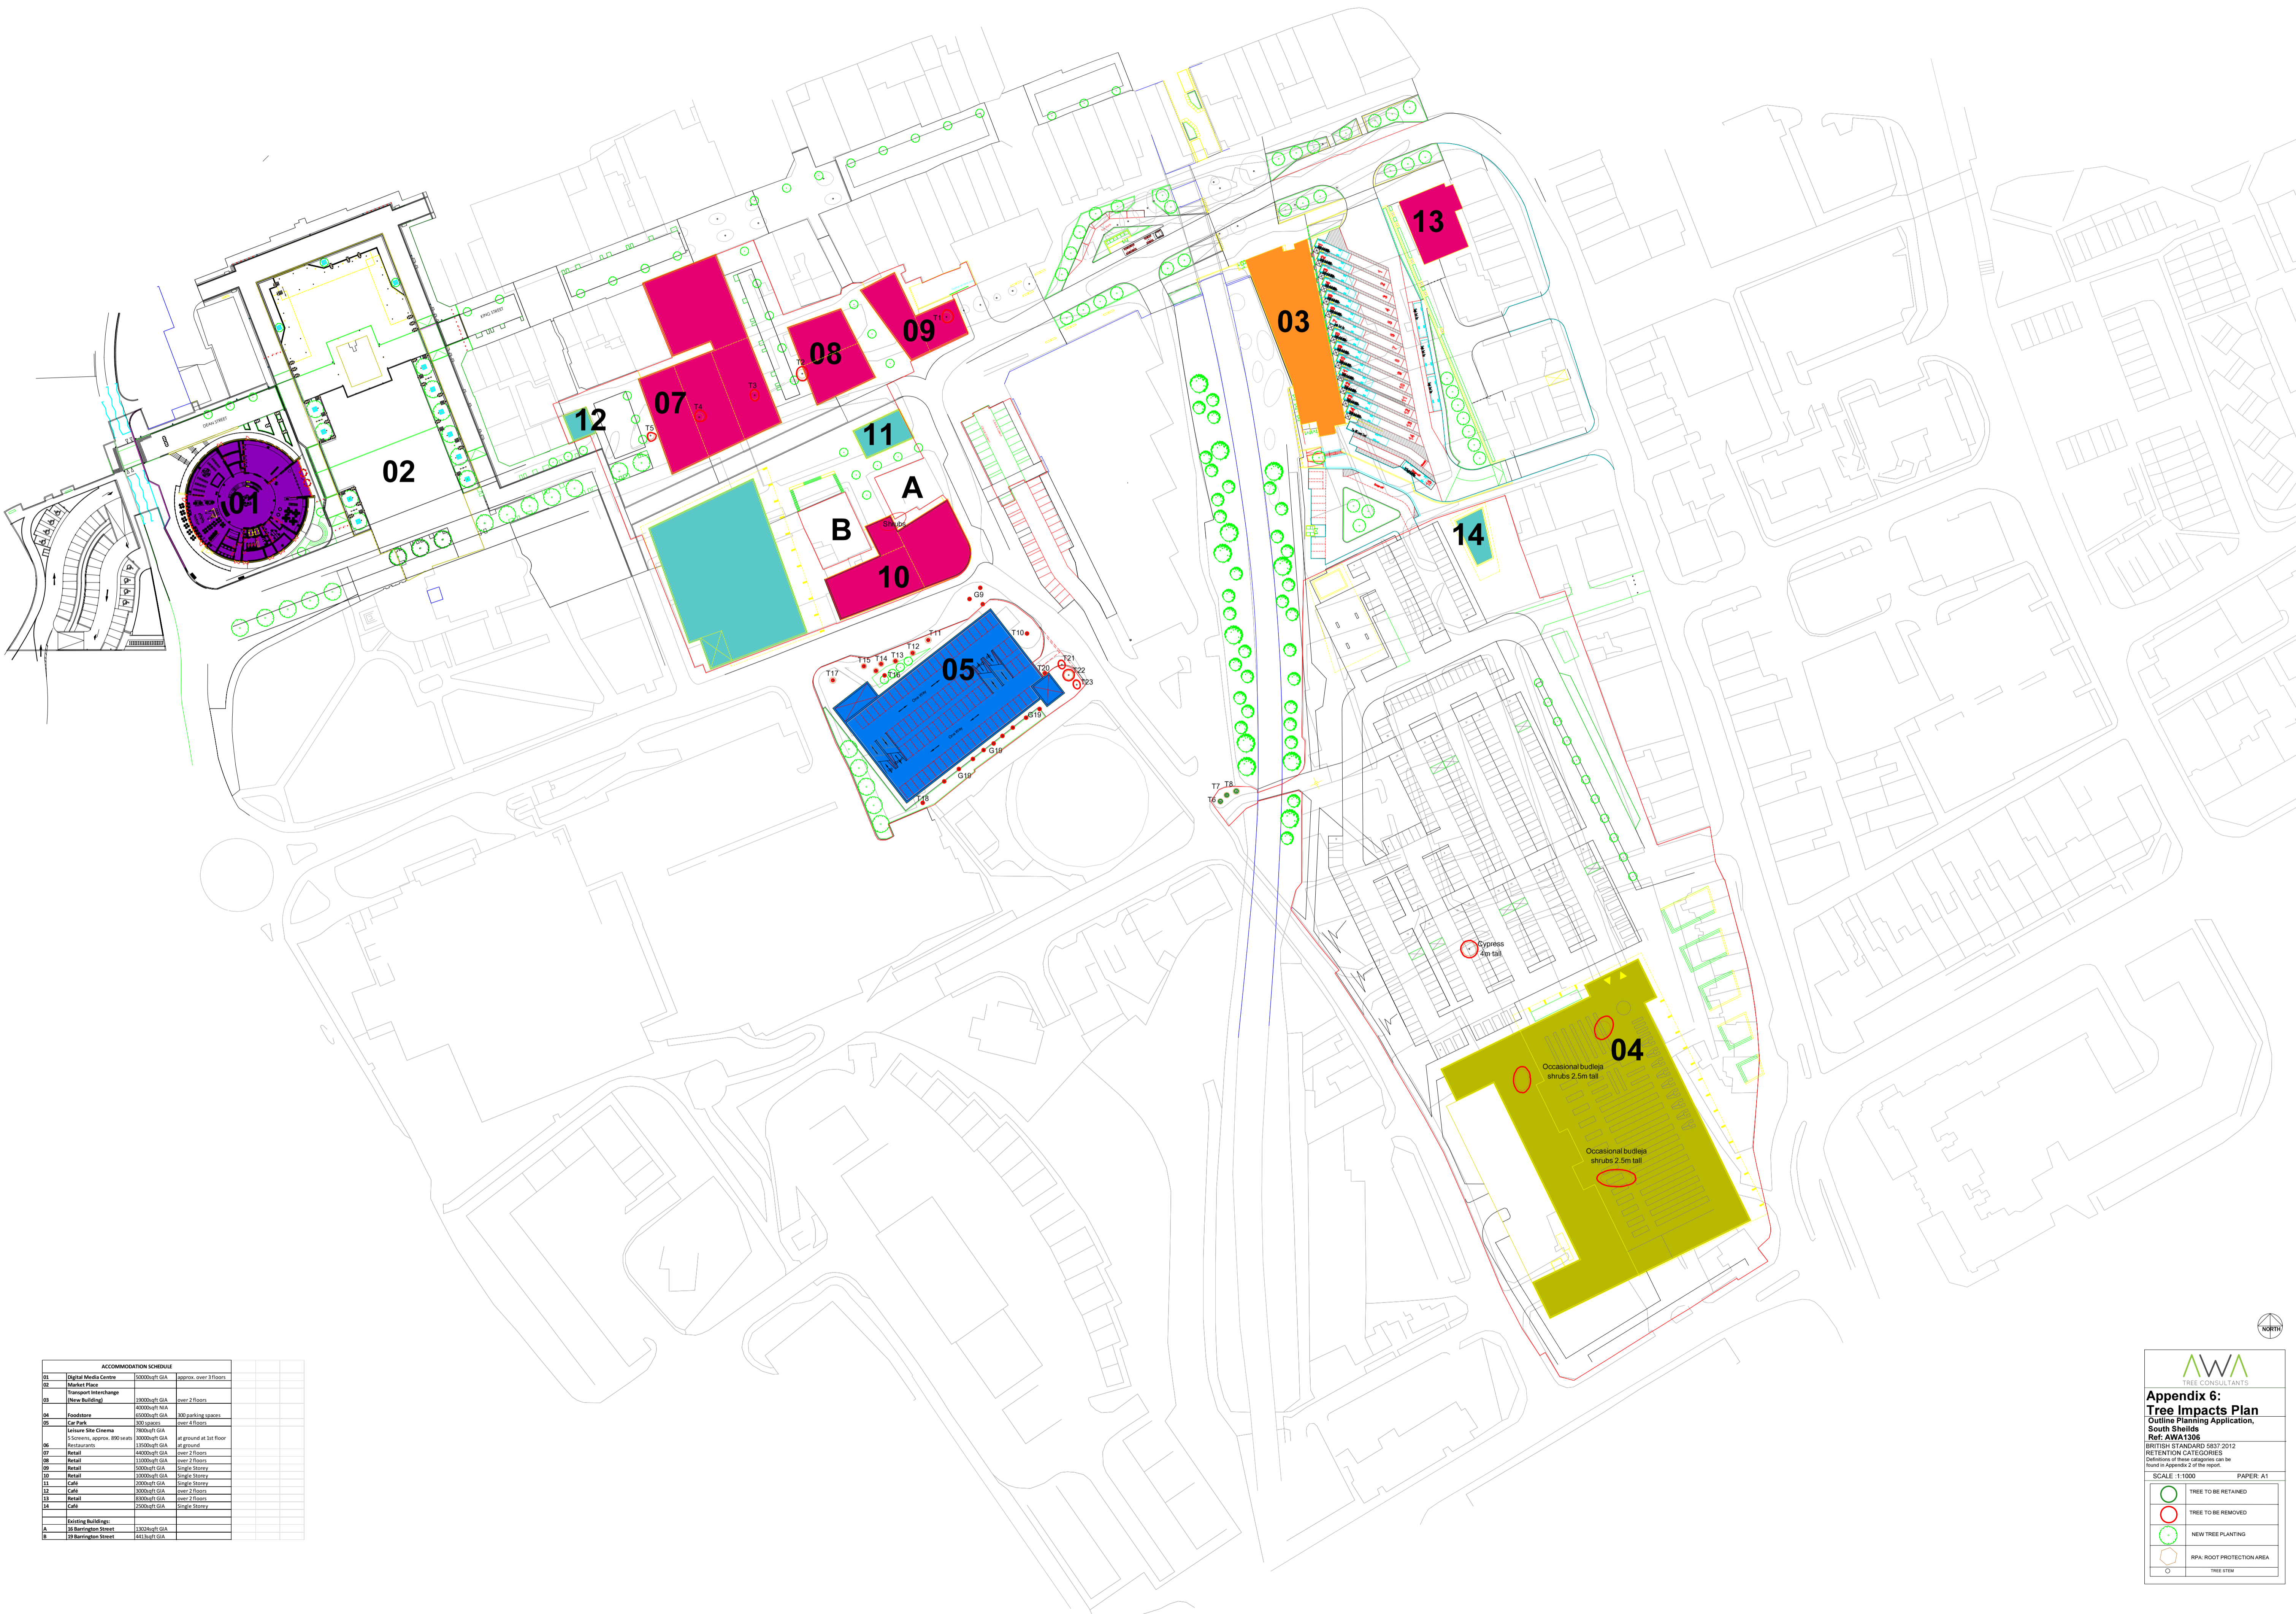
Appendix 6:
Tree Impacts Plan
 Outline Planning Application,
 South Shields
 Ref: AWA1306
 BRITISH STANDARD 5837:2012
 RETENTION CATEGORIES
Classification of trees and groups set out
 found in Appendix 2 of the report.

- 3.3.2 The proposal has been provided by my client and informs the Tree Impact Plan at appendix 6.
- 3.3.3 The redevelopment of the site will require the removal almost all of the surveyed vegetation (T1 to T5 and G9 to T23)

- 3.3.5 A small group of three recently planted Rowan trees may be able to be retained (T6, T7 & T8); however, if the trees required to be removed as part of the surrounding site works then their loss could be mitigated for by replacement planting elsewhere within the site boundaries.

- 3.3.4 It is possible that some of the better quality recently established planted trees could be re-located as part of the new landscaping scheme. Yet in general it is recommended to use the development of the site as an opportunity to replace them with better quality trees and shrubs.

- 3.3.6 While the removal of the existing trees may have some negative impact on the surrounding amenity in the short term, the new development includes extensive new tree planting of semi-mature trees that will mitigate the removals.
