# BEDE HOUSE MONKTON JARROW

## HISTORIC BUILDINGS RECORD

JUNE 2015

## Historic Buildings Recording

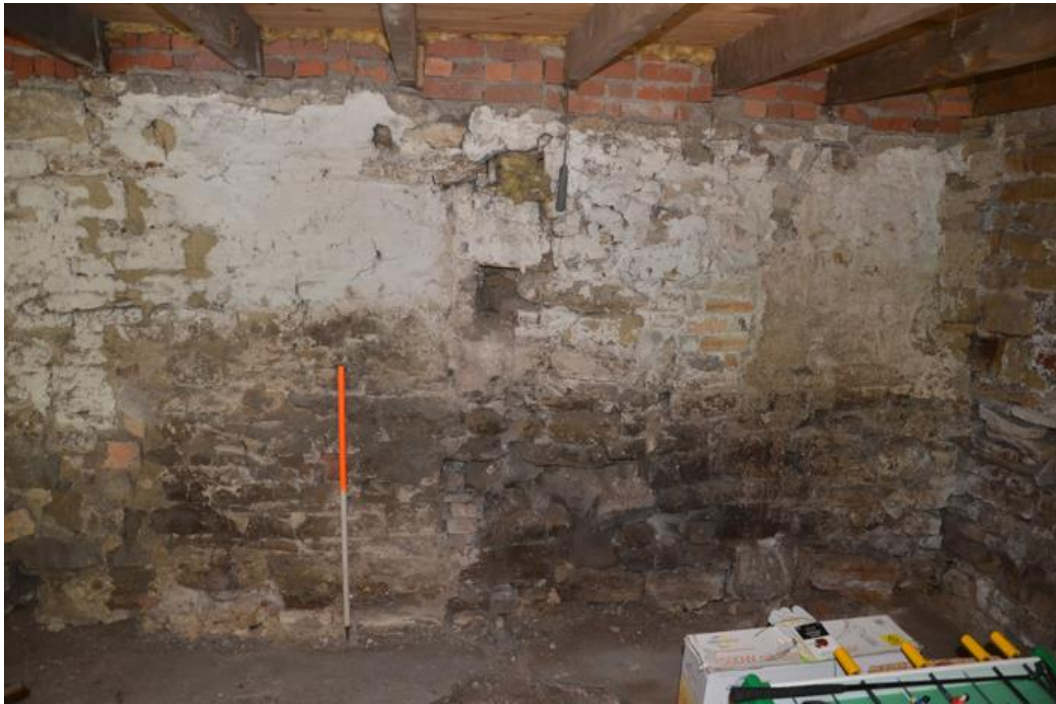
***Frontispiece:***

*The internal west part of the north elevation of the Western Annexe South Wall.*

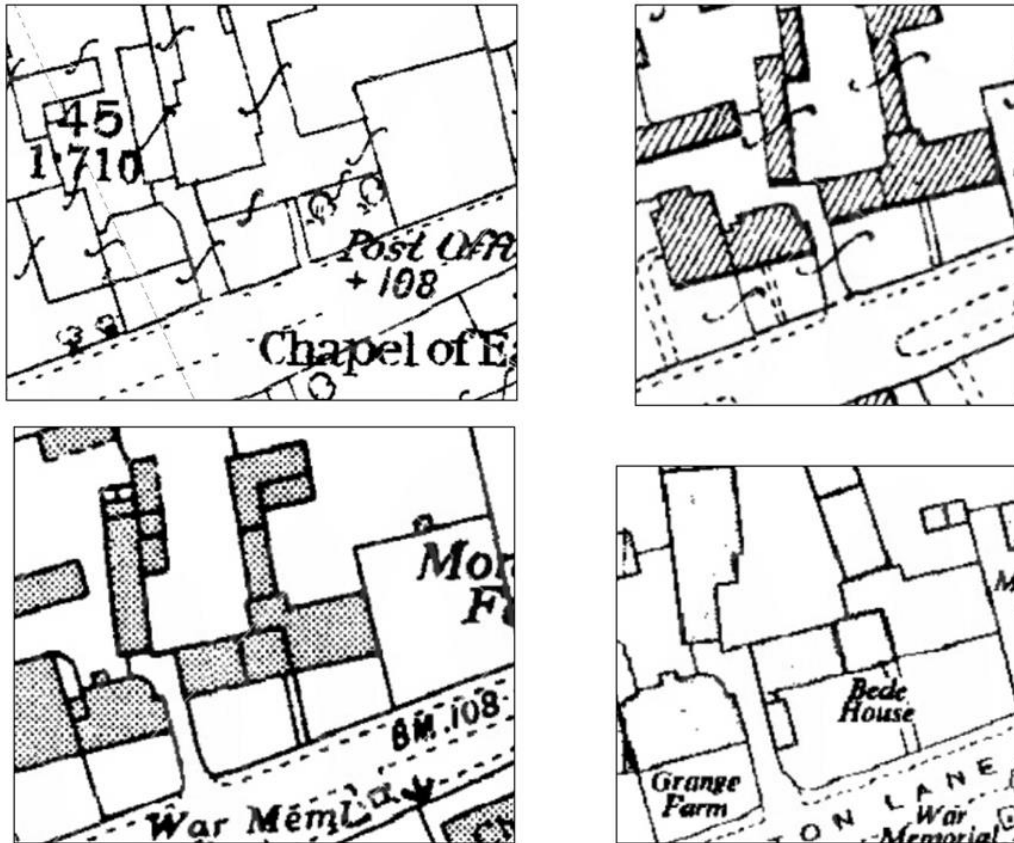
*Illus. 04-07:  
Extracts from Historic Ordnance Survey Plans of Bede House in Monkton.  
(clockwise from top left – 1870s, 1890s, 1940s & 1970s).*

The 1<sup>st</sup> edition and 2<sup>nd</sup> editions of the Ordnance Survey 25":1 mile map of 1873 and 1897 respectively show the outline of the building much as at present; the 1916 map

shows a small structure added to the west end of the south wall; this is absent on the 1941 edition but a similar construction, this time just detached from the main building, is shown in 1958. Both the 1841 and 1958 maps show the main stable divided into two approximately on the line of the present 1980s brick transverse wall.
