**BAT SURVEY &
SITE RISK ASSESSMENT
FOR BUILDINGS AT 51 SUNDERLAND ROAD
CLEADON**

Veronica Howard, BSc (Hons), PhD, MCIEEM
September 2014

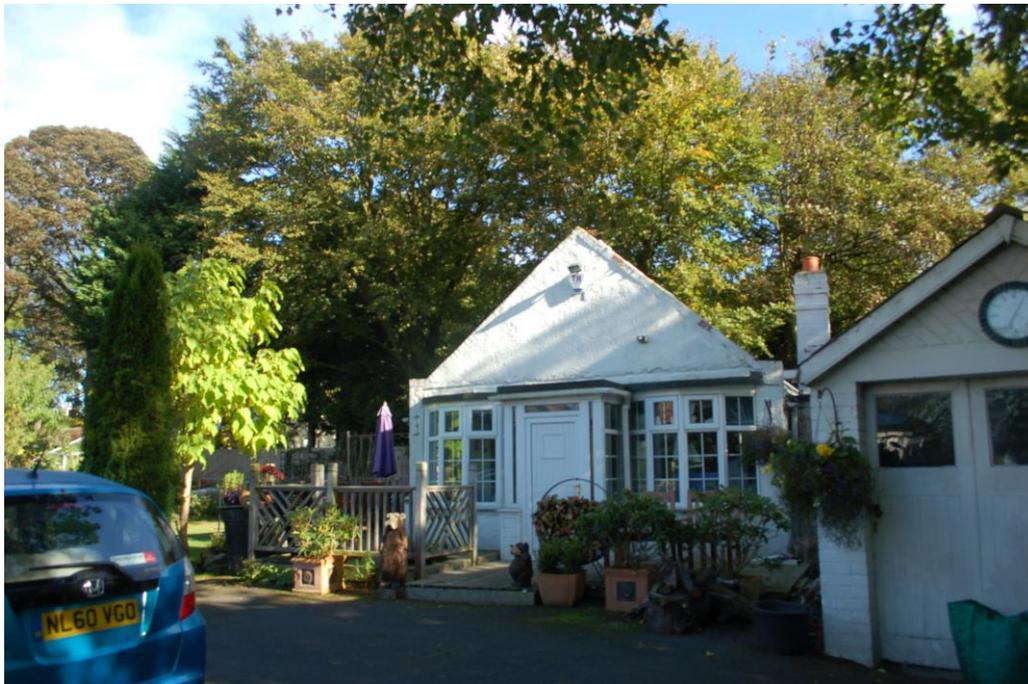
Front elevation

- 1.3 **Building 1** is a single storey summer house with rendered and painted walls and a pitched pantile roof. The whole building is in a good state of repair. There are no cracks or crevices in the walls, at the wall tops or around the window or door frames and no gaps could be seen under the pantiles.

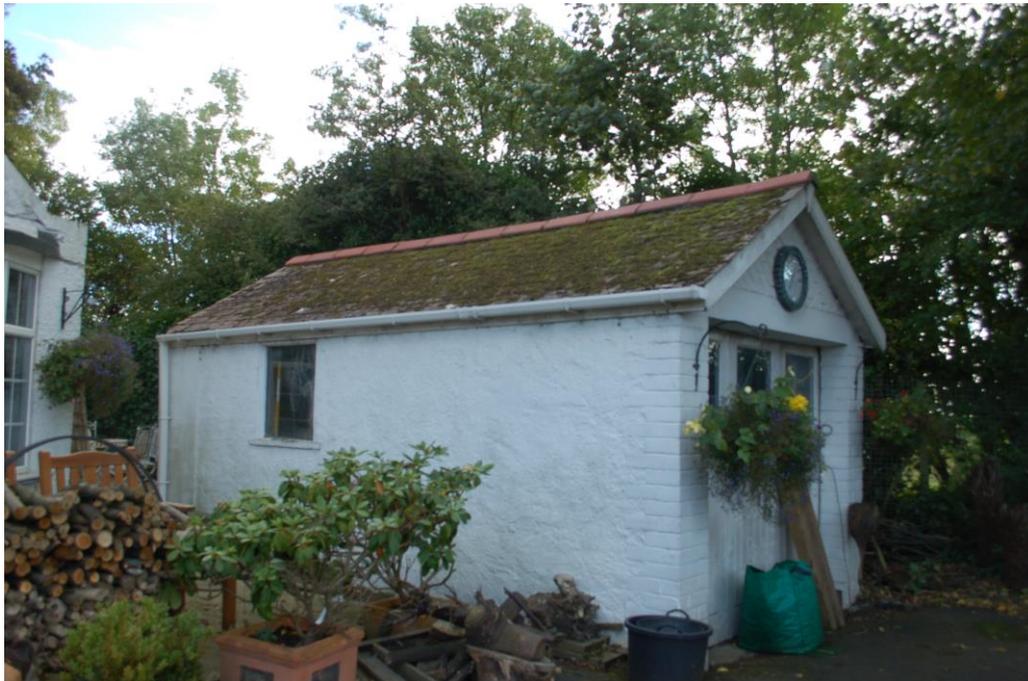
Garage

- 1.5 **Building 2** is a single storey garage with rendered and painted walls and a slate roof. It is in a very good state or repair with no crevices in the walls or gaps under the slates.
