Arboricultural Tree Survey Report

Mr. G. Lawton
6 Whitburn Road,
Cleadow,
South Tyneside,
SR6 7QL

Date: 19/07/2015

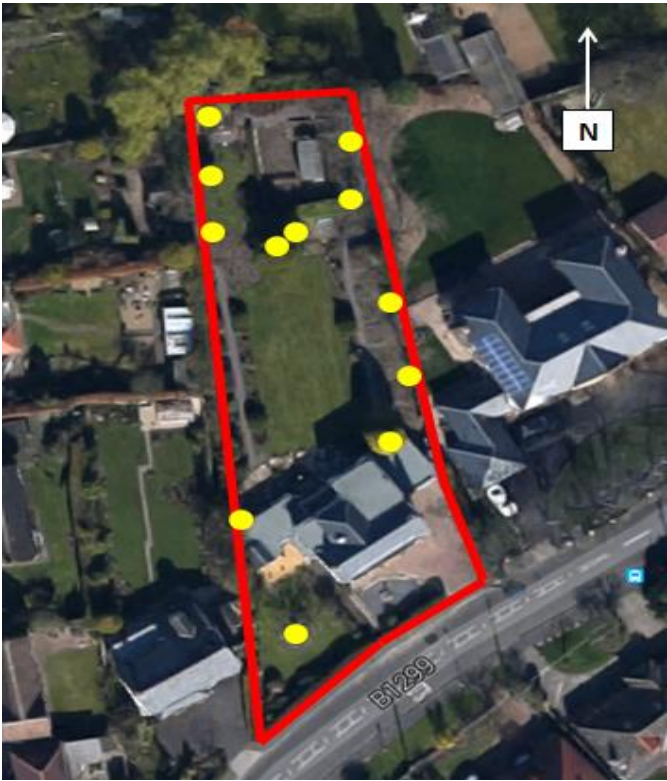
5a). Site Map – Tree Locations (Prior to tree work operations)

Map Key	
	Property Boundary	—
Tree Position	●	
General Information		
<p>In total 12 trees were surveyed, 1 tree in the front garden and 11 in the rear garden.</p> <p><u>Tree Species Status:</u> 8 trees are UK native species that are very common in both the wild and in gardens. The remaining 4 trees are non UK native species, but very common in gardens throughout the UK.</p> <p><u>Tree Health Details:</u> 9 trees are in good health, 1 in reasonable health & 2 trees in decline.</p> <p><u>Tree Work Programme:</u> 5 trees require remedial work & the remaining 7 trees should be felled.</p>

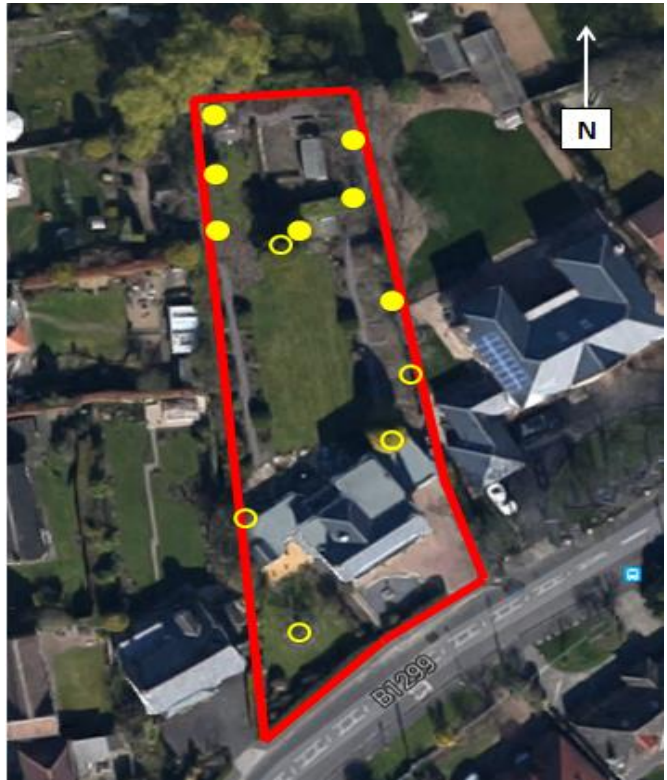
5b). Site Map – Tree Locations (After tree work operations)

Map Key	
	Property Boundary	—
	Tree Position	●
Tree Removal	○	
General Information		
<p>The map shows that 5 trees have been removed following my recommendations from my first tree survey.</p> <p>All the trees (4) within the immediate vicinity of the building have been removed.</p> <p>1 tree positioned near the rear of the garden has also been removed.</p>

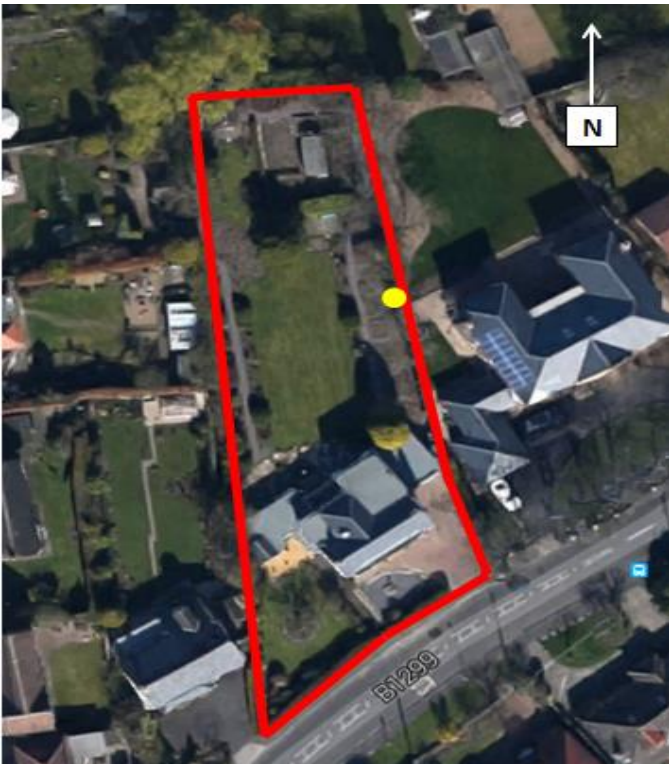
5c). Site Map – Tree Locations (Trees that could be affected due to the proposed construction plan)

Map Key	
	Property Boundary	 
	Tree Position	 
General Information		
<p>The map shows that 1 tree (No. 8) that was surveyed could be affected by the proposed design, demolition & construction.</p> <p>There are many other shrubs & plants that will be affected by the proposed design, demolition & construction due to their vicinity to the property, but as discussed with Greg Lawton, none of these will be kept so no protection recommendations are required.</p>

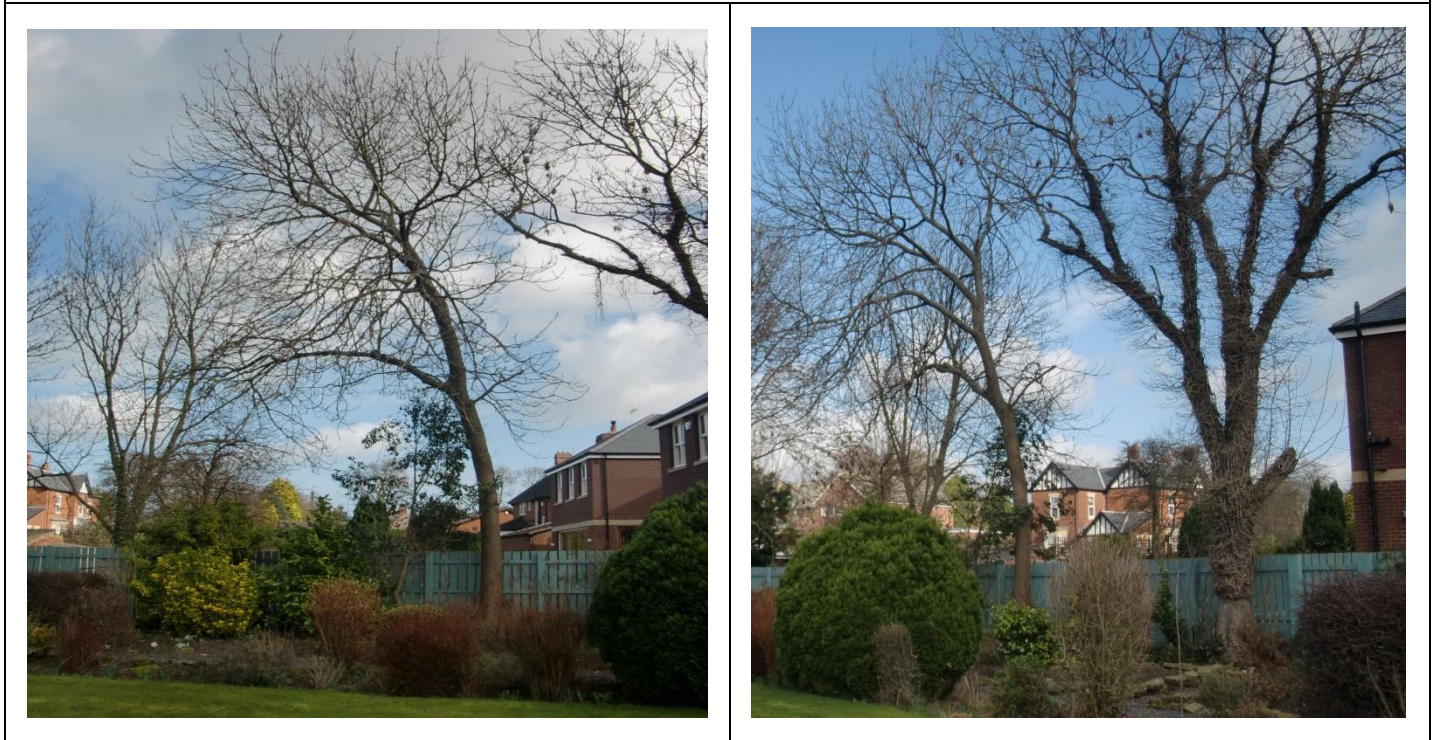
Images

Tree 8	Common Ash							<i>Fraxinus excelsior</i>								
Height (m)	12	Crown Spread (m)	N	7	E	1	S	2	W	7	DBH (cm)	40	Age Class	SM	S.U.L.E	4C

From the information shown in the previous section, there is 1 tree that could be affected by the proposed design, demolition & construction process. The client wants to retain this tree, due to the location of this tree in relation to the proposed construction plans it must be protected to prevent any untoward damage occurring to both the underground root system & the above ground structure.

Based on the survey data that I collected, this tree must have a protection area set out at a minimum diameter of 4.8m (2.4m measurement from all around the tree trunk). This area must be set out within the construction plans so all site workers are aware of the protection requirements & constraints this will place on any site works near to this tree.

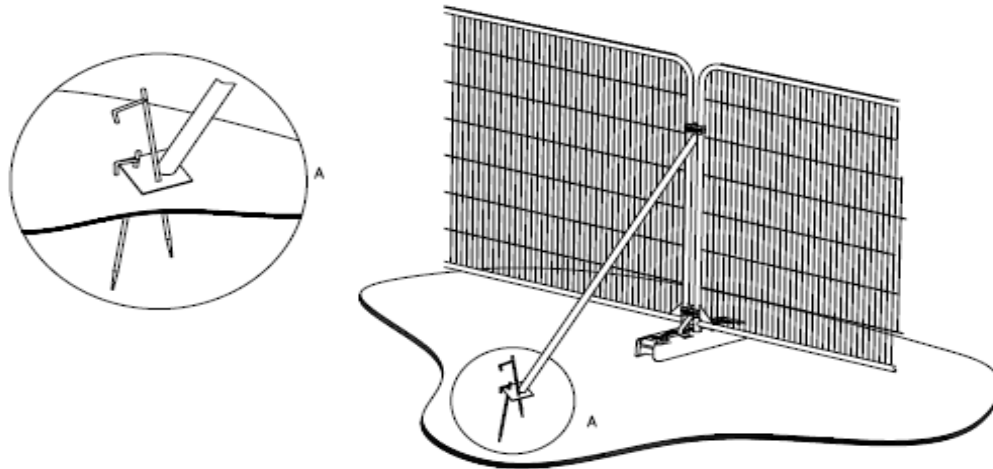
Temporary Protective Systems using 2m tall galvanized steel fence on rubber feet

1. Stabiliser strut with base plate secured with ground pins.

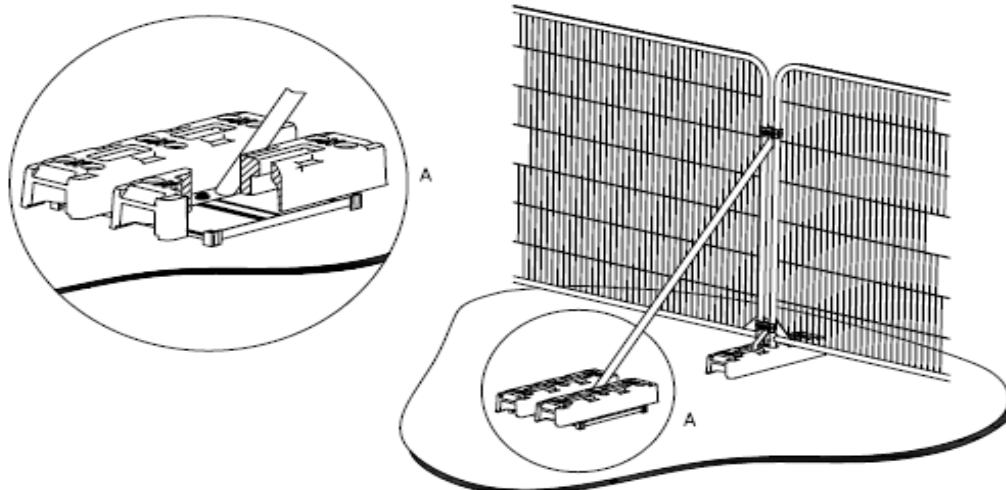
2. Stabiliser strut mounted on block tray.
