**BAT SURVEYS &
RISK ASSESSMENT
6, WHITBURN ROAD
CLEADON**

Veronica Howard, BSc (Hons), PhD, MCIEEM
August 2015

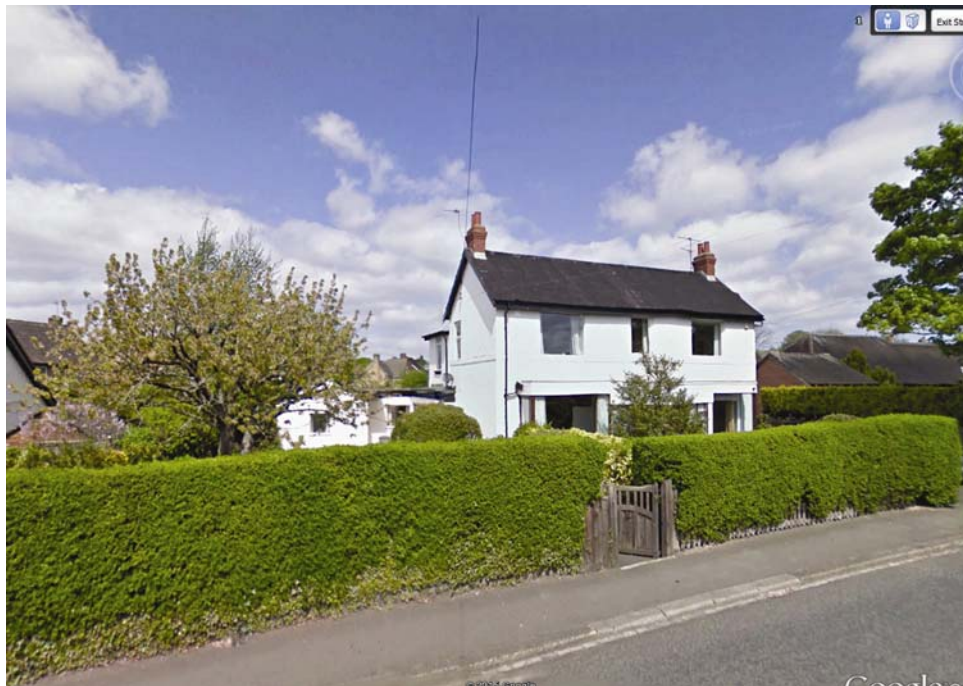
1.4 The exterior of the building is in a very good state of repair with no cracks or crevices in the walls or at the wall tops. All sections of the roof are in a good state of repair. There are no gaps under any of the barge boards and all such trims are made of plastic.

Front elevation

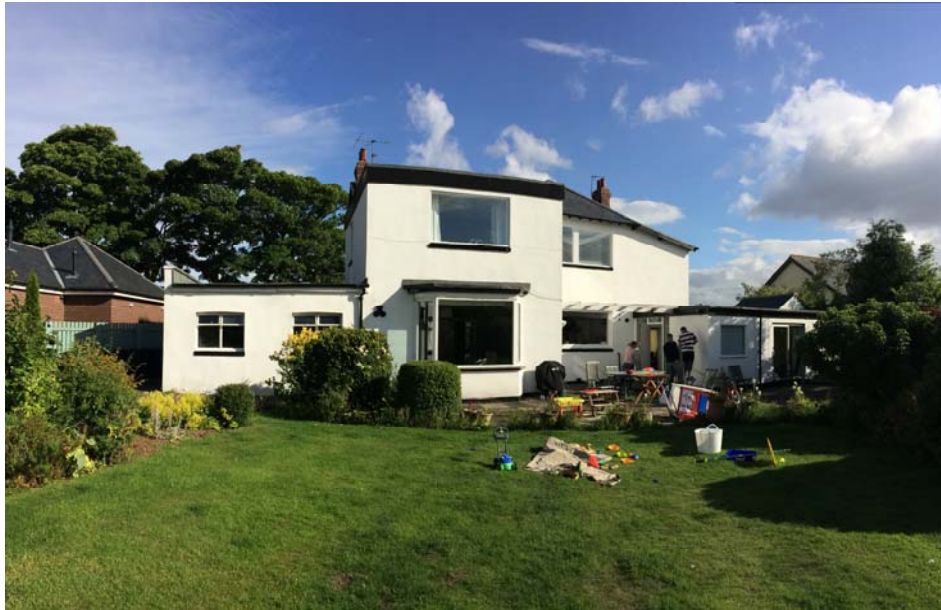
Rear elevation
