**BAT SURVEY &
RISK ASSESSMENT
FOR 21 SUNDERLAND ROAD
CLEADON**

Veronica Howard, BSc (Hons), PhD, MCIEEM
July 2015

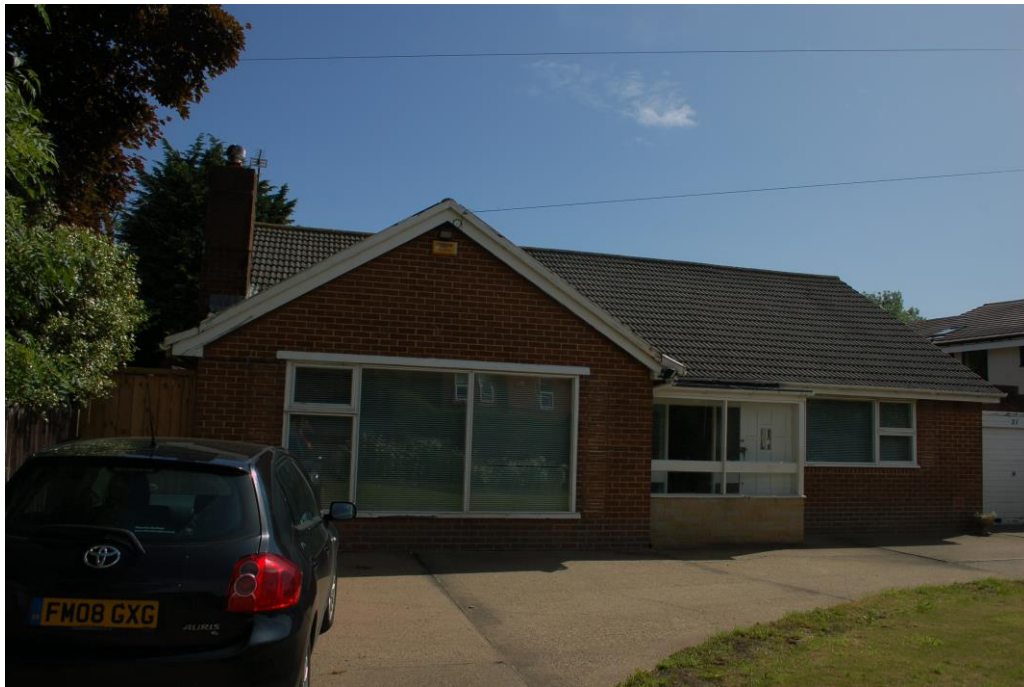
Front elevation

- 1.4 The exterior of the building is in a very good state of repair with no cracks or crevices in the brickwork or around the window or doors frames. The roof is also in a good state of repair and no gaps could be seen in the roof lining. The loft space is very dusty with cobwebs covering the roof timbers and the underside of the lining. The small extension on the back elevation is also in a good state of repair externally with no gaps under the roofing felt.
- 1.5 There are other properties to either side of the bungalow and a very busy road to the west side.

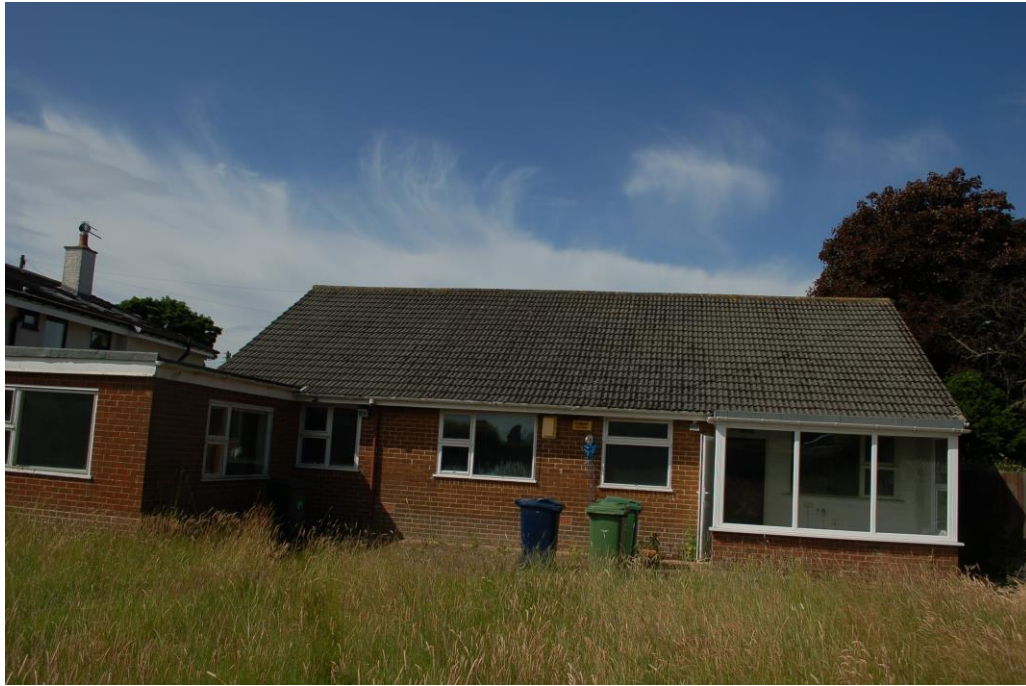
Back elevation

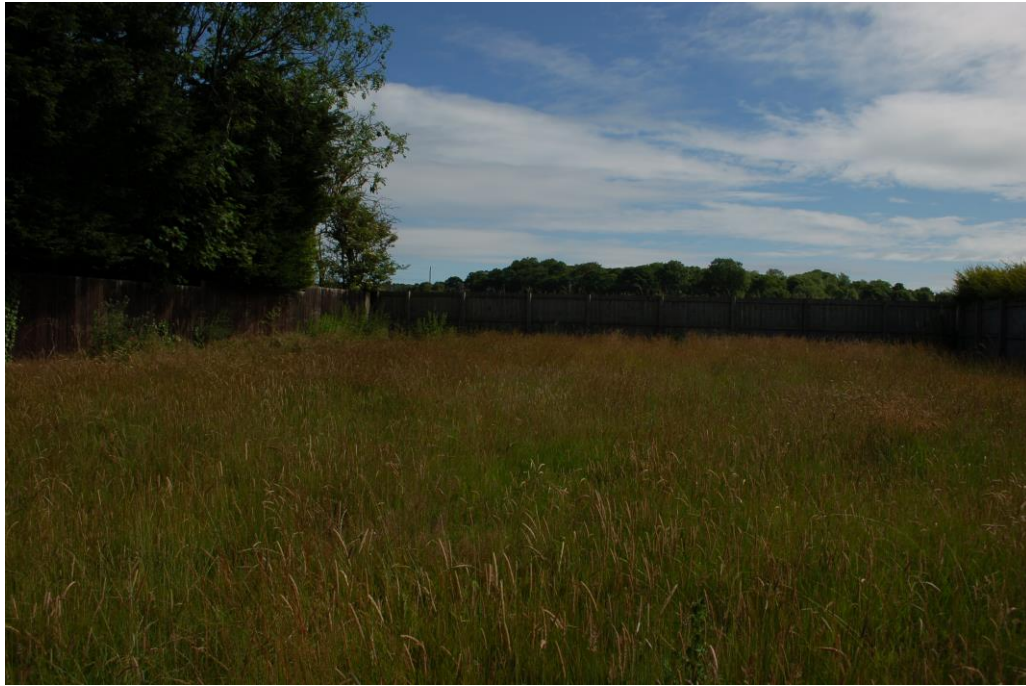
- 1.6 Both the back and front gardens of 21 Sunderland Road have been laid to lawn. The lawn at the front of the property has been regularly mown but the back lawn remains un-mown. This lawn is dominated by perennial rye grass and common bent grass and has very limited plant species diversity. There are no trees in either garden, though some branches do overhang the fence on the north side. The back garden is surrounded by a high wooden fence.

Back garden with unmanaged lawn and overhanging trees
