Willmott Dixon Construction Limited

Hebburn Community Hub – Multi-Use Game Area

Verification report

321447-R3 (00)

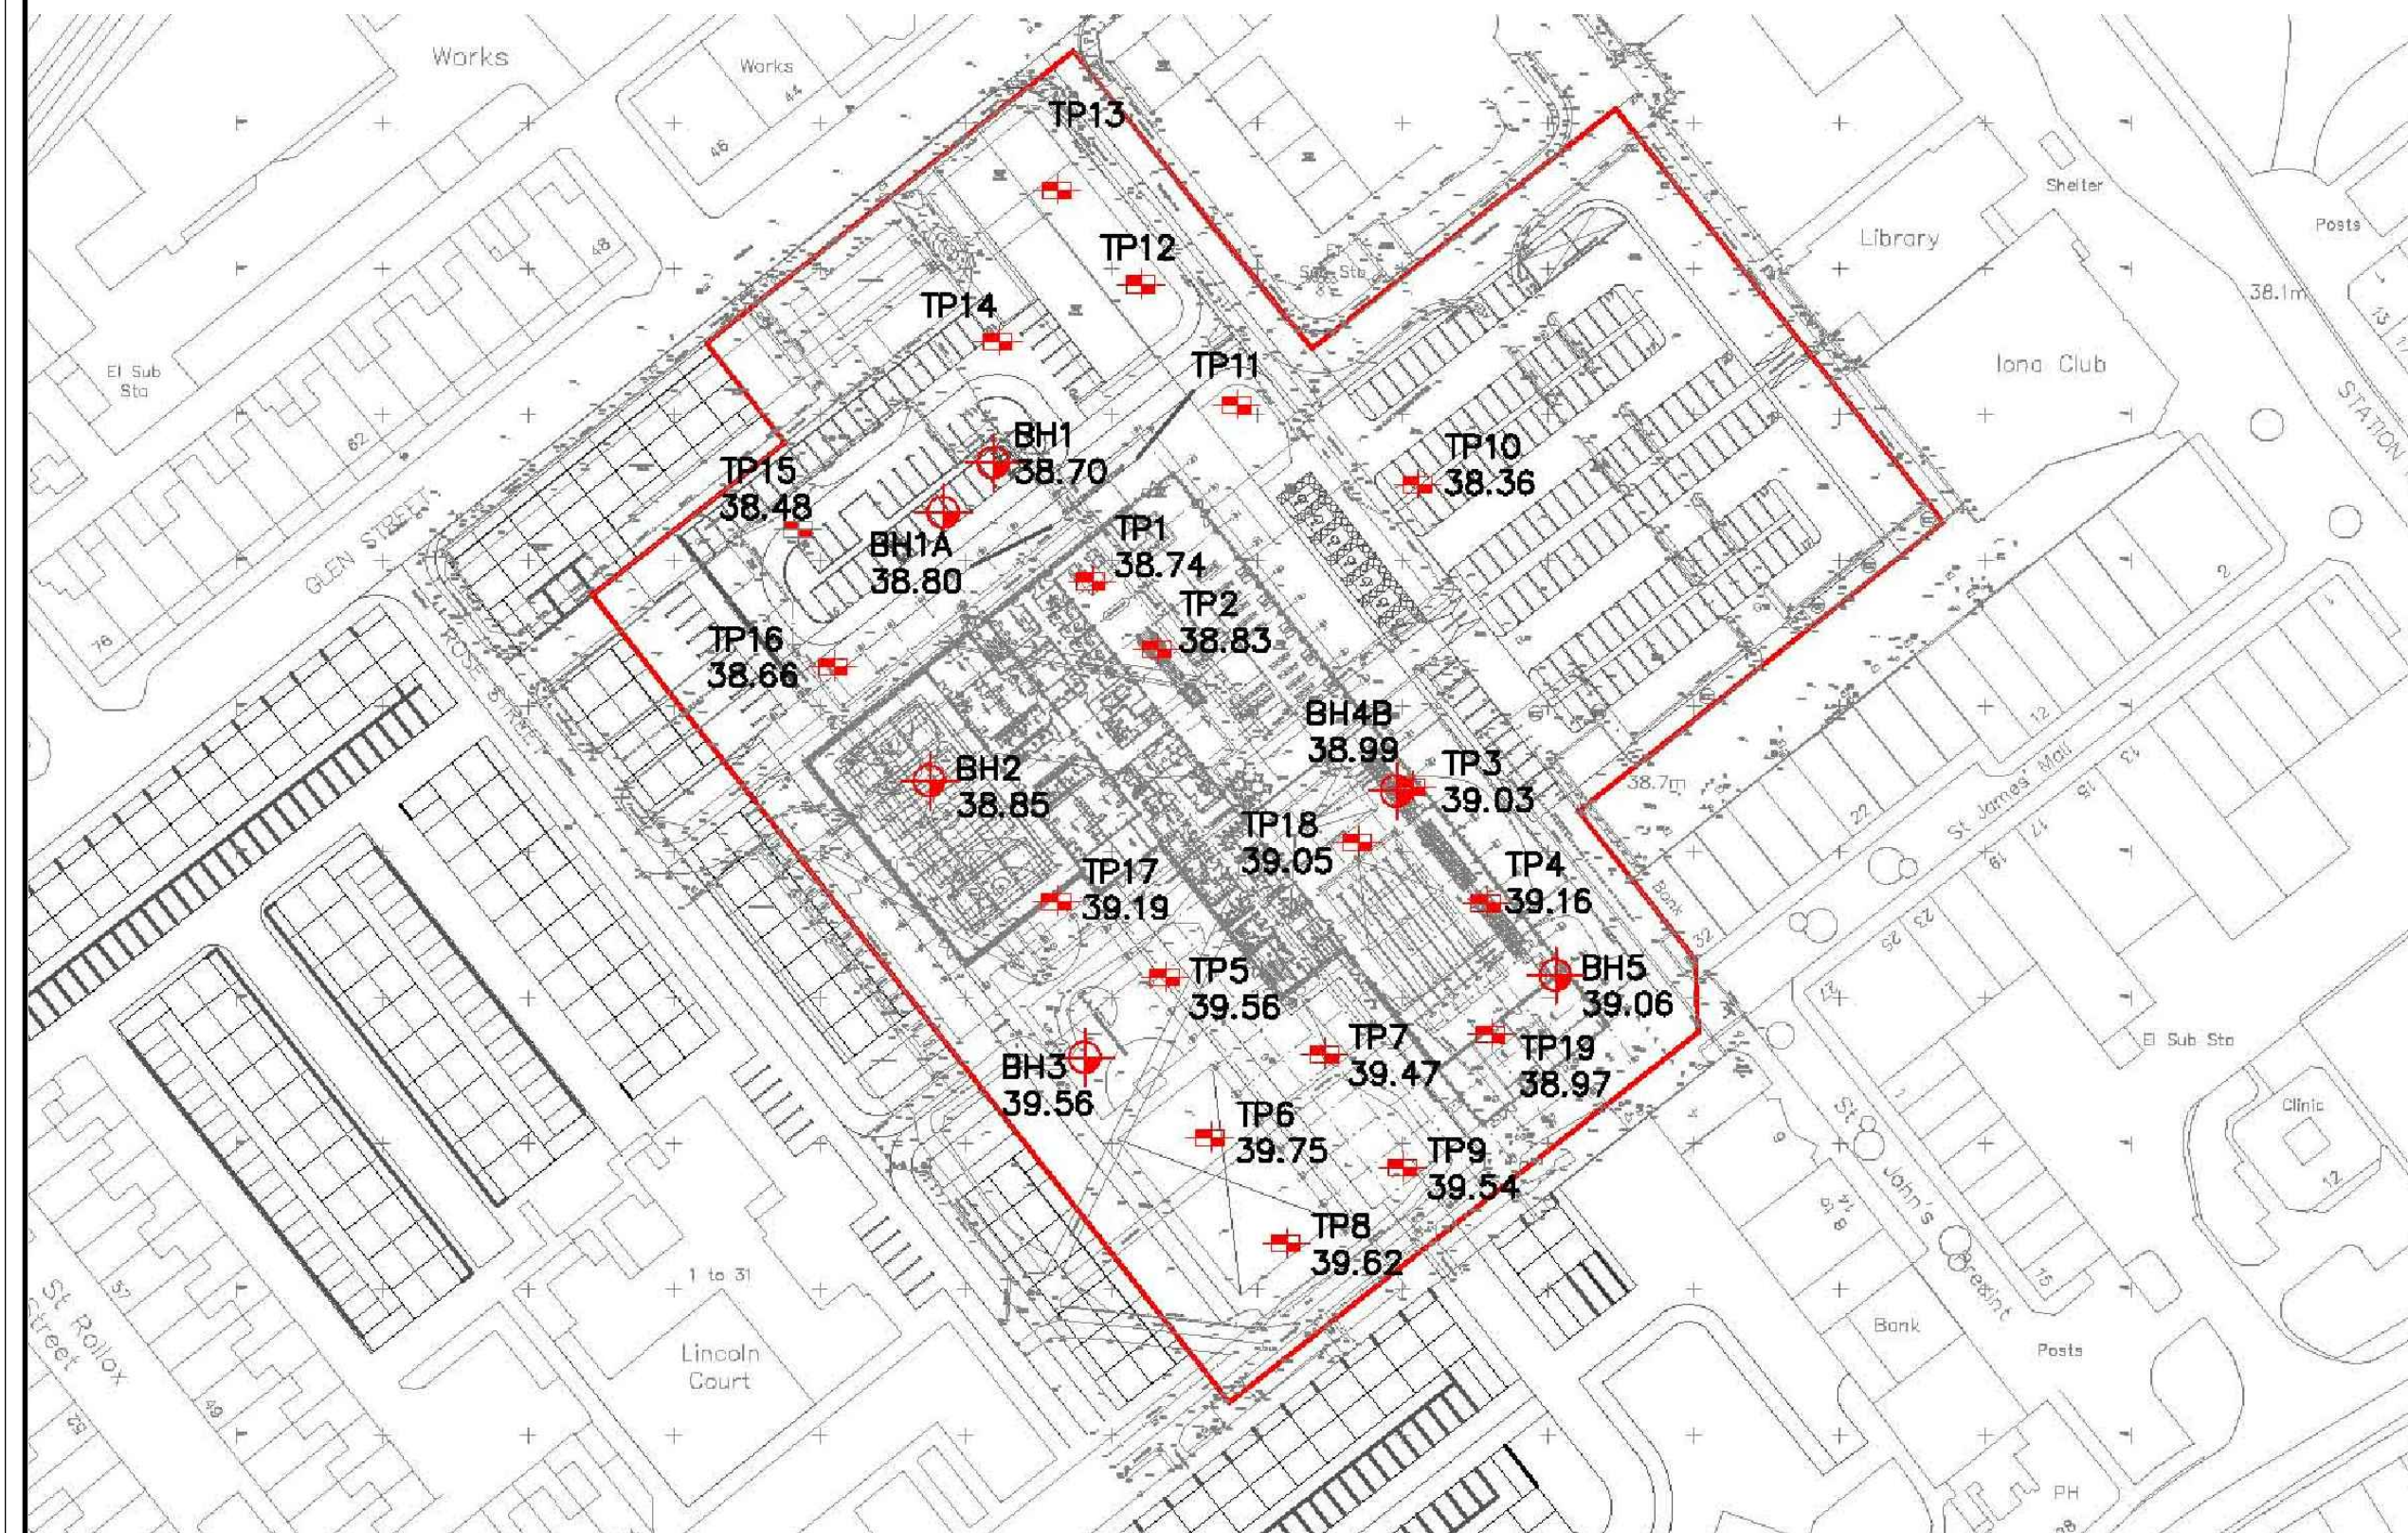
BY:	DATE:	CONTRACT NO.:	REV:
HD	01.12.14		FIGURE 2 A

The CSM is a key tool to enable linkages between contaminant sources, pathways, and receptors to be assessed in accordance with the CLR11⁽³⁾ procedures. Where exploratory hole locations from the preceding phases of work are referenced, their locations on site are presented on Figure 2 (this figure is from the Ian Farmer Association report⁽¹⁾ May 2013).

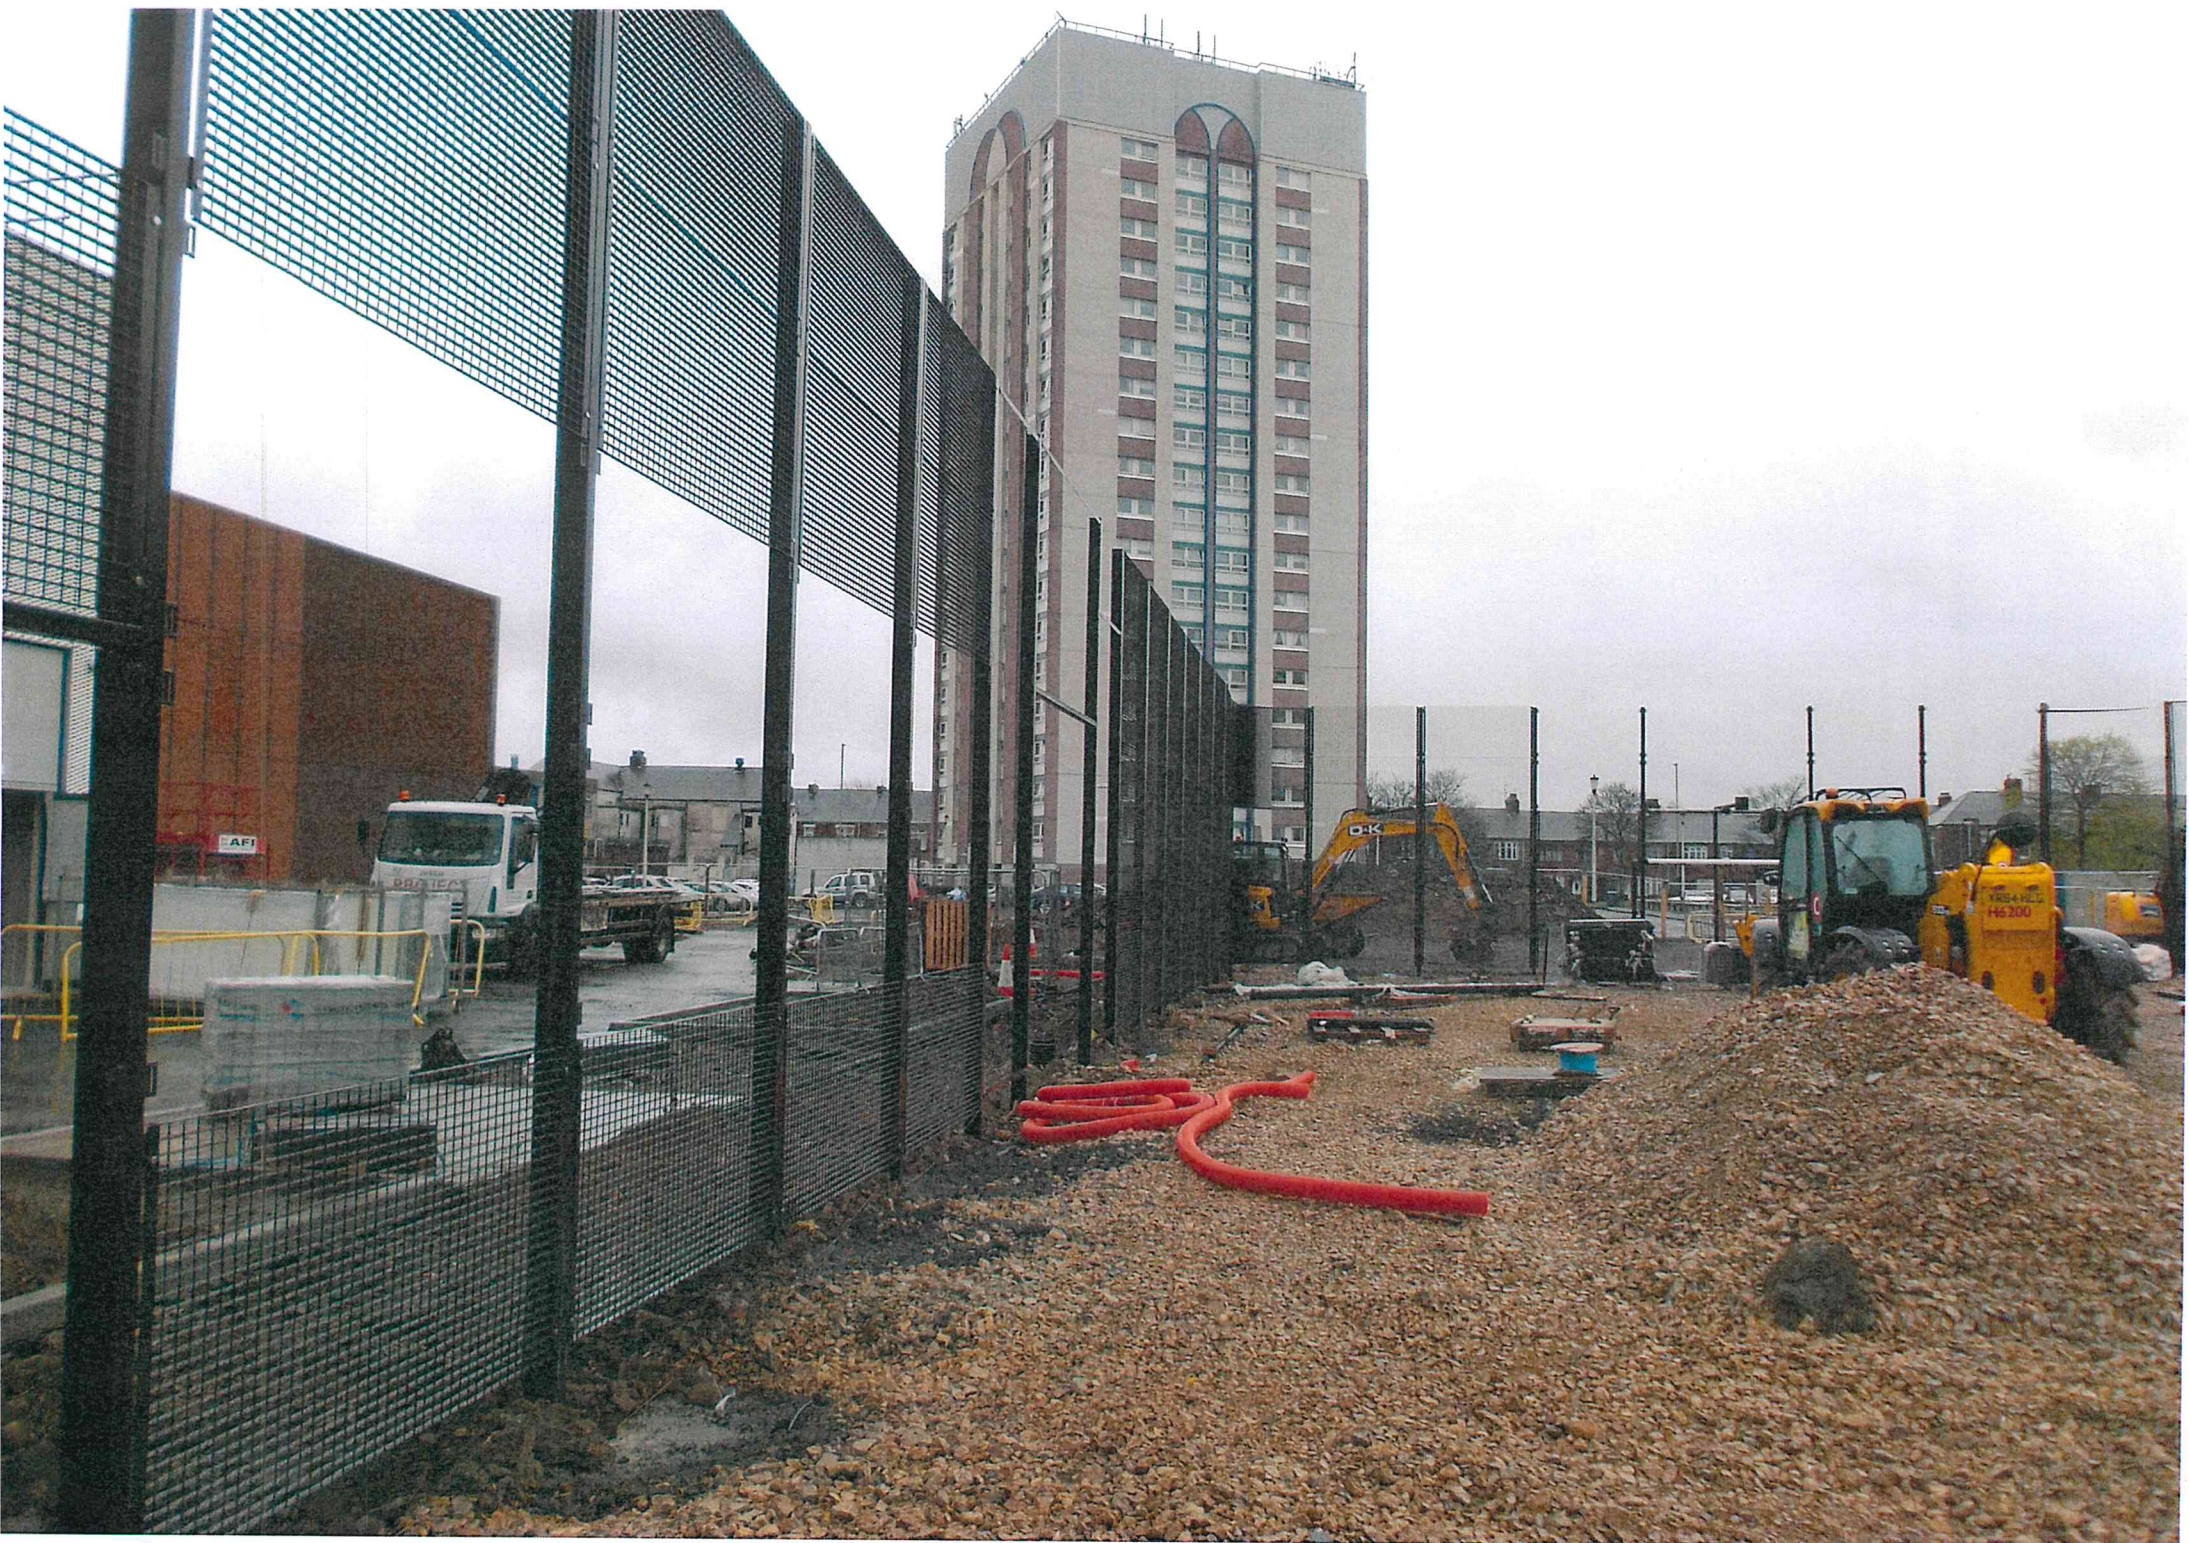
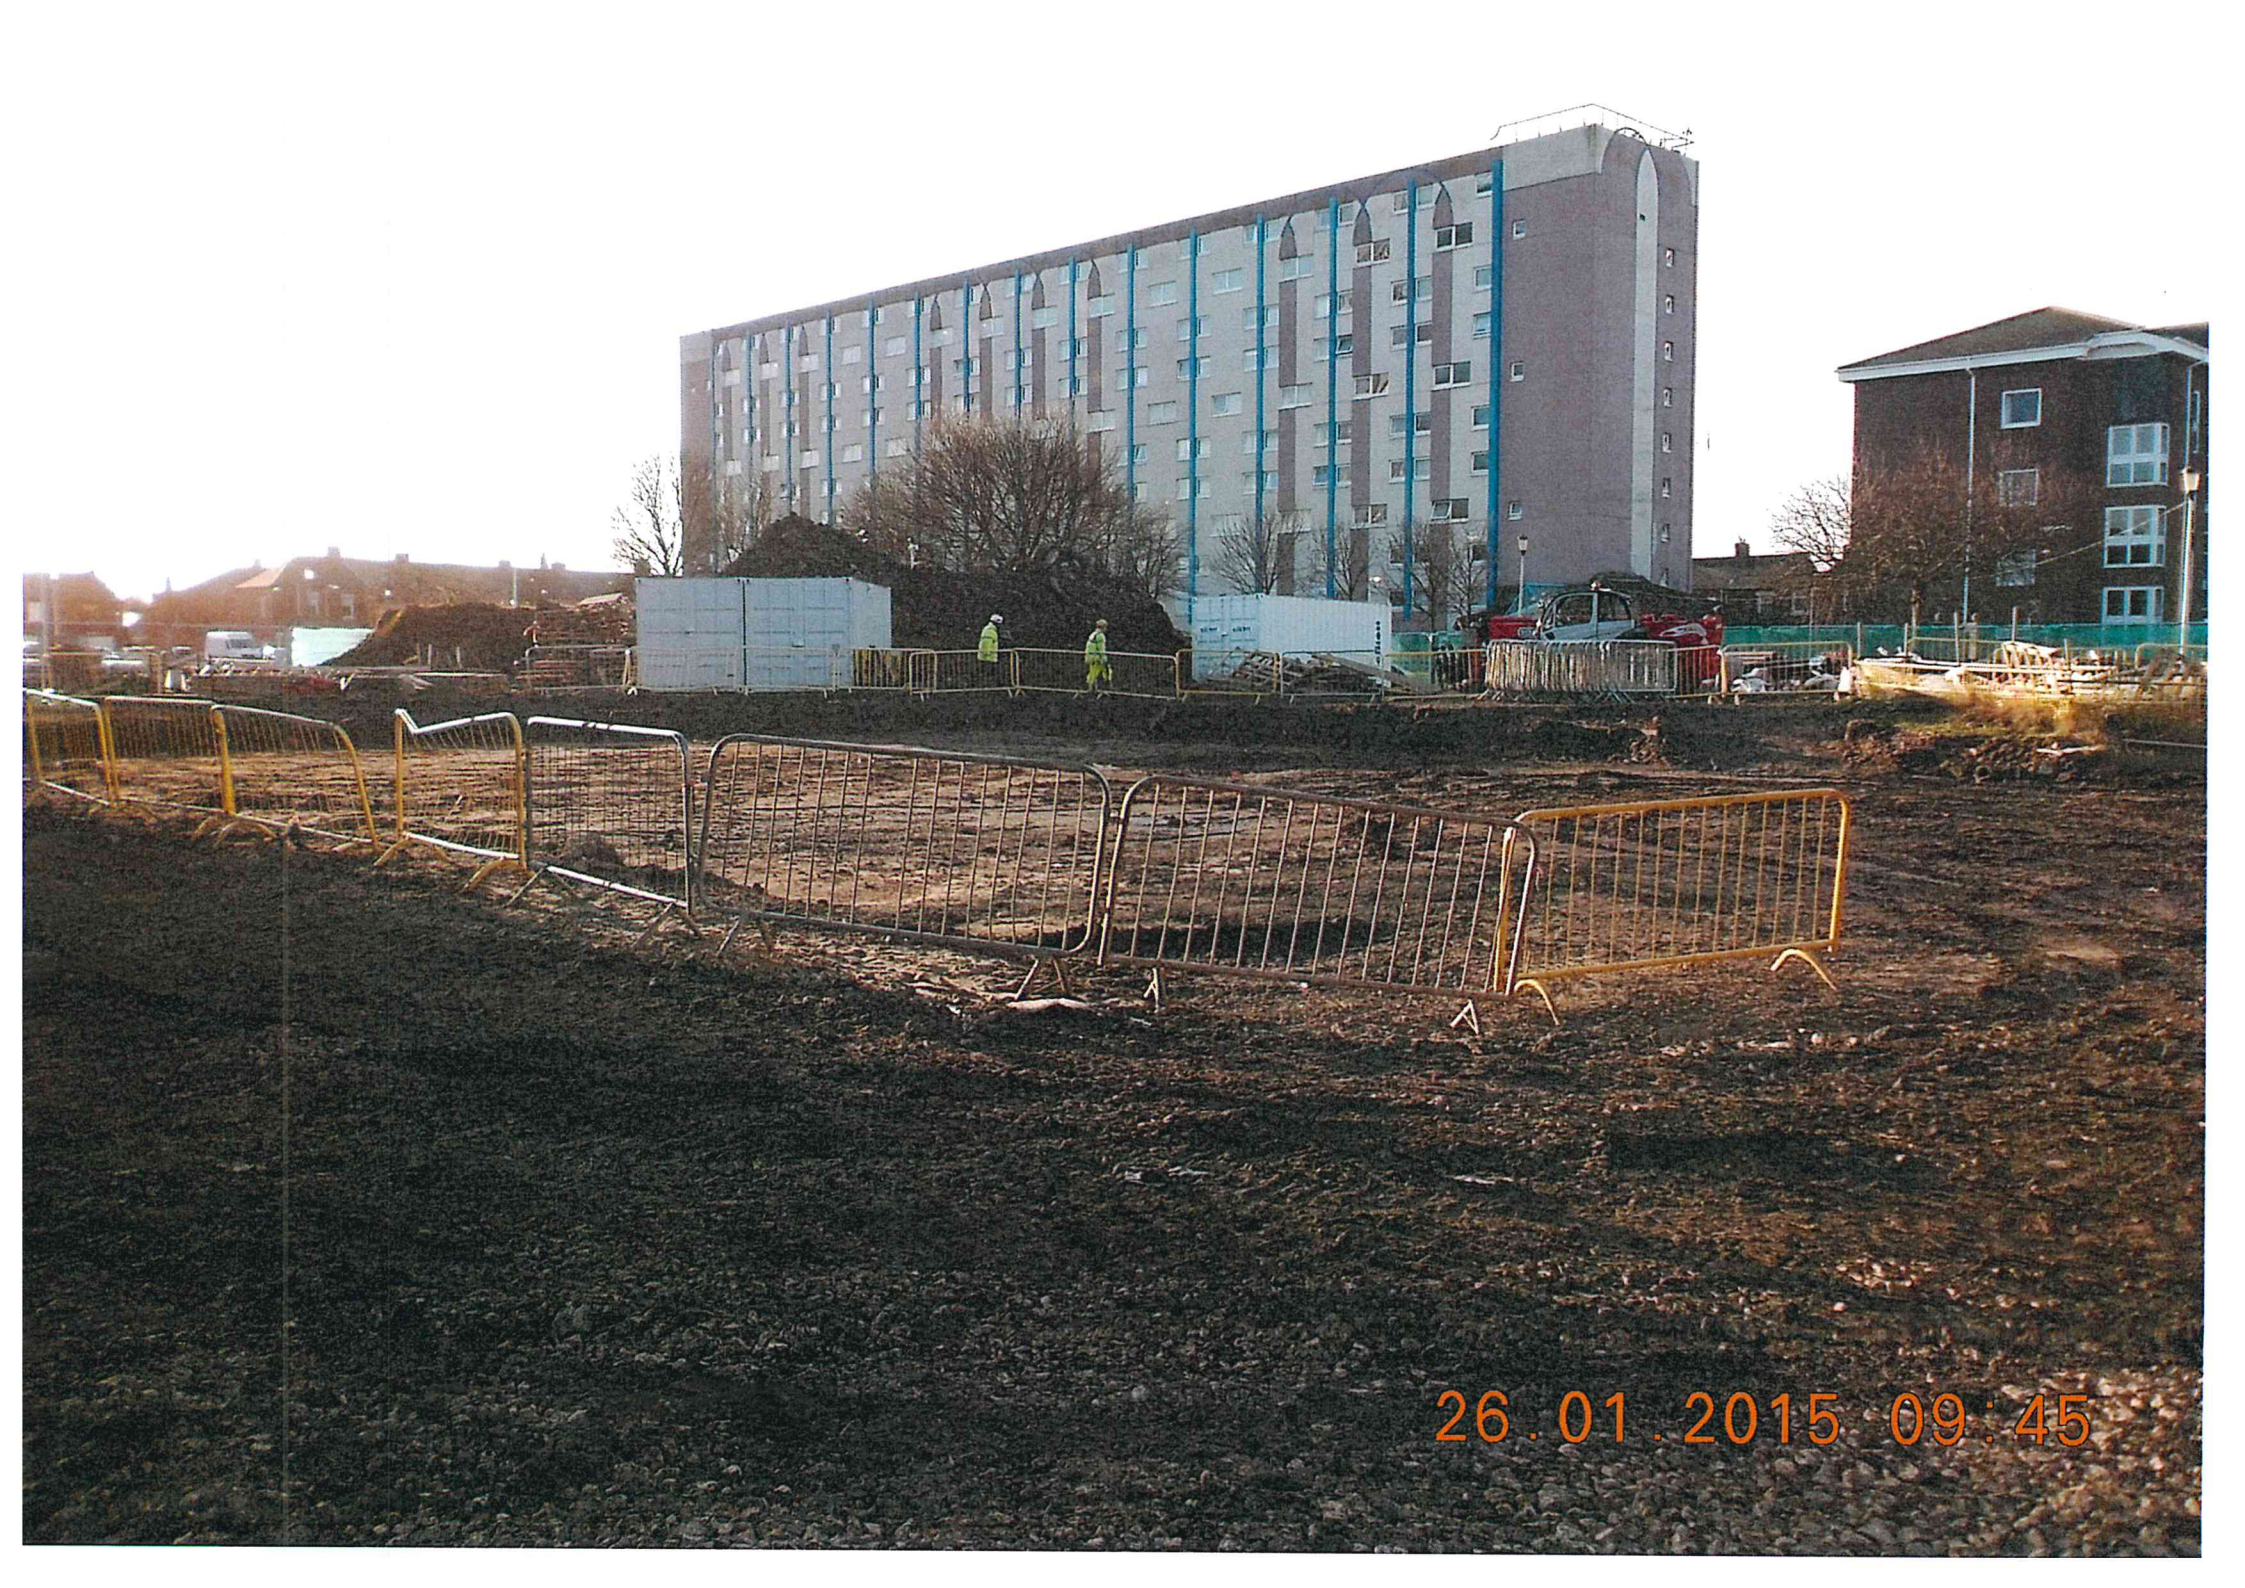
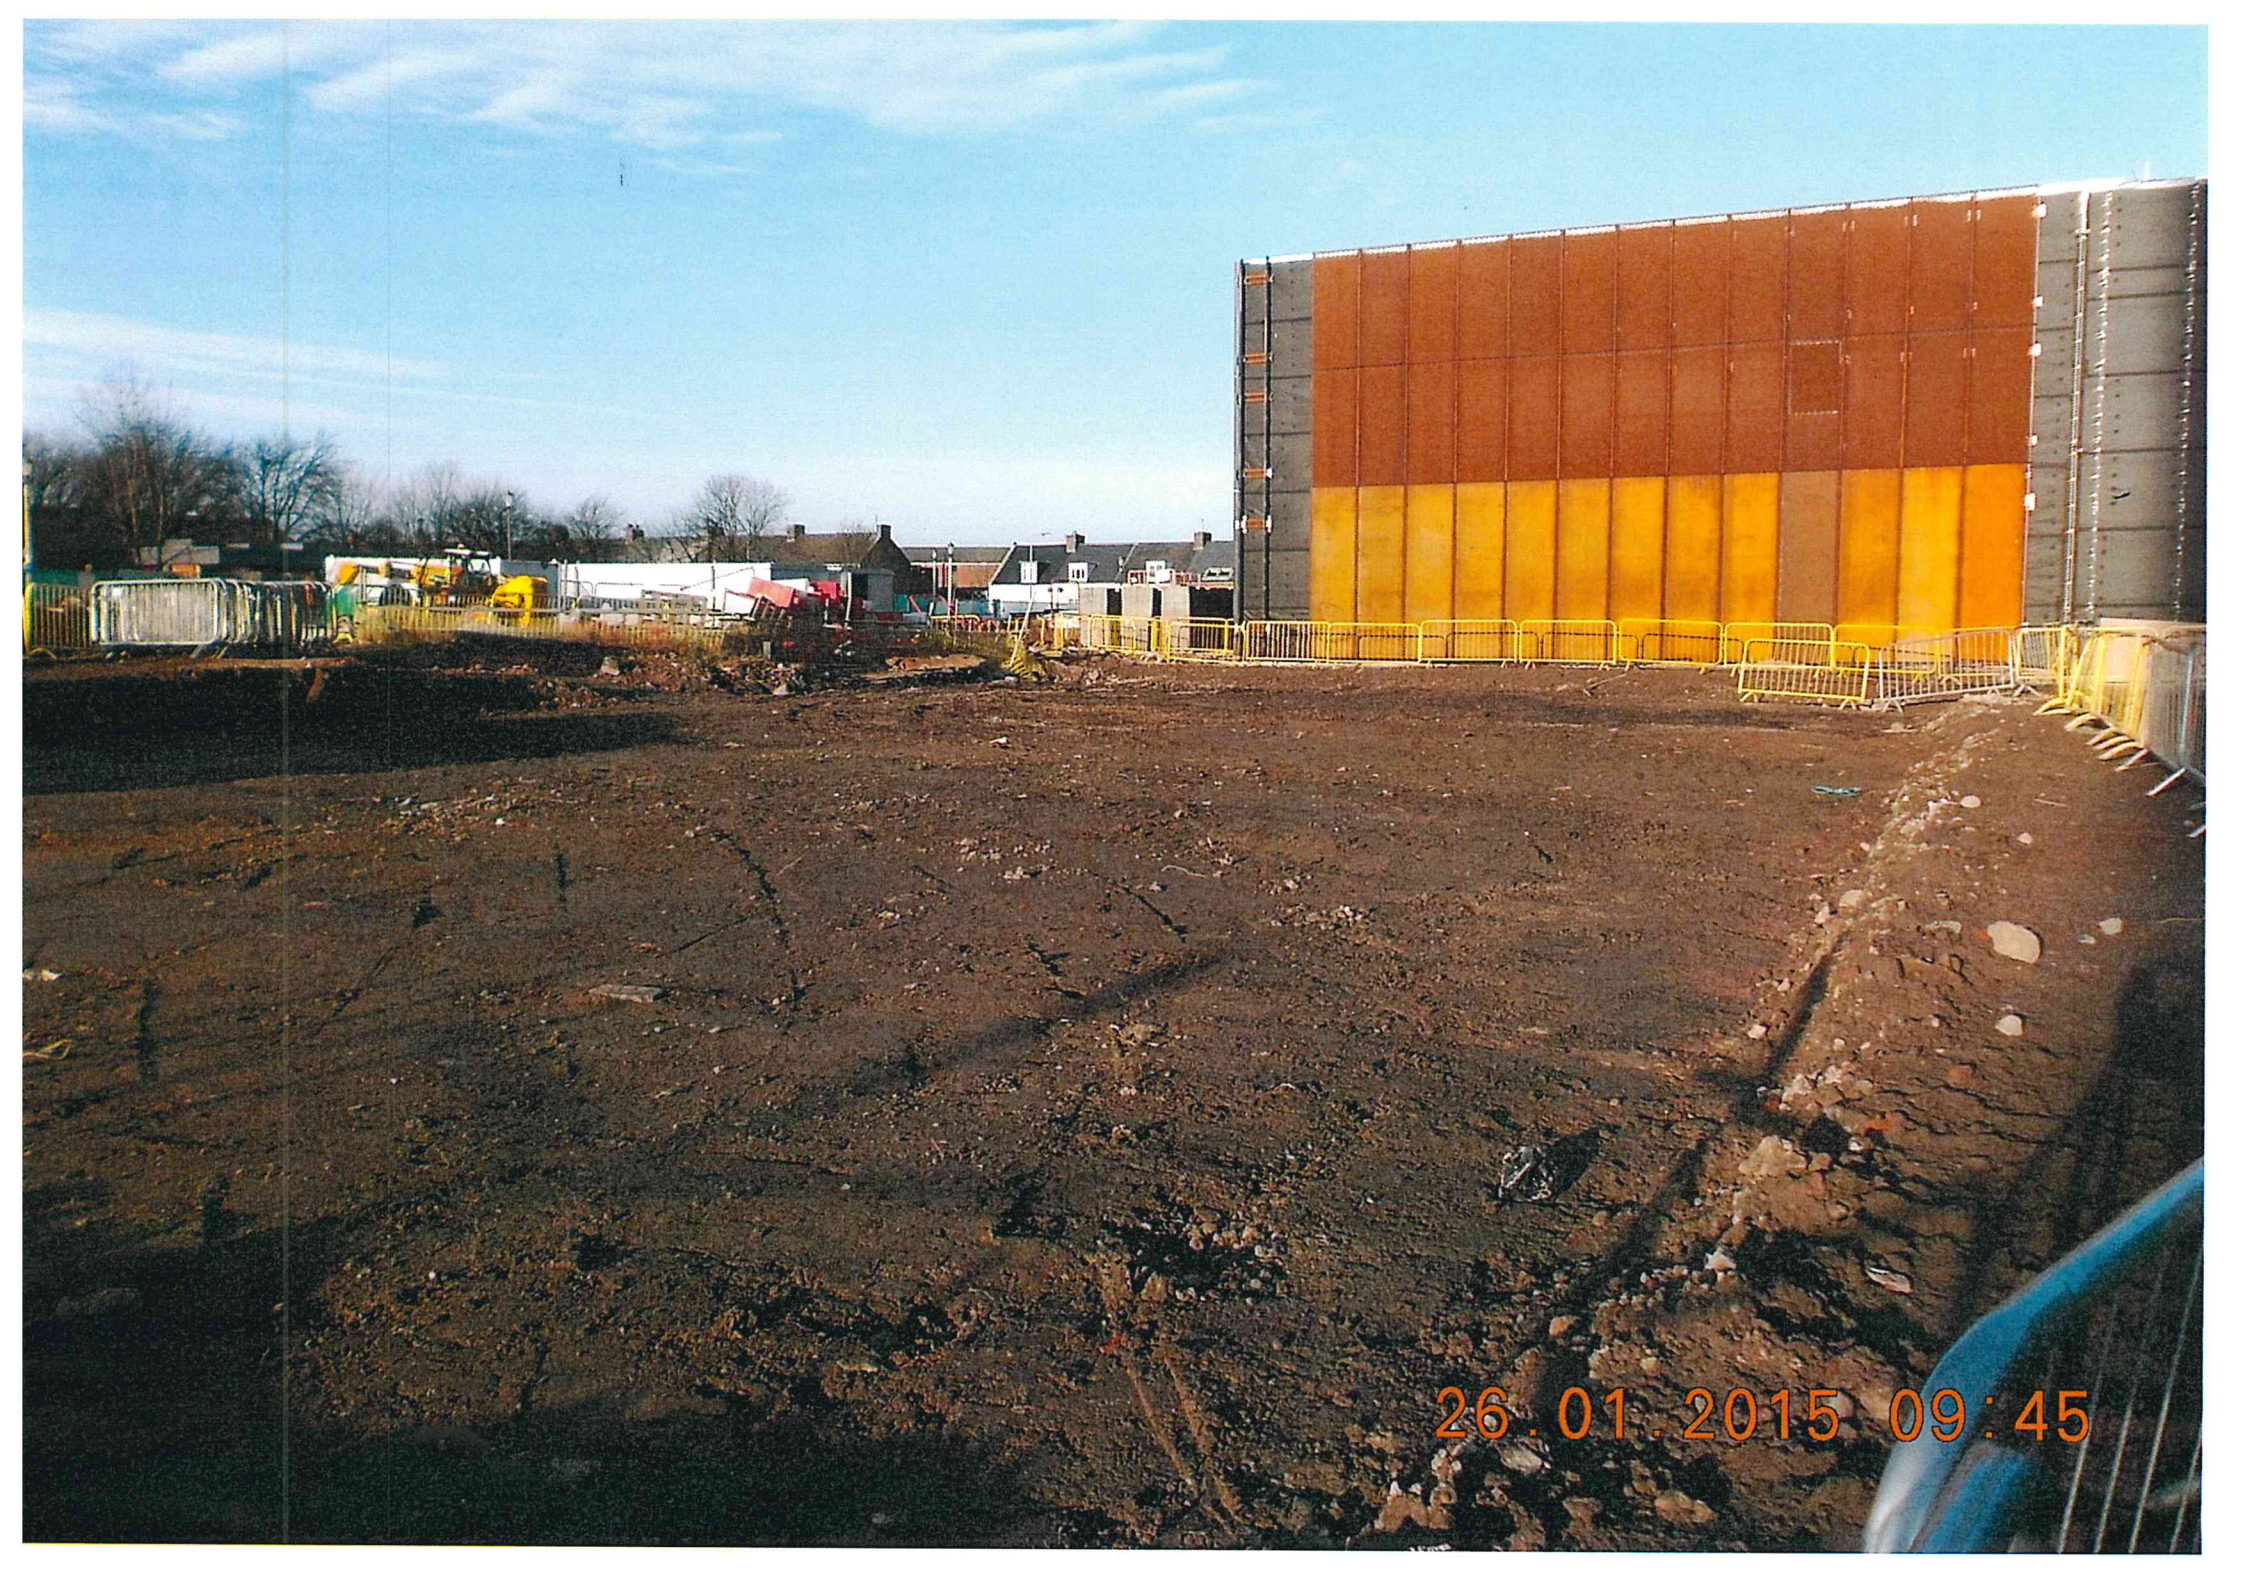
MUGA area (photographs and aggregate delivery notes)

- bituminous macadam base and wearing courses (150mm)
- aggregate stone sub base (Type 1 MoT) 200mm ,

The removal of soils from the MUGA with subsequent construction of macadam surfacing over compacted aggregate has mitigated the risks associated with direct contact / fibre inhalation in this area by providing the required engineered break in the pathways linking the contaminant source and receptors. Therefore, on this basis it is considered that the objectives of the remediation have been achieved.
