River Drive, South Shields
Phase II Geo-Environmental Assessment
For
Galliford Try Partnership North Ltd

| Report Ref | Issue | Prepared by | Date | Reviewed by | Date |
|---|---|---|---|---|---|
| 14643/SI | 1 | C Brewster | 19/1/15 | A Coverdale | 19/1/15 |

**River Drive, South Shields
Phase II Geo-Environmental Assessment**

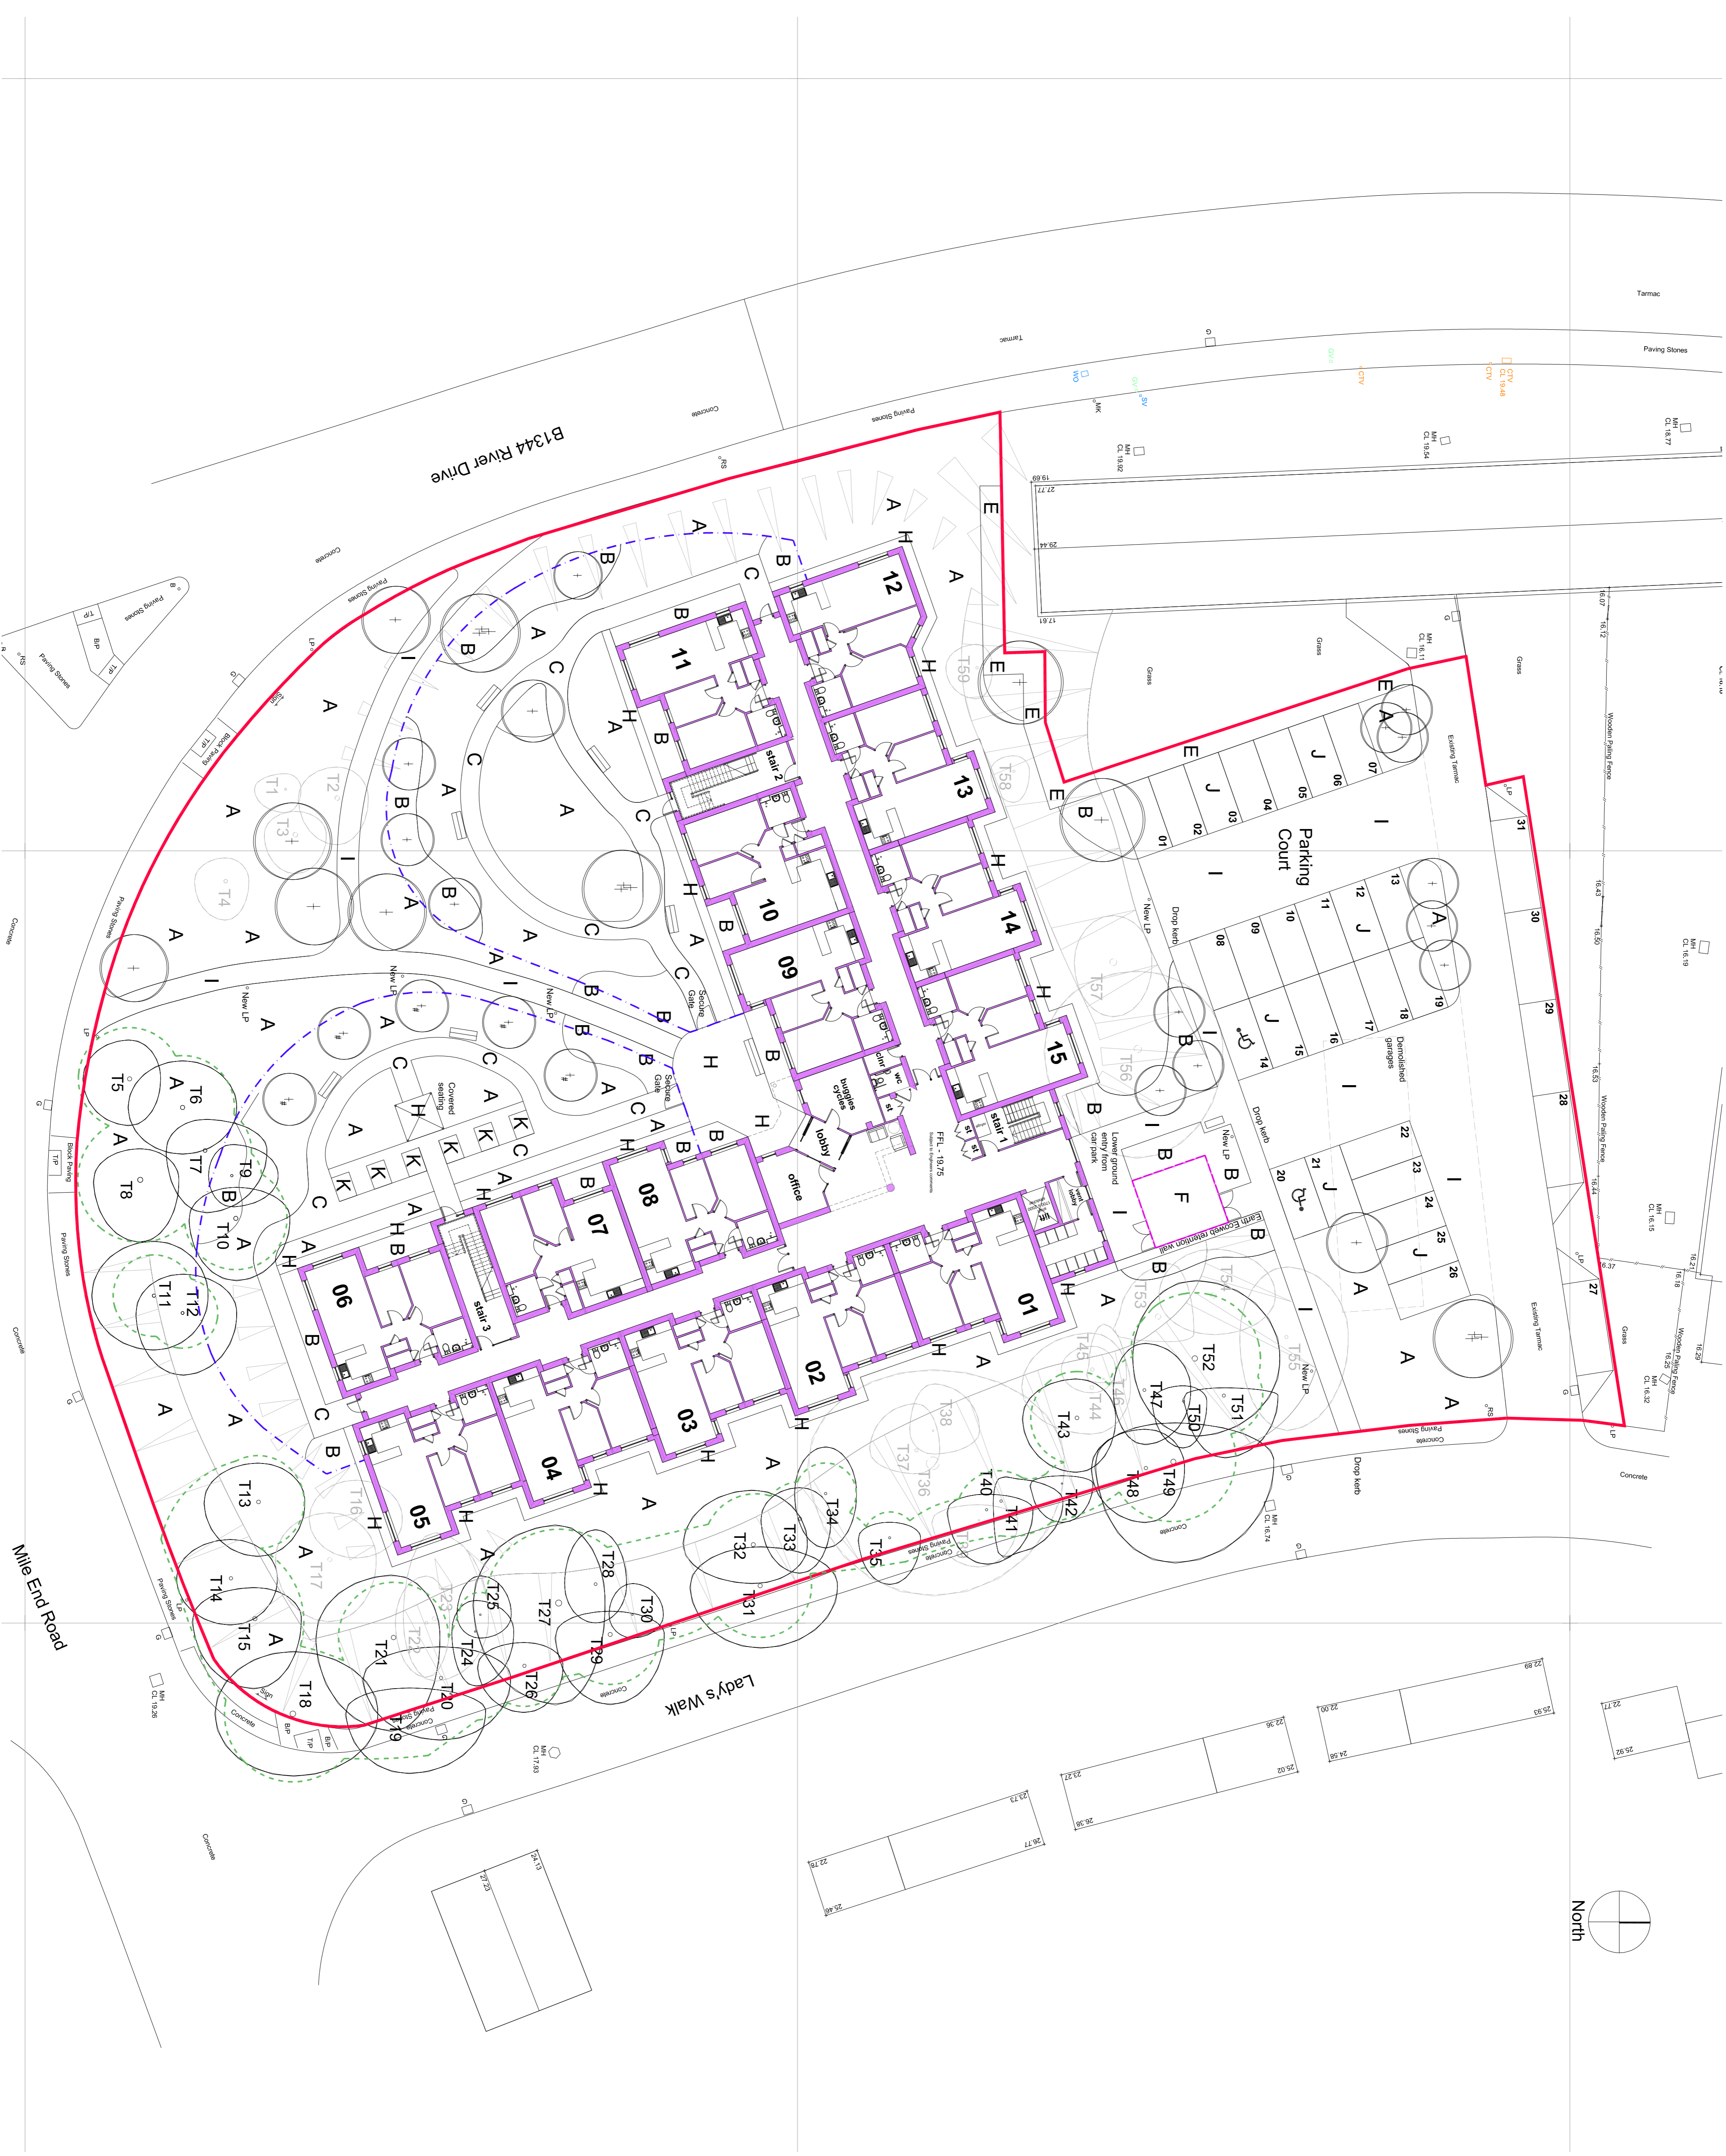
Proposed Development Plan

1.1 3e Consulting Engineers Ltd (3e) were commissioned by Galliford Try Partnership North Ltd to carry out a Phase II geo-environmental assessment of land located off River Drive in South Shields. The proposed development includes the construction of an over 55s residential apartment building with associated car parking and areas of soft landscaping, details of which are provided in **Appendix A**.

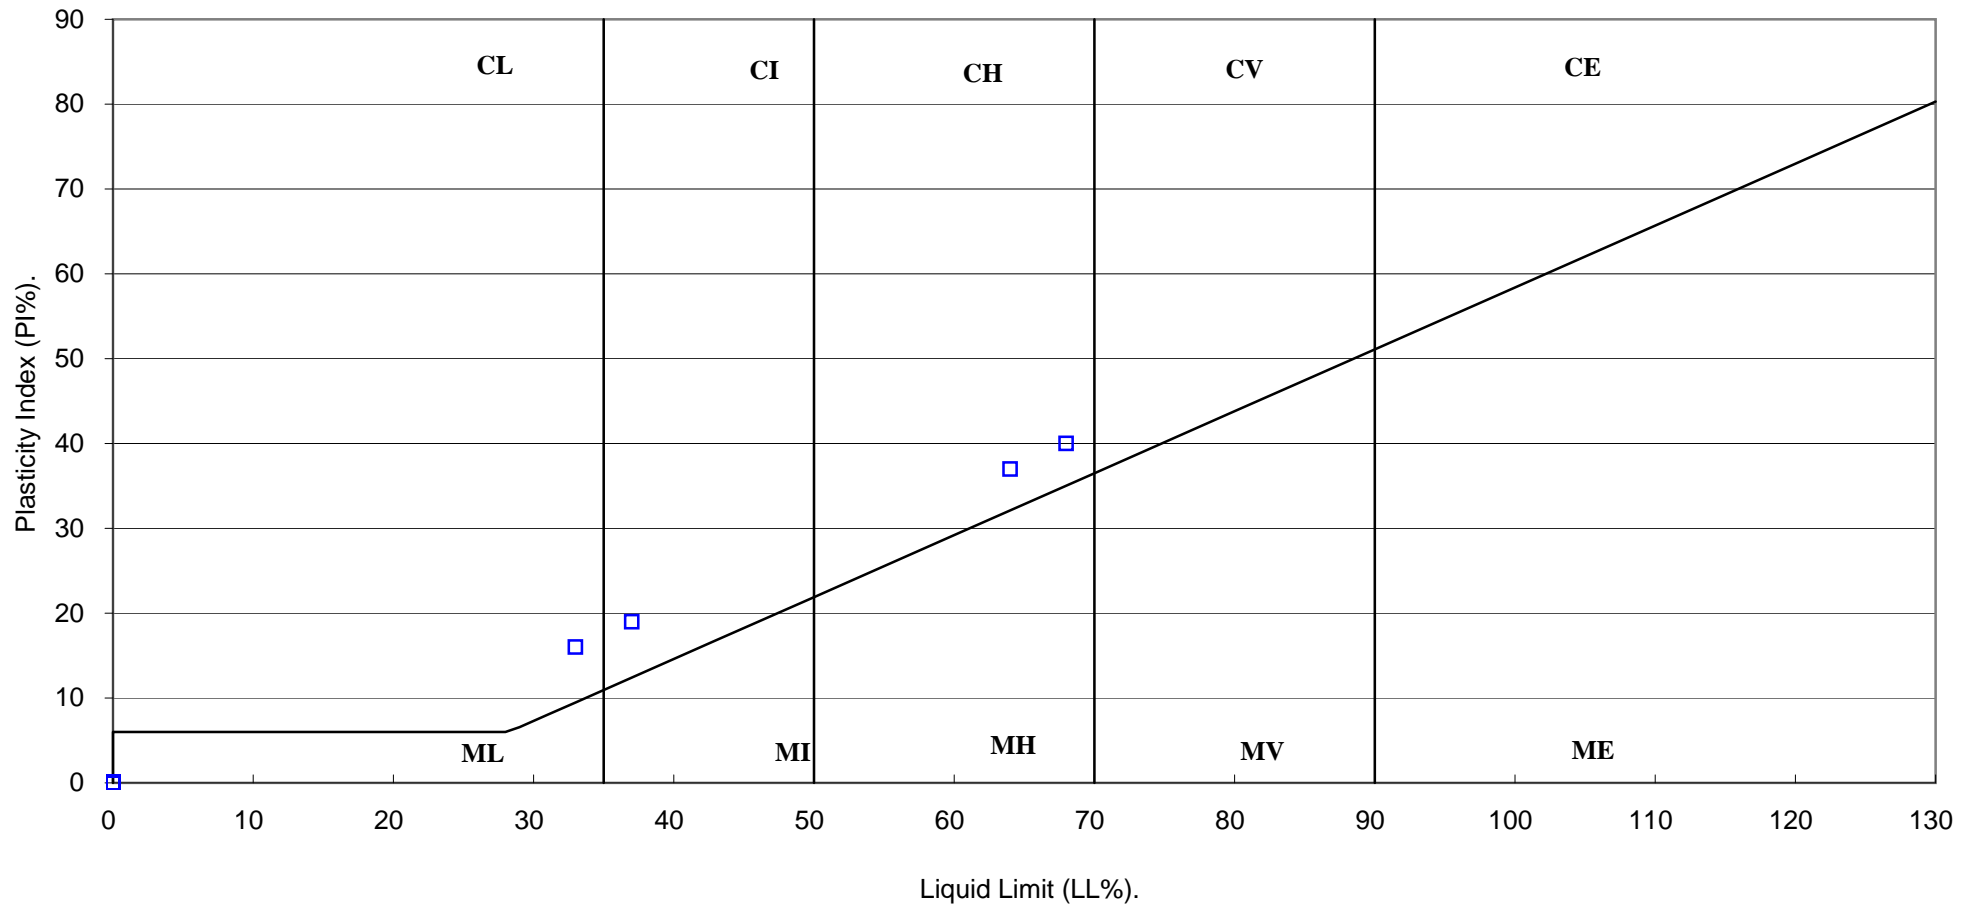
PLASTICITY CHART FOR CASAGRANDE CLASSIFICATION.

- Four Atterberg limits determinations to confirm field descriptions and classify cohesive soils.
